#### **PROTECTED SPECIES (BAT) SURVEY**

## CHURCH OF ST JOHN THE BAPTIST CHURCH LANE GRIMSTON LEICESTERSHIRE LE14 3BZ

October 2017

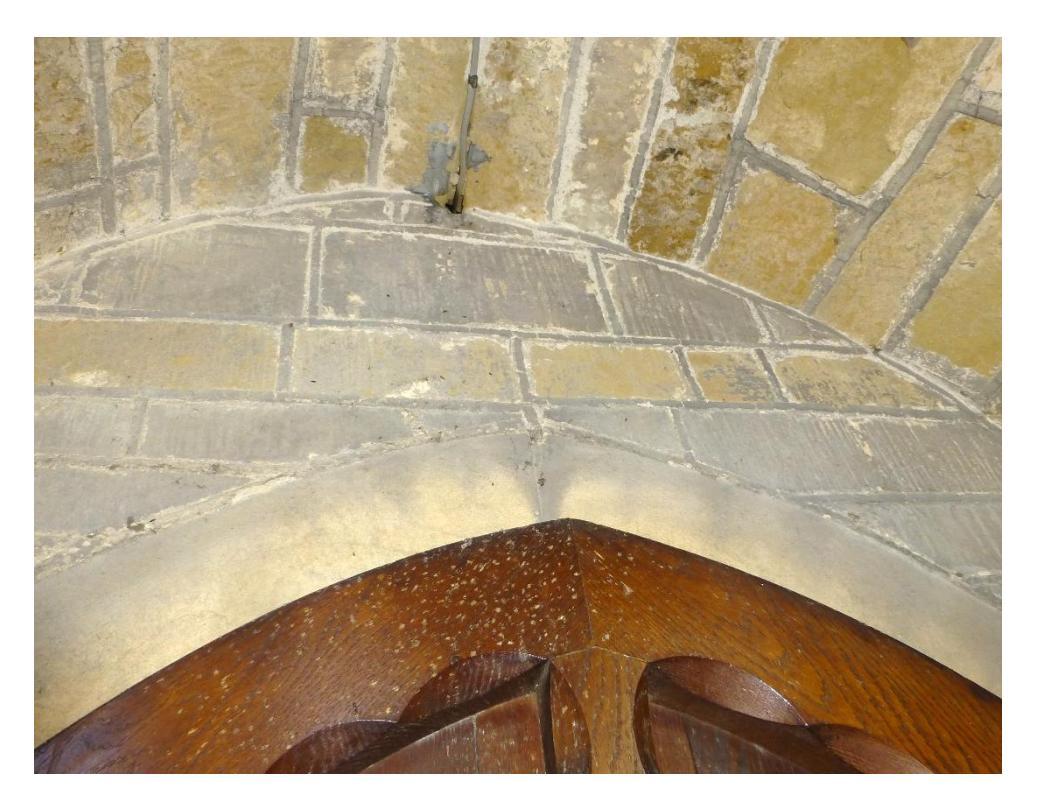
A summary of the findings of the visual inspection are provided in an annotated plan of the church in Appendix 1. The visual inspection identified a potential roost location within the wall between the nave and south porch where the wiring is inserted into the wall. Droppings of mixed ages, and of the size and shape typically voided by Pipistrelle bats were found on both sides of the wall. Urine staining was particuarly noticeable at the top of the timber door. This evidence is consistent with the findings of the 2008 survey. A gap exists between the door and stone surround which could serve as a potential access point.

Photograph 6: Interior of south door with urine staining from bats and droppings stuck to the stone work above

If works to either the door and surrounding wall are to be considered in the future then further survey work should be undertaken in the active season for surveying bats from May to end of August.

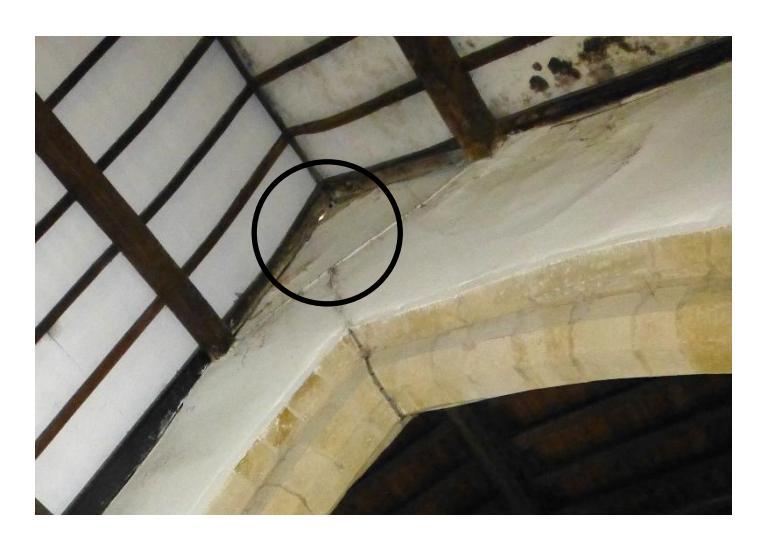
A feeding perch was identified in the chancel. Feeding remains of Yellow Underwing moth (*Noctua* sp.) had been collected from the same location on the floor of the chancel on a regular basis throughout July 2017 by the carers of the church. There is gap between the junction of the timber roofing frame of the nave and chancel arch which has potential to support roosting bats.

Photograph 7: Gap at apex of chancel roof and chancel arch

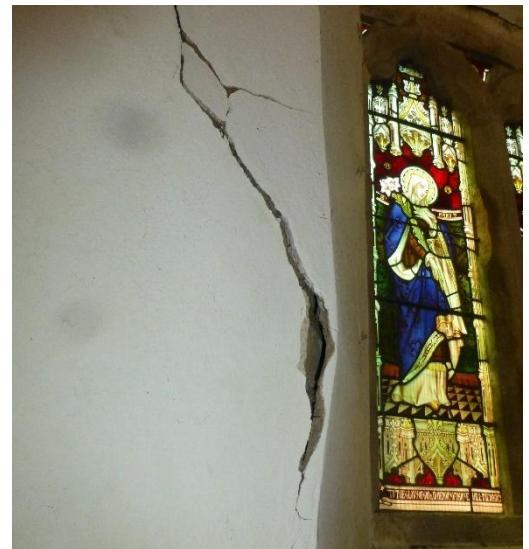
Wing fragments of overwintering butterfly species and old bat droppings were found on the floor and stuck to the walls beneath the bells and bell frame in the tower. It is possible that the butterflies have been consumed by a gleaning species of bat such as the Brown Long-eared which arouses regularly during winter to feed. This finding was also consistent with the results of the 2008 survey which identified a summer feeding perch in the tower. A gap was identified at the apex of the chancel roof at the junction of the exterior east wall of the nave. Day light could be seen penetrating through the roof covering and therefore it is possible this feature could serve as a potential access point into the church. Within the interior fabric of the church a potential roost feature exists between the plaster and the top of the stone surround of the south chancel window. There is also a large crack in the plaster to the east of the same window which also has potential to allow bats to roost behind the plaster.

Photograph 8: Gaps associated with plaster at south aspect of chancel

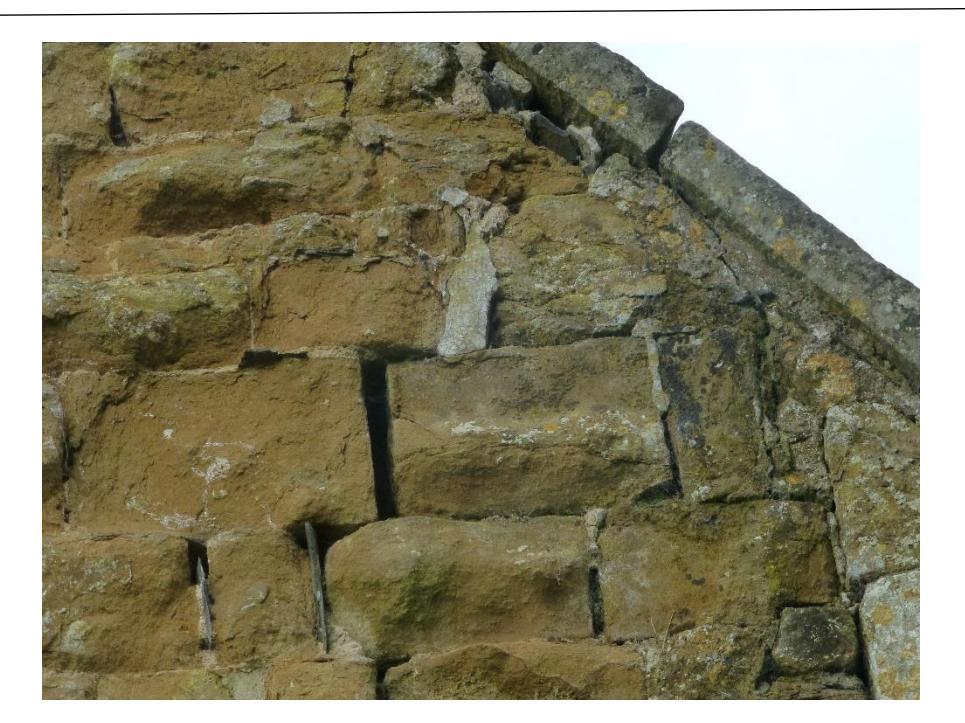
The exterior stonework is deteriorating creating numerous potential roost features suitable for crevice dwelling bat species, such as the Pipistrelles. Areas that were particularly badly affected include the east and north chancel walls, the north nave wall and the west and north aspects of the tower. Photographic examples are provided below. The gaps could serve as potential roost sites in themselves or as access to cavities within the walls. Areas of missing mortar were also identified at the eaves of the of south nave wall to the west of the porch and behind the timber barge board that supports the guttering on the west elevation of the porch.

Photograph 9: East chancel wall containing potential roost features

The extent of the works does cover potential roost features and therefore it is recommended that the niches provided in the stonework are inspected by a licensed bat worker with an endoscope prior to the repairs. If a bat or evidence of a roost site is found during this precautionary check works will have to cease to this area whilst further advice is sought. The resulting actions may be as simple as retaining the roosting feature, and leaving the immediate area undisturbed. In the event of a bat being found when an ecologist is not present a procedure has been supplied in Appendix 3.

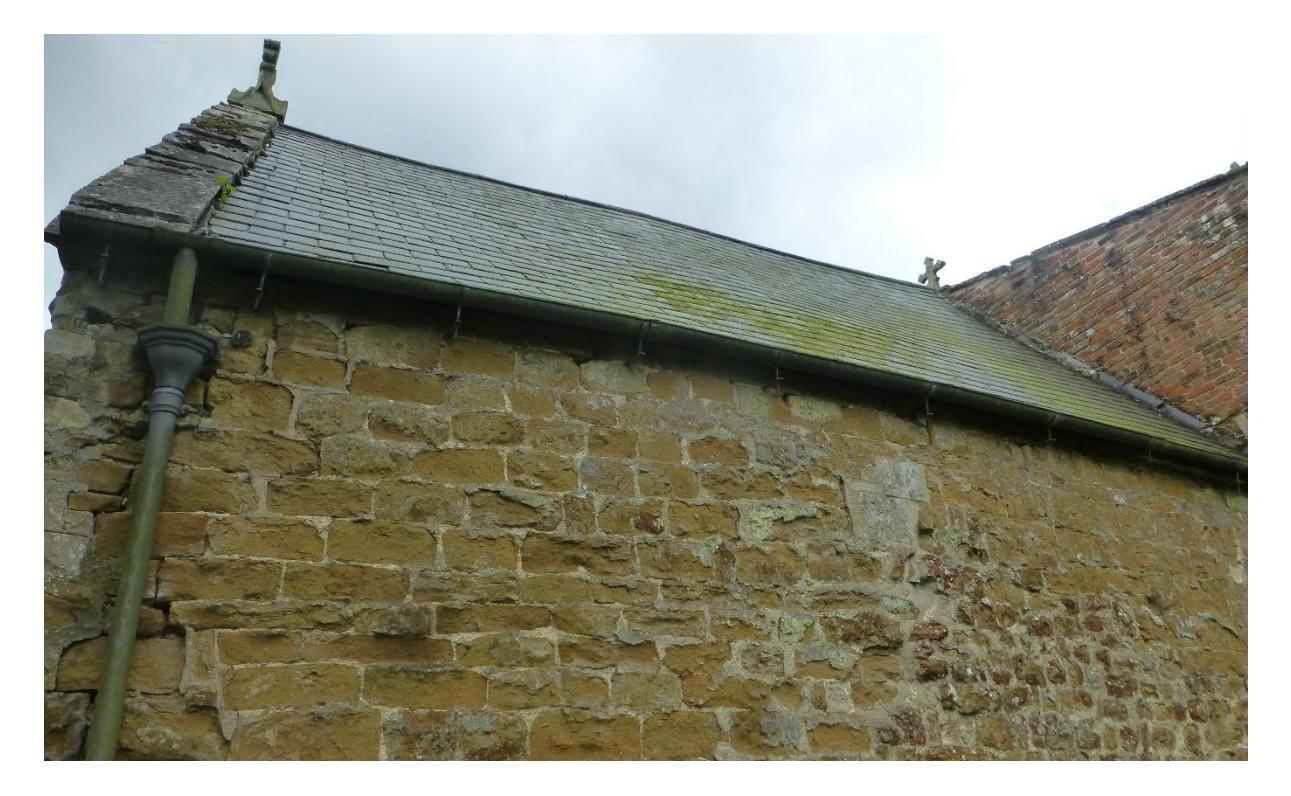
Photograph 10: North chancel wall with numerous gaps behind down pipe and below eaves

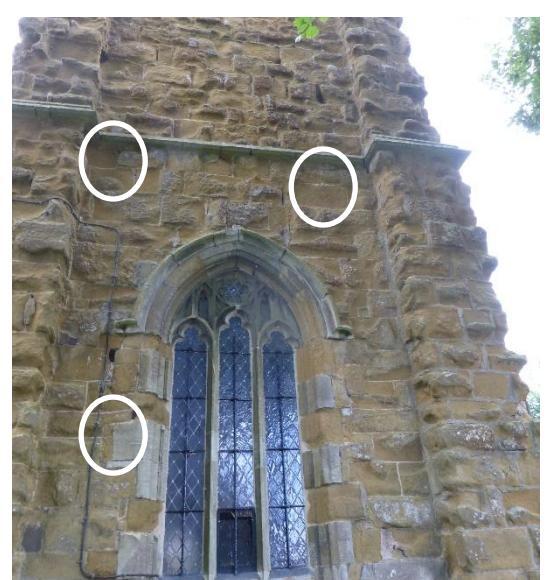
Photograph 11: West aspect of tower with gaps in stonework indicated

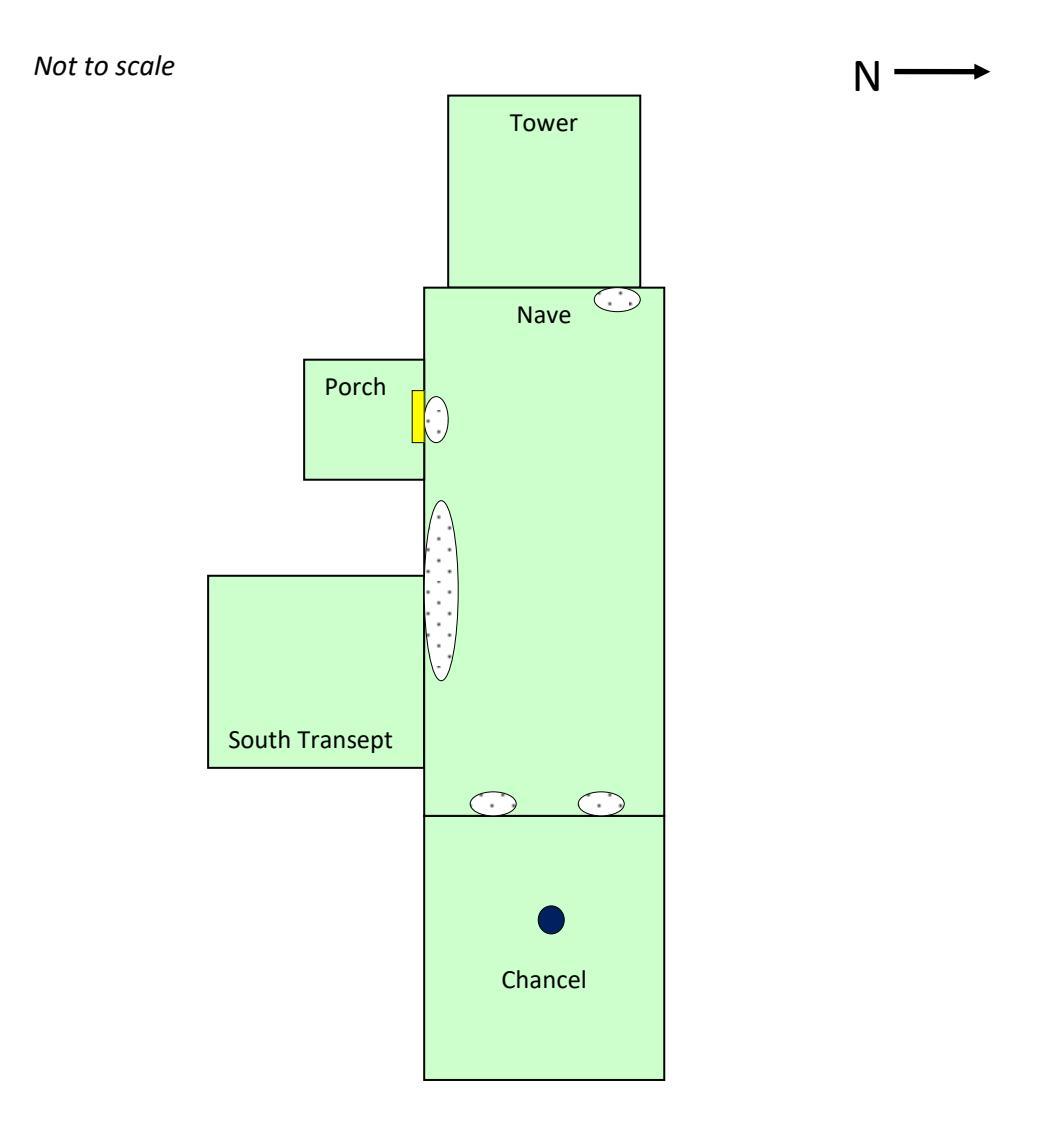
7.1 Appendix 1: Annotated plan of church with summary of 2017 survey findings

Access feature and Common Pipistrelle roost

Regular feeding perch (summer) used by Brown Long-eared
