**POST CONSERVATION REPORT ON THE WEST WINDOW BY CHARLES EMBER
KEMPE AT ST JOHN THE EVANGELIST CHURCH WATERBEACH**

Location: ST JOHN THE EVANGELIST CHURCH, WATERBEACH – WEST WINDOW BY CHARLES EMBER KEMPE

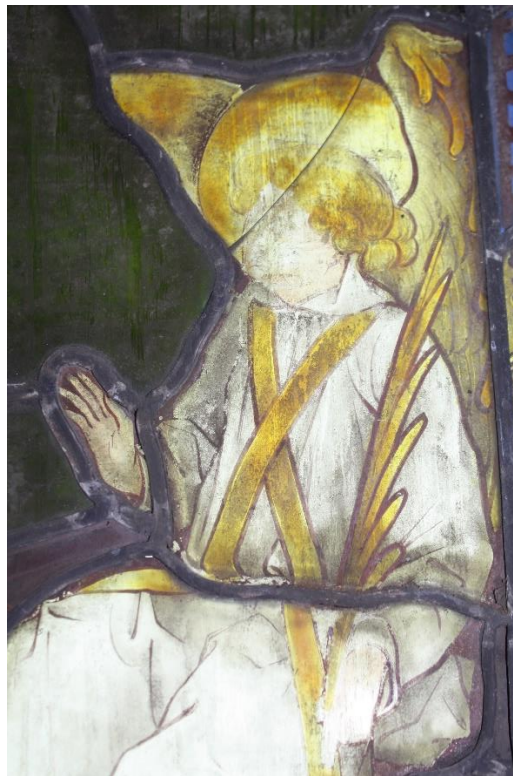
Figure 1: Example of the paint loss and fading which is typical across the entire window and also a single crack running through the head of the angel.

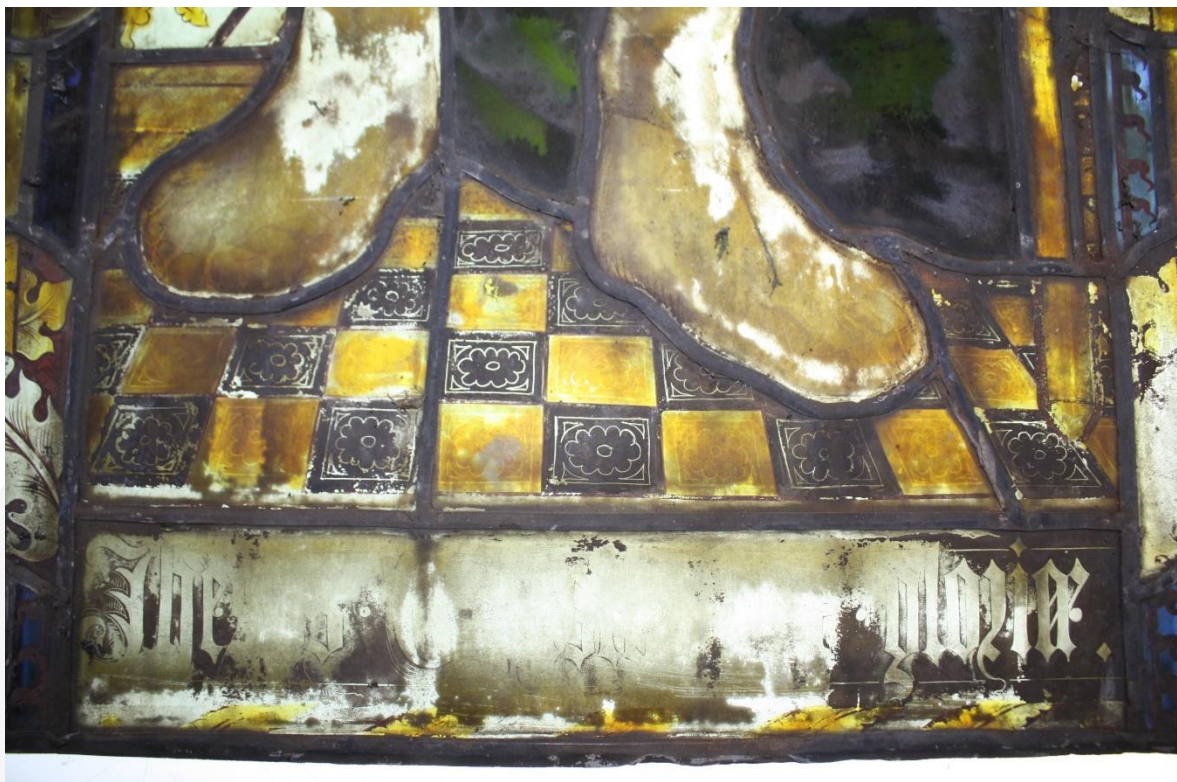
Figure 2: Detail of the extent of lost painted detail affecting the legibility of the inscription.
