THE REREDOS ST MATTHEWS CHURCH MARSTOW MONMOUTHSHIRE

Treatment Report
The Reredos
St Matthew's Church, Marstow, Monmouth

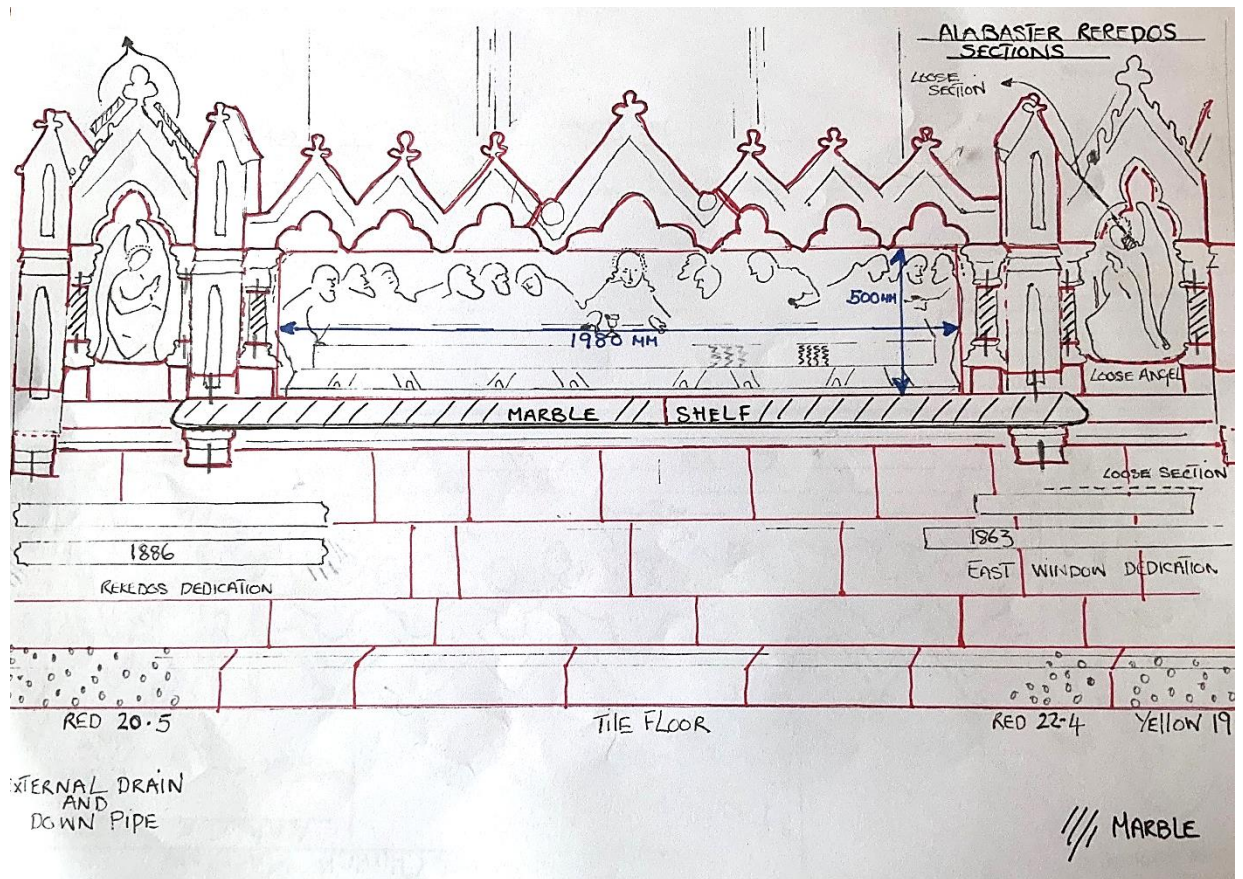
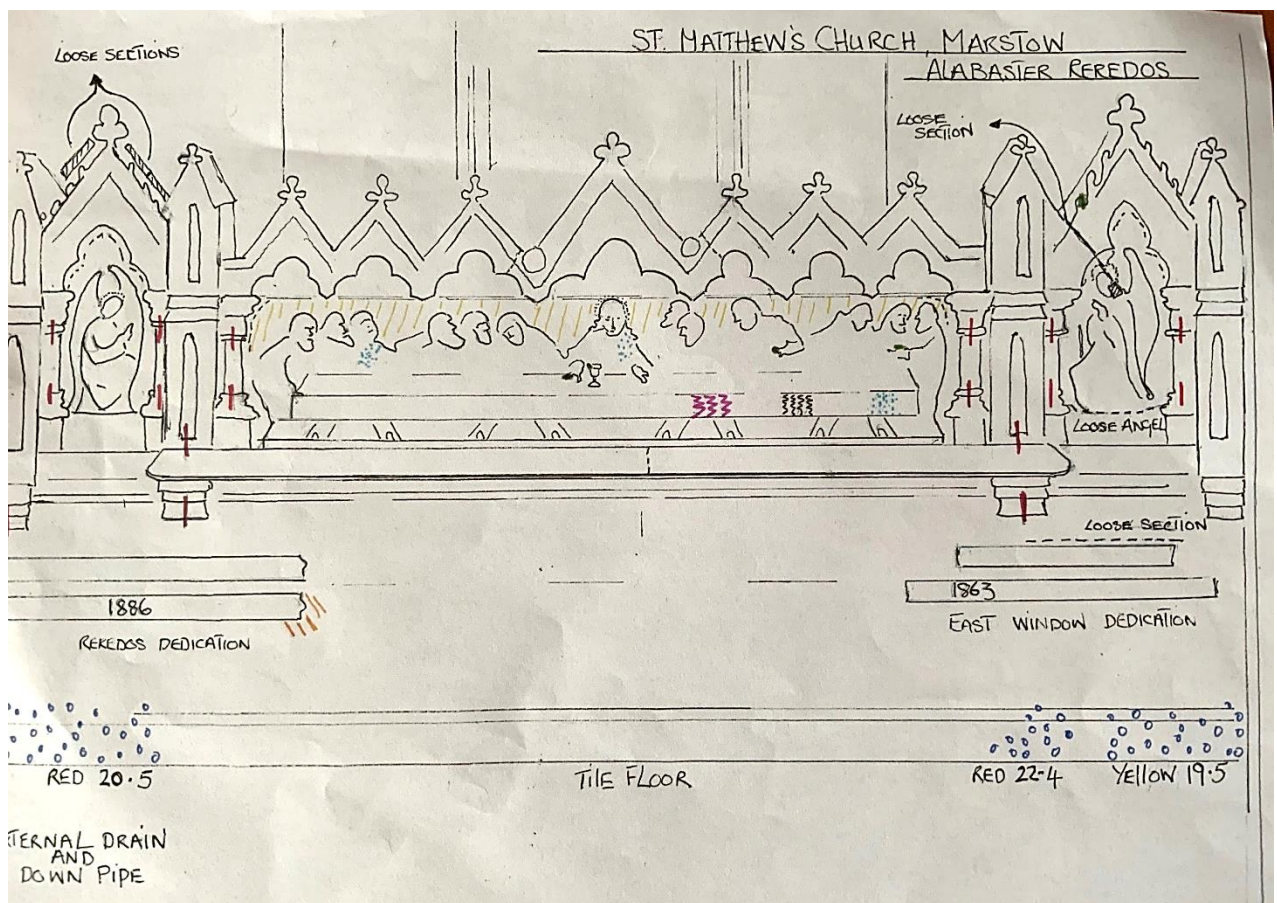
Figures 2 and 3 Site Records of sections, fixings, loose elements and cleaning trials

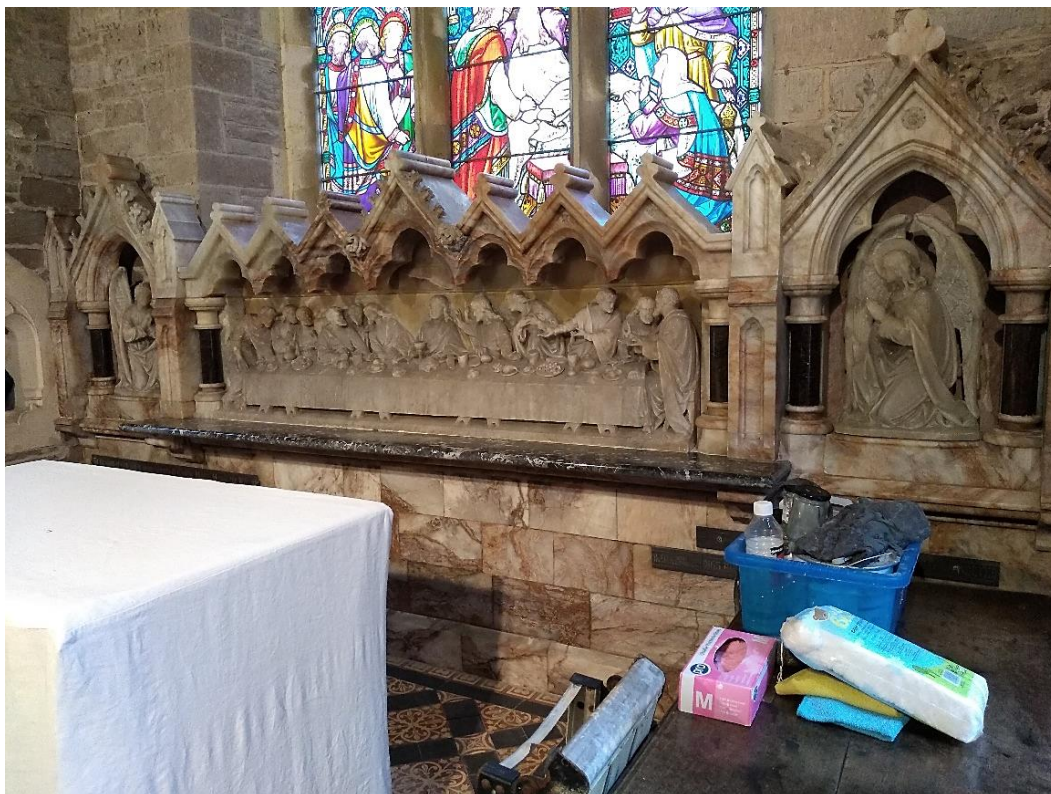
Figure 4: The reredos before the conservation programme

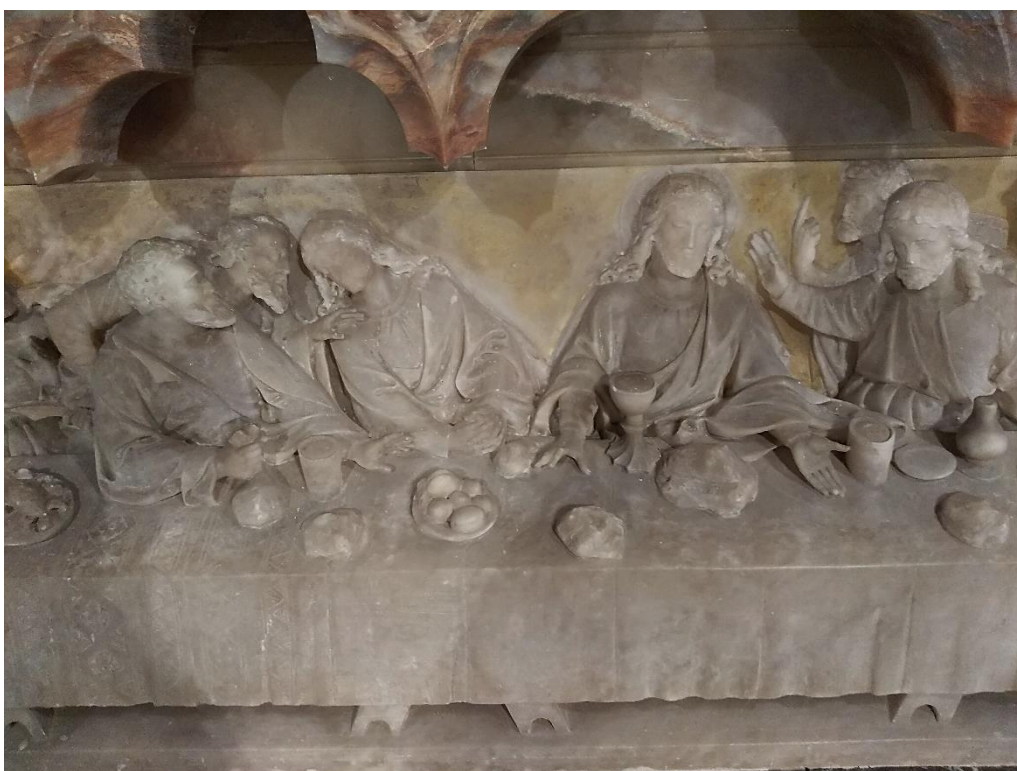
Figure 7: Detail of Christ and surrounding apostles showing the detail and movement to the carving. The ochre wash can be seen over the background and loss of fingertips most likely due to impact damage.

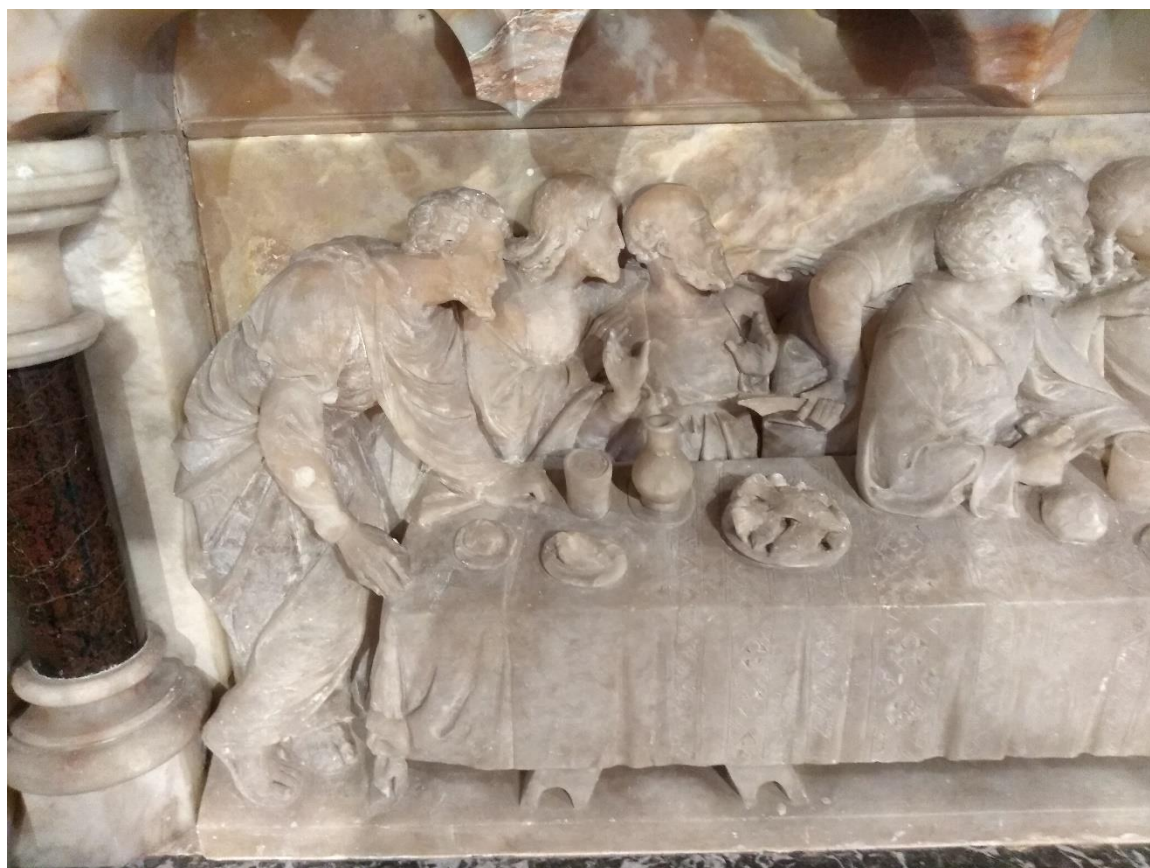
Figure 8: Detail of the dexter side of the carving illustrating the quality of movement and individual portraiture

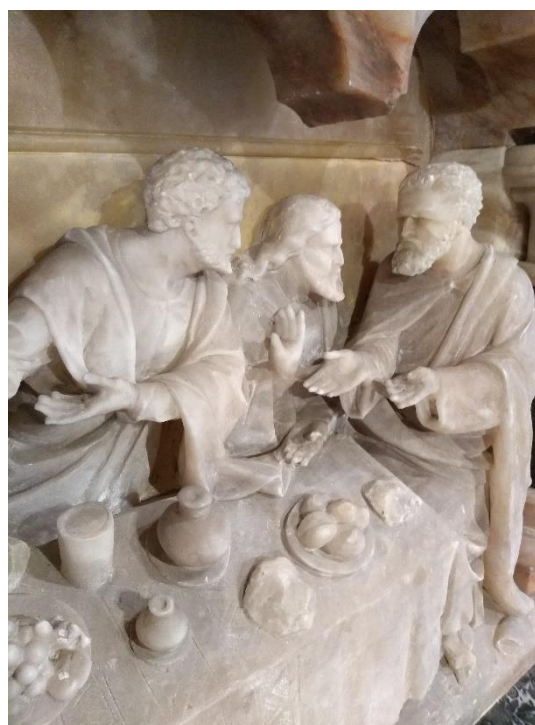
Figure 10: The sinister side of the carving showing further impact damage to fingers

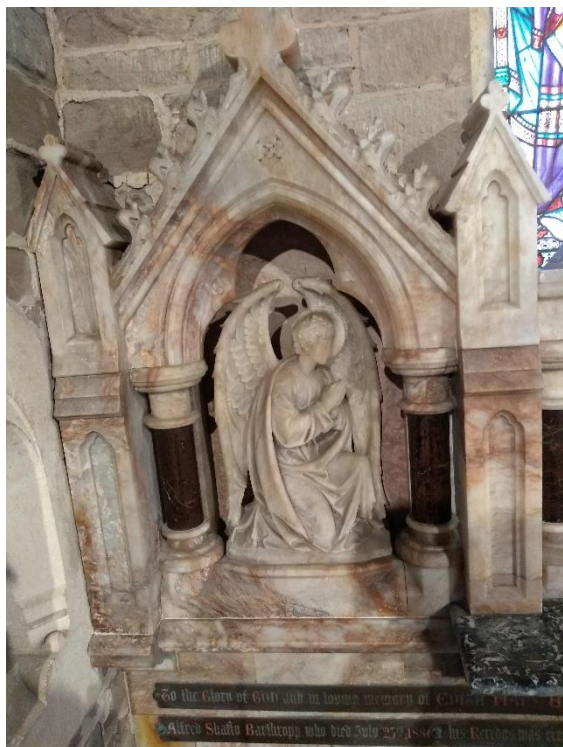
Figure 11: The dexter flanking angel showing the difference between the polished surface of the architectural setting and the duller areas of surface to the angel which may have been subject to an inappropriate cleaning programme

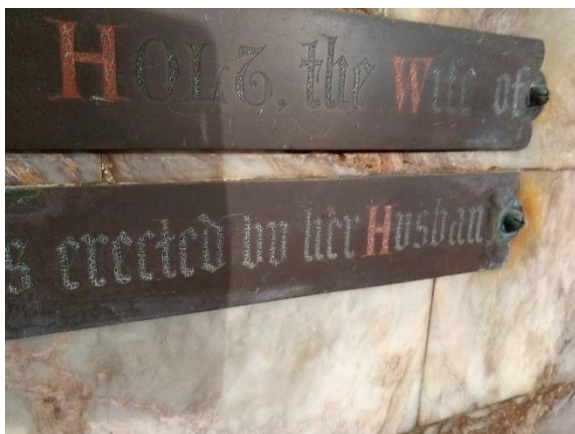
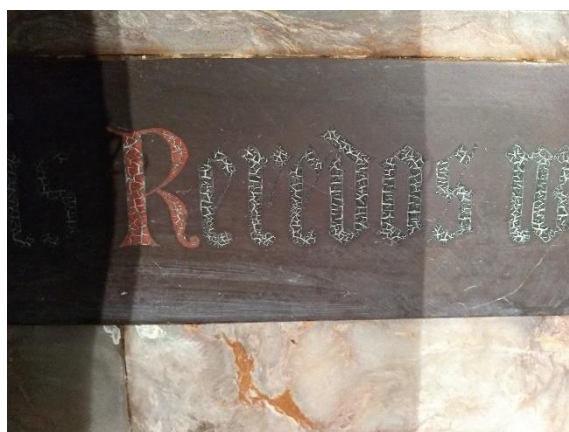
Figure 19: The coloured lettering to the dexter dedication panel. Not the iron staining caused by the fixings

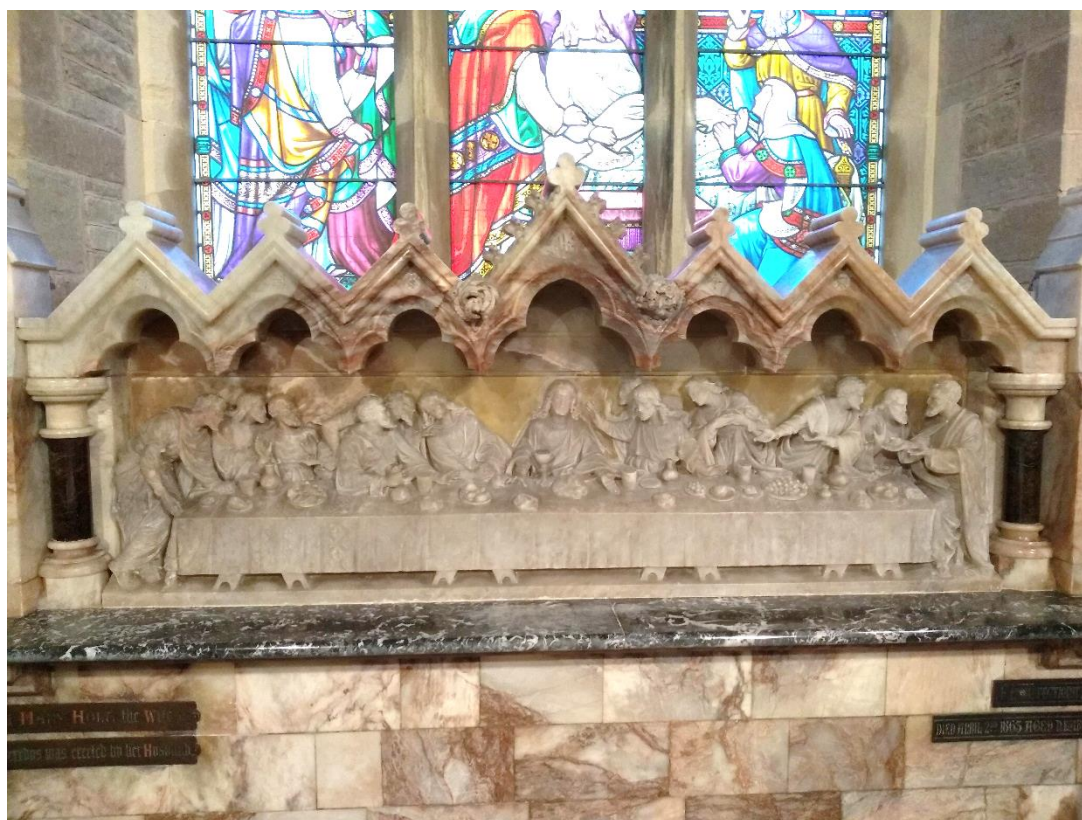
Figure 20: The reredos after cleaning and conservation repairs

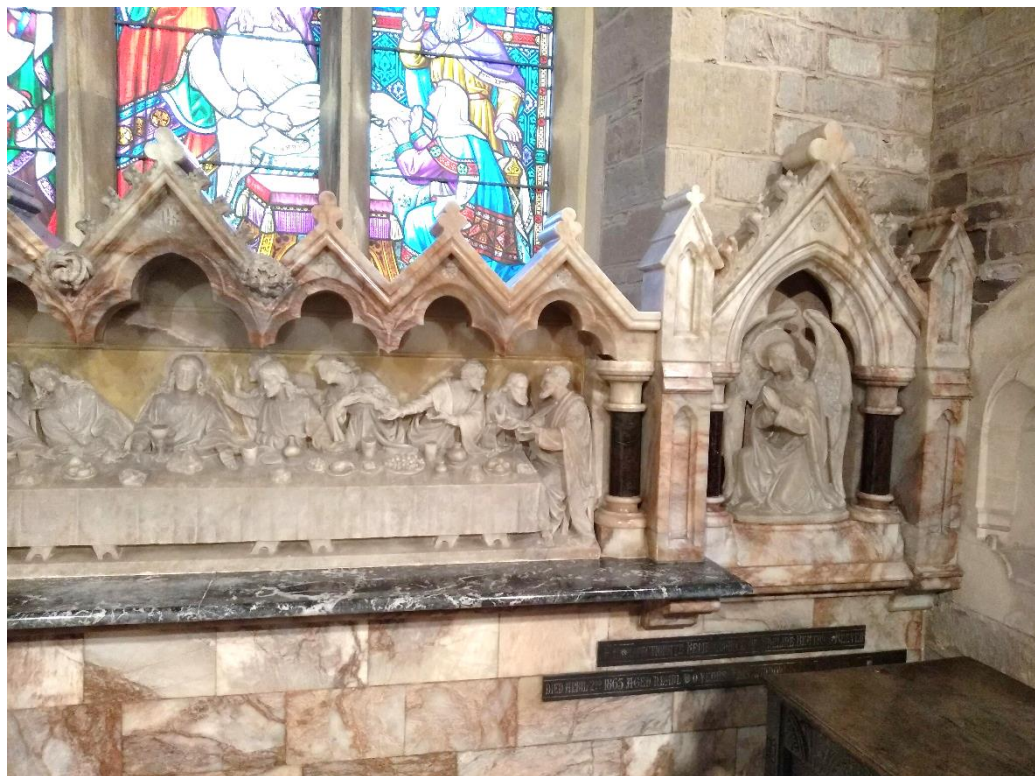
Figure 21: The sinister side after cleaning, repointing, repairs and protection

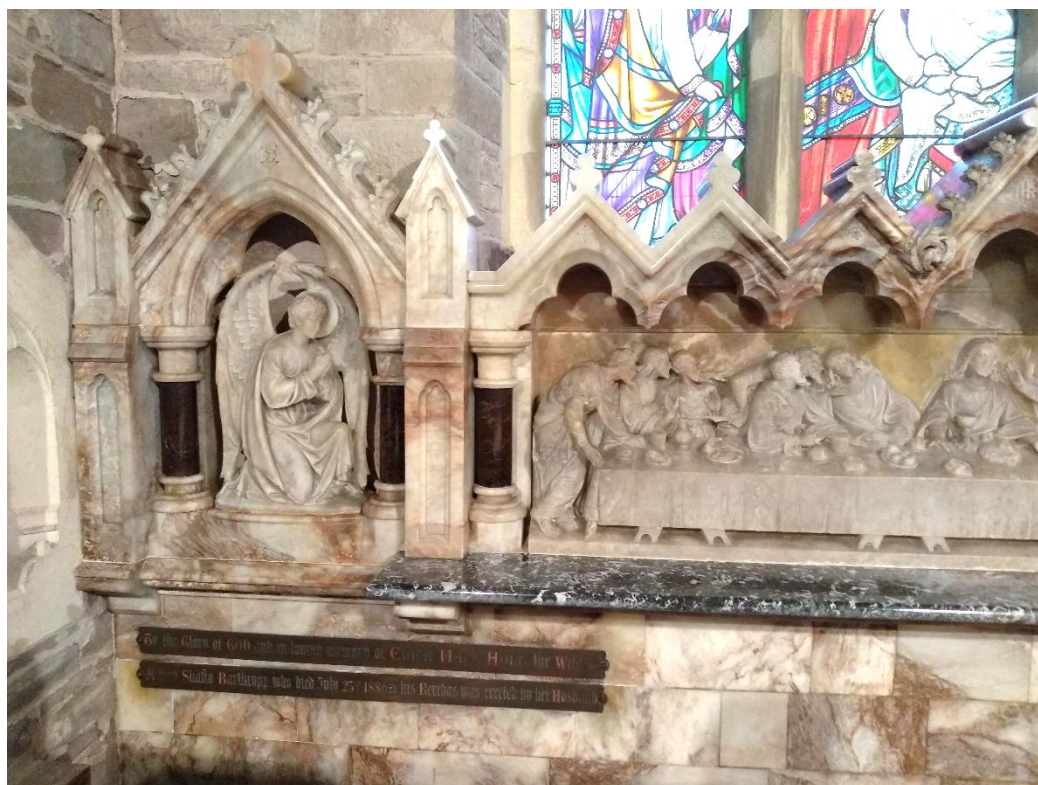
Figure 22: The dexter side of the reredos after cleaning and conservation showing the difference between the surfaces of the carved figures and the architectural setting
