Interim Report on the replacement of the nave floor of St Edburg's Church, Bicester, March 2020

Christopher Young, MA, DPhil, FSA 23 London Road Bicester OX26 6BU

April 2022

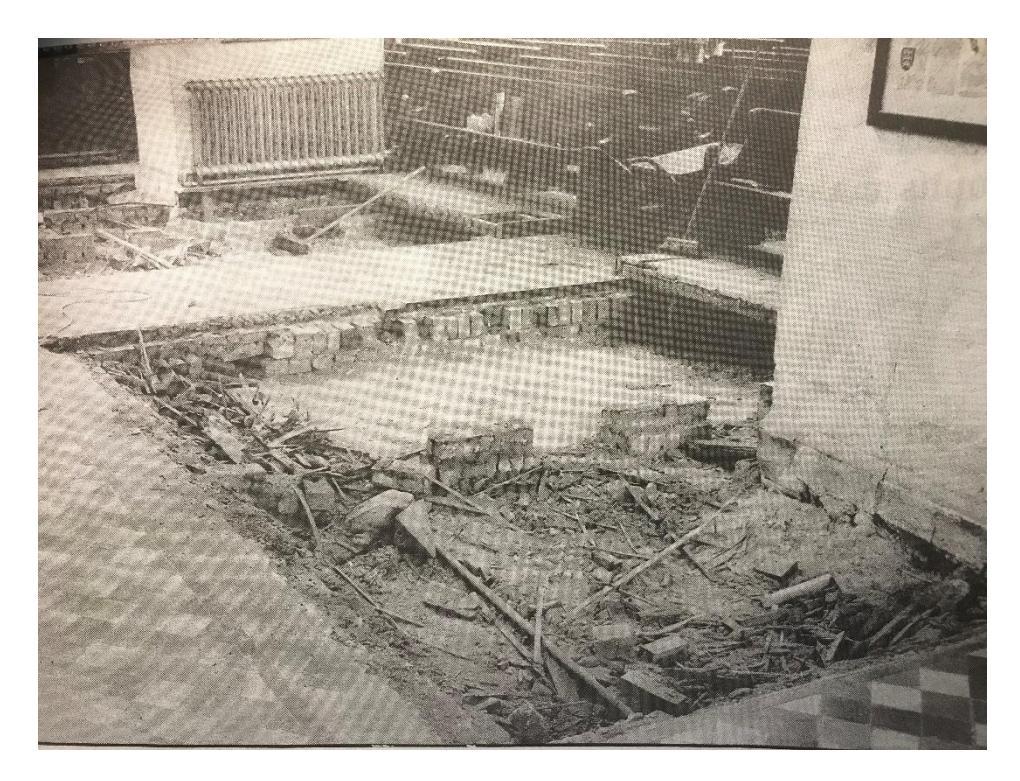
The building work was essentially the replacement of the suspended timber floors of the two pew platforms installed in 1862 by another suspended timber floor at a slightly lower level to provide a new level floor in the nave of the church. Some work was also done to the heating system to re site some of the radiators. All work was carried out within the void created in 1862, and there was no disturbance of archaeological deposits or structures. Possibly for this reason, the concrete layer reported by Mundin was not observed, and it may have been more obvious in section than in plan. No work was carried out within the crossing since pews there had been removed and the floor renewed when the platform for the nave altar was installed in 1994 (see Fig 1).

Fig.1 Floor replacement in nave crossing (Bicester Advertiser 8th July, 1994)

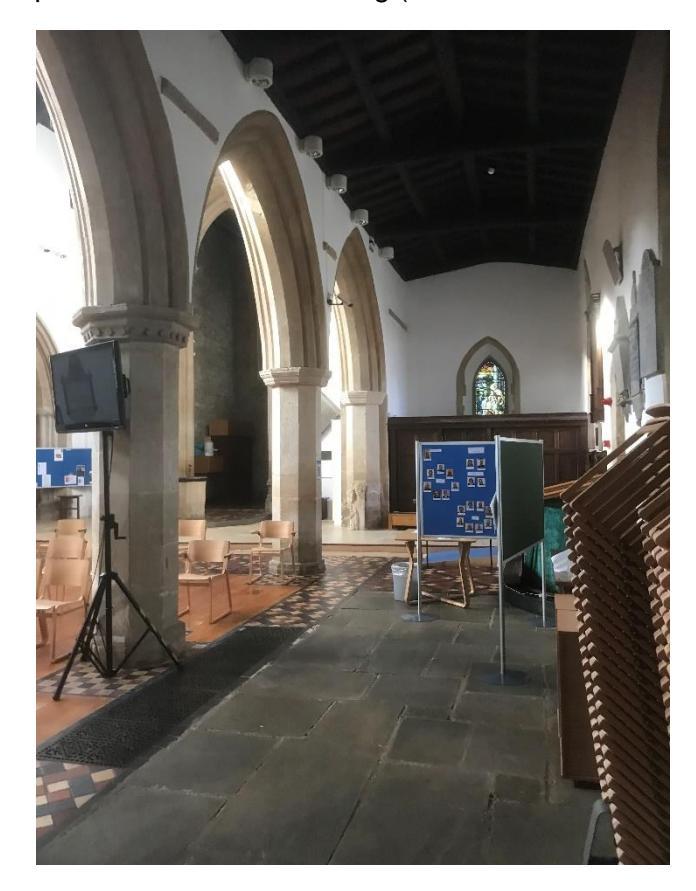
The earliest features found are the footings of the north and south walls of the nave from the early 12th century which were subsequently used to support the columns of the south and north aisles. The fact that an external string course with zig-zag ornament from the nave north wall survives at high level **above** the north aisle arcade (see Fig 2) shows that the openings were cut through the earlier wall and the columns and arches were inserted into the standing wall. The inner faces of both the south and north wall footings were observed. The outer faces were not seen and must lie under the Victorian tiled walkways. On the south side, the visible width of the wall is 1.2m from the edge of the tiled walkway, and on the north side 1.05m.

Fig 2 Nave north wall showing exterior string course pierced by aisle arcade

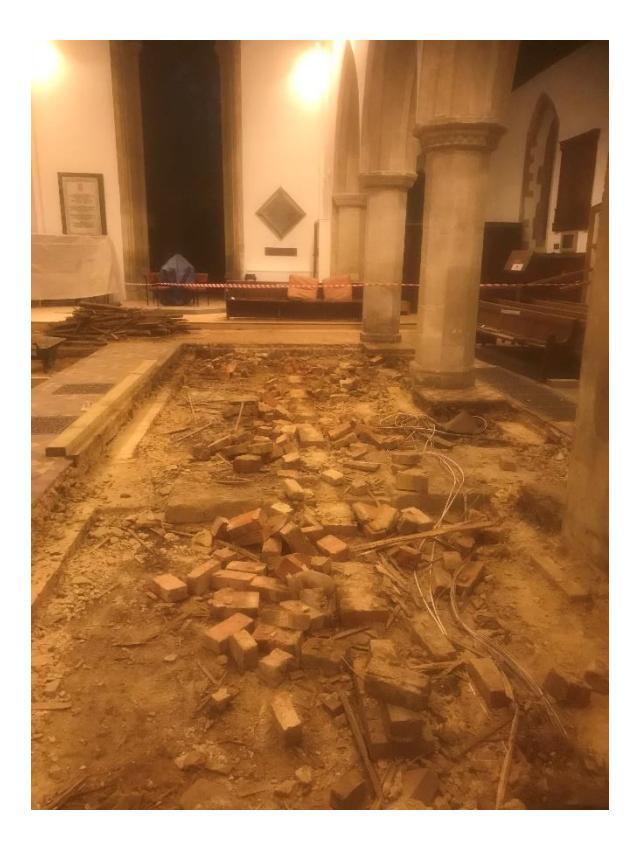
The eastern limit of the work was therefore within the 1862 floor void. The western limit of the work was the west end of the void. To the north and south, the edge of the 1862 void followed the edge of the tiled walkways installed in 1862. These came out to surround the column bases of both nave arcades so that there are series of rectangular projections into the void. The new floor follows the same plan (see cover picture). The work was observed archaeologically and records were made of features visible once the old floor structure had been removed and the debris left in the void in 1862 had been removed (see Figs 3 and 4)

Fig 3 North pew platform removed

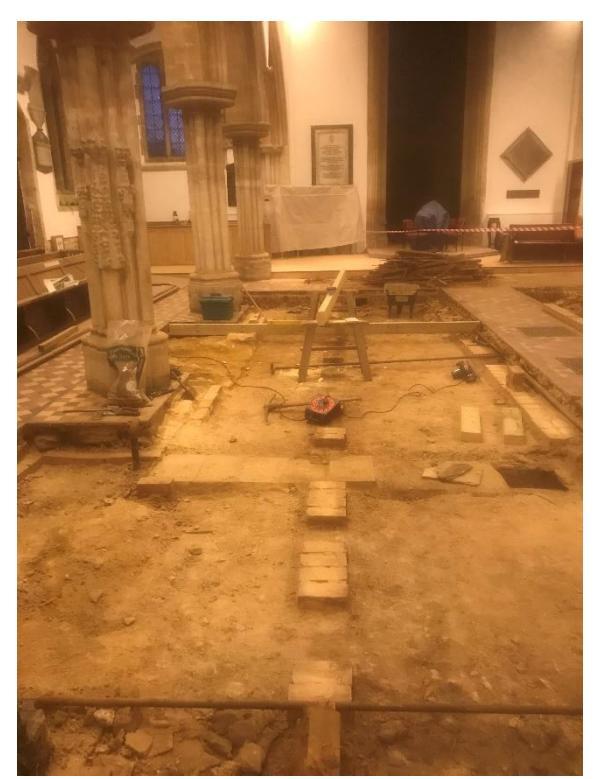
Because of the width of these pew platforms, the joists were further supported by an eastwest stretcher running the full length of each pew platform. This was supported on a series of dwarf brick piers built off the floor of the void. There were 11 piers on the south side and ten on the north. The bricks were laid flat with their long axis north-south. The piers were only one brick high and the number of bricks laid side by side in each pier varied from two to five (see Fig 4).

Fig 4 South pew platform debris cleared

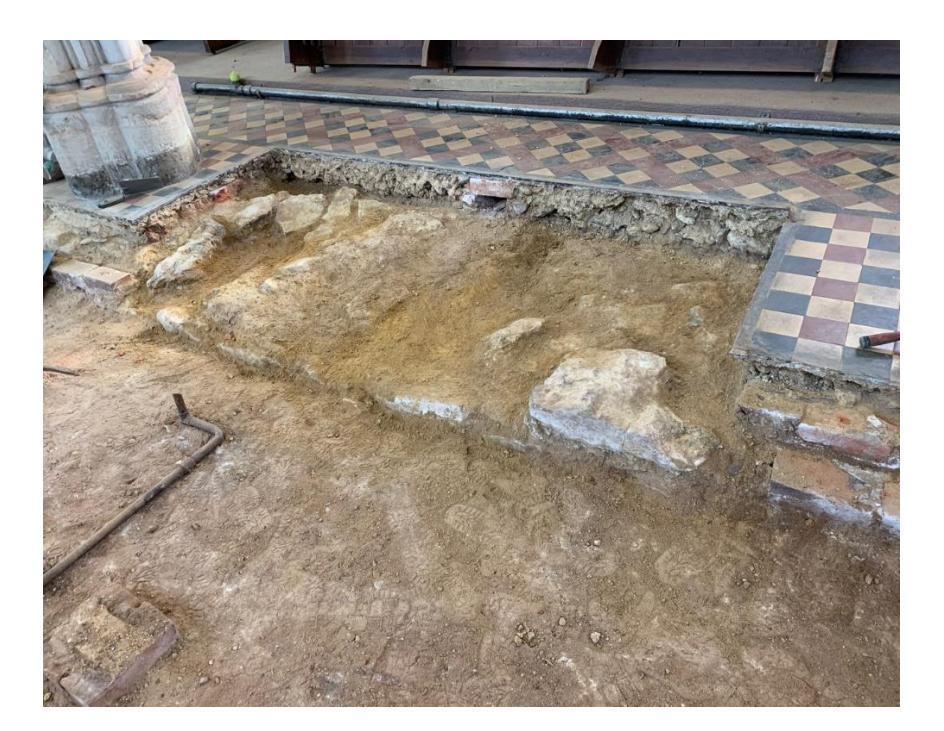
The wall footings were best preserved on the south side; where between the second and third pillars from the east the top few centimetres of the facing stones were seen (Figs. 5, 6). The largest stone is over 0.5×0.35 m while the others are around 0.4m along the wall face. The remains suggest that the wall has a rubble core set in sandy mortar which obscured the rear faces of the facing stones. The reason for the better survival of the wall in this bay is not clear, but it is possible to trace the footings of the south nave wall for the whole length of its exposure.

Fig. 5 South nave wall footing from north; gas pipe visible on left

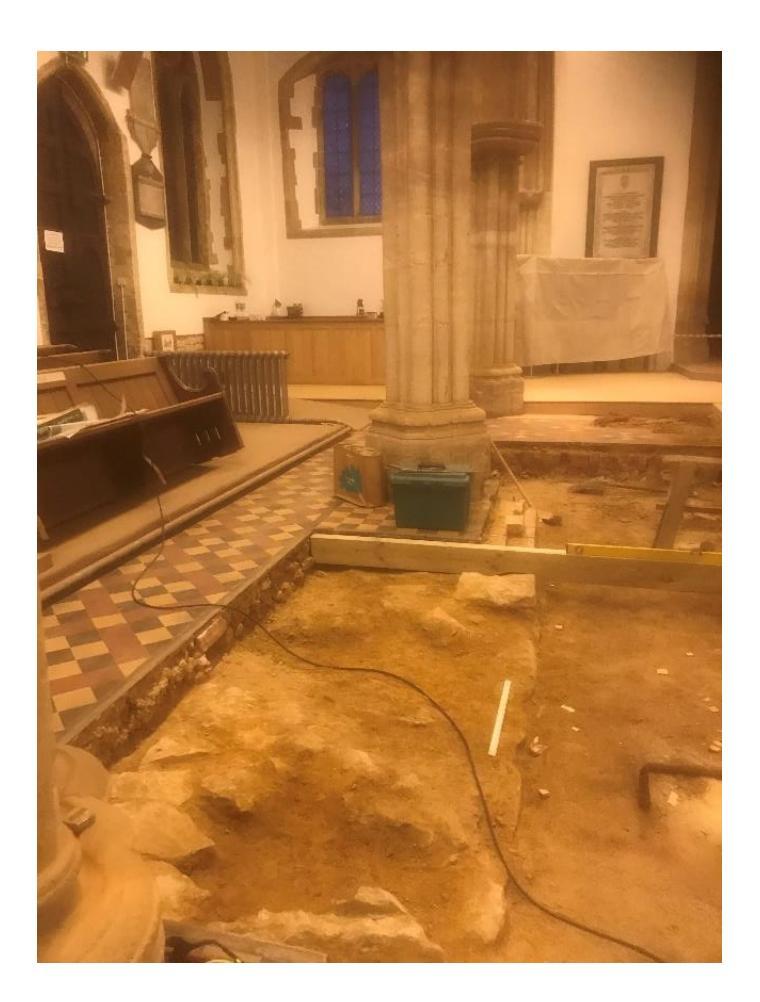
Fig 6 South nave wall footing from east (scale 0.5m)

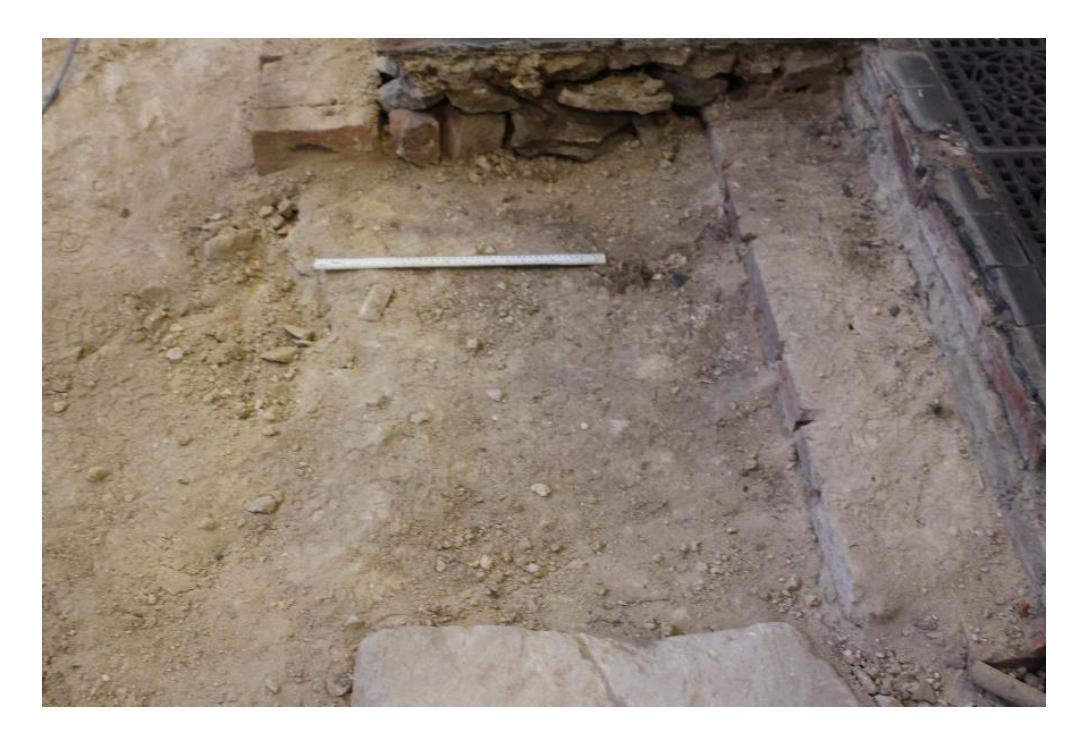
pier are at a slight angle to the overall alignment of the north aisle arcade and the footings of the north wall of the nave. The facing of this pier appears to drop vertically as opposed to the other piers in this arcade which appear to sit on the wall footings. The difference in alignment and the apparent greater depth of the pier foundations may suggest that it is a survivor from an earlier building, which would also account for its different alignment and the incorporation within it of the triangular-headed opening to the north of the nave. Equally these facts could just indicate the role of this pier as one support of the putative crossing tower. While the remains of the north nave wall footings are less diagnostic than those of the south nave wall, the wall is clearly there with a mortary matrix and an apparent face, of which the top course of facing stones may have been robbed, around 1.05m from the edge of the tiled walkway (Fig 6).

Fig 7 North nave wall footing from east (scale 0.5m)

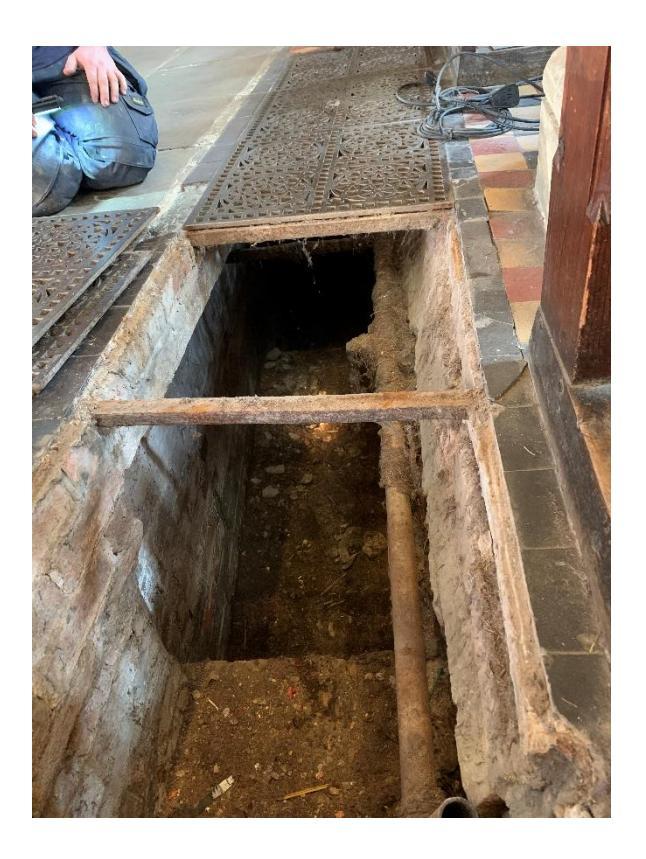
A boiler in a chamber under the north aisle heated hot air which passed through large ducts and entered the body of the church through iron grilles in the north and central tiled walkways. Access is possible to the ducts, almost high enough to stand in, in both aisles and further investigation is needed in due course. That in the north aisle curves round towards the boiler house (Figs.8 - 10). The one in the central aisle stops on either side of the end grilles in the floor and it is not yet certainly established how heat would have reached it. It could have been served by a duct from that in the north aisle or it could have contained its own furnace.

Fig 8 Entrance to north aisle duct

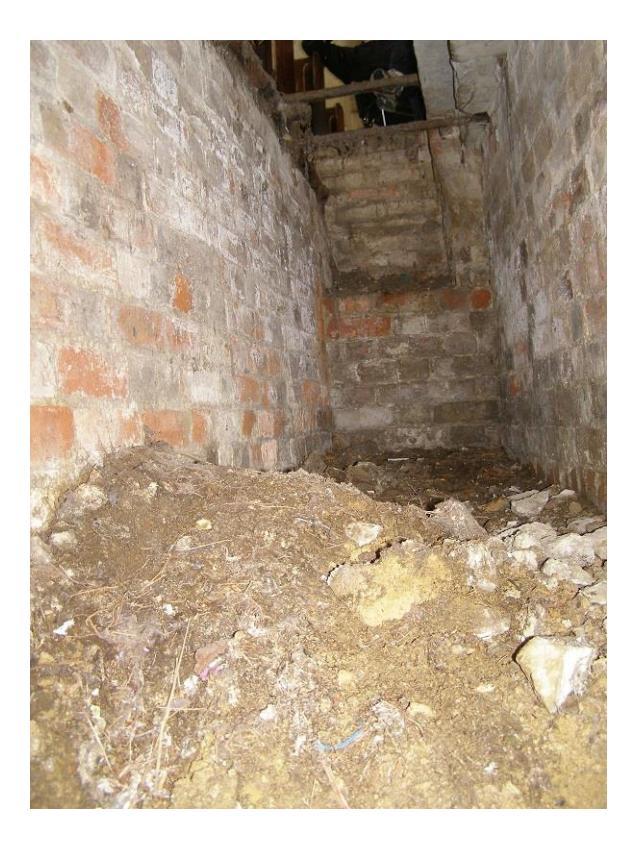
Fig 9 Entrance to north aisle duct from below

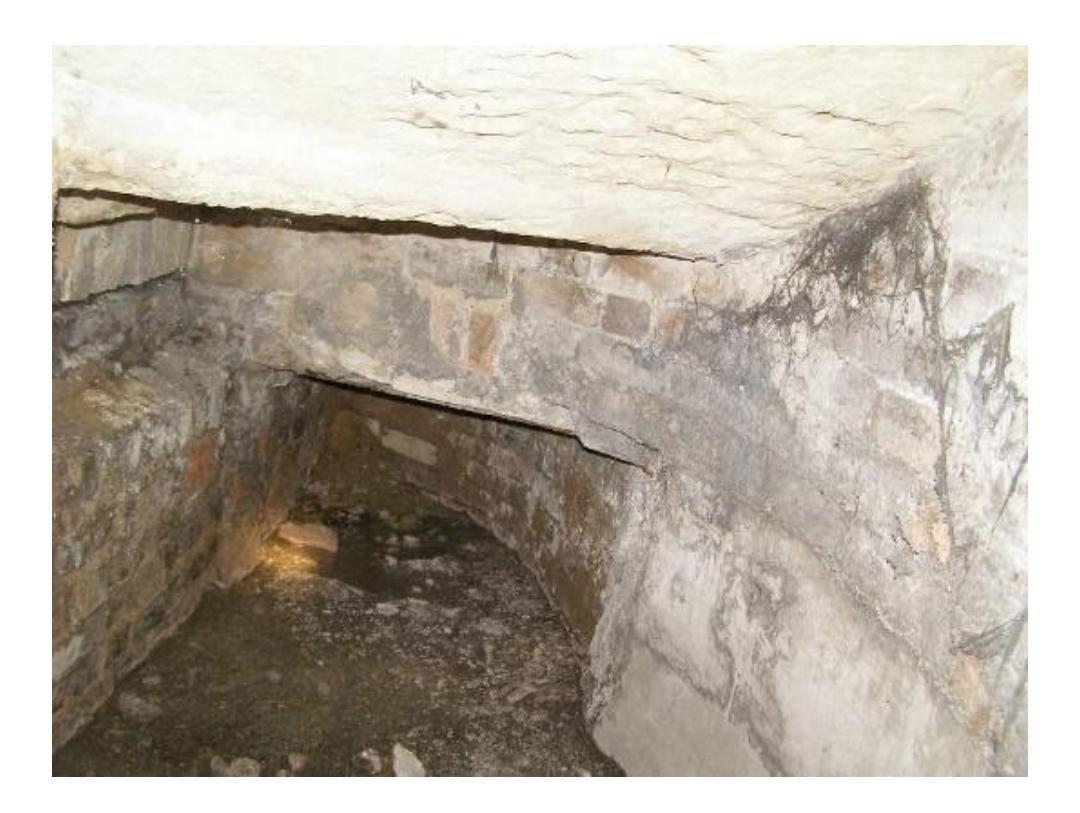
Fig 10 Duct going down to boiler room

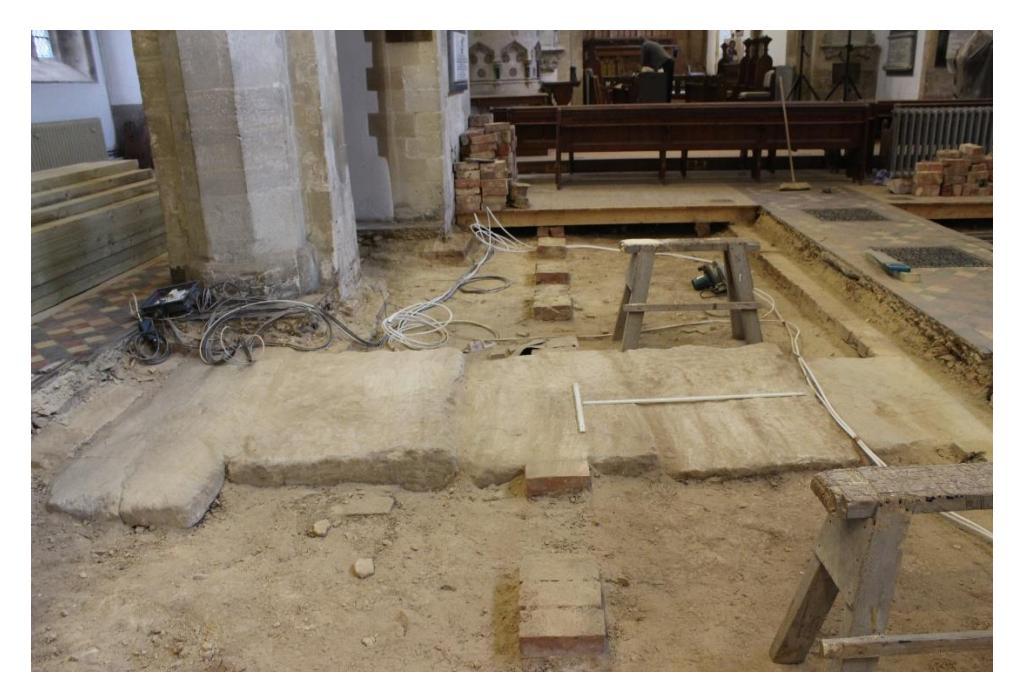
A line of large stone slabs (possibly re-used grave slabs turned upside down) running northsouth under the north pew platform may cover a duct which could have joined the tunnels under the two aisles, but access under the slabs was not possible. Further examination of the two ducts under the north and central tile walks may reveal blocked openings in their walls which would have communicated with a duct under these massive stone slabs. (Fig 11) The heating system was re-used to house hot water pipes from the boiler room at some time when the heating system was changed (more work is needed on when this might have happened). The hot water pipes were then carried under the south pew platform to the south aisle in a small duct (Fig 12). It was necessary to open up this duct to carry out changes to pipe work necessitated because of essential alterations to the heating system. The duct had brick walls and was capped with thin stone slabs of uniform size. Its overall width was 0.5m and its interior width was 0.35m. It contained two large bore iron pipes laid down its central axis one above the other. It appeared to continue under both the central and south aisle tiled walkways. It is probable that this duct was installed specifically for the hot water system and the wooden floor above it showed signs that it had been opened at some point in the past.

Fig 11 Massive stone slabs, possibly capping a duct across north side of nave (Scales 0.5m and 1 m) $\,$

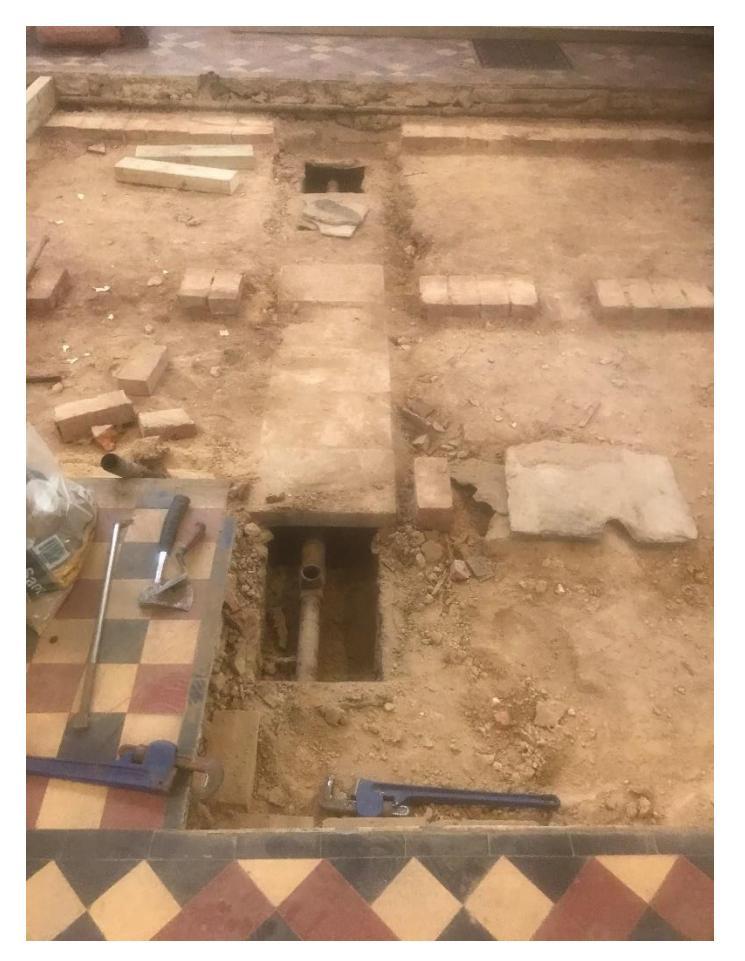
Fig 12 duct containing water pipes across south side of nave

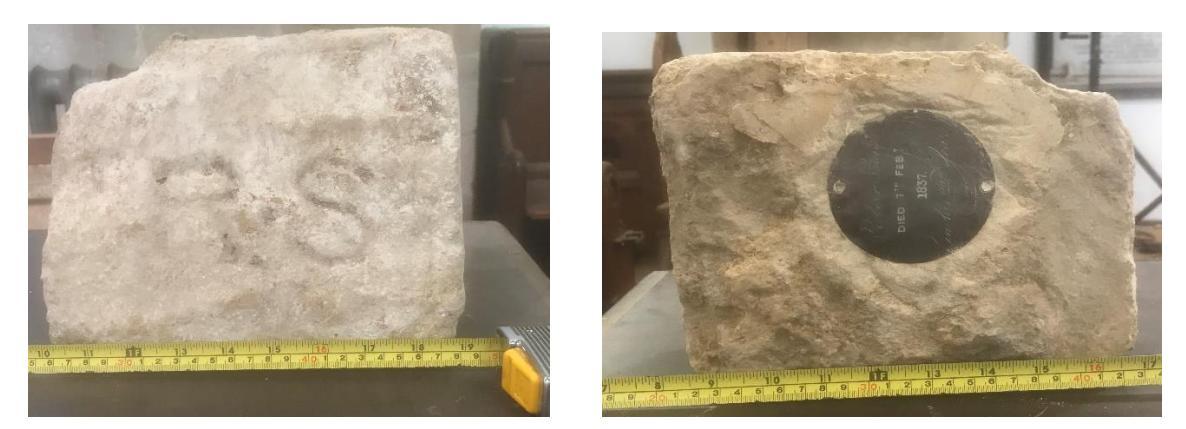
There were few finds. The most interesting discovery was a roughly rectangular stone c.23cms x 17cms. It was 8cms thick on one side and 5cms thick at the other and could have been a re-used voussoir from an arch. On one side the letters R S had been incised into the surface of the stone which had been roughly smoothed. On the other side is a silver disc, 7.5cms in diameter which had been stuck to the stone (figs 13, 14). When found by the workmen, the silver disc had been largely covered by a layer of mortar or plaster. On it is inscribed (Fig 15):

Figs 13 + 14 obverse and reverse of Robert Smith grave marker

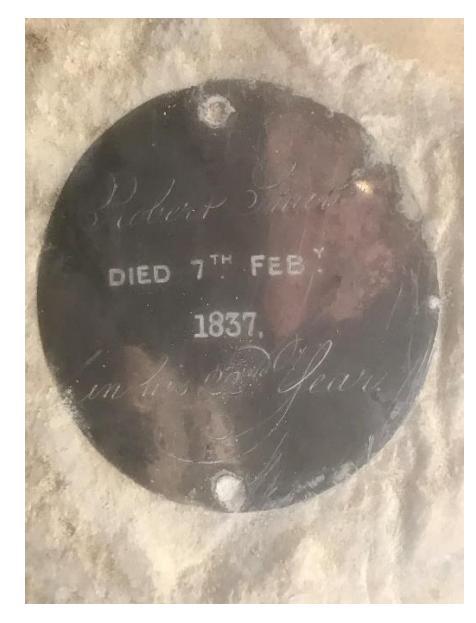
Fig 15 engraved silver disk

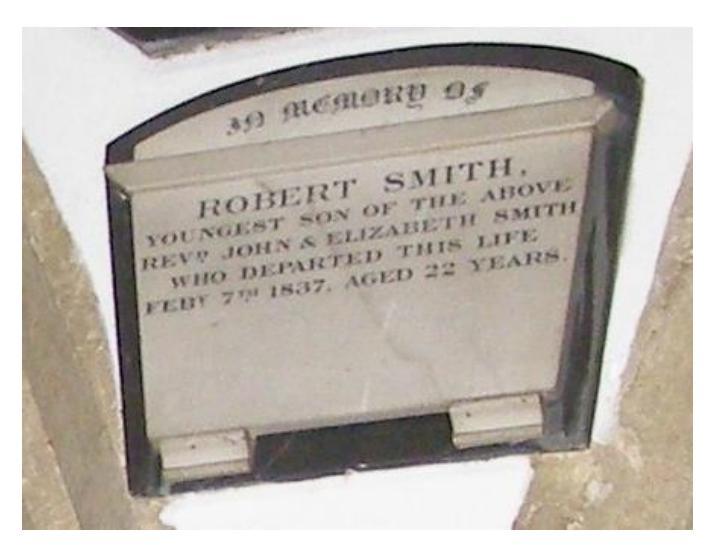
This is the same Robert Smith who has a wall tablet memorial (Fig 16) above the area where the stone was found. He was the son of a Vicar of Bicester who had died two years previously with a memorial tablet above that of his son. The purpose of the stone is unclear, but it was possibly a footstone for his actual grave under the box pews which would have been there in 1837. More research is needed on this.

Fig 16 wall tablet to Robert Smith
