St. Michael and All Angels. Michaelstow. Cornwall

The Royal Arms

Post Conservation Report

Record of Treatment

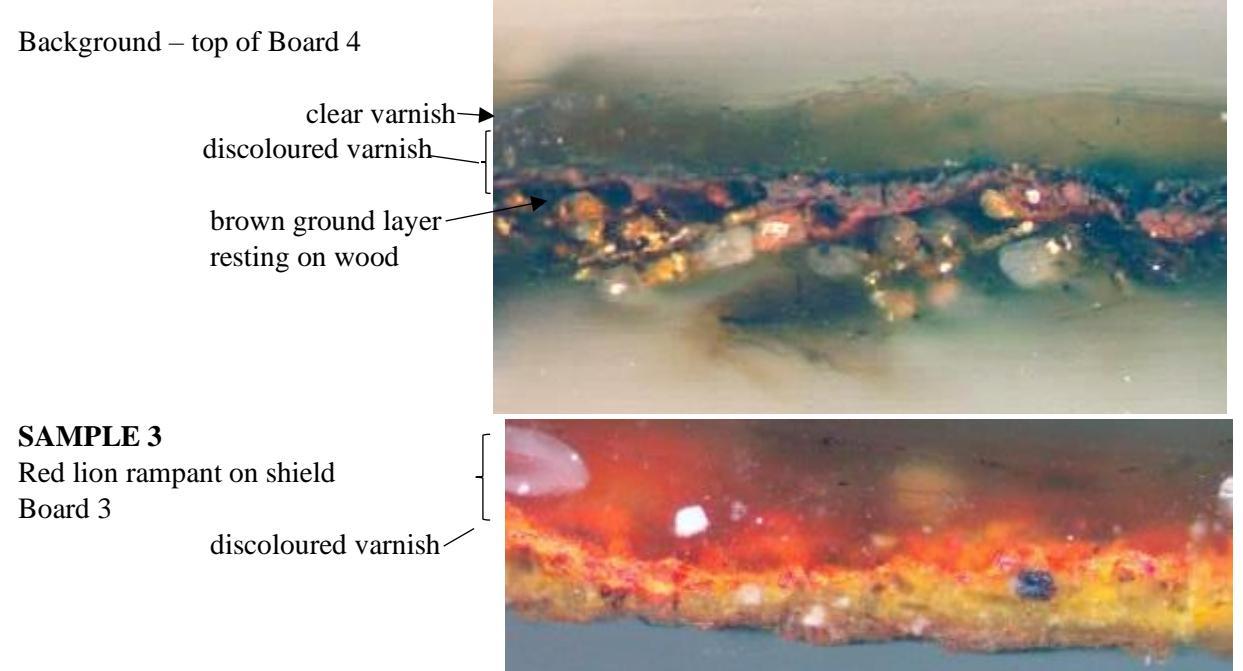
SAMPLE 2

Sample 2	Only the dark brown ground layers were found. In the cross-section they can be seen covered by a thick layer of discoloured varnish, so they were presumably not affected by the 1970 restoration.
Sample 3	A dull yellow undercoat mixed from ochres and a little lead white was applied first, followed by a top coat of pure vermilion.
Sample 4	A pinkish undercoat of red iron oxide mixed with lead white, followed by a yellow/brown top coat of lead white tinted with yellow and red iron oxides.
Sample 5	A similar pink undercoat as seen in Sample 4 was found in some fragments. A light blue undercoat of lead white and smalt was followed by a layer of pure smalt. The pigment has largely lost its colour, but a few particles are still a strong blue.

A thick layer of discoloured varnish can be seen over the paint layers in all of the samples, including Sample 2.

A second, thinner layer of clear varnish rests on top of the discoloured varnish. This may be what was applied in 1970

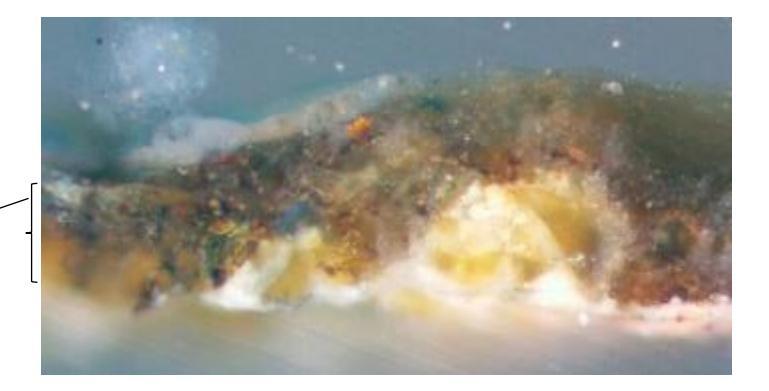
SAMPLE 5 Belt background colour

Mostly the top coat of pure smalt

top coat of smalt particle surrounded by discoloured and dirty varnish
