LADBROKE CHURCH

Comments on Dessication statement in Ground Investigation report by Client and subsequent meeting with Structural Engineer and Architect to how to proceed

PART 1 Client comments of Ground investigation report

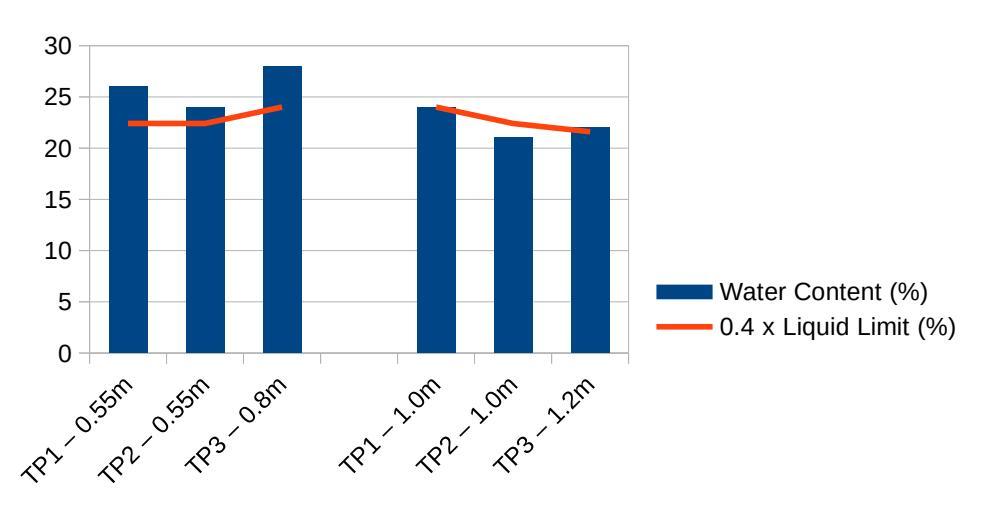
Comparison of the water content of each sample with the calculated 0.4x liquid limit

4. For the higher level samples, all three had water content results are slightly above the matching value for "0.4 x liquid limit".

5. For the lower level samples, all three were close to the matching value for "0.4x liquid limit", with only sample TP2 below it. Note TP2 was a reference position, close to the tree, by the porch buttress with no evidence of twisting or cracks in the masonry.

I think it is safer to say that all the lower samples are drier and close to the "0.4 x the liquid limit", considered by some to be the cut off for dessication. However, there is **no** strong evidence of a lower water content nor more dessication for TP1 (the test position) vs TP2 and TP3 (the reference positions) nor between TP1 and TP2 (near the remnant yew/rose) vs TP3 (other end of the aisle).
