Nether Alderley Parish Hall, Nether Alderley

Design and Access Statement,
including a Heritage Impact Statement

August 2020

Report on
Structural Inspection
at
Nether Alderley
Parish Hall
for
Lloyd Evans Prichard
on behalf of
The PCC of St Marys
Nether Alderley

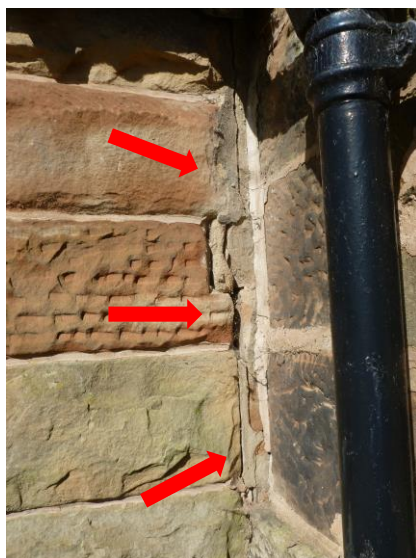
keyed into the existing building and is moving away from them. Its removal will cause no harm or damage to the fabric of the earlier buildings.

Figure 12: Fuel Store Bloc, crack and gap to the mortar and joint between Fuel Store Block and the adjacent blocks.

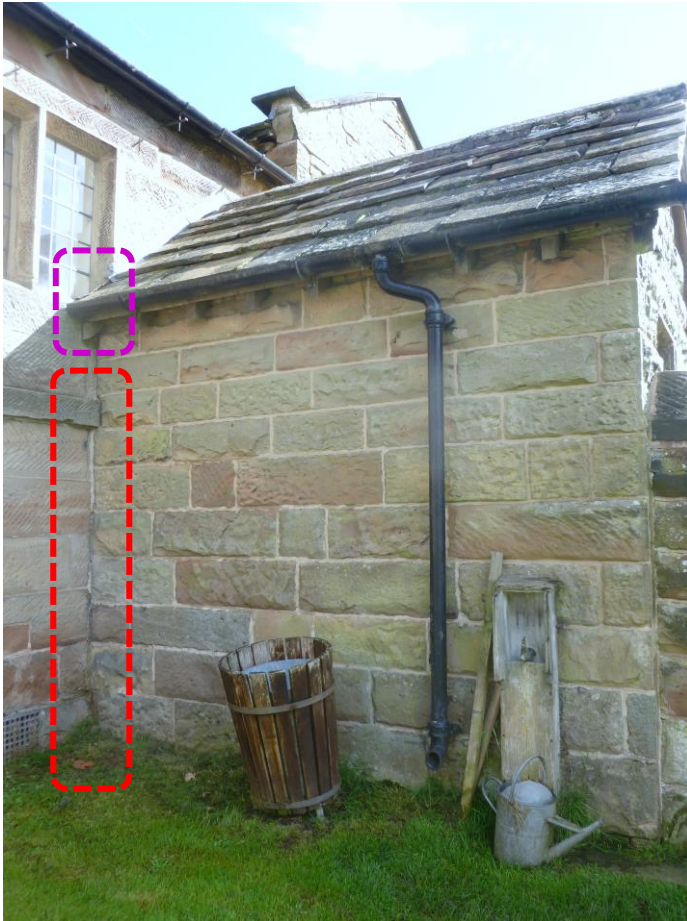
Figure 13: Fuel Store Block, Roof clashes with the Hall's window inside the purple colour area. Also, poor mortar joint detail, see figure 14.

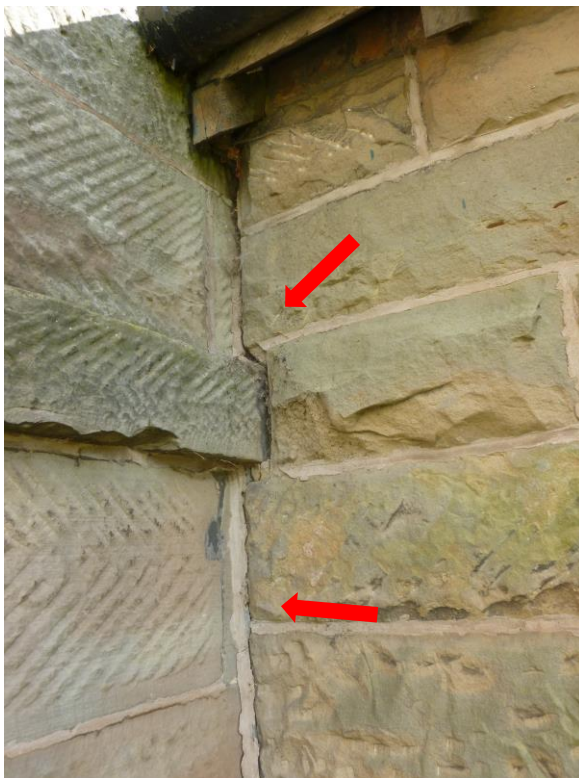
Figure 14: Poor construction to the hall's masonry wall.

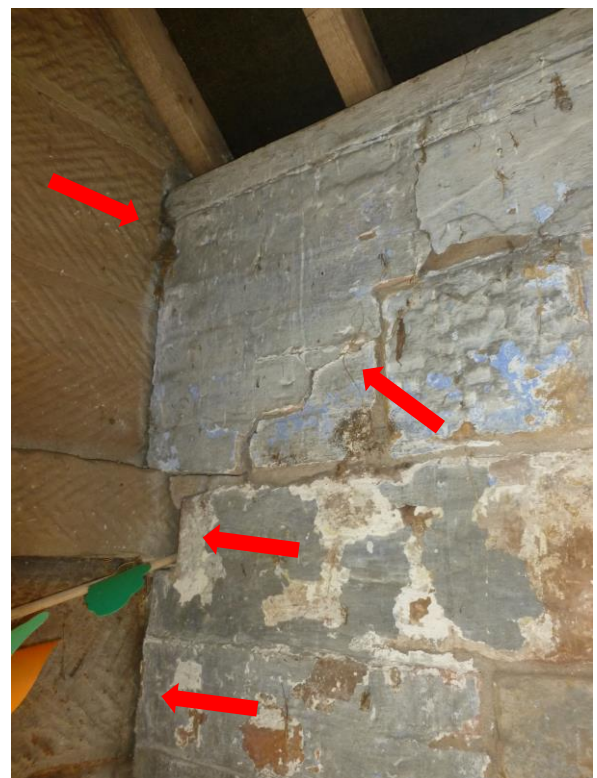
Figure 15: Inside Fuel Store Block, poor mortar joint and crack to masonry due to poor construction.

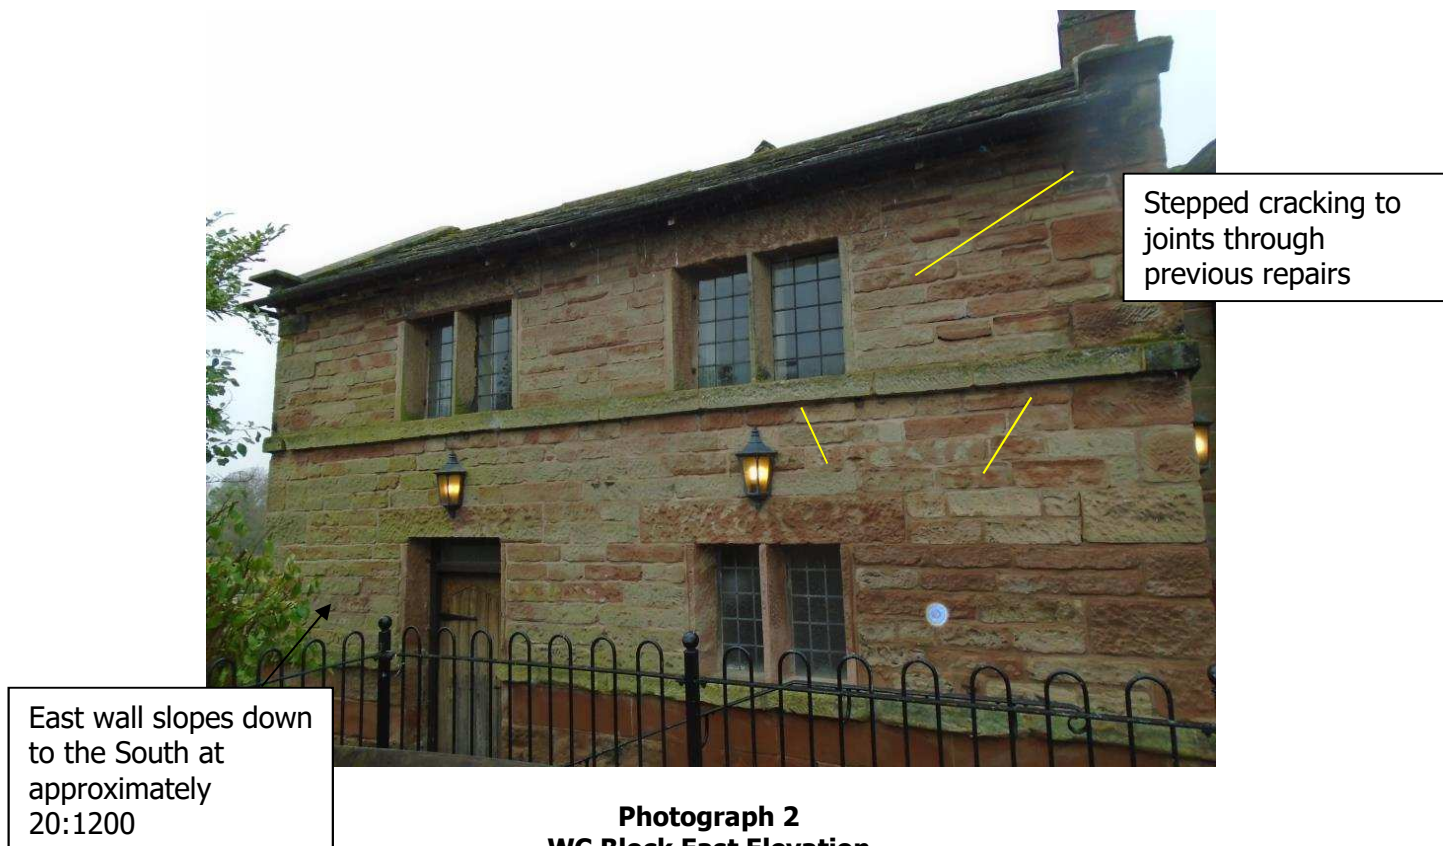
- a) North end (at top of external steps) wall is nominally vertical and bed joints are nominally horizontal. Minor stepped cracking is evident to the top right of the ground floor window opening and to the right of the first floor window opening. These cracks appear to be though recent repointing.

Photograph 2
WC Block East Elevation
Stepped cracking at North End

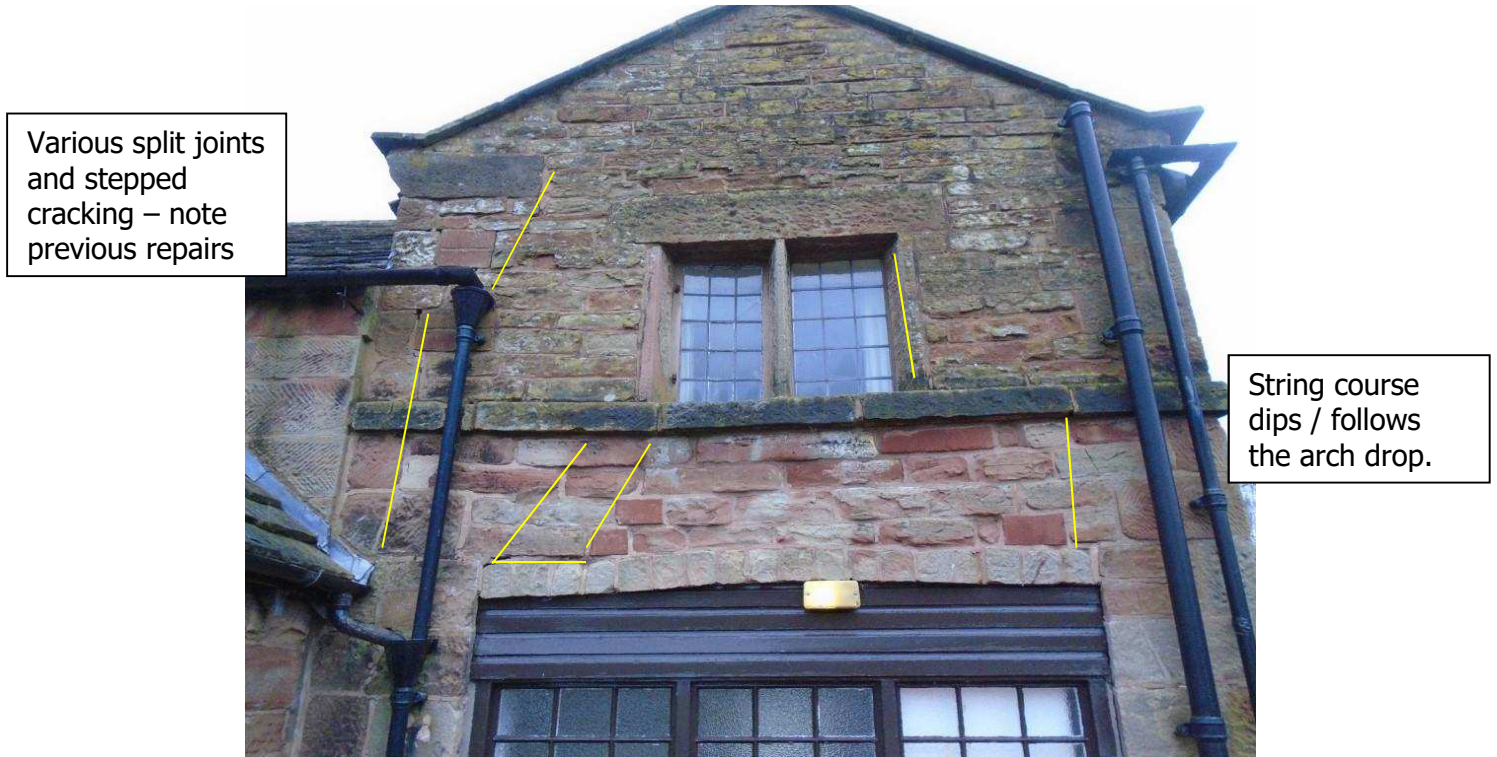
- c) There is a shallow masonry arch above the ground floor framing but this has distorted downwards on the left side with splitting to the bed joint and stepped cracking above. There is also cracking above the right hand end of the arch. The timber panelling under

- d) A number of repaired cracks and split stones indicates that sagging type movement above the ground floor opening has been a long standing issue.
- e) The open joints / gaps at the left hand end of the arch showed no signs of an outer leaf beam or lintel.
- f) At the left hand edge is the junction of three walls of different ages and the stone courses do not match. The vertical joints appear to be butted rather than bonded and mortar pointing is generally loose.

- b) The South end wall shows historic and recent movement associated with the large opening in addition to the tilting. The dip in the first floor cill and some of the old repaired cracks indicate that much of the sagging type movement is long standing. The outer masonry and shallow arch appears to have been rebuilt relatively recently but has an irregular profile and is showing new movement. It is likely that the timber infill framing is preventing some of the masonry from falling. Internally there was no view available of the inner beam supporting the floor joists ends and the inner masonry thickness. It is likely that a timber beam is present and the bearing ends may have compressed but are concealed by tiling (metal detector gave a stop / start signal along the length i.e. not steel beams). Movement of the inner beam is indicated by the local increase to the slope of the first floor at the South end. Allowance should be made for taking down of the outer masonry arch and the panel above up to the first floor cill. Also allow to investigate and repair of the inner beam which could involve replacement subject to proposals. The outer shallow arch appears to have failed on a few occasions hence an alternative arch detail or introduction of an outer beam should be considered

Photograph 4
WC Block South Wall
Ground Floor Arch Head Dropped

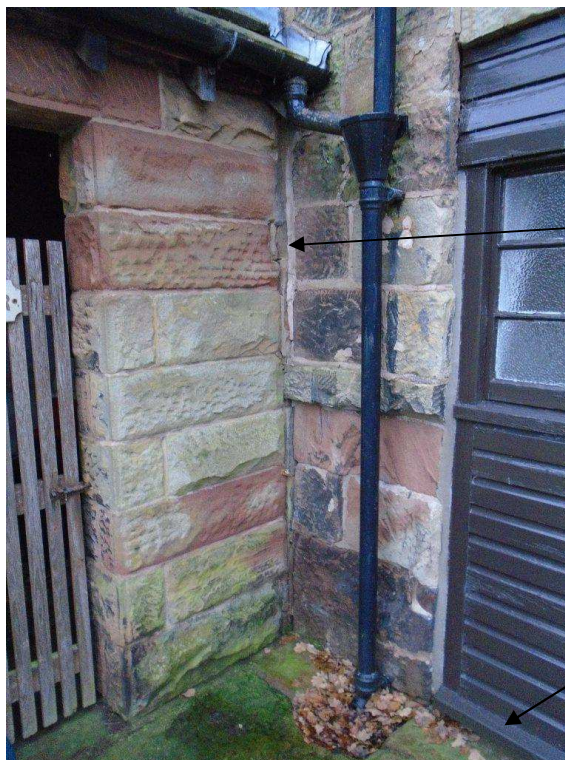
Junction of three different walls abutting – no bonding evident

75mm step – concrete slab edge

Photograph 5
WC Block Junction With Main Hall and External Store

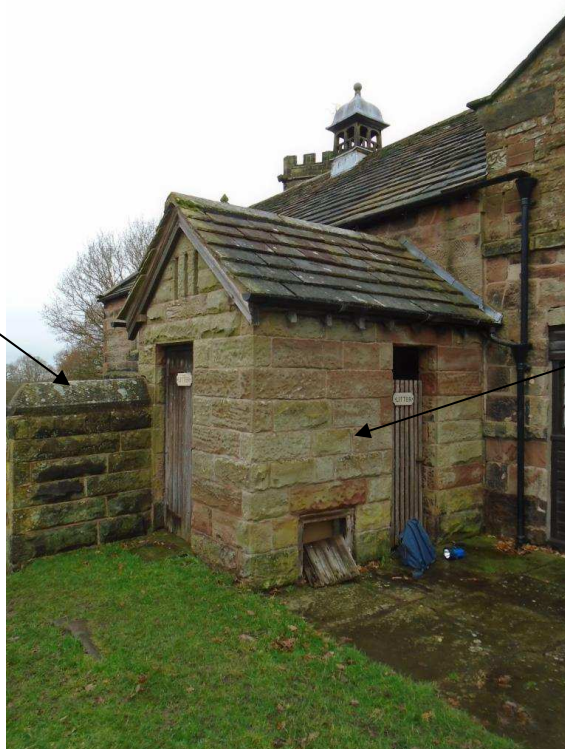
- 4.5 The external store building, the garden wall and the South wall of the main hall all show tilting to the South similar to the toilet block but all appear in fair condition and currently stable. The North side of the parish hall buildings appear to be in fair alignment.

Garden wall masonry tilts to the south at approximately 60:1200

Store masonry tilts to the south at approximately 20:1200

Photograph 6
South Elevation External Store

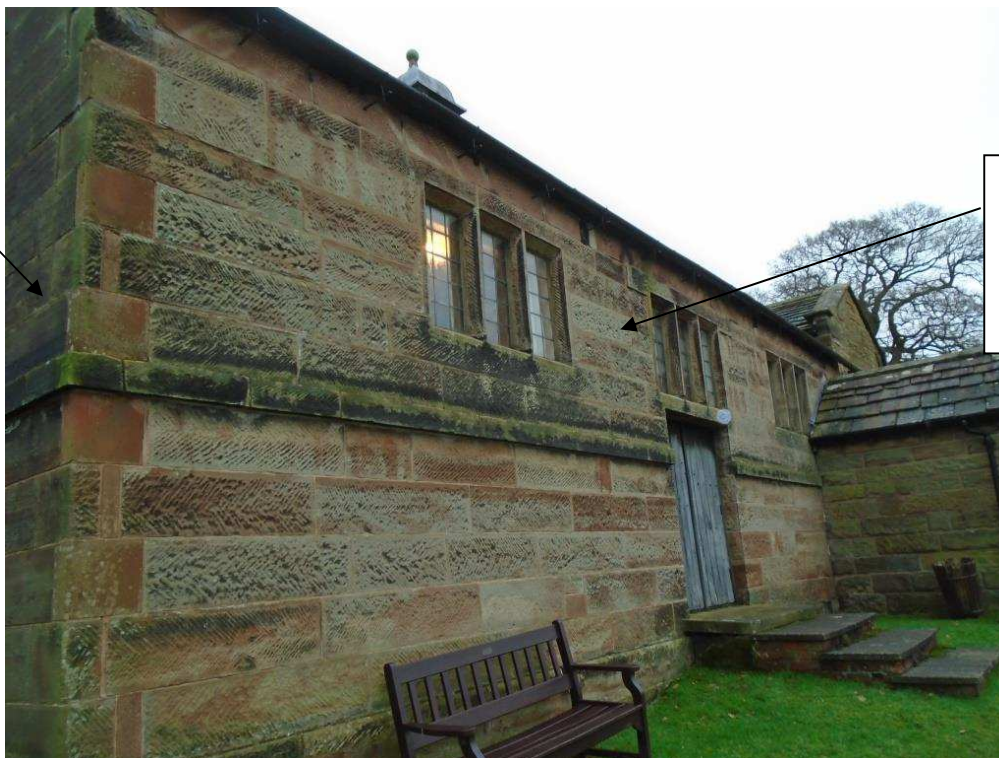
Corner and
West wall
nominally
vertical

Away from the
SW corner the
wall tilts South
at approximately
20:1200

Photograph 7
Main Hall South Elevation

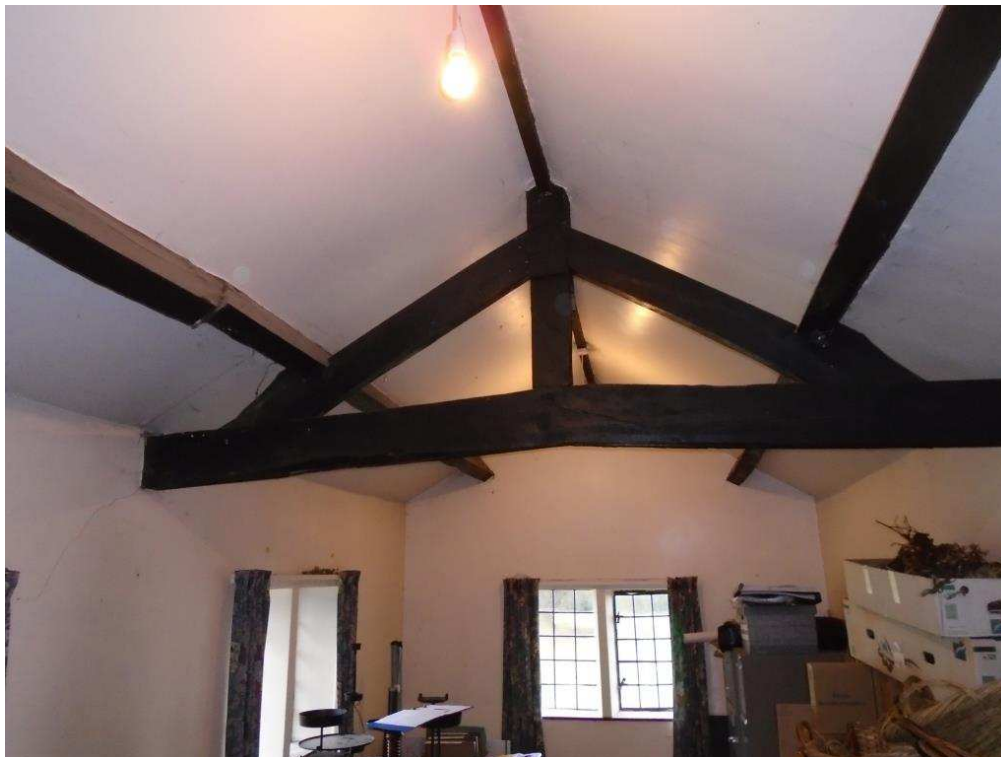
- a) The East purlin (North span) has a scarf joint that is in poor condition with splitting and displacement evident.
 - b) The East purlin (South span) shows sagging and rotation and corresponds to the displaced wallplate that is noted externally. The opposite slope is abutted by the main hall.

Photograph 8
WC Block First Floor
Mid roof truss – note joint to East purlin

- 4.4 The toilet block roof, East purlin splice joint requires repair and strengthening where it is displaced. Allow for a side lap splice to be developed in the design / construction stage.

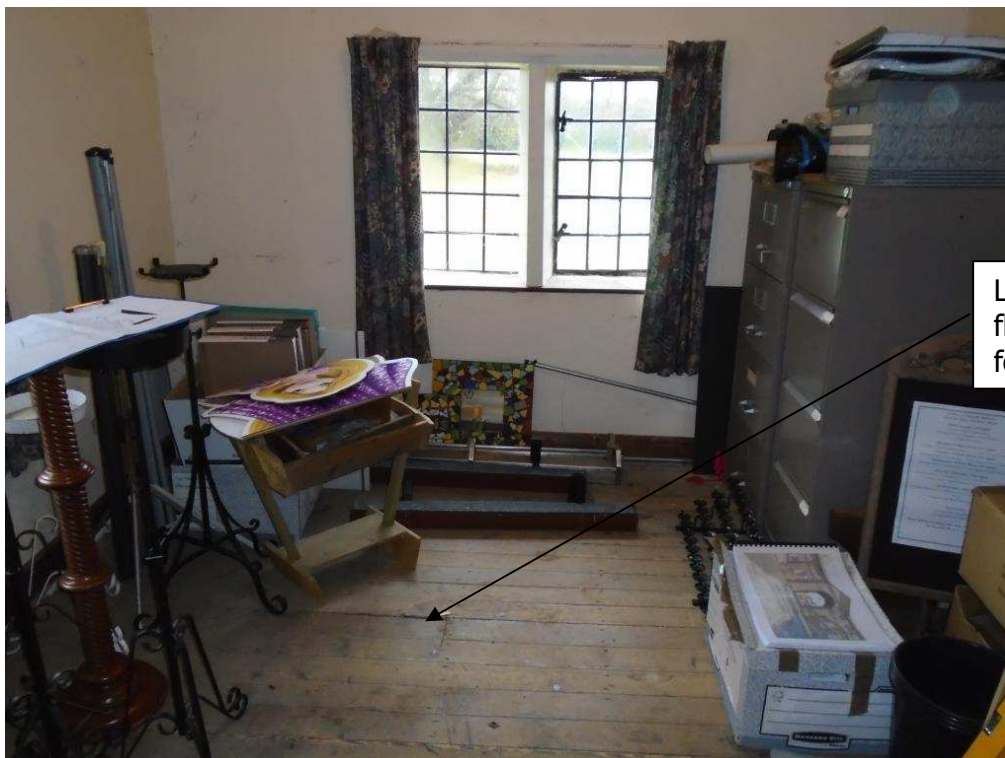
Loose softwood floorboard lifted for inspection

Photograph 9
WC Block First Floor
Floor slopes down to the South (towards window)

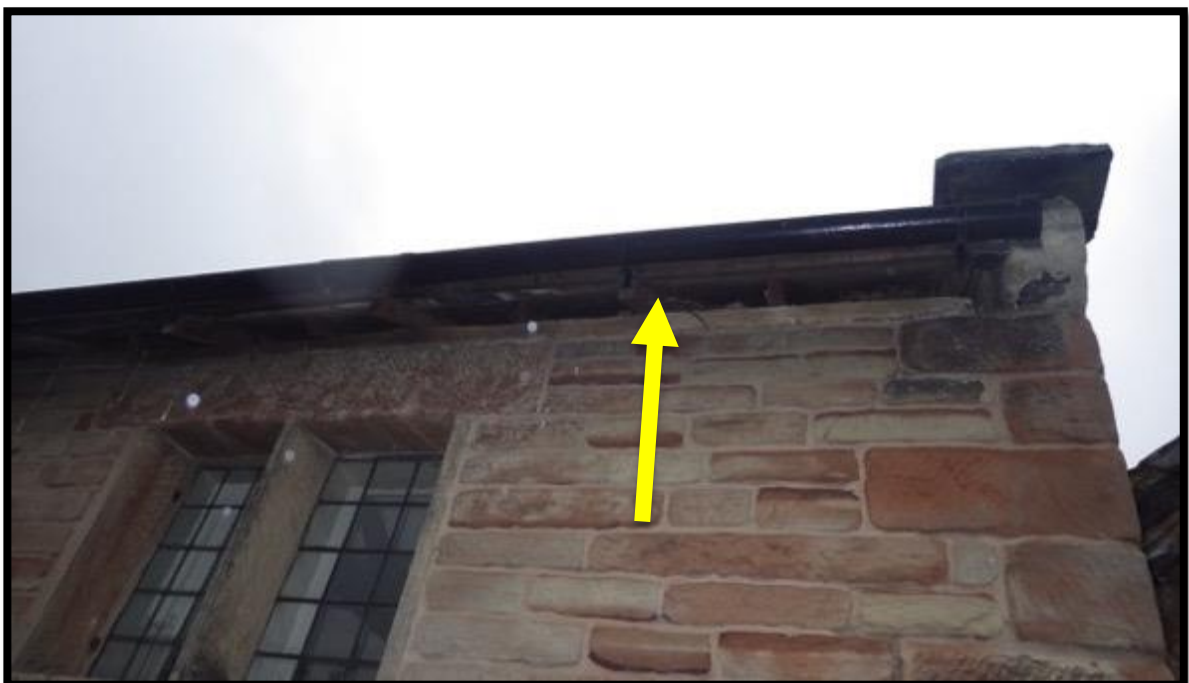
Fig 5. The underside of the guttering along the building reveals small holes underneath, showing possible potential for nesting birds or a route in and out for bats.

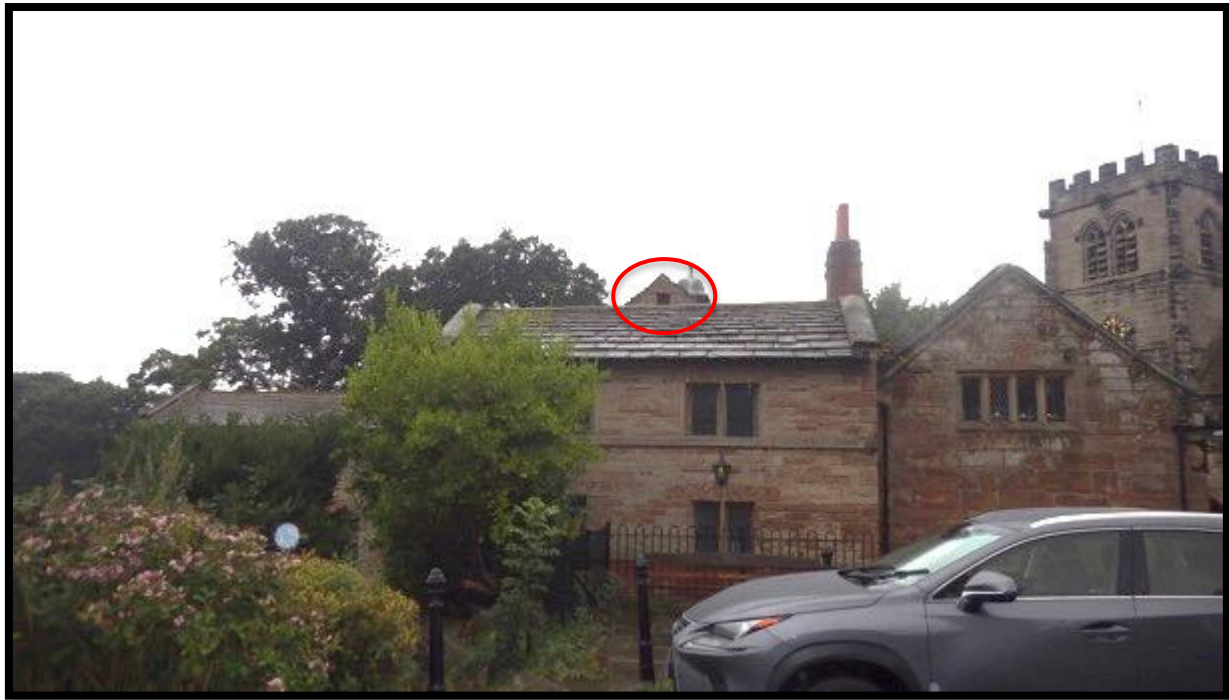
Fig 6. *A small vent can be seen circled in the image, possibly acting as an access point for potential bats.*
