St MARY'S CHURCH Swainswick Somerset

Heritage Statement

Report reference: 3780-1v3

August 2018

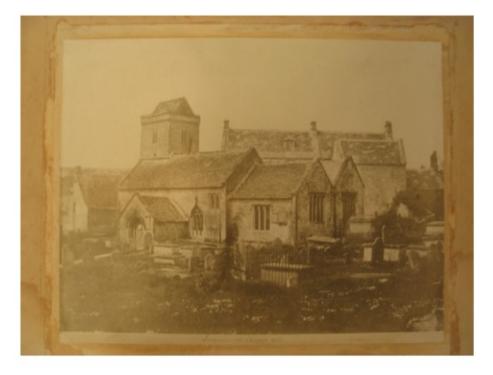
The church in 1855. Note the shorter Chancel and the round-headed form of its east window

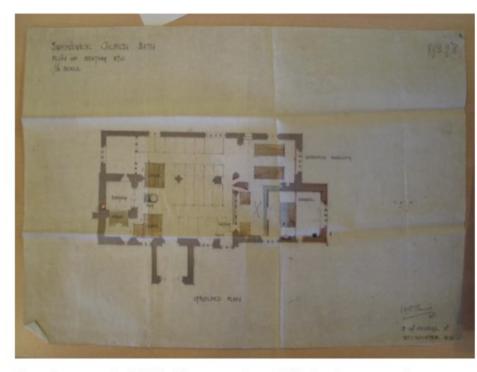
Caroe's proposal of 1921. Correspondence indicates the proposals were realised over a period of c. 17 years.

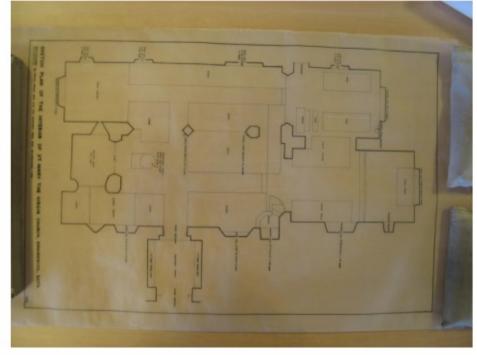
Figure 1

Layout of the interior in 1972.

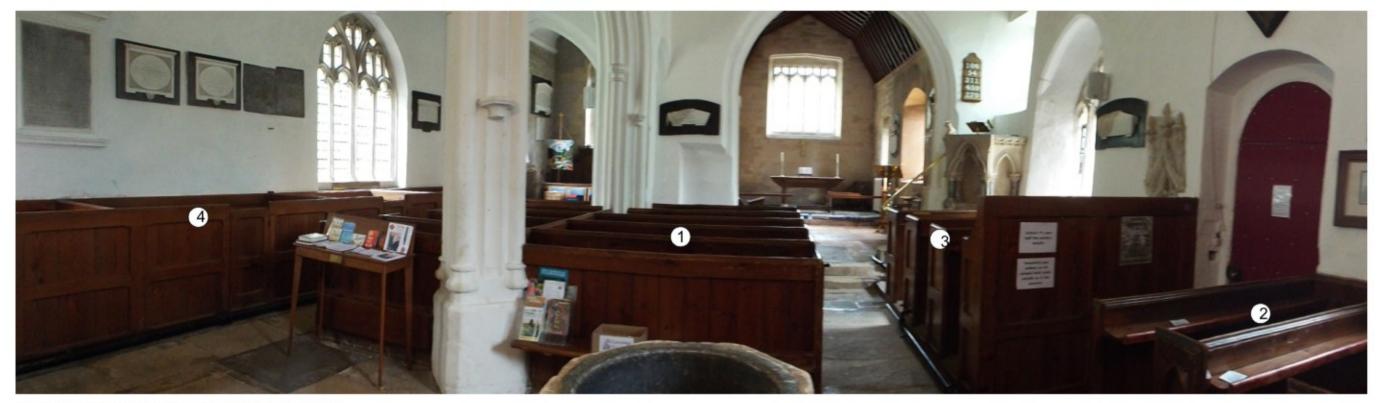
General view of the interior from the west end

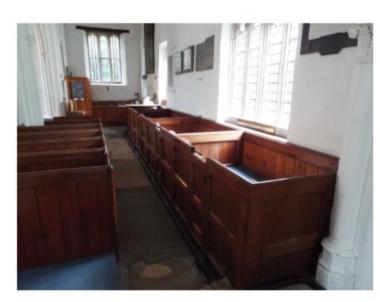
Figure 3

- 5.2 That complex structural history is reflected in the surviving fixtures and fittings, particularly the seating. Of the five blocks of seats, two (4 and 5) post-date Caroe's re-ordering design of 1921 and appear to have been installed, or at least substantially altered, after 1972. The Baldwin hinges incorporated in the box pews (4) were patented in 1949¹⁷ and, as there is no evidence for earlier hinges, we must conclude that these were installed here after 1949; whilst the historical sources suggest they were at least re-configured after 1972, if not installed wholly anew. Caroe's benches, together with their commemorative mural panel, were designed in 1921 for the east end of the North Aisle (Memorial Chapel) but at least one had been moved to the west of the Chancel by 1938. It appears both were together again in the Memorial Chapel by 1972, but they were again separated in c. 2000 when one set was placed in storage outside the church and the other turned through 90° to face the North Aisle.

Box pews (4). Their layout does not match that of the 1972 survey
