CHURCH OF ANDREW, CHURCH STREET, CHEDDAR, SOMERSET BS27 3RF

Report on the Potential Impact of Proposed Reordering Works on the Archaeological Significance of the Church

Report on the Potential Impact of Proposed Reordering Works on the Archaeological Significance of the Church.

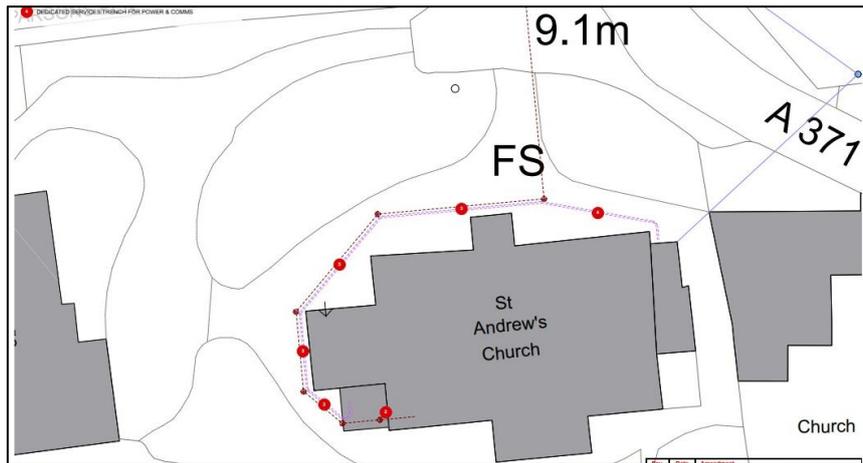
Figure 1. Proposed Service Trench Route (after Communion Architects)

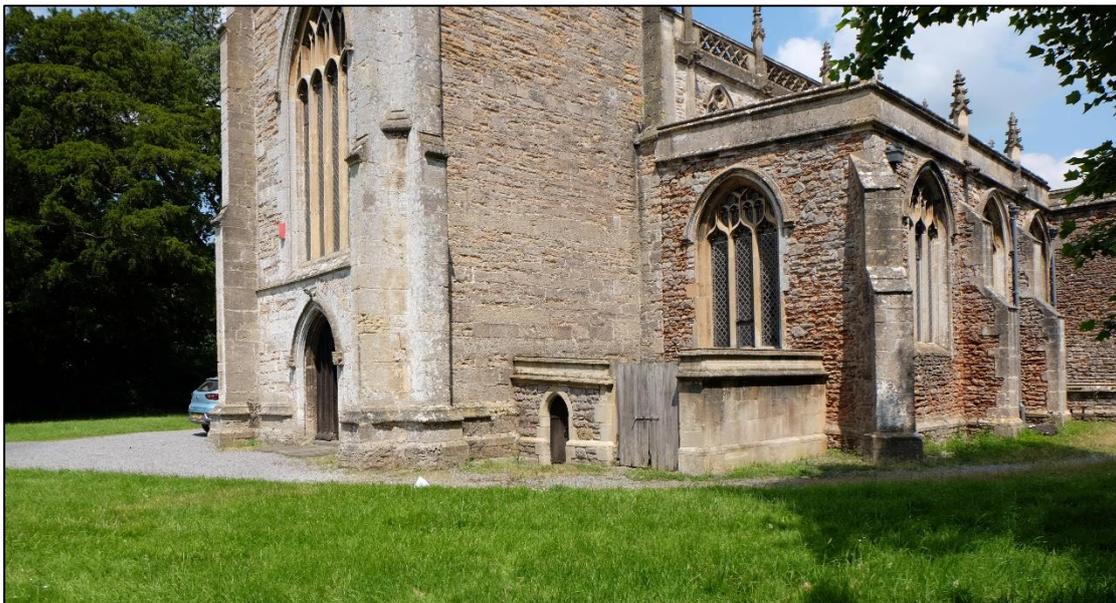
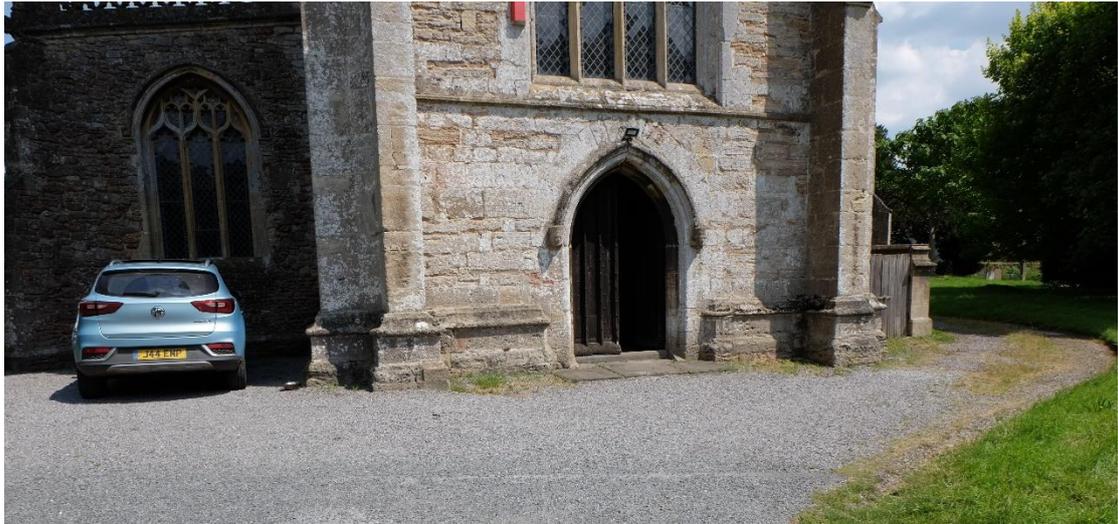
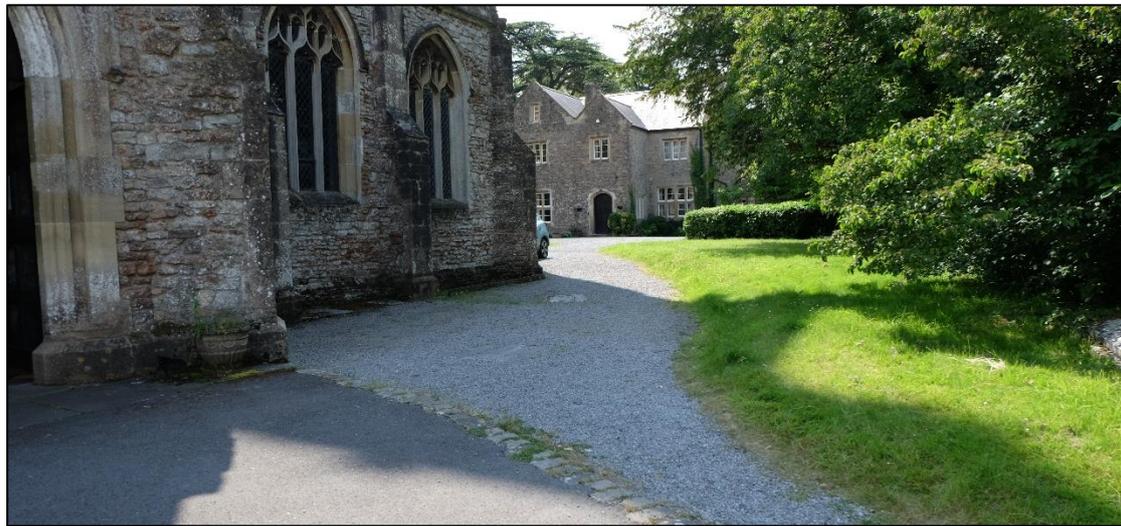
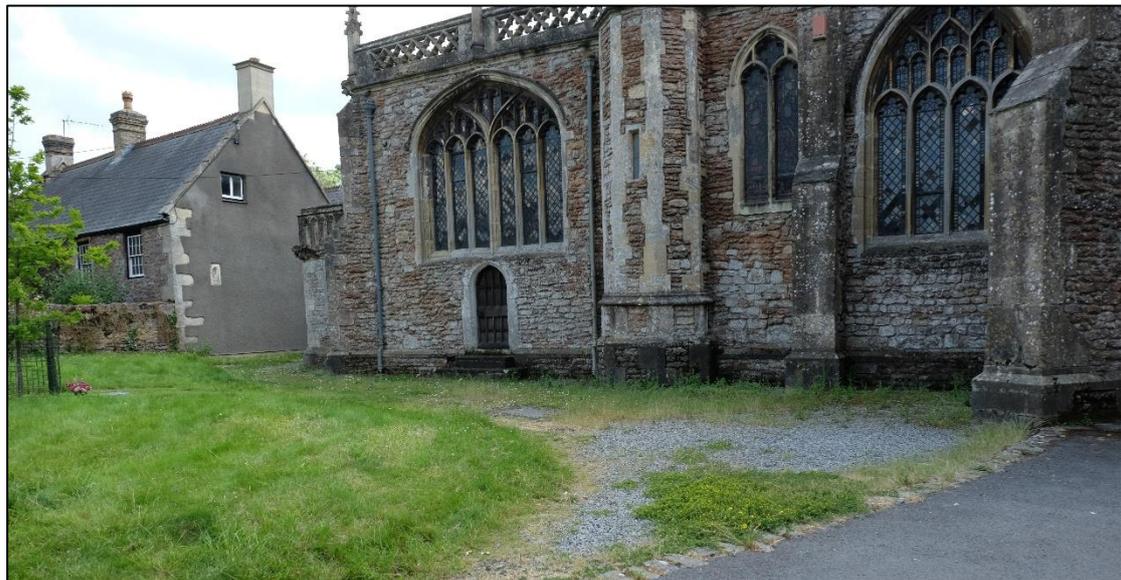
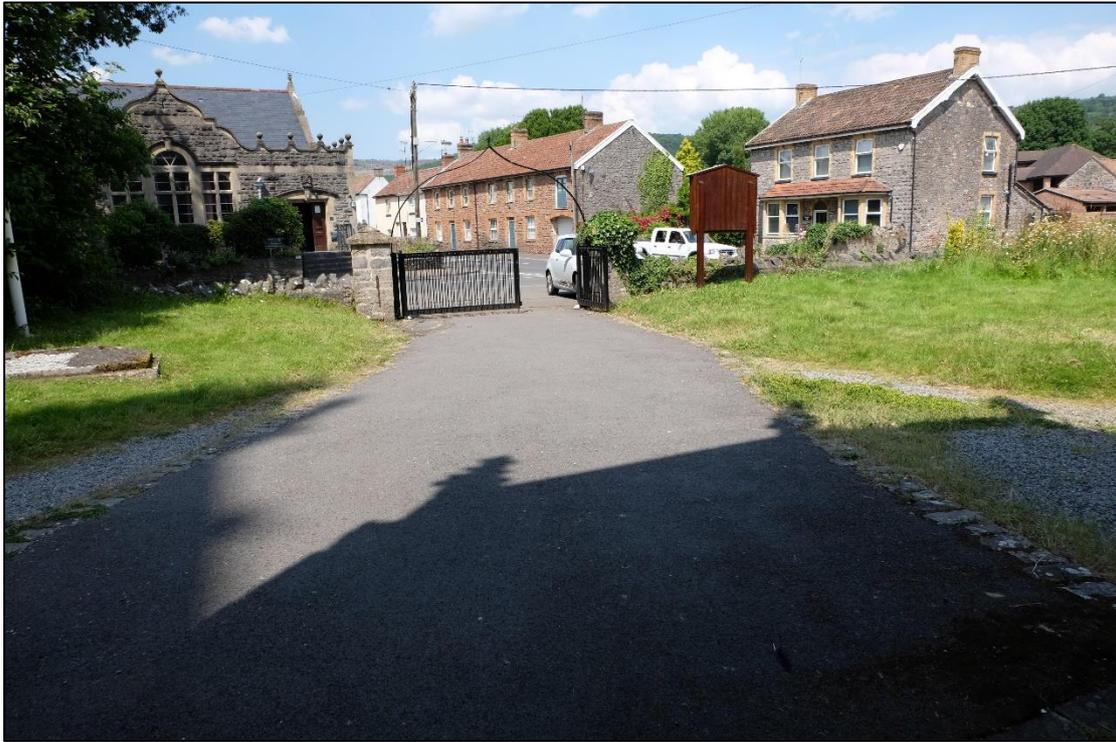
The proposed route runs from the external compound on the south side of the tower and will be excavated through existing access roads and footpaths around the west side of the Tower continuing around the north side of the church and eventually heading north to join existing service in the road (Figs 2 - 6). There are a series of concrete manhole covers already installed along this route and are assumed to relate to existing services of some form but there are no records of any archaeological monitoring works being carried out during this installation but may be associated with the drainage works undertaken in 1990.

Figure 2. Proposed Service Trench Route, SW corner of Church: facing NE

Figure 3. Proposed Service Trench Route, W side of Tower: facing E

Figure 4. Proposed Service Trench Route, N side of Church: facing SW

Figure 5. Proposed Service Trench Route, N side of Church: facing SE

Figure 6. Proposed Service Trench Route, N side of Church: facing N towards road

Although the proposed route for the service trench follows existing paths and roadways Roman remains are recorded as being found within the churchyard and the watching brief in 1990 recorded shallow burials and foundations on the north side of the church therefore it is highly likely that similar deposits will be uncovered during these works. Any excavation work within the churchyard is also likely to uncover disarticulated human remains from the fills of numerous inter cutting graves and therefore these will need to be collected and reburied during the works.

The DAC's archaeological advisor is likely to recommend that archaeological monitoring is required as a condition of any faculty granted and carried out during any internal and external excavation work including removal of floorboards. A further requirement may be that a photographic and descriptive record is made prior to the removal of the pews and a similar record made once the floor coverings have been removed in the new stage area. The DAC may also require an archaeological Written Scheme of Investigation to be produced and approved prior to the commencement of the works.

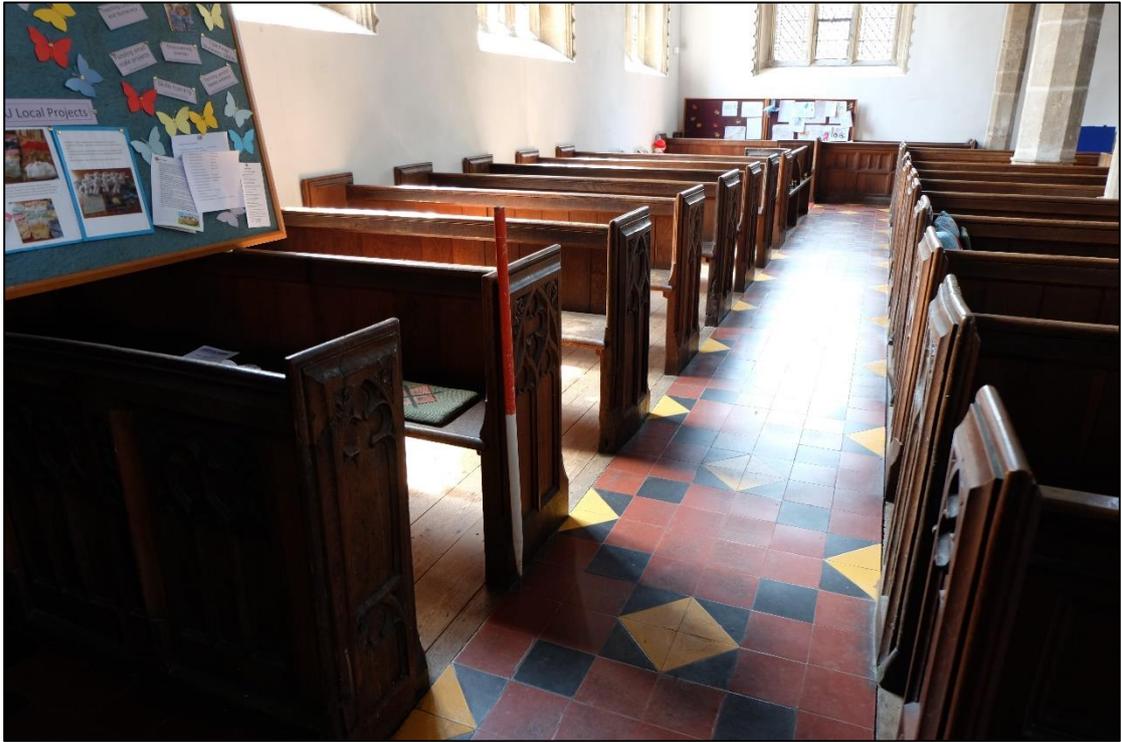
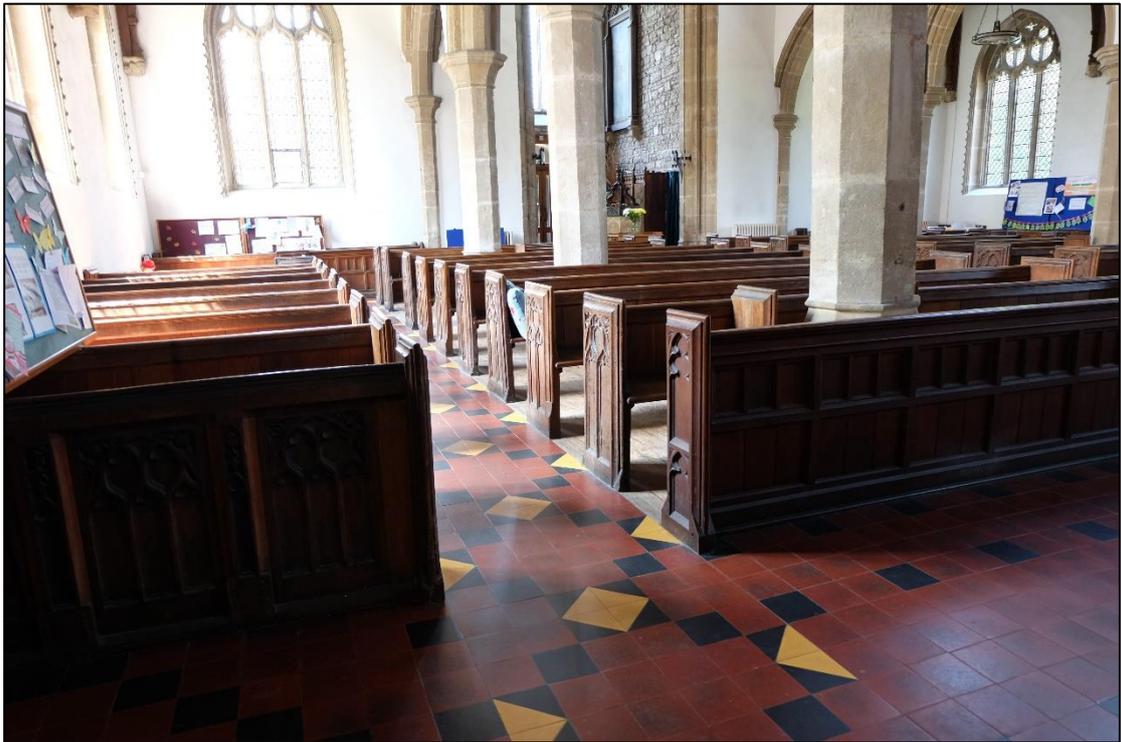
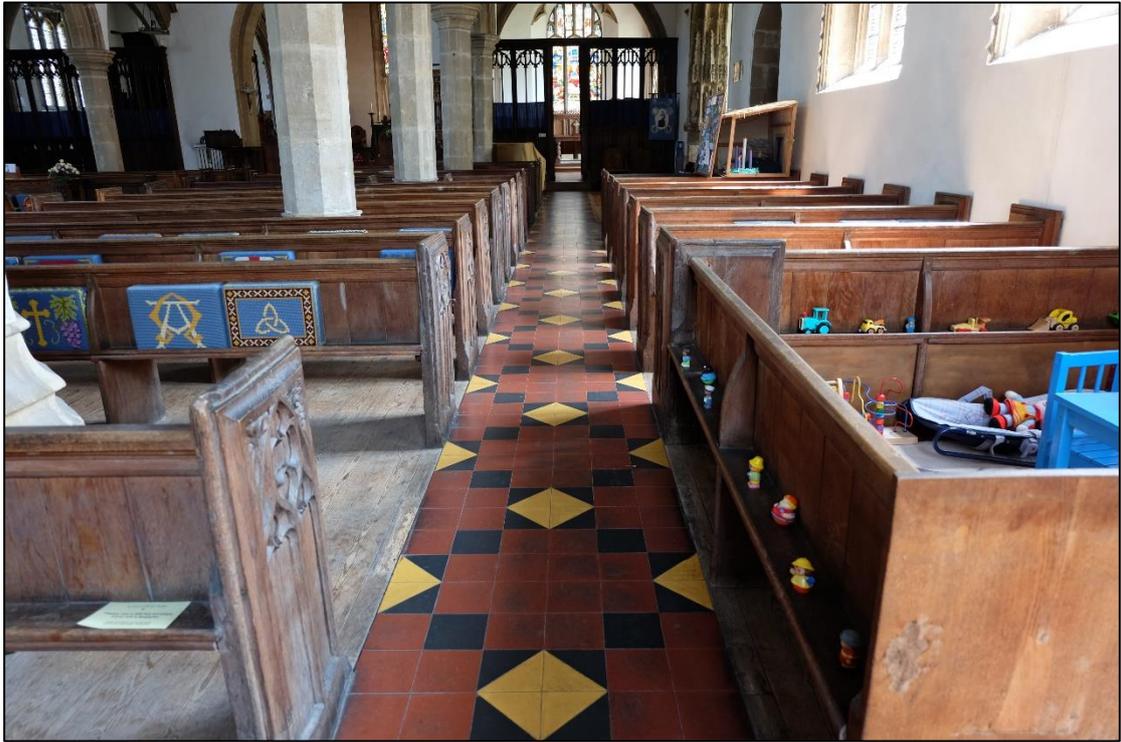
The installation of a single pod for hospitality and lavatory facilities and a free-standing served frontal will require the removal of the remaining pews in the south aisle and shortening the south ends of the opposite pews in the nave (Figs. 7 - 9).

The pews in this area are attached to wooden floorboards which are at the same level as the tiled (19th Century?) aisles. The pew benches would appear to be 19th Century or later with a mixture of contemporary and earlier bench ends (identified on architects drawing E10). The 19th Century ends appear to replicate the earlier ones and at least three different styles of carved blind tracery and floral spandrels were identified on the earlier ends during this visit (Figs. 10 - 12). The block of pews in the north aisle again appears to consist of later benches with mainly earlier ends. The bench ends in this area are more elaborately carved (Fig. 13) with some of the spandrels containing caricatures of human faces.

Figure 7. Pews in S aisle: facing W, 1m scale

Figure 8. S end of Nave pews: facing W

Figure 9. Pews in S aisle: facing E

If consent is given for the removal of pews in the north and south aisles, then careful consideration should be given to how these are going to be dismantled to protect the earlier ends from damage as these are of local, regional and national significance and should be treated as individual artefacts that may also require conservation work to help preserve them. Removal of the ends may reveal more information on their dating, and possibly present an opportunity for appropriate specialists to catalogue the different styles and carved detail.

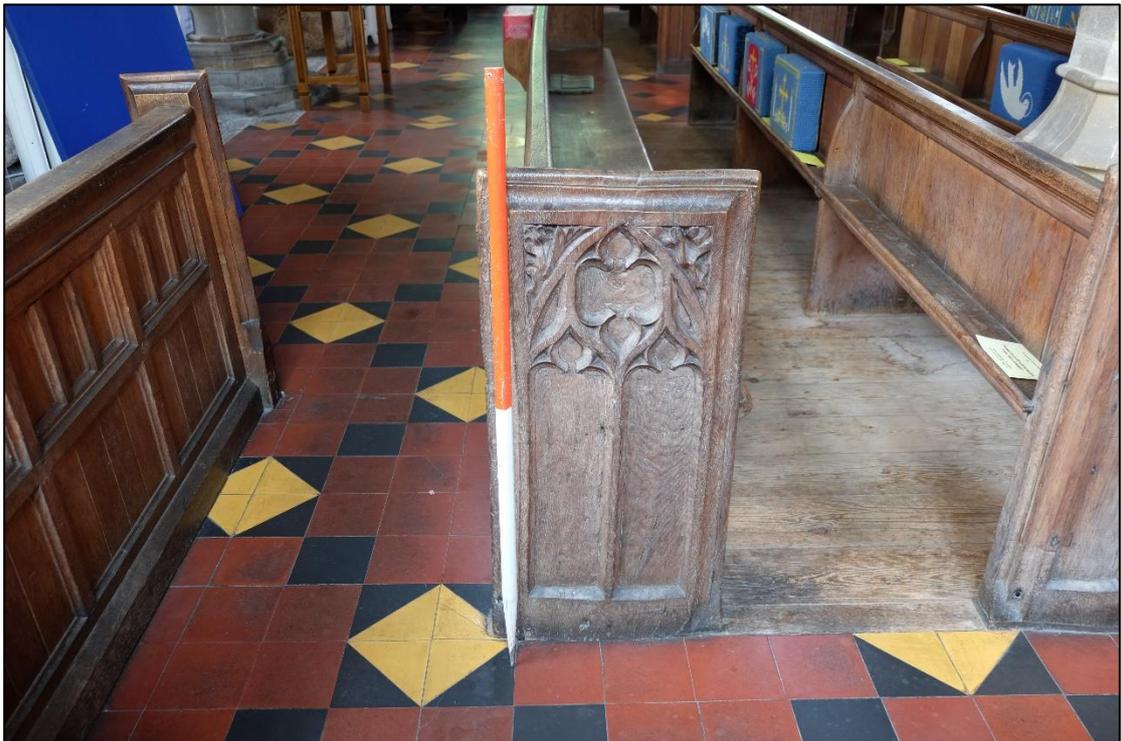
Figure 10. Bench End in S aisle with elongated blind quatrefoil tracery: facing N, 1m scale

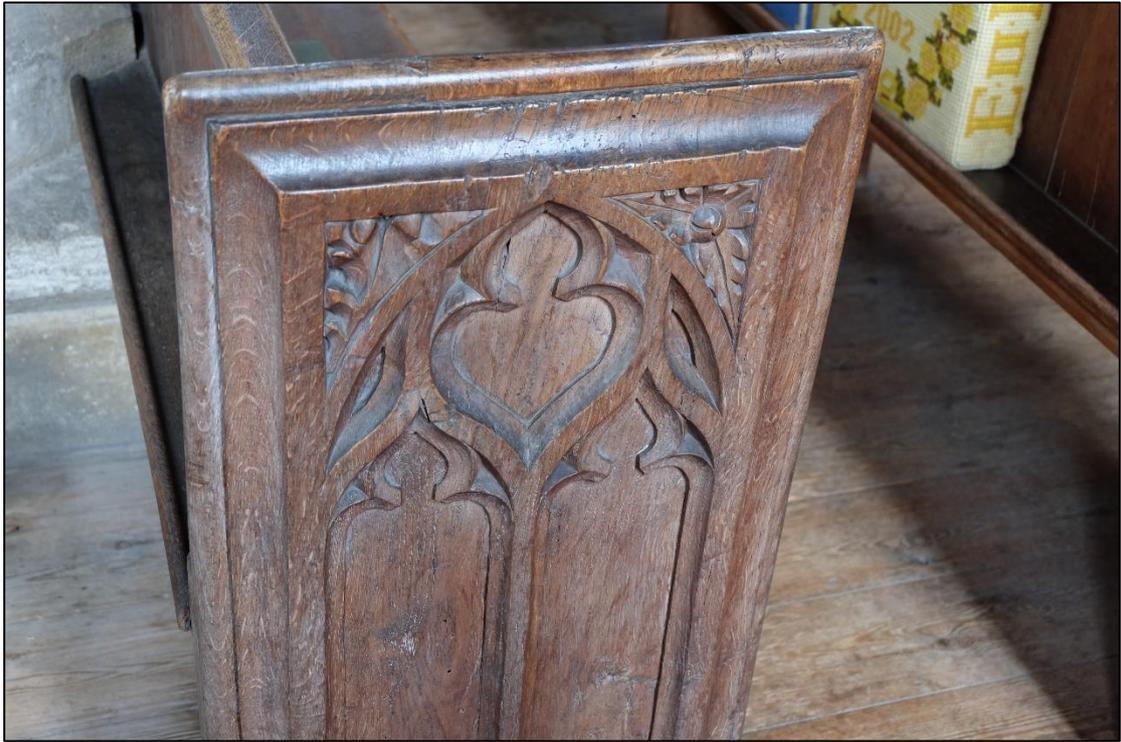
Figure 11. Bench End in S aisle with blind two cusped, flowing tracery: facing N

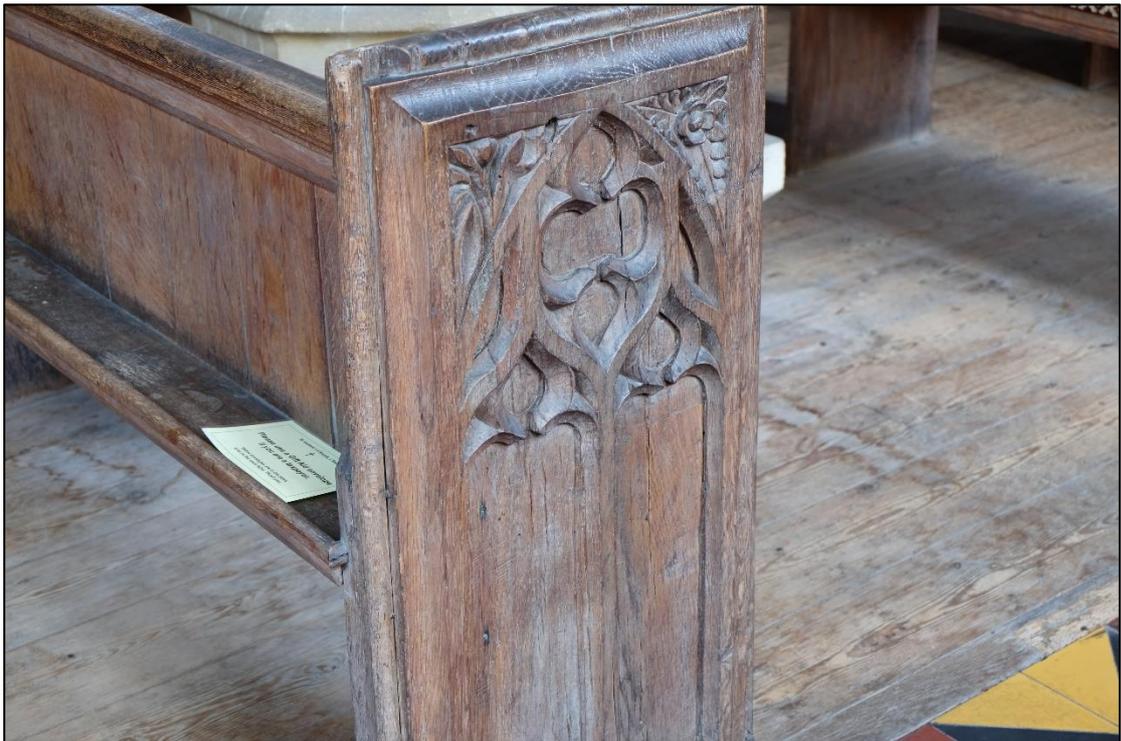
Figure 12. Bench End in S aisle with blind quatrefoil tracery: facing NE

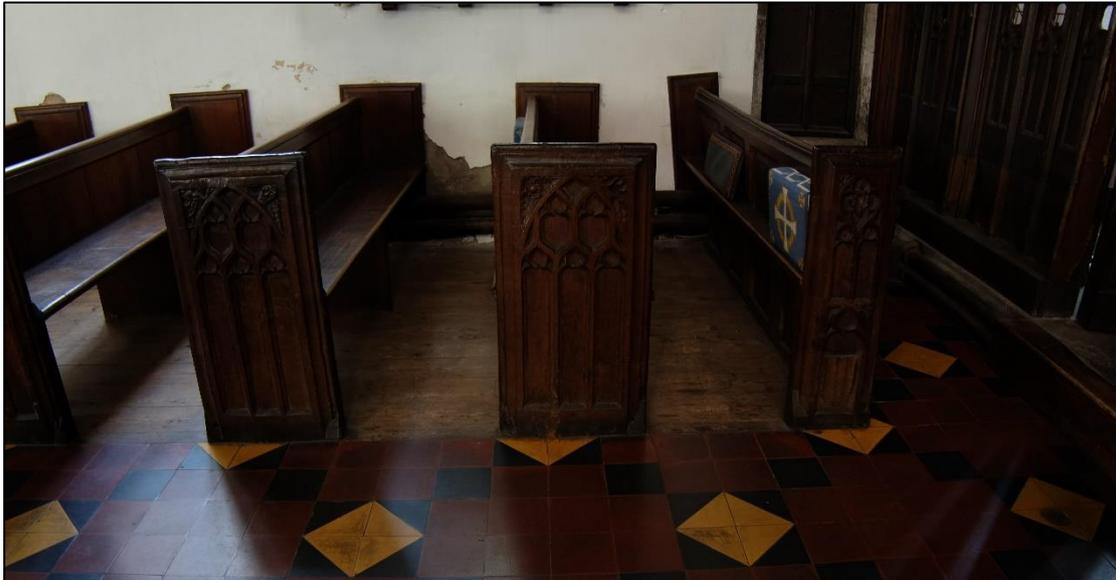
Figure 13. Elaborately carved Bench Ends in N aisle: facing N

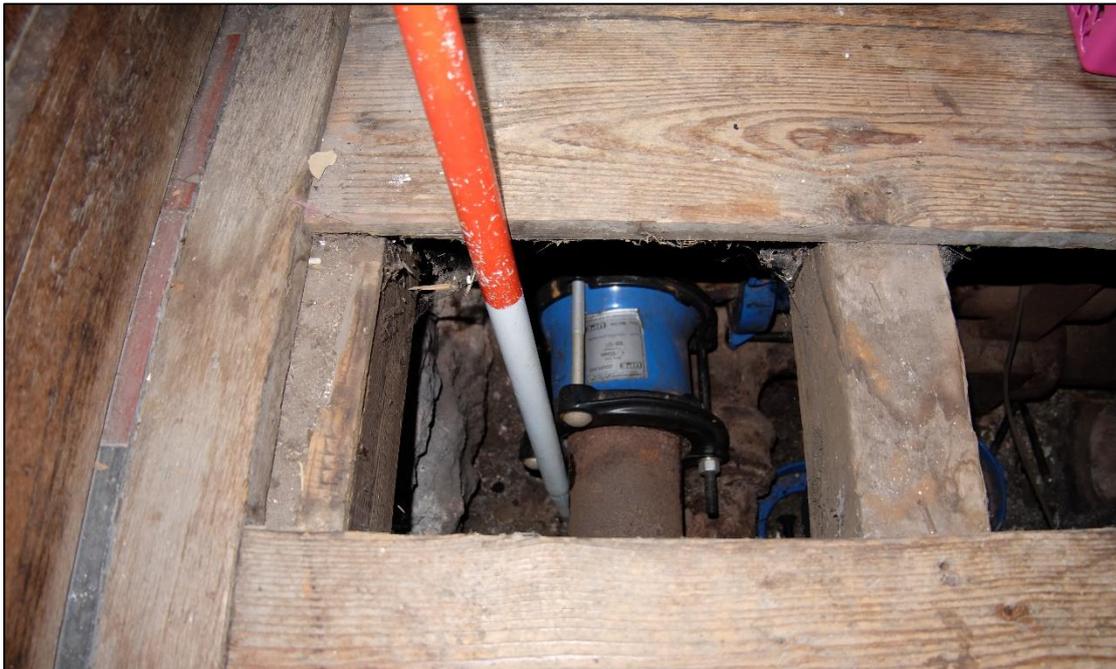
A loose floorboard was lifted at the west end of the south aisle during the visit, revealing existing pipework in a void up to 600mm deep (Fig. 14). Brick and stonework supporting walls were also visible under the timber flooring and a brickwork pad was visible under the west wall of the south aisle.

Figure 14. Existing pipework below the floor at W end of S aisle

It is assumed that the wood flooring installed in the 19th Century is of a suspended construction to allow air flow for ventilation and service ducts for heating. This is partially backed up by the void containing pipework at the west end of the south aisle and a series of grills in the aisle inside the north entrance covering voids of between 400mm and 1.1m deep. The current proposals are for the wood flooring to be retained, and only small areas will be lifted for the installation of new pipework and no further excavation will be required. However no investigation work has taken place within the rest of the church to confirm how much of the floor area was excavated during the 19th Century reordering works. There is a strong possibility that any exposures below the existing floor may reveal earlier floor surfaces, earlier phases of the church's construction, burials and vaults.

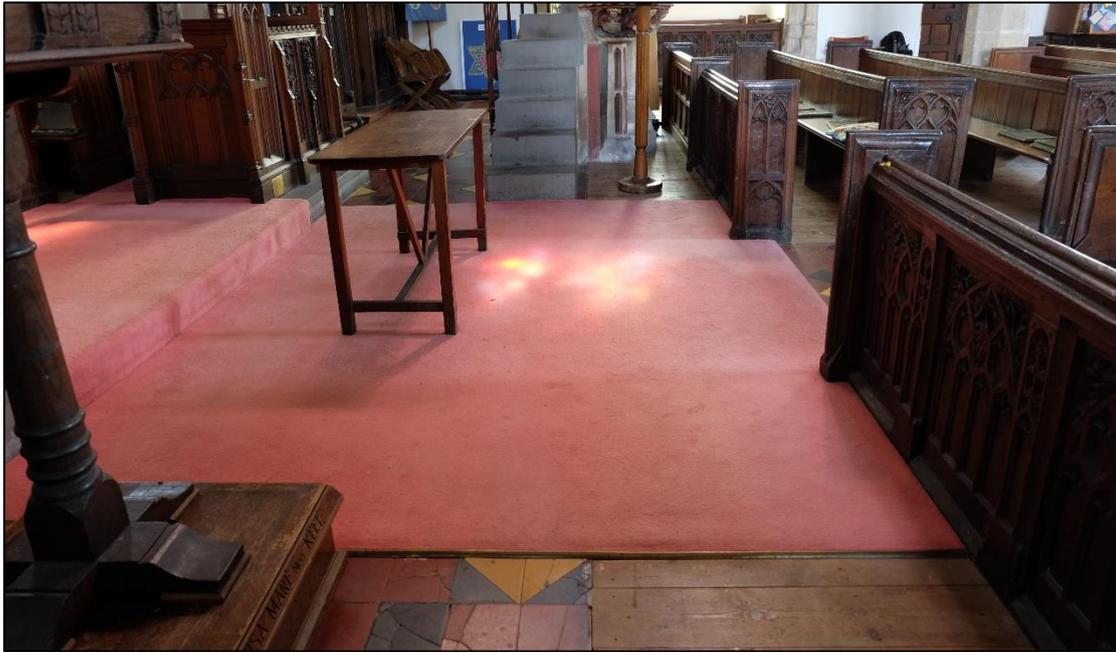
The proposals include the construction of a timber stage at the east end of the nave. There is no excavation associated with this feature as it will be seated on the existing floor. The area was carpeted during this visit so it was not possible to see the underlying flooring (Fig. 15), but it is assumed that it will be a continuation of the tiled and timber surfaces.

Figure 15. Proposed Stage Location at E end of Nave: facing S
