January 2025

<u>Methodology Statement for the repair of</u> <u>18th Century heraldic Pane in the Belltower of</u> <u>Leamington Hastings Church</u>

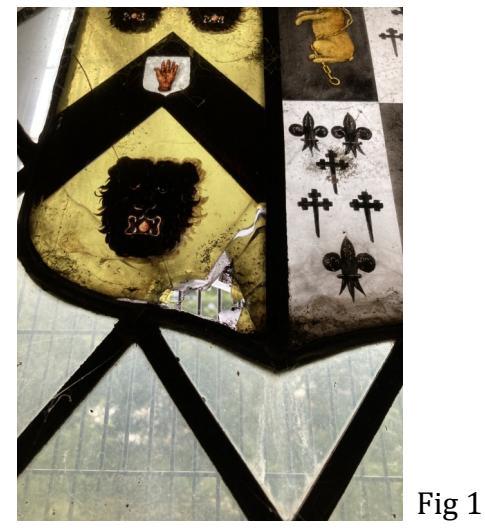
The damage to the heraldic panel (Fig1) consisted of a jagged crack going from just below the bottom of the chevron, right hand side, to the bottom centre of the panel. Some of the glass still extant. Size of damage approx 1" across x 2" high. There is also a visible crack just below the centre to left bottom of the lions head. Due to the nature of the glass, which is uneven in surface, it has not run on any further.

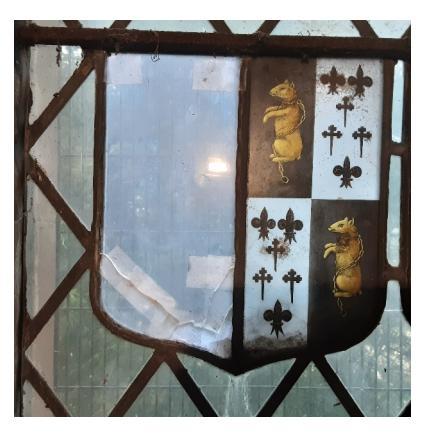
Fig 2

The large crack running through the lions head upward to the left hand side is actually in the outer plate glass. (Fig 2)

The Heraldic pane was then removed, leaving the outer pane in situ and patched up with clear tape. This protected against the weather and remained until the completed repair was refitted.

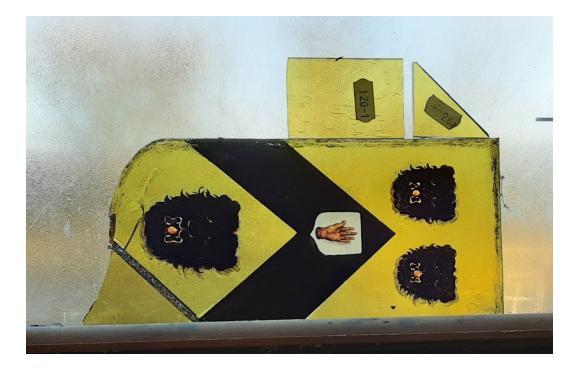
Tatra Glass reference '28P' Yellow was the closest match to the original glass.(Fig 3 triangular sample)

Due to differences between the original glass and repair glass in thickness I decided to use copper foil, rather than Hxtal to join the two together to get a better join.

The Heraldic piece was then cut to a straight line to remove the jagged edges, ensuring as much original glass remained as was possible.

The replacement glass piece was cut to match the line, to the original shape.

Copper foil was attached to the joining edge of the two pieces and soldered into place.

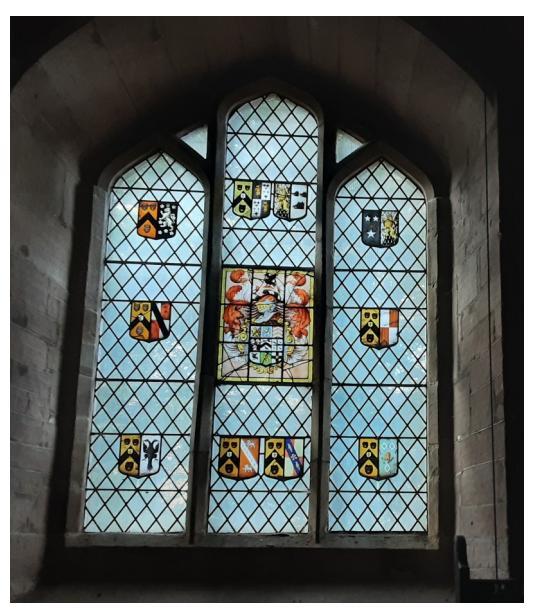
Having restored the glass, evidence suggests that all the 18th century panes have been plated in the same way- sandwiched, but not sealed, between two pieces of clear plate glass. Very little evidence of putty cement within the lead cavities. This would explain the high frequency of organic surface pollution visible between the layers of glass across the panels as a whole, and may need to be looked at in future as it could contribute to damaging the surfaces of Heraldic glass on both sides, over time.
