**CHURCH OF ST MARY MAGDALENE,  
STOCKLAND BRISTOL, BRIDGWATER,  
SOMERSET TA5 2PZ**

**Report on the Potential Impact of Proposed Reordering  
Works on Below Ground Archaeological Deposits**

**Prepared October 2023 for**

**The PCC of the Church of St Mary Magdalene, Stockland Bristol**

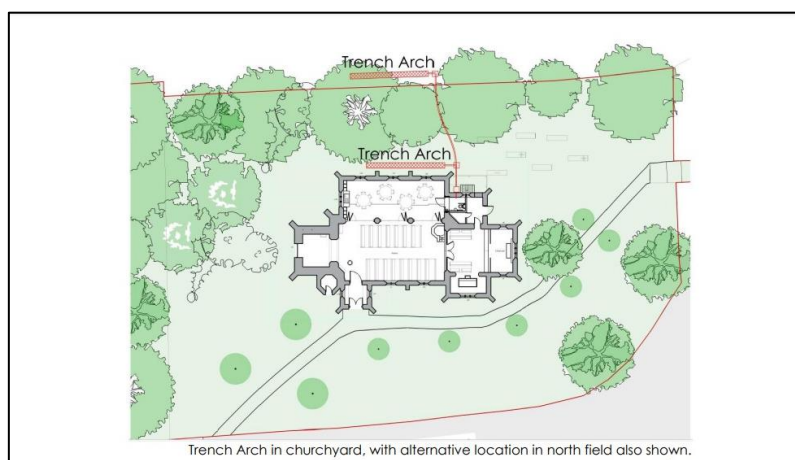
The main excavation work for the project is likely to be the installation of drainage for the new WC and kitchenette. Various drainage options are being considered at this stage (Benjamin + Beauchamp Architects 2023), but the writer was informed that the preferred option would be to instal a Trench Arch System on the north side of the church as the other options involve excavation in neighbouring land or a long run of drainage to an existing cesspit west of the church. Therefore the focus of the site inspection was concentrated on the location of the proposed Trench Arch System (Fig. 1).

**Figure 1.** Trench Arch System Location (after B2 Architects)

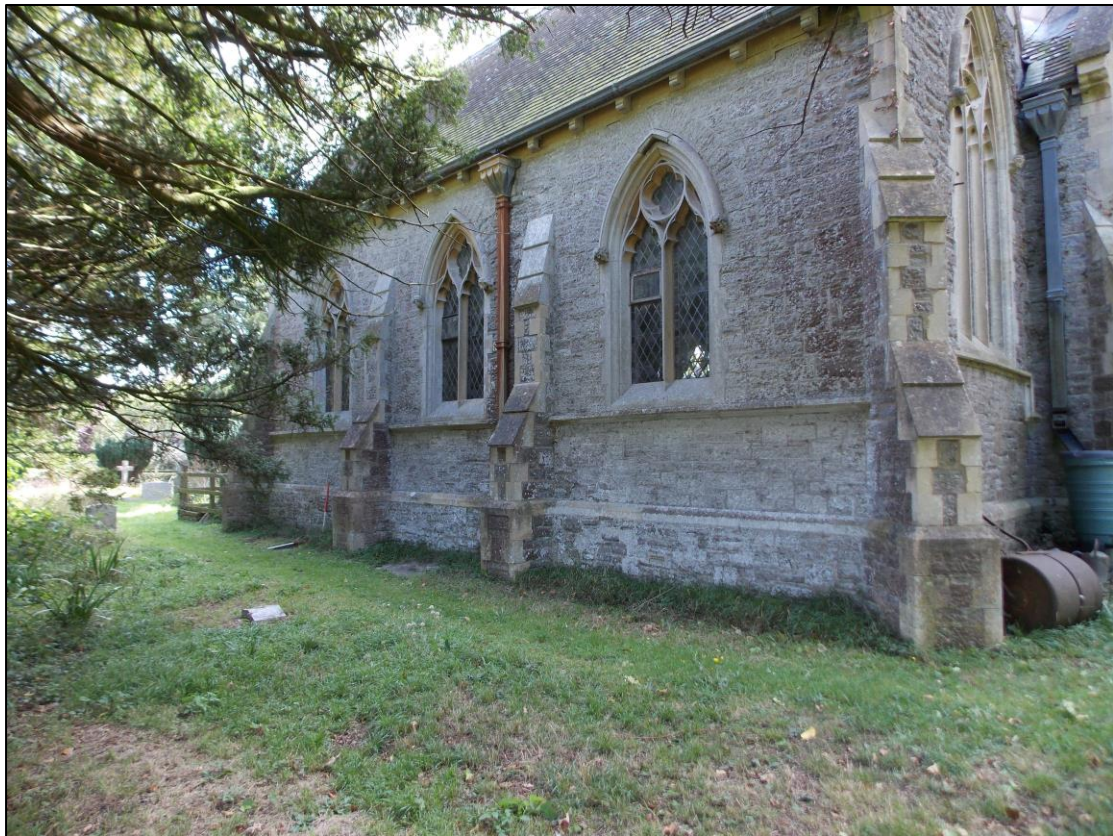
There are no upstanding headstones in the proposed Trench Arch System location (Fig. 2). The nearest ones are a Headstone for James Govett to the north of the Boiler Room entrance (Fig. 3) and a memorial stone to the Pearce family 2.8m north of the church wall, opposite the third buttress heading west along the North Aisle (Fig. 4).

**Figure 2.** Proposed Trench Arch System Location, N side of Church: facing SE

If the Trench Arch System is installed on the north side of the church, it is unlikely to impact upon in-situ burials due to the shallowness of its construction being approximately 400mm in depth. There is however the possibility that the churchyard may have been reduced during the rebuild, but the churchyard in this area is approximately 1.4m higher than the field to the north suggesting that this area was probably built up in the 19<sup>th</sup> Century to accommodate more burials rather than being reduced.

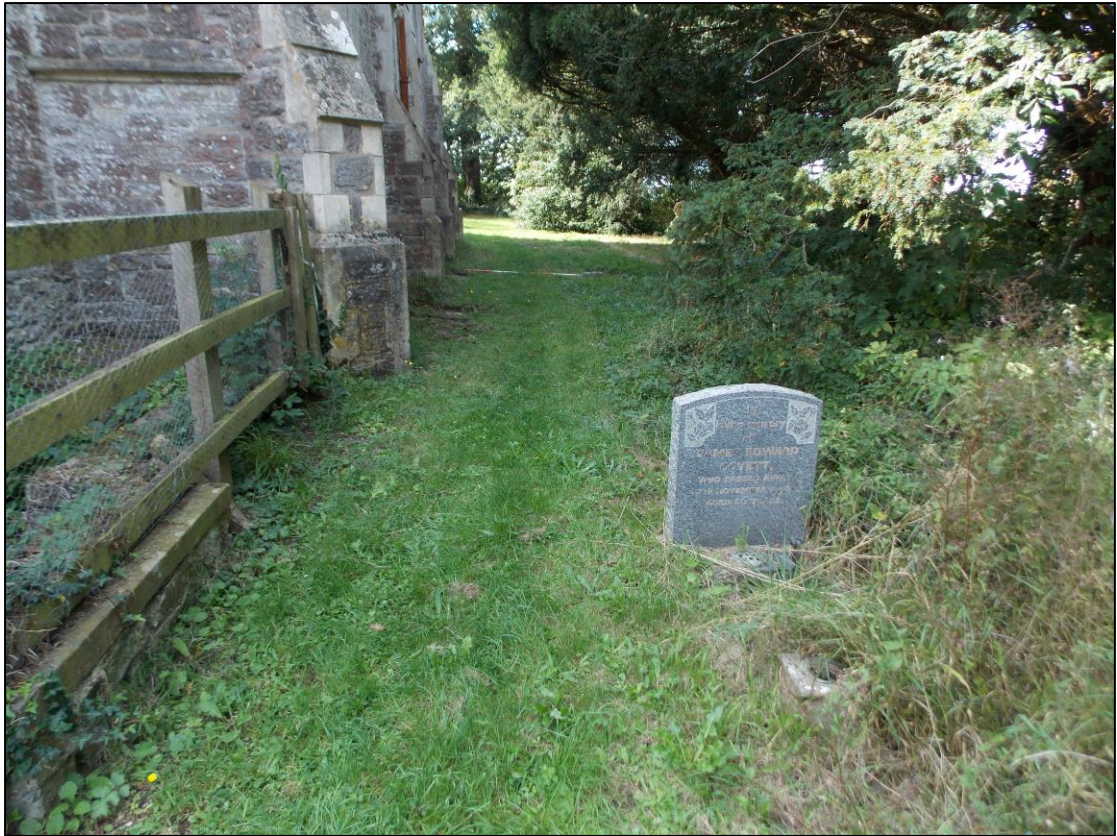
**Figure 3.** James Govett Headstone: facing W

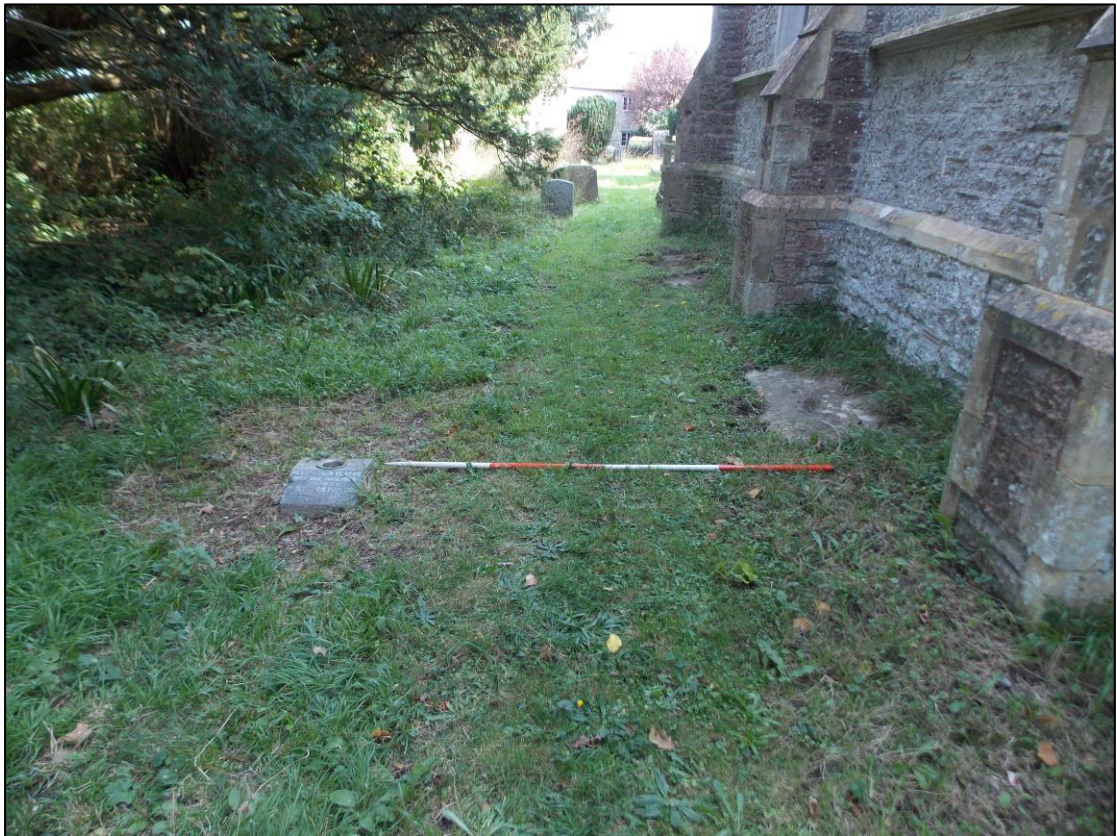
**Figure 4.** Pearce family memorial: facing E, 2m scale

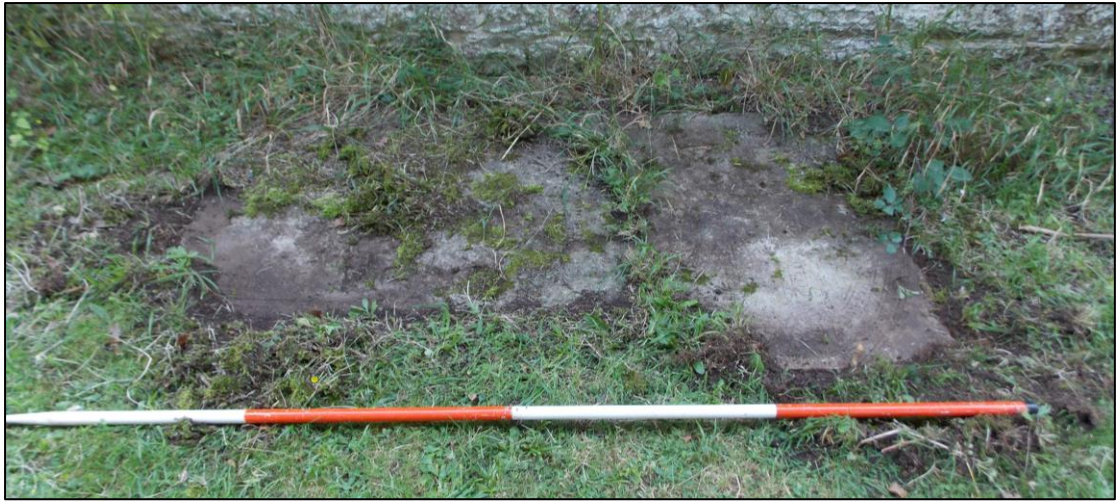
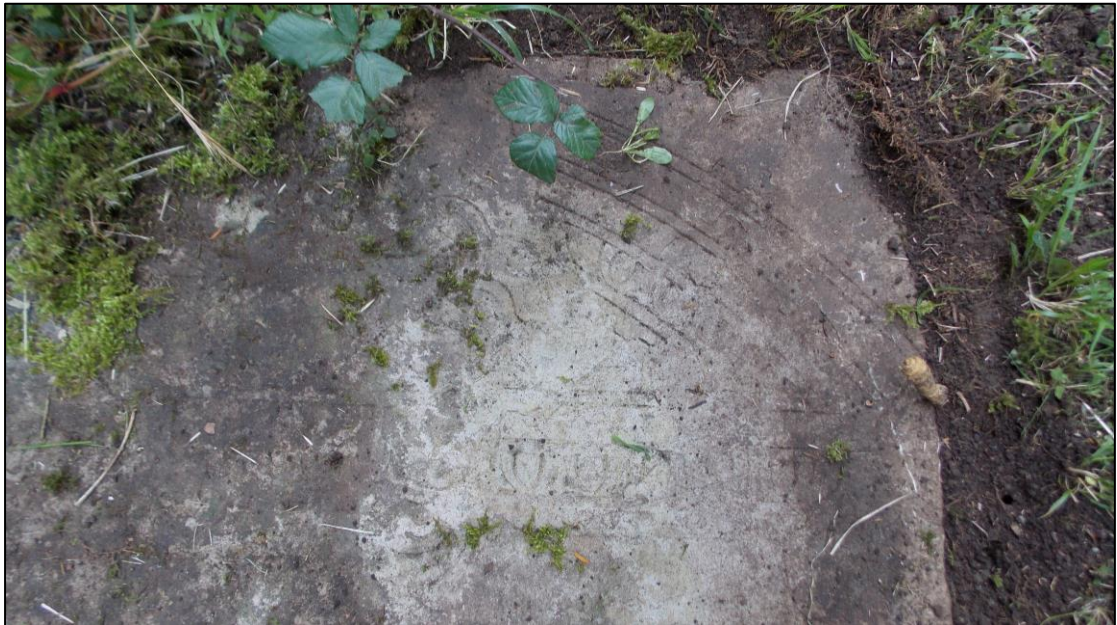
A broken and eroded, decorated Ledger stone/Headstone, 1.8m long x 920mm wide has been laid against the north wall of the church in between the first and second buttresses running west, no inscription was visible (Figs. 5 & 6). A further stone slab, circa 1.3m long x 760mm wide is also visible between the second and third buttresses running north (Fig. 7). No inscription or decoration was visible on this stone, but it is possible that it may have been laid face down.

**Figure 5.** Decorated Ledger stone: facing S, 2m scale

**Figure 6.** Ledger stone detail: facing W

The two memorial stones laid against the church wall have may have been moved from within the churchyard or church and are probably not in their original positions. The decorated one appears to be of an 18<sup>th</sup> Century design and is possibly a Ledger stone that was moved from inside the church during the rebuild. If this stone is in-situ potentially covering a brick constructed burial vault against the church wall, then this feature is likely to have been partially destroyed during the rebuild.

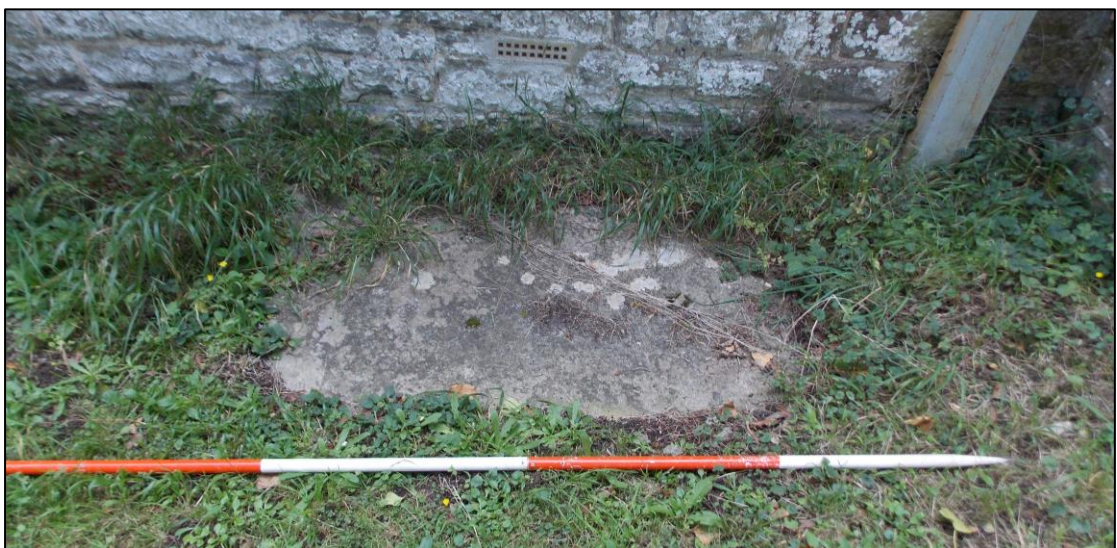
**Figure 7.** Uninscribed stone slab: facing S, 2m scale

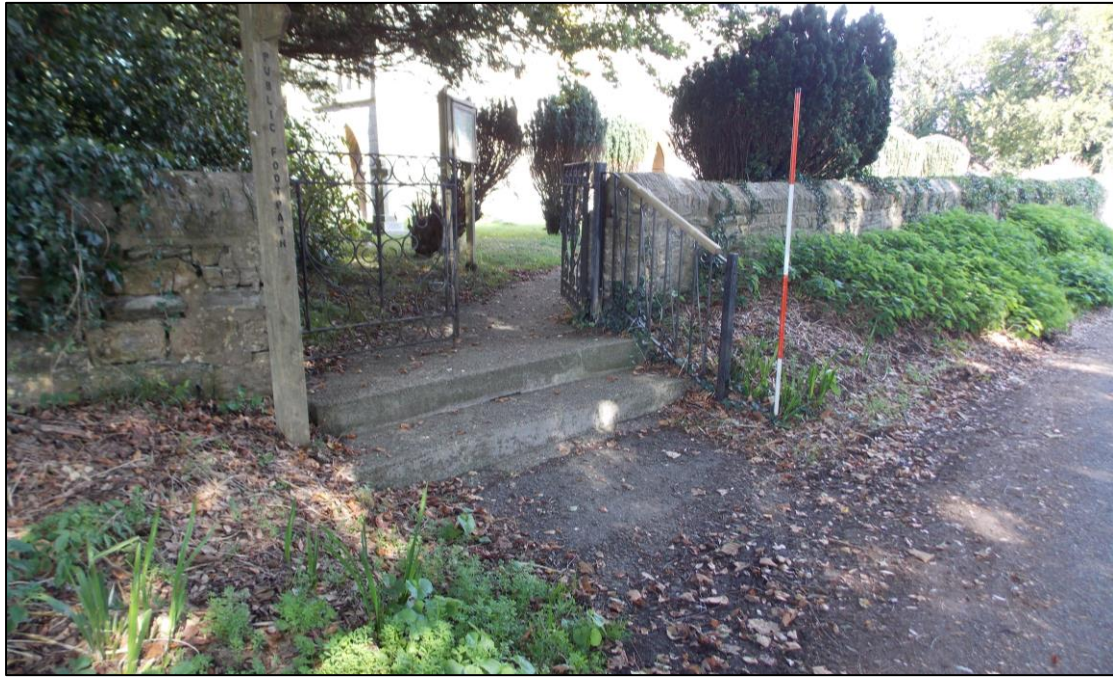
The main entrance into the church is through the South Porch and is accessed by a gently sloping concrete path running SW to a stepped gateway out onto the road. The path in this location is approximately 500mm above the road (Fig. 8) and generally 150mm lower than the churchyard on either side as it runs NE towards the church (Fig. 9).

**Figure 8.** Stepped gateway entrance: facing NE, 2m scale

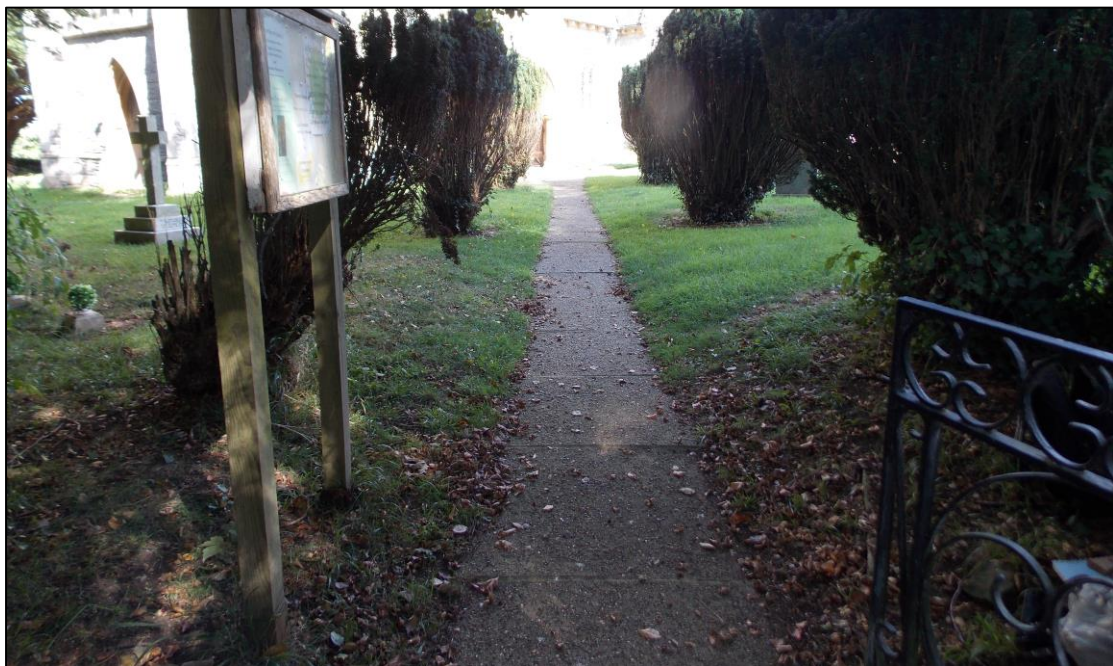
**Figure 9.** Pathway to South Porch: facing NE

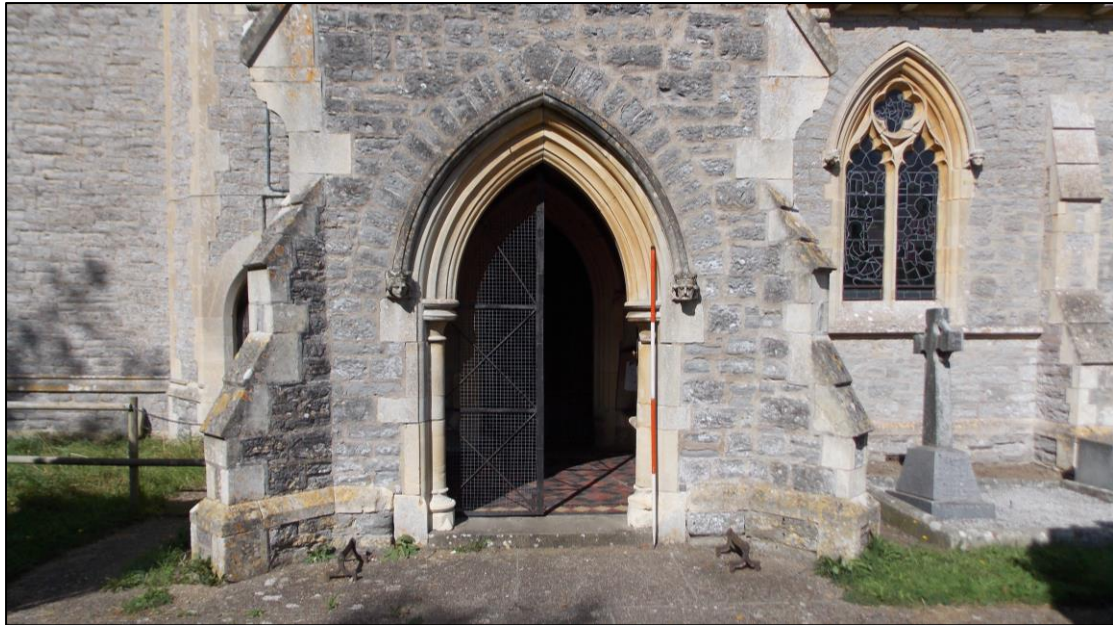
The tiled floor within the South Porch is approximately 100mm higher than the outside path and is accessed by a single stone step (Fig. 10).

**Figure 10.** South Porch tiled floor & stone step: facing N, 2m scale

It is assumed that the works to allow level access into the church would involve the raising of the path outside the South Porch and possibly a ramped entrance out on to the road. Depending on the depth of the excavation works associated with the re-profiling there is again a possibility that burials and earlier phases of the church's construction may be revealed.

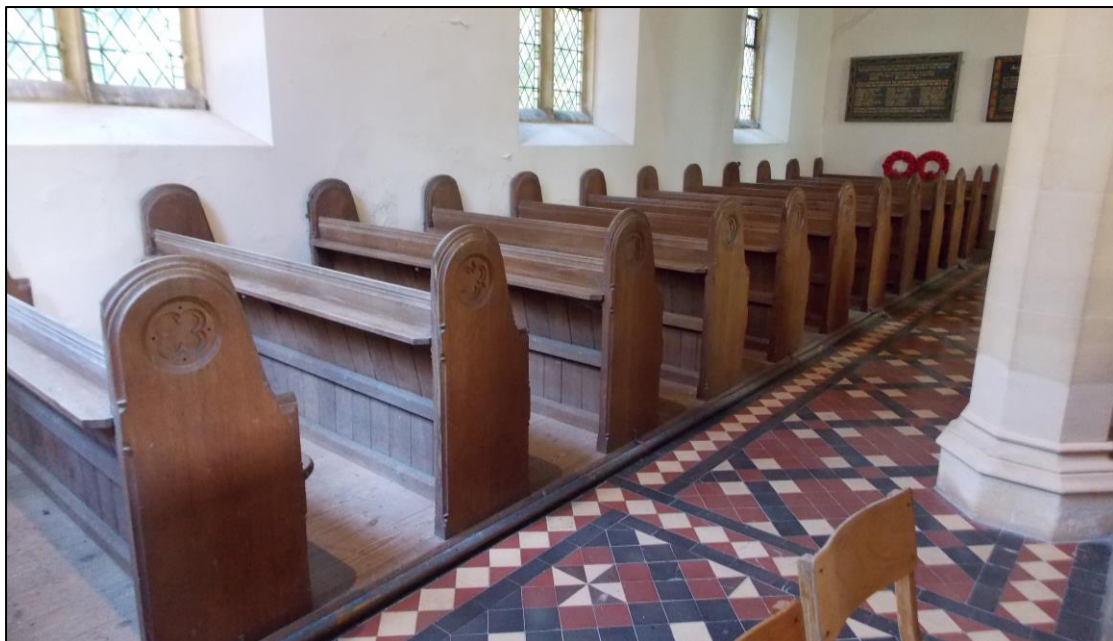
The pews in the North Aisle appear to be 19<sup>th</sup> Century or later and are sat on a raised timber platform approximately 60mm above the tiled floor (Fig. 11). A cast iron grill runs along the south side of the pew platform at the east end (Fig. 12) and covers a 130mm wide x 1m deep service duct for the existing heating system.

**Figure 11.** North Aisle Pews: facing NE

If permission is granted for the pews and platform to be removed, then the DAC are likely to stipulate that a photographic and descriptive record is undertaken prior to their removal.

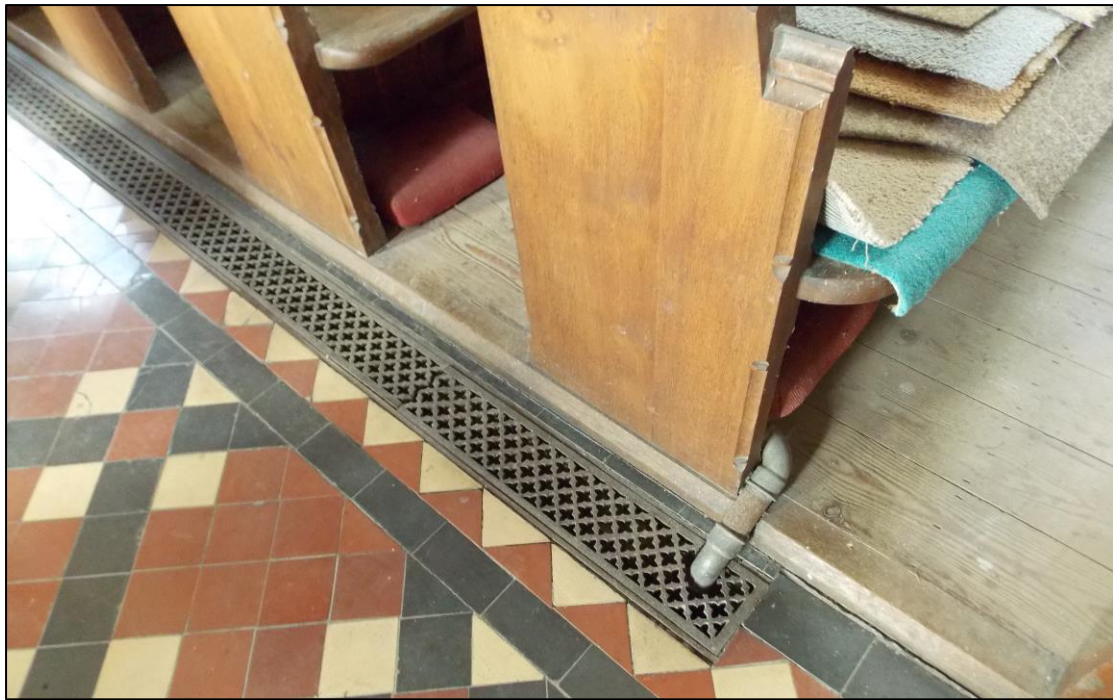
**Figure 12.** Service duct at east end of pews: facing NW

The removal of the pew platform may reveal an existing void deep enough to accommodate a new heating system without major excavation, however if the existing surface must be reduced further, then there is a strong possibility that 17<sup>th</sup>, 18<sup>th</sup> and 19<sup>th</sup> Century burial vaults may be uncovered at a fairly shallow depth. It is unclear at this stage how much of the original church floor was removed during the rebuild but service ducts have been excavated up to 1m below the existing floor surface.

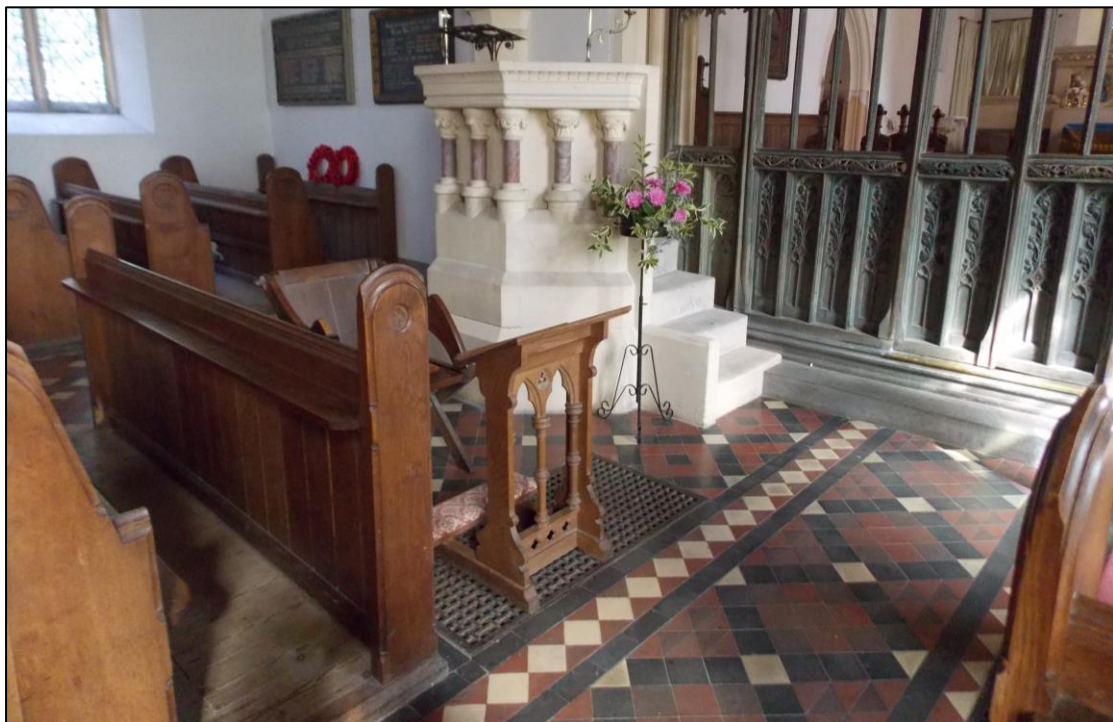
A larger cast iron grill covers an area 1.22m long x 620mm wide and up to 880mm deep, SW of the pulpit (Fig 13).

**Figure 13.** Cast iron grill SW of pulpit: facing NE

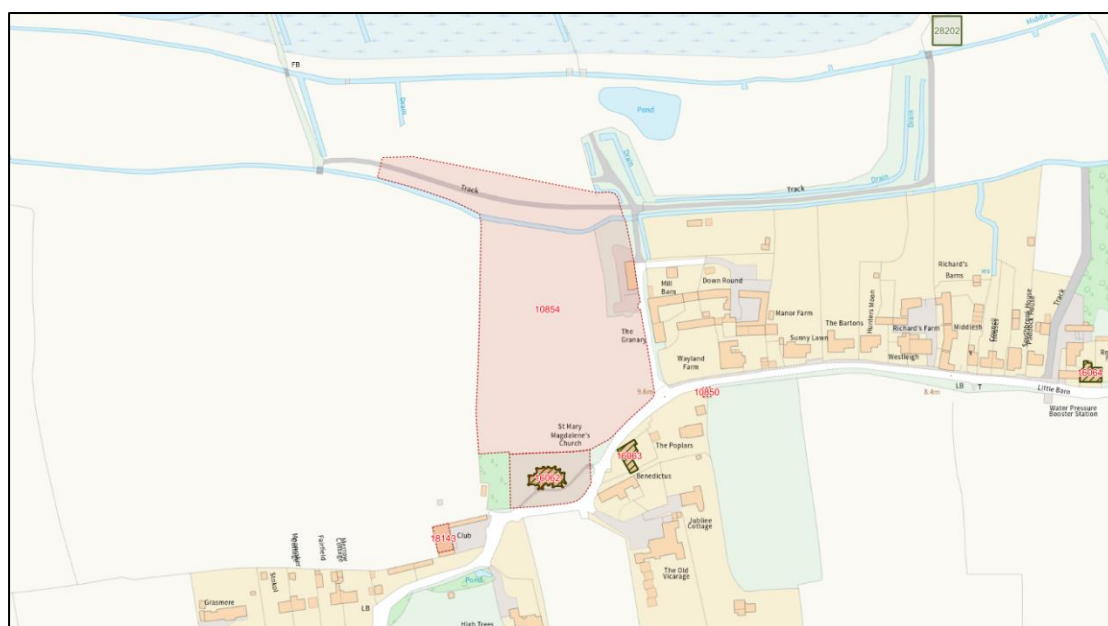
The entire field on the north side of the church is recorded on the SHER as a Heritage Asset (Fig. 14). Although the field was fairly overgrown with vegetation during the site visit earthworks were clearly visible (differing sheep levels) in the south end of this field opposite the west end of the churchyard (Fig. 15).

Because the field is recorded on the SHER and earthworks are clearly visible then the DACs archaeological advisor is likely to recommend against installing a drainage system within this area. If however they were to consider this option, then an archaeological evaluation would probably have to be undertaken in the form of trenching prior to any decisions being made thus increasing the projects costs considerably.

**Figure 14.** SHER Record No 10854 marked in field N of church (after SWHT)

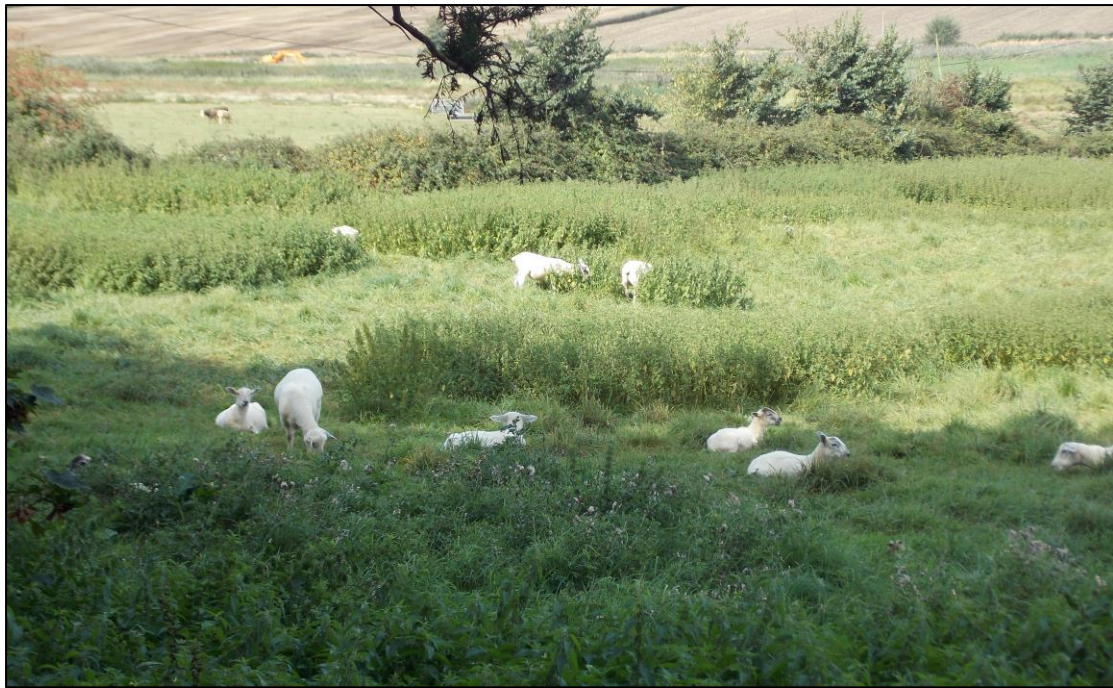
**Figure 15.** Earthworks, south end of field on N side of church, grazing sheep for scale
