**NEVILLE HALL
FREELANCE ARCHAEOLOGIST & CONSULTANT**

AN ARCHAEOLOGICAL WATCHING BRIEF AT
THE CHURCH OF ST. ANDREW, FIRSBY ROAD,
HALTON HOLEGATE, LINCOLNSHIRE.

PREPARED FOR THE HALTON HOLEGATE PAROCHIAL CHURCH COUNCIL

March 2025

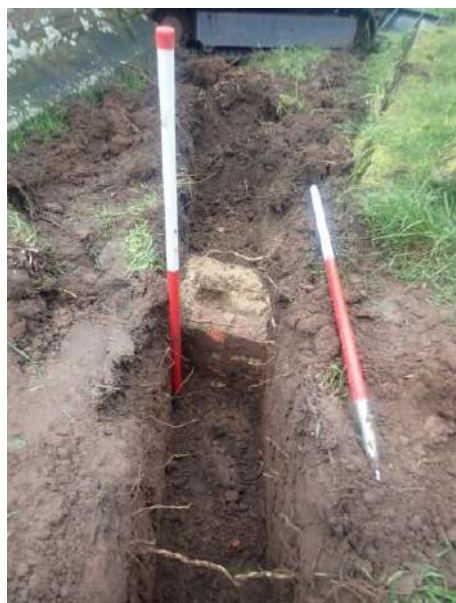
- 8.3 To the north-east of the church, the north-south orientated line of a brick wall foundation was exposed by the excavation of a drainage trench here. This was of three courses in height and of two courses in thickness and composed of handmade brick stretchers that were all laid on bed. The bricks were bonded by a lime mortar. A small square shaped posthole was also recorded in the midst of this foundation. It is considered that this may have supported a timber fence or a possible wrought iron fence. It was at first considered that this may have marked the line of a former churchyard boundary wall, but was latterly interpreted as marking the site of part of a 19th century grave marker or brick vault. Its line was overlain to either side by a tomb of 1855 to the north and by a further tomb to the south of 1886, respectively.

Plate 74: View of an *in situ* brick wall foundation, from the west

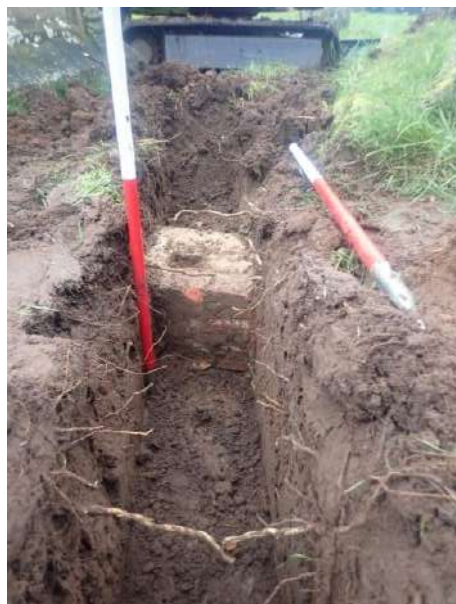
Plate 75: View of an *in situ* brick wall foundation, from the west

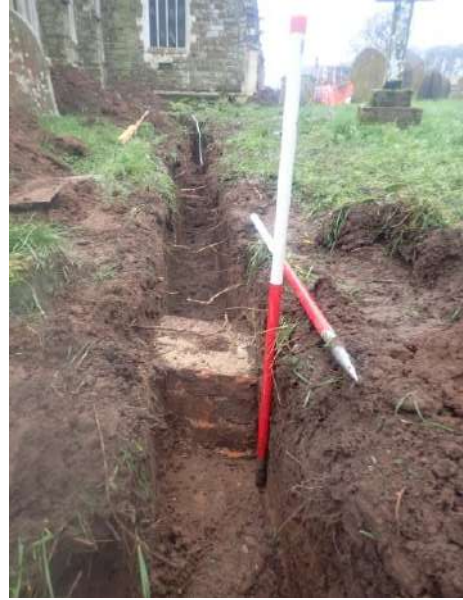
Plate 78: View of an *in situ* brick wall foundation, from the east

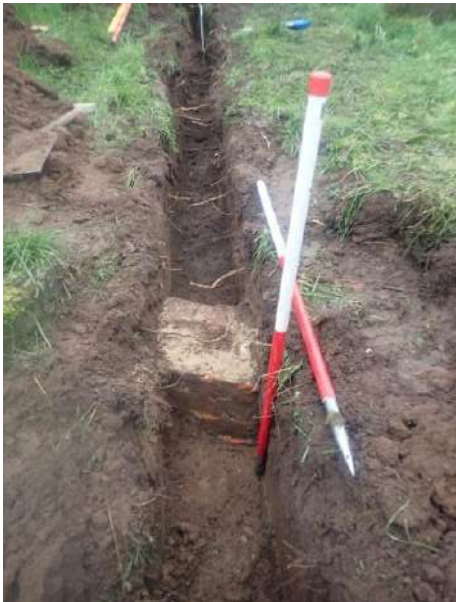
Plate 77: View of an *in situ* brick wall foundation, from the west

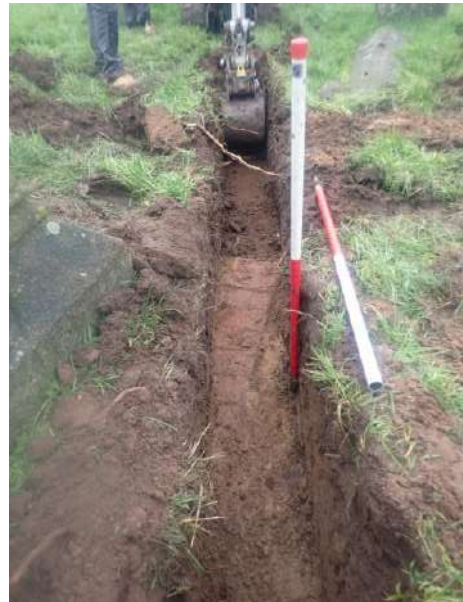
To the immediate north-east of this was the exposed brick base for a nearby and adjoining 19th century tomb. This was also recorded within the same drainage trench excavation. This consisted of one course of handmade brick stretchers laid on bed with no visible bonding material.

Plate 79: View of a brick base to the adjoining tomb, from the west

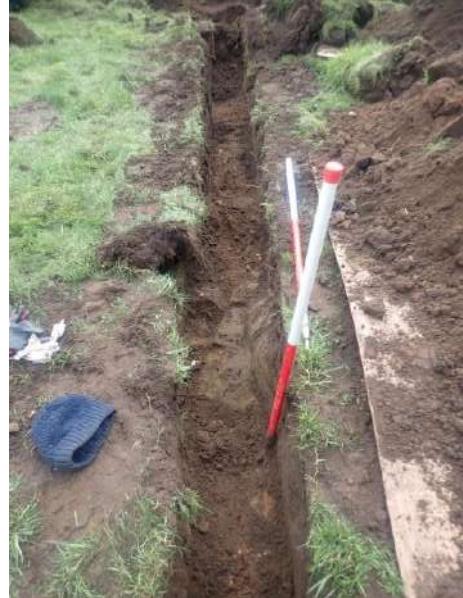
To the south of the chancel, the site of a possible stone base of greensand blocks for a further undated grave marker was also exposed and recorded during the course of the excavation of a further drainage trench here.

Plate 144: View of an *in situ* stone base for a grave marker, from the north-west
