# Final Conservation Report for The Monument to Evan Beavan Holy Trinity Church – Preston Wynne Hereford Diocese

## Final Conservation Report for the Memorial to Evan Beavan †1814

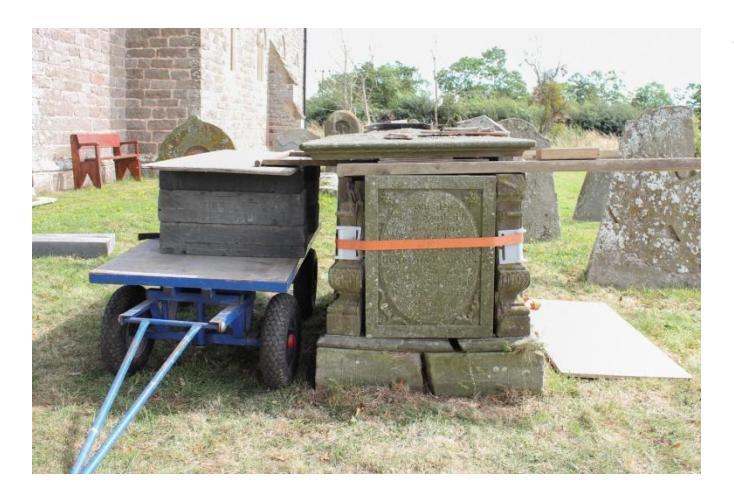
The lid being manoeuvred off the effectively loose side elements, the majority of insubstantial iron fixings, beneath, either having failed completely or corroding/expanding into the narrow, shallow channels, causing some splitting of stonework.

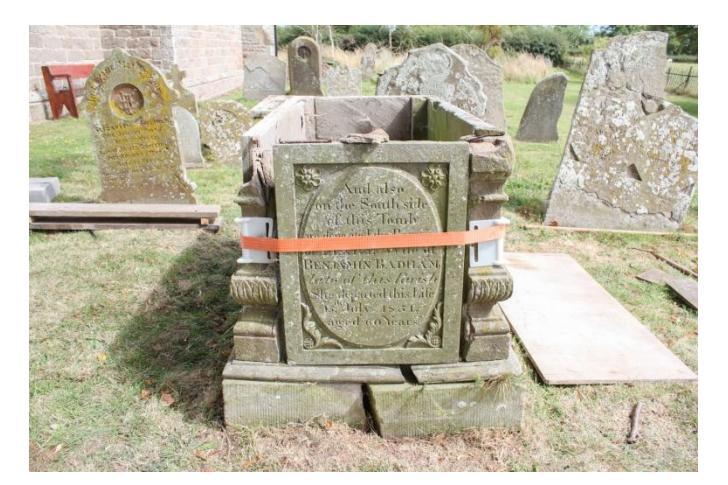
The 8 tombchest elements were precarious once the overlying weight was removed, being too thin (front to back) in design/manufacture. The ratchetstrap is to stop loose elements moving during dismantling.

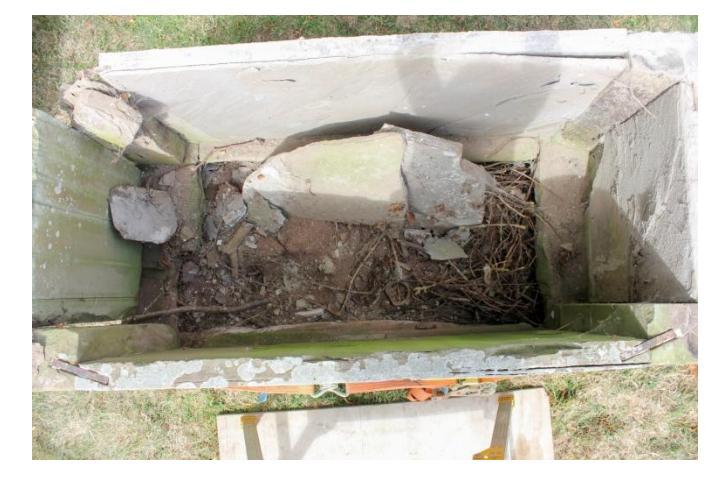
The inside of the tombchest after removal of the lid, which weighed a little over 300kg. One of the corner pilasters (top left) had sheared down its natural, transverse bedding planes, as had both long panels. The 5 main fragments of the long, fluted block were found to be beyond practicable repair and so a new replacement section was carved.

- 3.3 The south, long-side, fluted block was replaced with a new piece of stone, which helps bear a little of the weight of the lid. It is formed in 2 separate pieces stuck together with an external grade resin. The upper fluting having been formed by a vertical milling machine (and not chiselled, adding shock into the stone) with the lower bull-nose moulding formed with a masonry router. The rose motifs at the corners and midway along its length where carved by hand, with the fluting also finished by hand so it didn't look so 'machine-cut'. Carving it by hand completely would have been much more laborious and therefore prohibitively expensive.

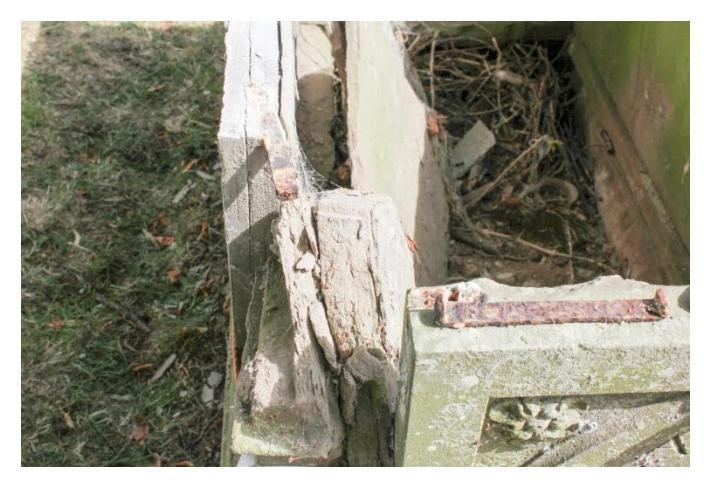
The corner pilaster that sheared, due to poor quality stone and expanding iron fixings. Note the vertical laminations in the neighbouring panel, showing the slab is *face-bedded* – at 90 degrees to its stronger '*natural'* bedding plane.

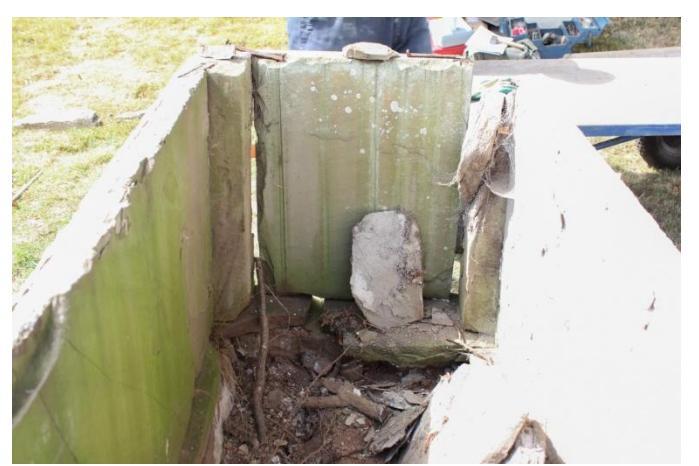
Mortar was completely missing from the internal mitres (you can see through both vertical joints) allowing easy access for weathering and more importantly moisture, acting against the iron fixings.

- 4.5 The internal mitres or corners were filled from the rear with traditional coarse mortar to ensure rainwater could not easily enter the core of the memorial. All external joints were pointed as far as possible to exclude rainwater.

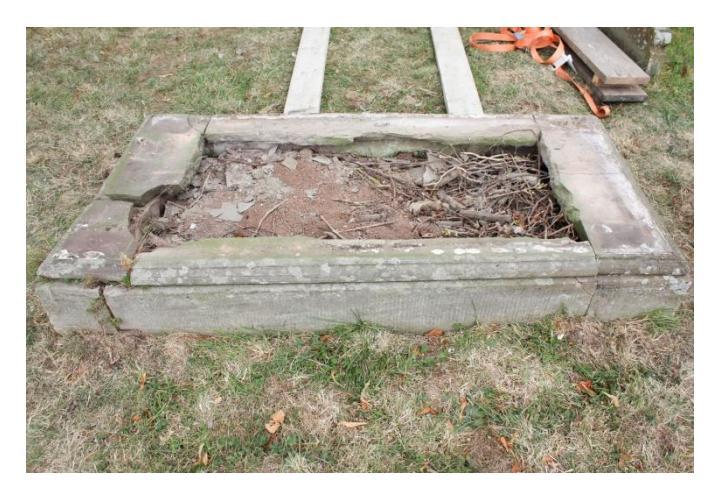
The plinth courses, showing detritus within the void, which was higher than external ground level. Fractures through thin individual blocks, had been exploited by point-loading caused by lack of proper foundations and uneven settling of blocks into the soil.

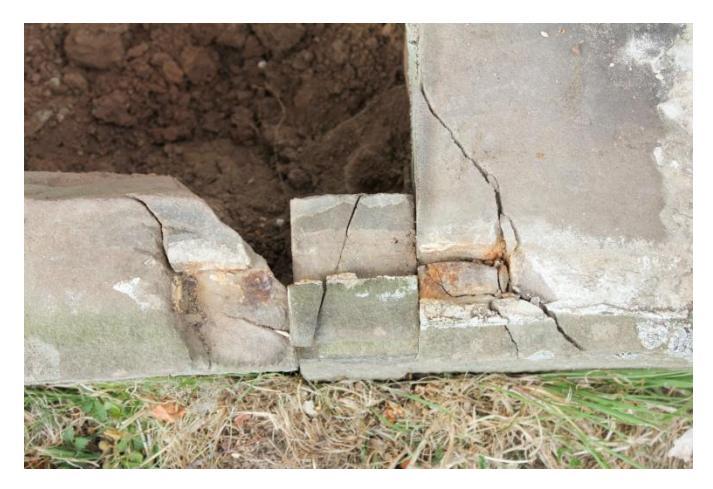
The top bed of the lower plinth course, highlighting the forces exerted by corroding, expanding iron fixings, having split 3 separate blocks.

3.1 Insubstantial iron fixings with tiny turn-downs were found in the top and bottom beds of the whole memorial. All corroded metal was removed, much of it fell out or was easily removed but several sections which had expanded into the sockets had to be drilled or cut out. This was slow work as the side panels were relatively thin and we could not risk bursting the stonework and damaging the edges which would be seen. All of the original fixing holes were widened/deepened to accommodate new, more substantial stainless-steel fixings.

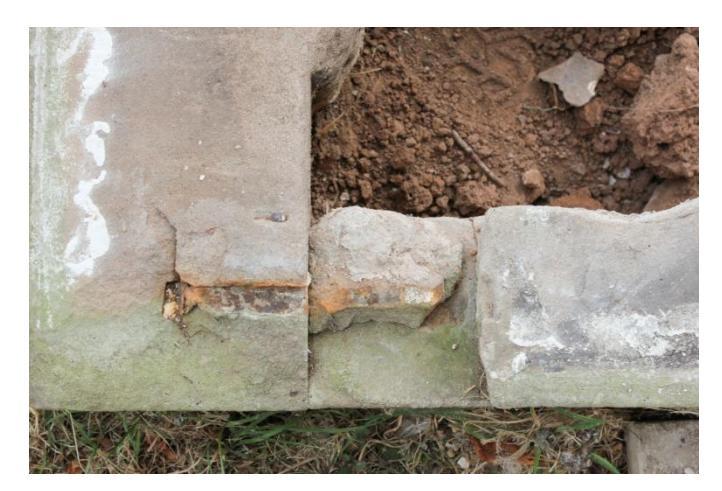
Another corner or mitre which has been damaged by an iron fixing.

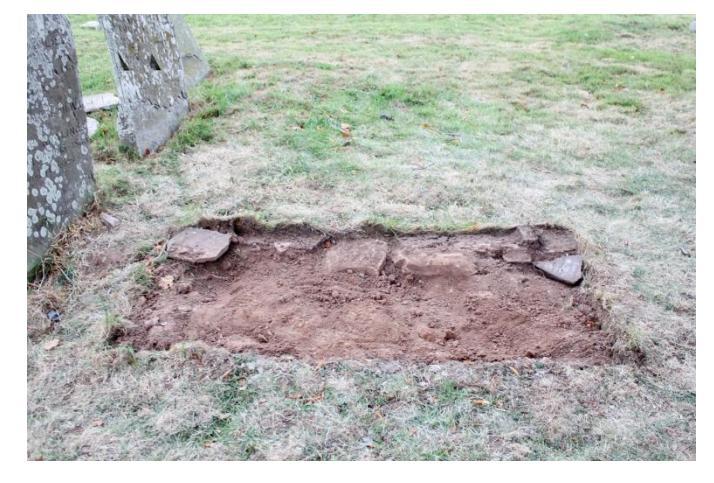
- 2.1 Work was done to excavate soil down to a suitable depth (150mm below ground level) in which to form a new cast base, giving a slightly larger footprint for rebuilding. During excavation a small network of animal burrows adjacent to the plinth blocks became clear. Several largish slabs of thin stone were discovered acting as the foundation for all of the overlying stonework, little wonder these could not bear the overall imposed load in the long-term.

The extent of foundations beneath the plinth, highlighting why there was such settlement of the plinth course which was effectively sinking into the ground, leading to many of the structural problems witnessed before dismantling.

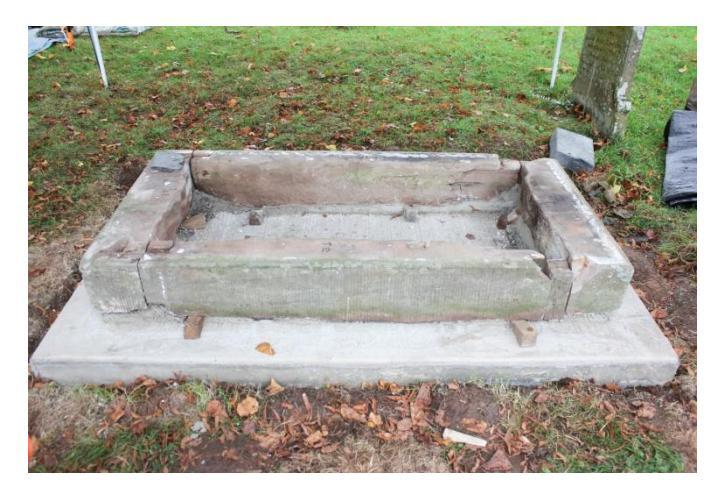
The bottom-bed of the lower plinth course is not flat and undulates significantly, as it was built straight onto the soil footprint. This meant the bed joint varies significantly but the top bed of the plinth is level, parallel with the concrete slab.

- 2.4 Once the concrete padstone was hard enough, the process of re-building began. The bottom two courses were bedded in traditional mortar onto the concrete slab re-using existing channels and holes that were adapted (made deeper). Blocks were fixed to one another with stainless-steel fixings secured with an externalgrade resin. The bedding mortar for both lower courses was allowed to harden before inserting Limecrete into the void. This was necessary as the plinth blocks were much deeper (front to back) than expected and would have compromised the new supporting core, making it too narrow. The bottom-beds of the plinth blocks were not worked flat, meaning the height of the bottom joint varies widely as the joint is as thick as the high-point of the plinth block bottom bed.

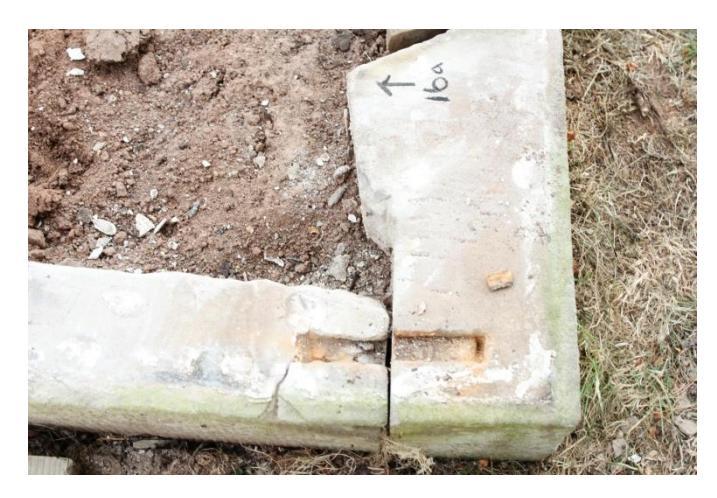
During dismantling it was observed many of the blocks were out of correct alignment, caused by uneven settlement and iron fixings.

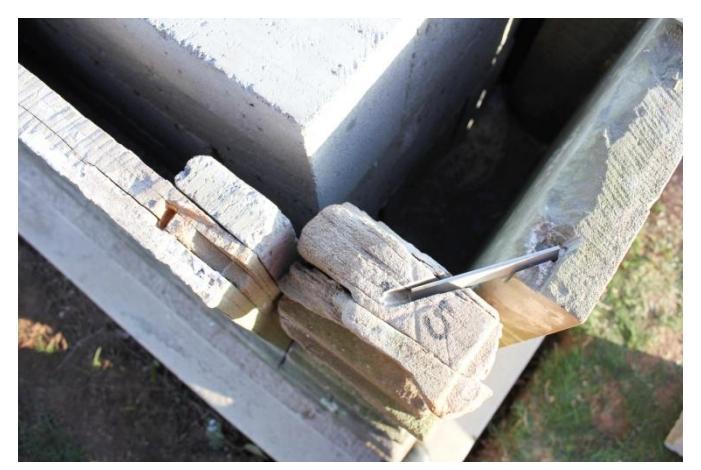
The majority of the side panels are too thin for purpose (front to back) with insufficient bearing for the much deeper, overlying fluted blocks. Some stone was so eroded and/or thin, it was not possible to install traditional dog-cramps, so slots were ground into the stone instead and secured with an external grade resin.

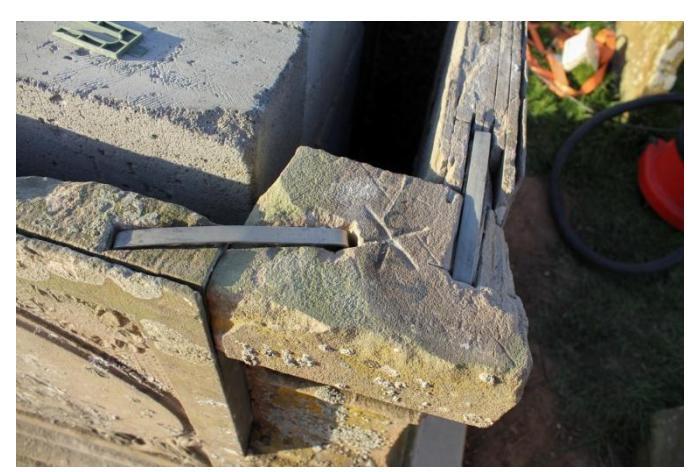
Although some corner blocks were thick enough to incorporate traditional fixings, the poor-quality stone slabs are delaminating. Note the *masons marks* on the top-bed of the pilasters, which determined how much the stonemasons were paid, from the amount of work they had carved.

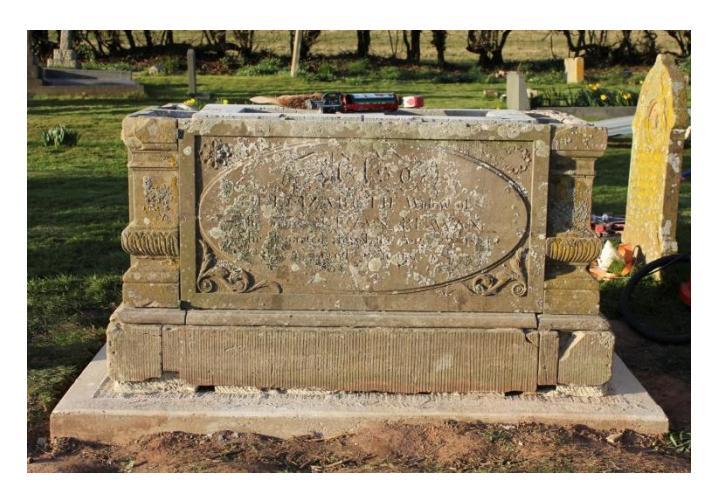
The tomb chest elements secured into position, with bespoke fixings in their topbeds. Note the biological growths still in place on the long panels, which covered the historic, genealogical information.

5.1 Limited cleaning was undertaken to the monument and only the dedication panels displaying the historic, genealogical information. Wooden modelling tools were used to remove loose mosses hiding the inscriptions on both long panels in particular. Flat scrapers and scalpels were employed to remove loose mortar and soil debris from the break edges and mating surfaces of joined elements. Other exposed elements of the memorial were not cleaned, as this was not the intention of the project.

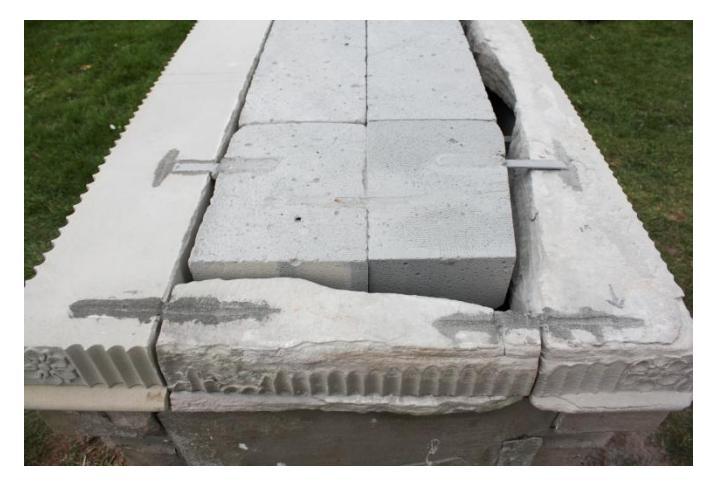
The lightweight blocks were as wide as possible to provide maximum support. Note the extent of loss to the top arriss or corner of the original fluted blocks, caused by poor quality stone and moisture ingress, corners being the point of greatest evaporation and therefore deterioration.

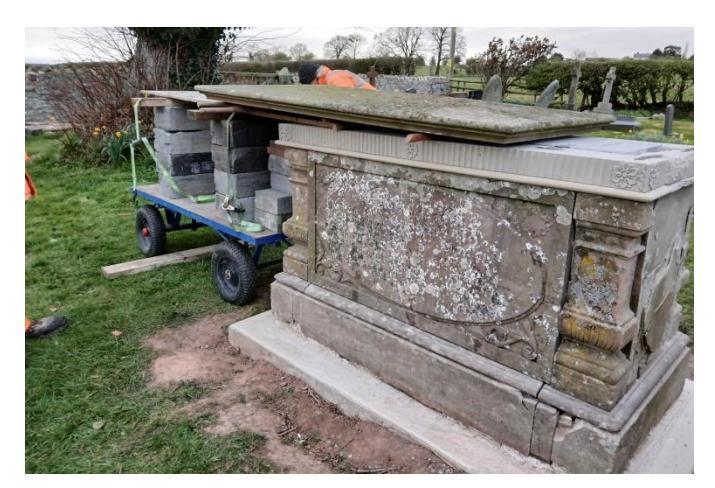
The heavy and fragile lid being rolled into position. It was removed and stored on a plywood sheet during dismantling, to prevent it snapping, as it is thin and long proportionally. We could not see the centre of the bottom bed was rough stone which kept the slab up out of position.

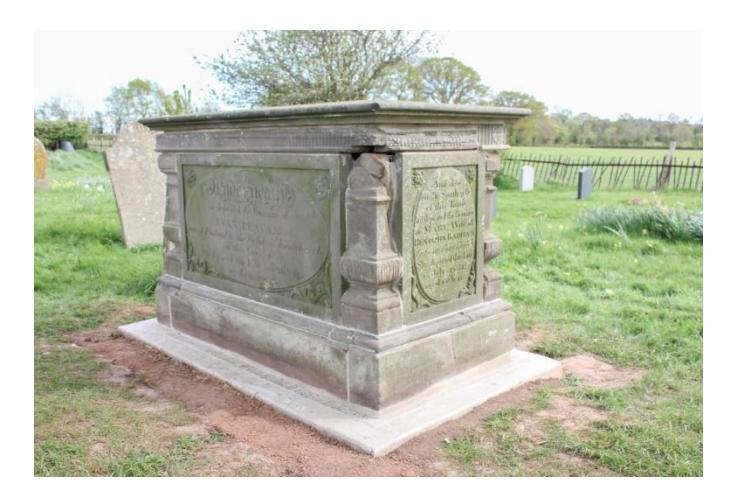
The tomb chest at the correct height, note the dirty demarcation line on the upstand of the plinth where the stone sat, sinking below ground level, leading to permanent, rising saturation of the stone, notwithstanding poor build quality.

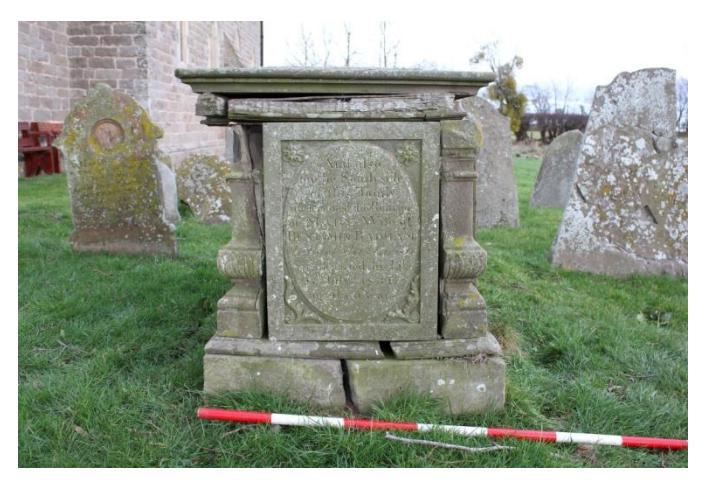
One of the short sides before dismantling, note the amount of movement to the lid (on the left) which weighs over ¼ ton. Note also the left-hand pilaster the top of which has fractured and sheared into the tomb chest. Note the large, historic vertical fractures in the plinth blocks caused by no support beneath.

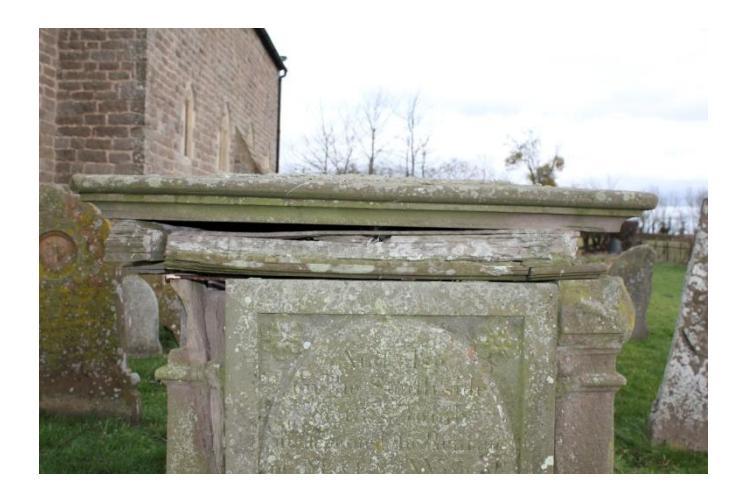
Loss of material to the fluted short block and over-hang on at the left of the tomb chest.

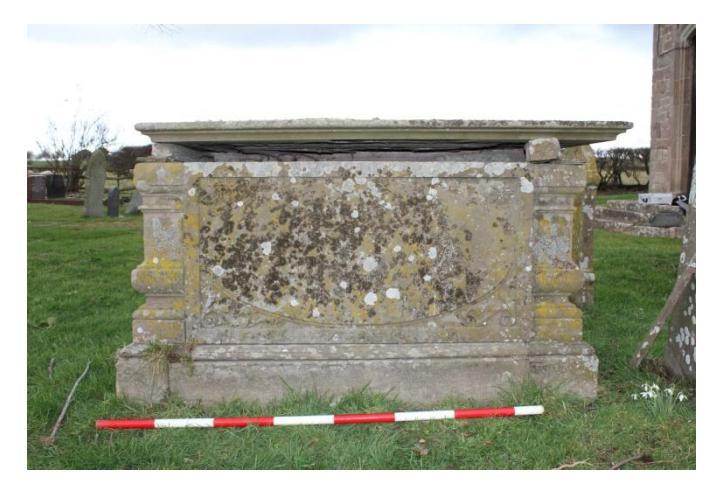
The rear face highlighting the loss of the fluted block into the core, which was broken in sections and was saturated with soluble-salts from being partially submerged in the ground, suggesting the fragments had been like that for a very long time.
