# Bat and Bird Report

## Bath Abbey, Bath City Centre

| Document No.: | NPA 30092 0400 |

Project: Bath Abbey

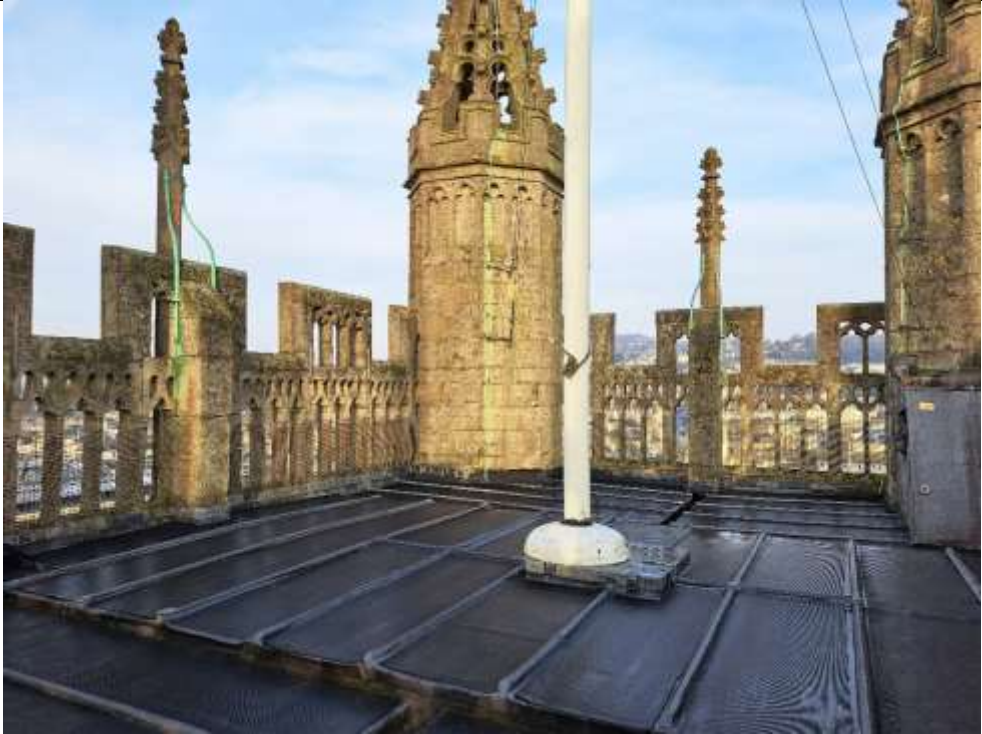
| 1. | <p data-bbox="411 1131 853 1160">View of bell tower roof from south-east corner</p> |

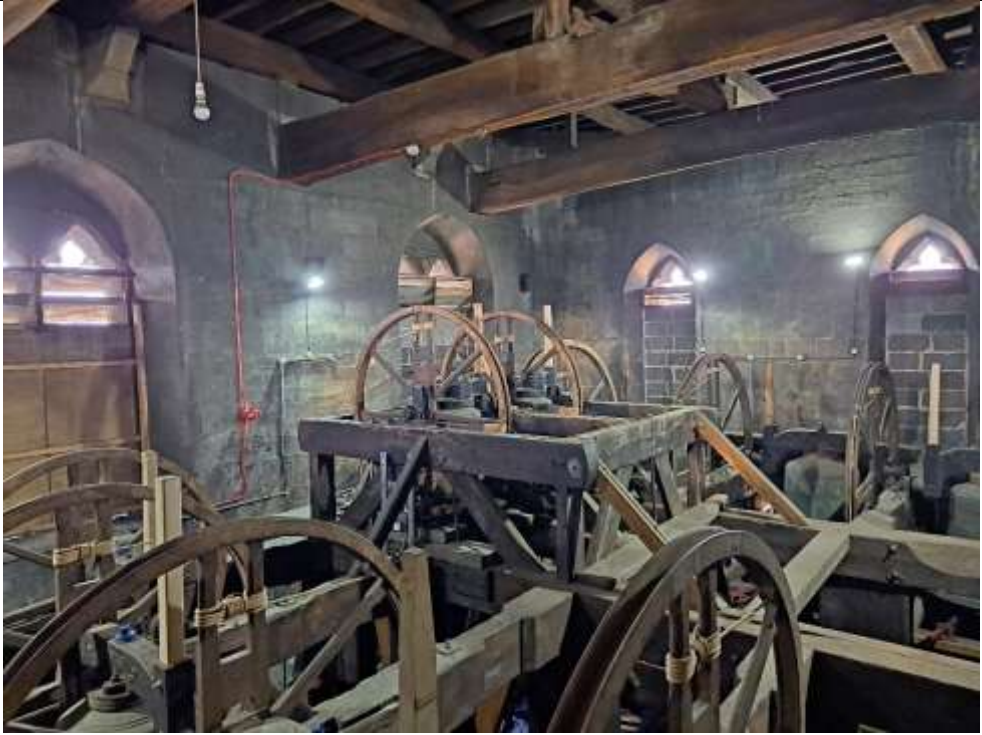
| 2. | <p data-bbox="411 1921 619 1951">Internal view of belfry</p> |

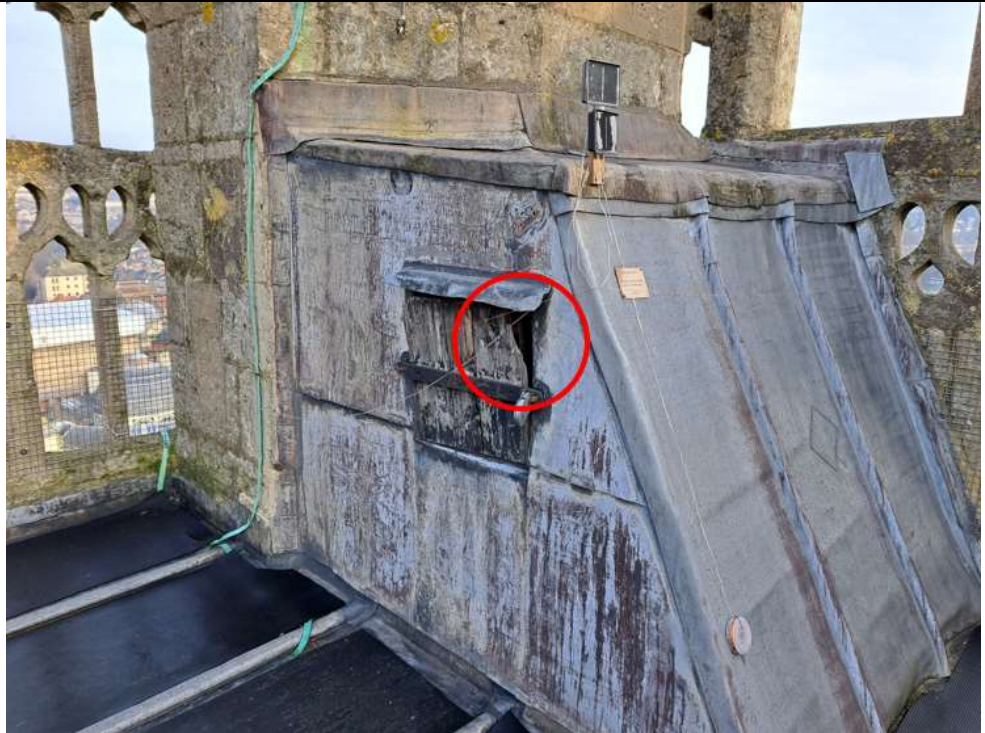
3.

| Overview | |
|---|---|
| Tower roof | Gaps under lead flashing at edge of weight's cabinet. Potential access into belfry via small gap in timber hatch of the weight's cabinet (Appendix 1; Photo 3). Potential access into south-west turret via linear gaps at side of small roof access door (Appendix 1; Photo 4). |

Access gap at side of timber hatch (leads to belfry)

- 5.1 Whilst no definitive evidence of roosting bats was recorded, the tower roof and belfry chamber are considered to have the potential support a 'Moderate' status bat roost. In accordance with Good Practice Guidelines<sup>1</sup>, 2 No. dusk emergence/re-entry surveys are recommended to determine their actual presence/absence ahead of the works. Such surveys are seasonally restricted to May – August/September.

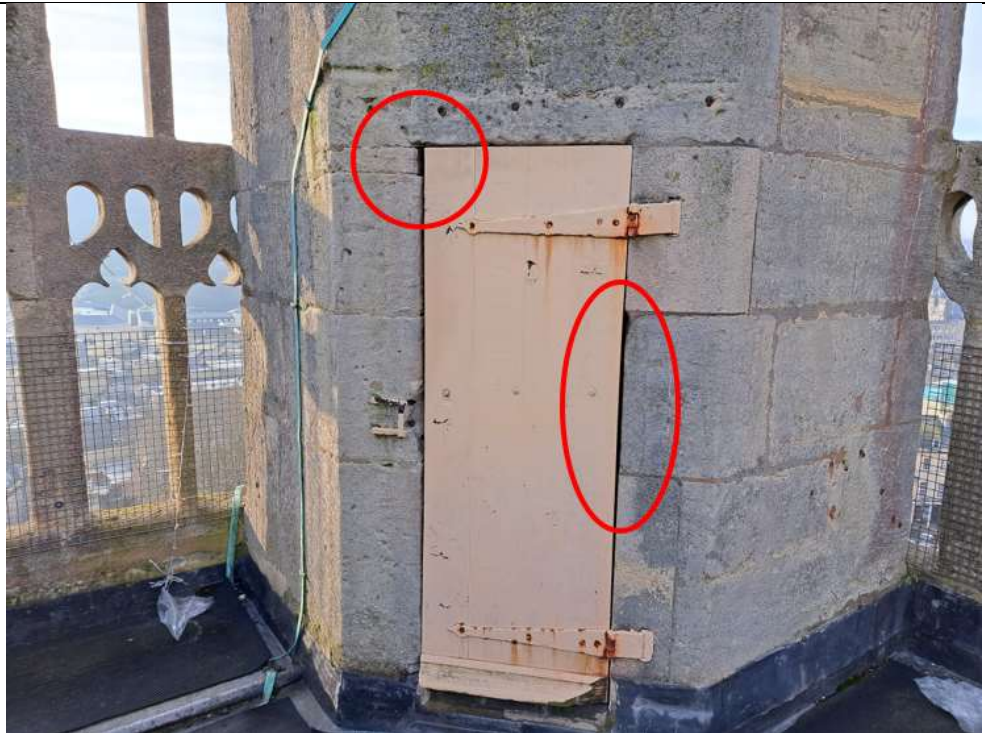
4.

Access gaps at side of roof access door (leads to stairwell/lower chambers)

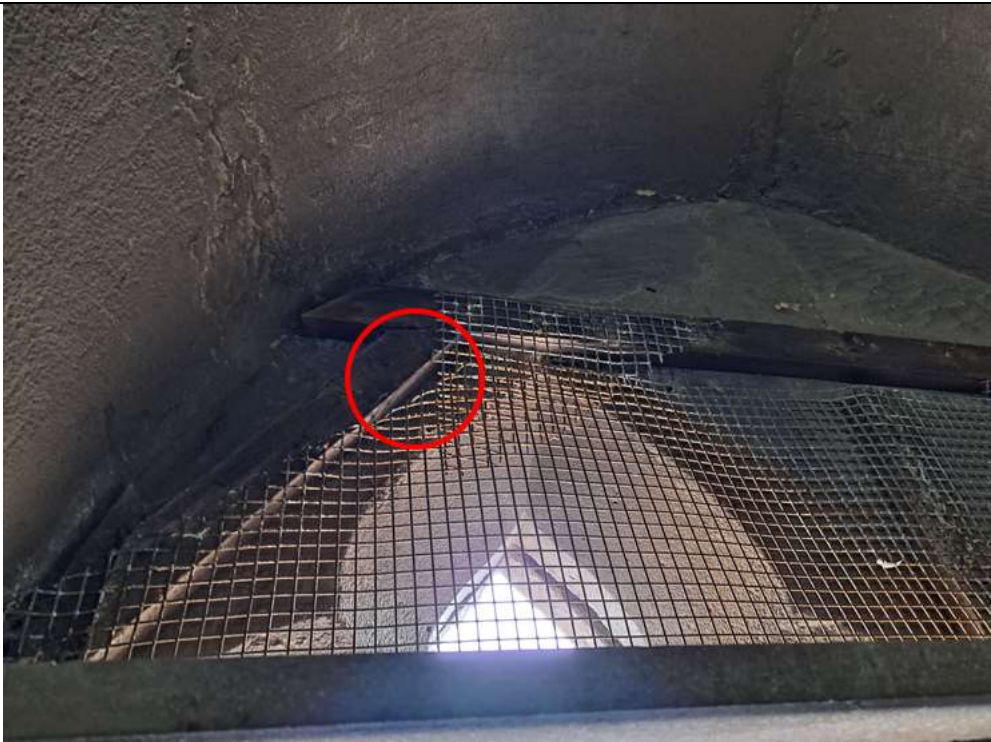
| Overview | |
|---|---|
| Belfry | Access into belfry via small gaps in metal mesh (Appendix 1; Photo 5) and below timber louvres (Appendix 1; Photo 6) on windows. Splits/cracks suitable for crevice dwelling species in timber ceiling beams below wall plate and in bell supports (Appendix 1; Photo 7). Small cavities/cut outs in stone wall. Gaps in timber floor panelling with access into intermediate chamber. A single potential bat dropping was collected from on top of one of the bell supports. Extent of potential cavities between the belfry ceiling and tower roof floor unknown but may be sufficient to support multiple roosting bats. |

| 5. | <p>Access into belfry through gap in metal mesh</p> |

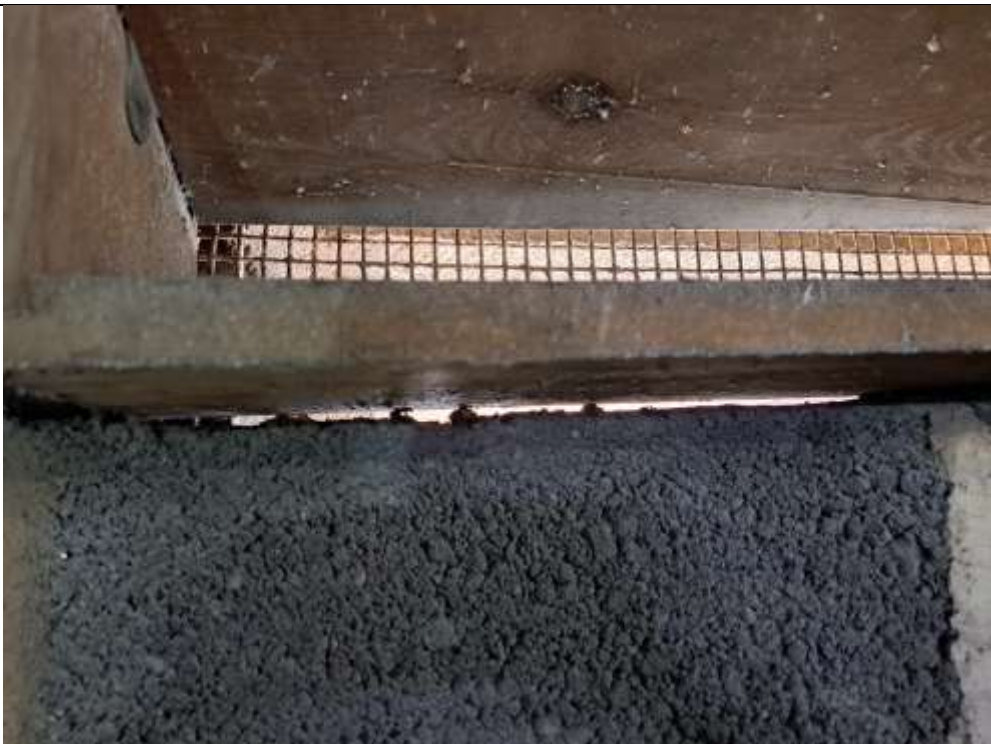
| 6. | <p>Access into belfry through gap below timber louvre</p> |

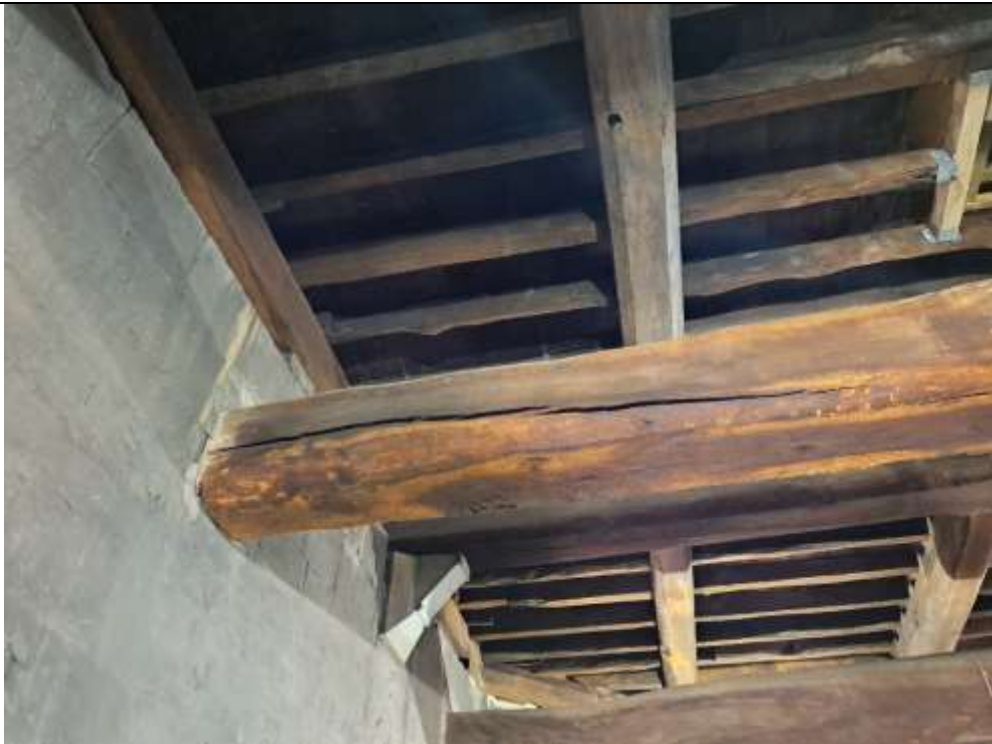
7.

Split/crevice in ceiling beam in belfry
