# Mytholmroyd Flood Alleviation Scheme: Church of St Michael Mytholmroyd, West Yorkshire

Archaeological Watching Brief

Ref: 114020.04  
September 2016

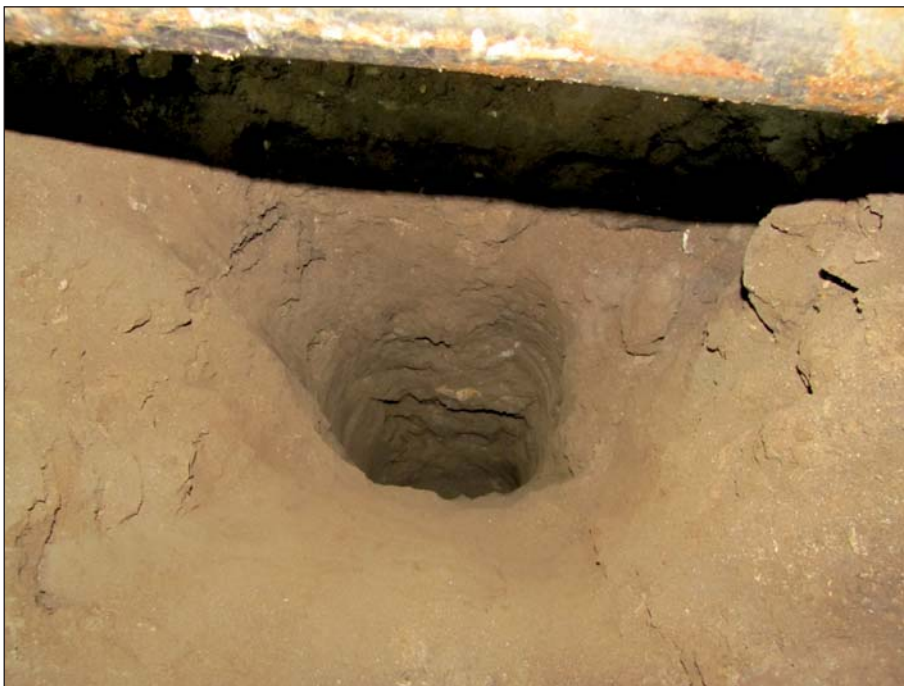
Plate 4: Trench 3 (TP 103) excavated

- 4.1.11 Trench 3 was located inside the Church, adjacent to the north wall of the North Aisle, in the fifth bay from the west (**Plate 4**). The trench was re-located following discussions with the architect and the Church Warden to an area to the east that was not covered by wooden pews. Wooden tongue and groove flooring was levered out to reveal a series of joists running west to east that lay over beams which rested on shallow sill walls. The majority of these sill walls (showing in a number of locations in the Church) were of dry laid sandstone. One of the two walls revealed in the opening up process for Trench 3 was of brick. This was due to heating pipes having been laid at a later date within a brick conduit which was used to support a beam.

- 4.1.12 A number of joists were cut out sufficient to allow the excavation of a trench 0.70 m by 0.50 m in plan. The first layer (**301**) was encountered at a depth of c.0.40 m below the base of the joists. This very dry material held large quantities of stone and brick rubble and was interpreted as the top of a construction layer. Following its removal, the top of (**302**) was revealed. This layer was similar to layers (**103**) and (**204-205**) on the outside of the Church and was interpreted as redeposited river dredged material.
- 4.1.13 The nature of the lower courses of the north wall of the Aisle matched the external evidence; three courses of dressed sandstone overlaying undressed footings of undetermined depth below.
