# Mytholmroyd Flood Alleviation Scheme: Church of St Michael Mytholmroyd, West Yorkshire

Archaeological Watching Brief

Ref: 114020.06  
January 2017

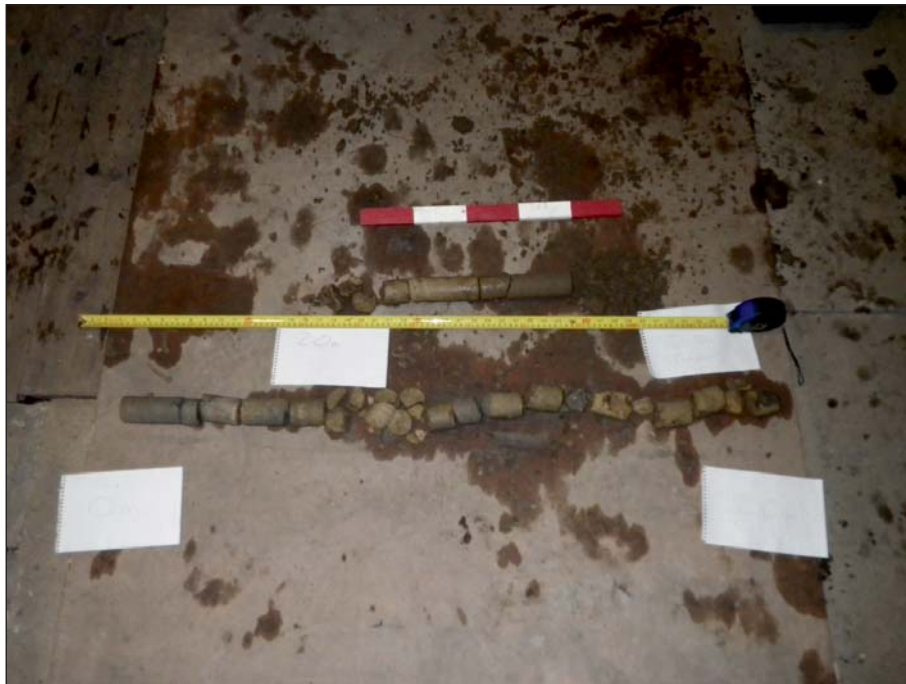
Plate 2: General view of vertical core C301

- 4.1.4 Core C301 was a vertical core located inside the Church, through the wall which continues under the floor between the openings of the North Aisle and the organ chamber (Figure 2). The floor structure of the Church comprises floorboards (30101) resting on timber joists (30102) that are supported by small brick walls (30103). The sandstone foundations (30104) of the wall, the top of which is located at approximately 0.55 m below the internal floor level, were cored through to a depth of 3.05 m below the internal floor level. Beneath the foundation wall was a natural mid-brownish clay which was observed to a depth of 3.26 m (Plate 2).

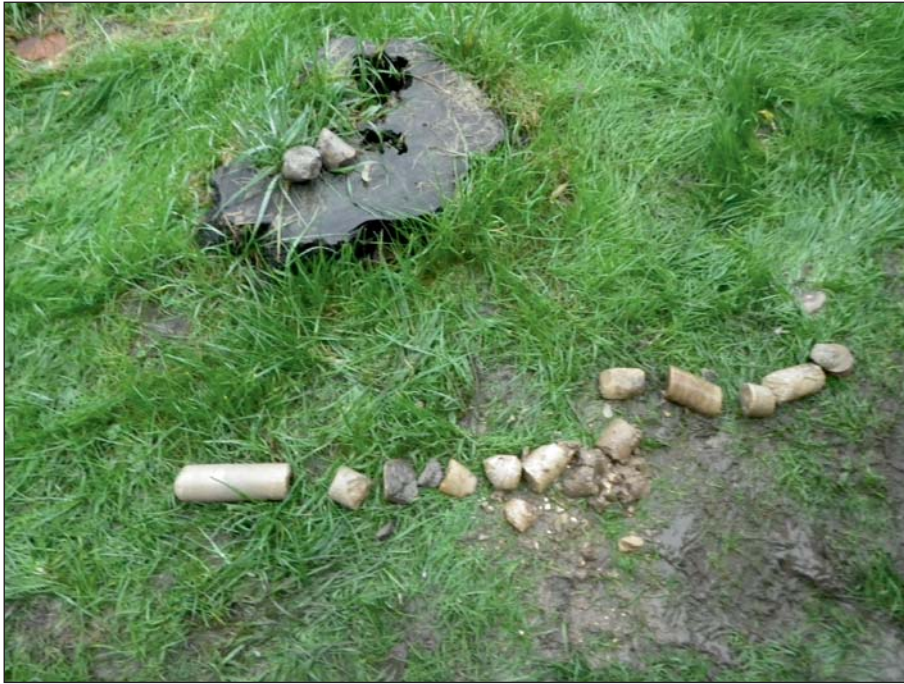
Plate 3: General view of inclined core C303A

- 4.1.6 Two cores were also drilled at the C303 location (Figure 2). Core 303A was at an angle of 21° from the vertical to investigate the depth of the north wall buttresses. Core 303B was drilled at an angle of 26° to ascertain the depth of the foundations of the north wall. C303A drilled directly into the buttress (30301) which continued to a depth of 1.20 m below the external ground level (Plate 3) where underlying silty made ground material was located. C303B drilled through buttress 30301 and into north wall 30302 of the Church. This north wall foundation continued to a depth of 2.70 m below the external ground level, below which natural clay deposits were encountered.

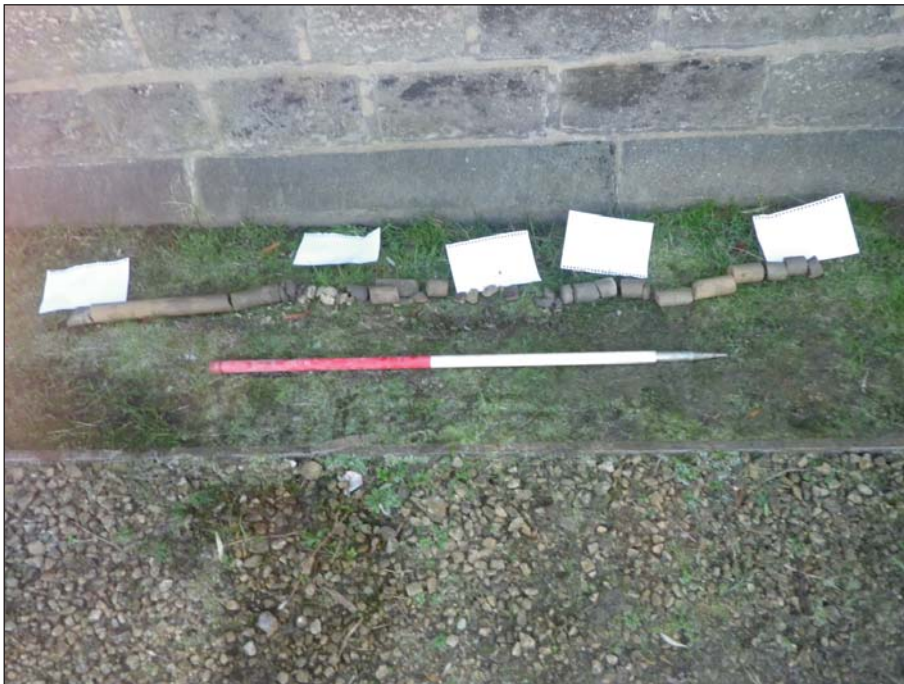
Plate 4: General view of inclined core C304

- 4.1.7 Core C304 was positioned at the eastern end of the north wall of the Church, close to the northern projection of the Choir Vestry (Figure 2). The core was drilled at an angle of 13° from the vertical into the north wall (30402, 30403, 30404). The wall was found to contain some minor variations in the sandstone material (a fine grain sandstone between 0.04-0.80 m, fragmented sandstone core from 0.80-1.30 m, small pieces of fine sandstone core from 1.30-1.50 m and fragmented sandstone core from 1.50-2.07 m), and continued down to a depth of 2.07 m (Plate 4).

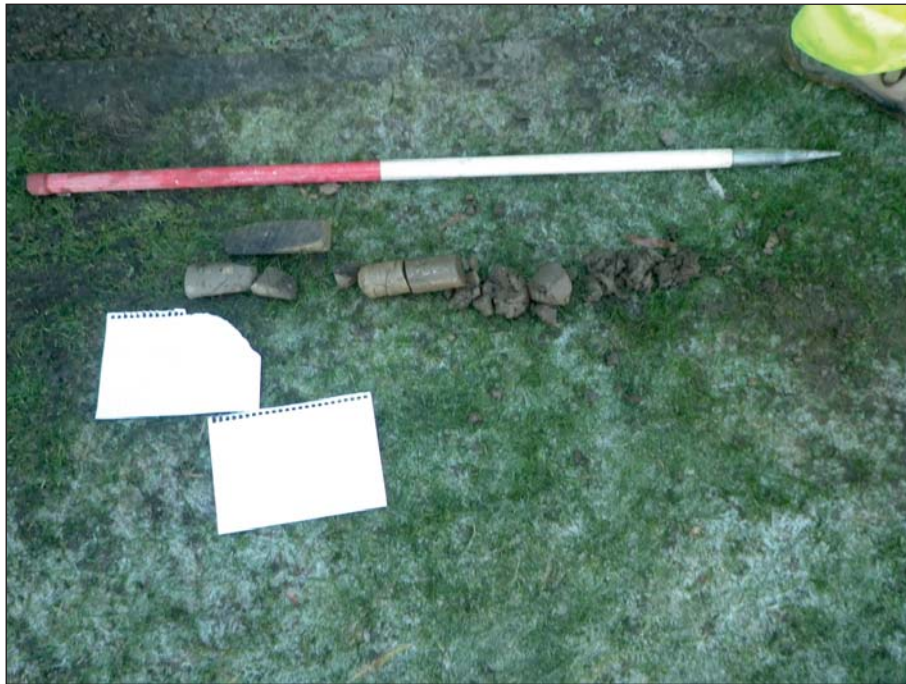
Plate 5: General view of inclined core C305

- 4.1.8 Core C305 was located to establish the depth of the easternmost buttress of the north wall of the Church (Figure 2). The core was drilled at an angle of 13° from the vertical through the concrete pad and into the buttress wall (30502). The base of the buttress was between 0.4-0.5 m below the external ground level (Plate 5).

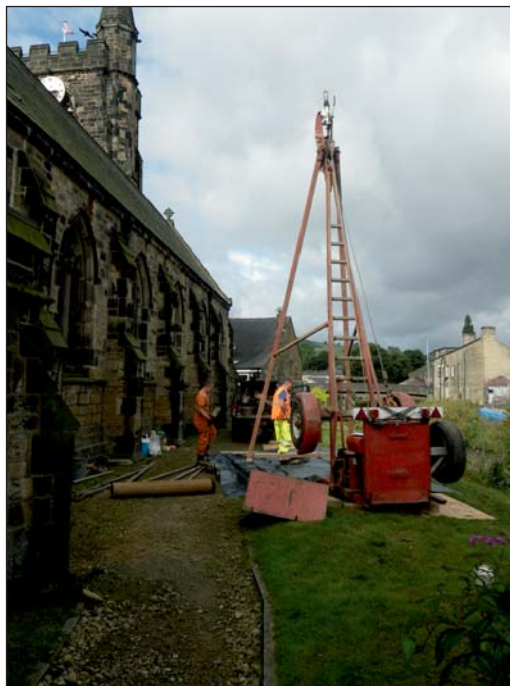
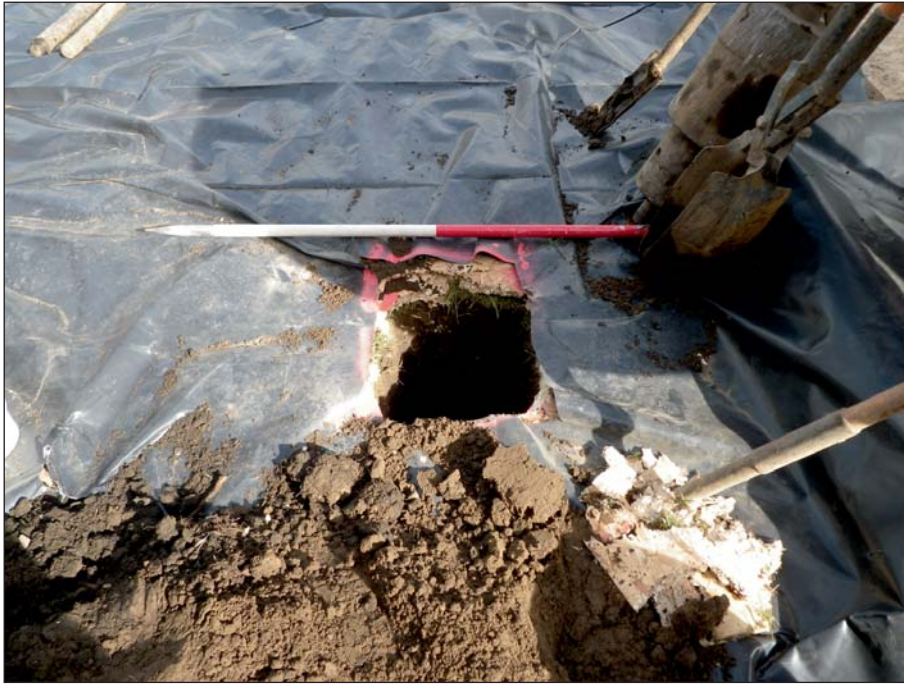
- 4.1.9 Trench 6 (BH012) (Plates 6, 7) was located to the north of St Michael's Church, on the right (southern) bank of the River Calder (Figure 2). The borehole identified natural (604) at 4.70 m below ground level (bgl), which comprised a mid-brown to grey silt at 7 m+, above which were natural sands and gravels. Laying above the natural, between 1.10 m - 4.70 m bgl, was a light brown silty sand with small lenses of a darker loam (603). This was interpreted dredged, redeposited material from the river. Above this layer, 602 was a mid-

light brown sandy loam deposit that was identified as a later redeposited layer of dredged river material at a depth of 0.25 -1.10 m bgl. A mid- to dark brown sandy loam topsoil was recorded to a depth of 0.25 m bgl.

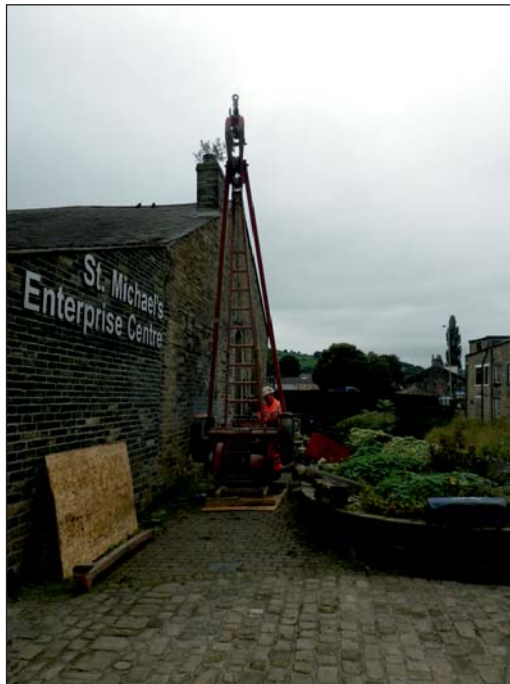
Plate 8: General working shot of trench 7, borehole BH013

- 4.1.10 Trench 7 (BH013) (Plate 8) was located to the north of St Michael's Enterprise Centre, on a small pathway, adjacent to the right (southern) riverbank of the Calder (Figure 2).
- 4.1.11 Natural (707) was located at a depth of 5.50 m bgl, and comprised sands and gravel. Above the natural deposits, located between 0.80 m and 5.50 m bgl, was a layer of, redeposited dredged river material or made ground (706) consisting of a loose silty sand with small pebbles and stones, becoming gradually siltier with depth. Above this were layers of mid-20th to early 21st century made ground and bedding layers overlain by the current granite setts forming the pathway.

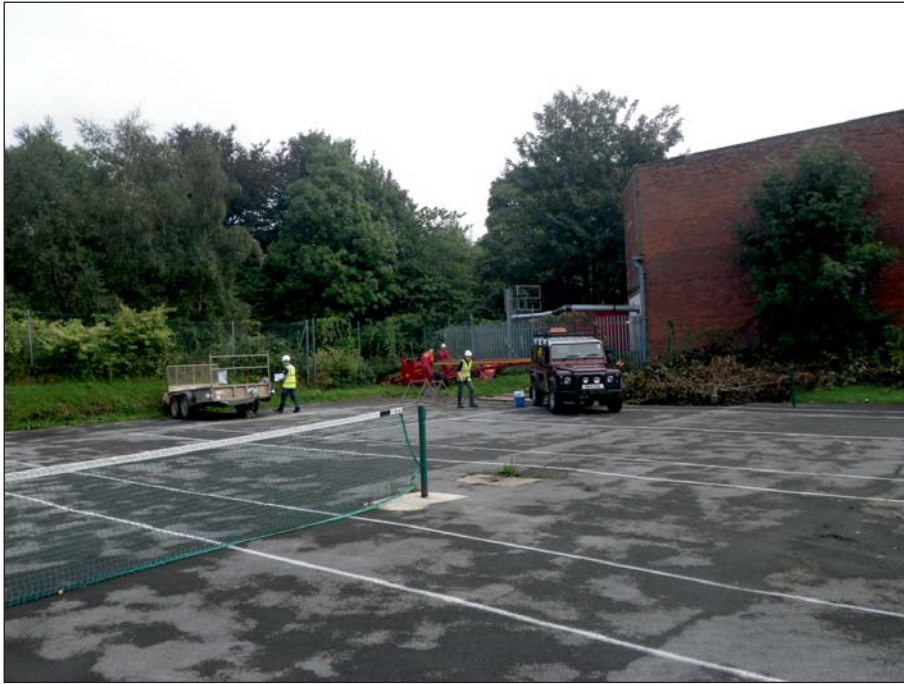
Plate 9: General working shot of trench 9, borehole BH034

- 4.1.12 Trench 09 (BH034) (Plate 9) was located at the north-east corner of a tennis court to the south-east of the Church (Figure 2) and comprised a borehole with a diameter of c. 0.20 m, drilled to a depth of c. 8.0 m. The first 0.60 m was hand excavated and a total depth of 2.50 m was monitored. Topsoil (901) to a depth of 0.40 m bgl included fragments of CBM and it was considered likely that the raised bank beyond the tennis court was the result of ground clearance within the last 40 years. Brown silty material (902) lay beneath the topsoil and was observed to a depth of 2.50 m. This may have been dredged material removed from the river and banked up.
- 4.1.13 A single small sherd of 19th century pottery located within the topsoil showed no evidence of having been river abraded and would have therefore originated on the side of the river and not within it.

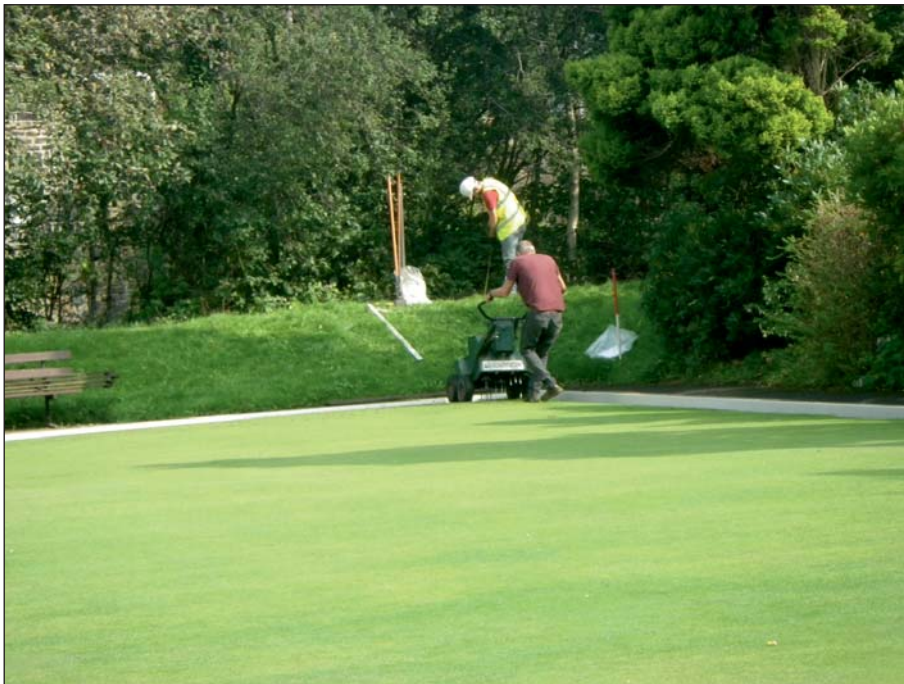
Plate 10: General working shot of trench 10, window sample WS18

- 4.1.14 Trench 10 (WS018) (Plate 10) was located on the right (south) bank of the River Calder above the north-east corner of a bowling green which was established sometime between 1907 and 1921, to the south-east of the Church (Figure 2). In practical terms the window sample was identical to the boreholes, but only extended down some 5.00 m of which the first 1.00 m was hand excavated.
- 4.1.15 Material from the upper soil horizon (1001) comprised stone, CBM and fragments of slag which continued to a depth of 0.75 m bgl and was consistent with a process of ground clearance prior to the construction of the bowling green. Below 0.75 m, silty material (1002) was identified, similar to river dredged material identified from the other locations in the vicinity. This was observed down to 1.2 m, but deposit 1002 continued to a depth of c. 3 m, below which natural gravels were located.

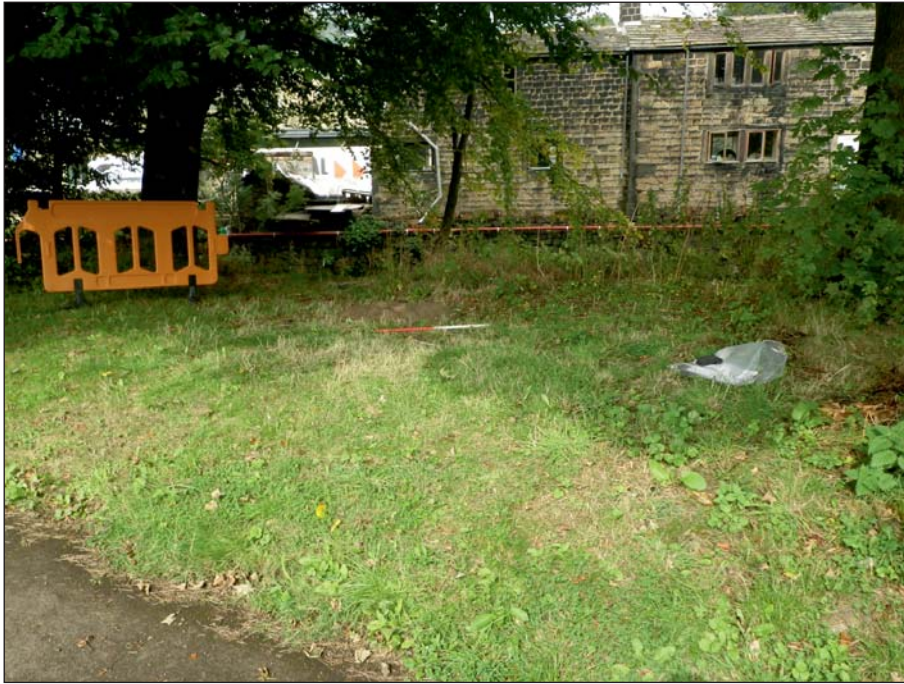
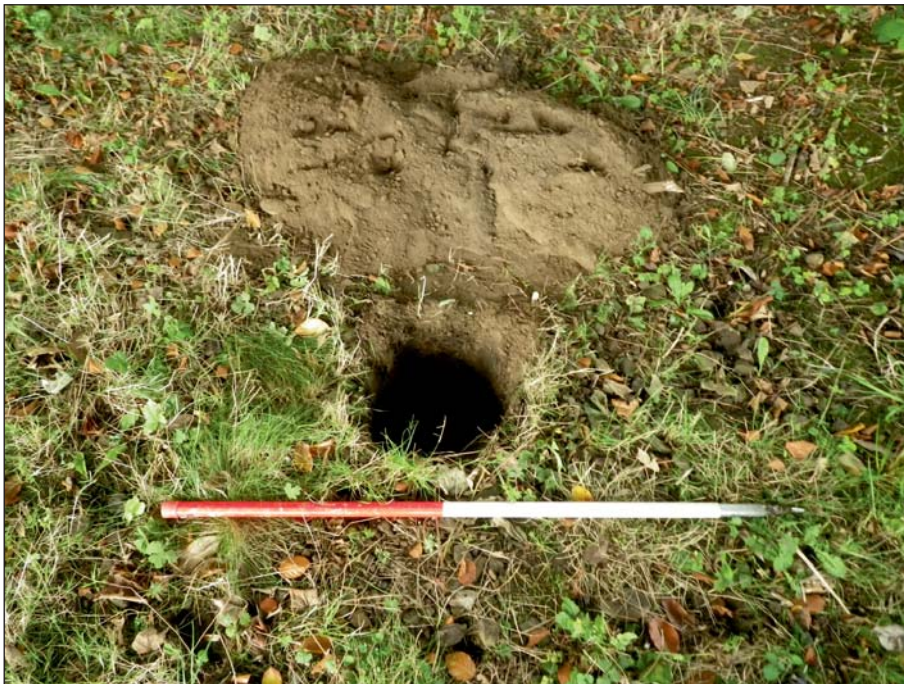
- 4.1.16 Trench 11 was moved several metres to the west of its original position due to access difficulties. It lay on a raised bank above the south side of the river positioned between the Church and the bowling green (Figure 2, Plate 11).
- 4.1.17 The trench was monitored to a depth of 1.15 m (Plate 12). The upper material (1101) was similar to 1001 within trench 10, but dryer due to the position of deep tree roots. The shallow bank upon which the window sample was taken is thought to represent an elevation of the bank as part of soft landscaping following earlier river dredging.
