**Report on Works under Archaeological Supervision and Control at  
'Saint Mary's Church, Cranworth, Norfolk'**

**ENF142481**

**CB551R v.1.0**

Groundworks associated with repairs to the tower floor at 'St Mary's Church, Cranworth, Norfolk' (Norfolk Historic Environment Record event number ENF142481) were carried out under archaeological supervision and control in August 2017. Pew foundations and a flue structure were recorded, possibly part of the 19<sup>th</sup> century restoration of the church.

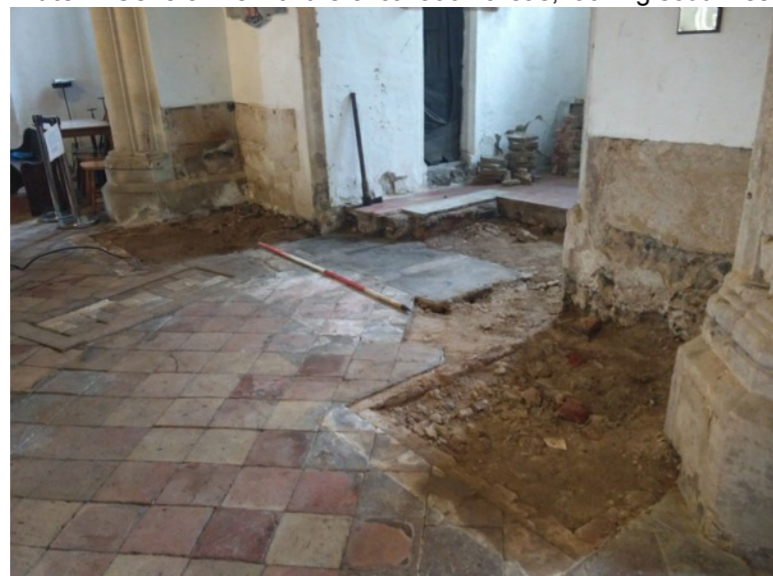
Plate 1. General view of the excavation areas, looking southwest

Excavations revealed probable 19th century pew foundations [2] and [4] and flue [9] and ledger stone [8] whose inscription was illegible.

Excavations within the east side of the base of the tower measured c. 2.45m by c. 1.75m to a depth of c. 0.31m beneath present floor level removing pamment tiles on a cement and brick base (5) above dark greyish brown silty sand (6) that partly exposed compact mid brownish yellow sandy gravel (7). Timber joists from the former organ base were removed. Ledger stone [8] measured 1.86m by 0.81m and remained *in situ*. East-to-west orientated brick structure [9] measured 0.77m long and 0.58m wide and contained a flue pipe conduit.

The bricks are of probably 19<sup>th</sup> century in date.

- 6.1 The author has a high confidence rating of the results. The minimal depth of excavations revealed few remains. The red brick walls of probable 19<sup>th</sup> century date most likely functioned as foundations for pews removed prior to the commencement of the excavations. A brick flue is probably of the same date and these may relate to the restoration of the church in the 19<sup>th</sup> century. No finds or further features of archaeological significance were present.
