Archaeological Watching Brief on collapsed drain at Parish Church of St Margaret of Antioch, Rochester, Kent ME1 1UF

Site Code: SMA 18

Watching Brief Report

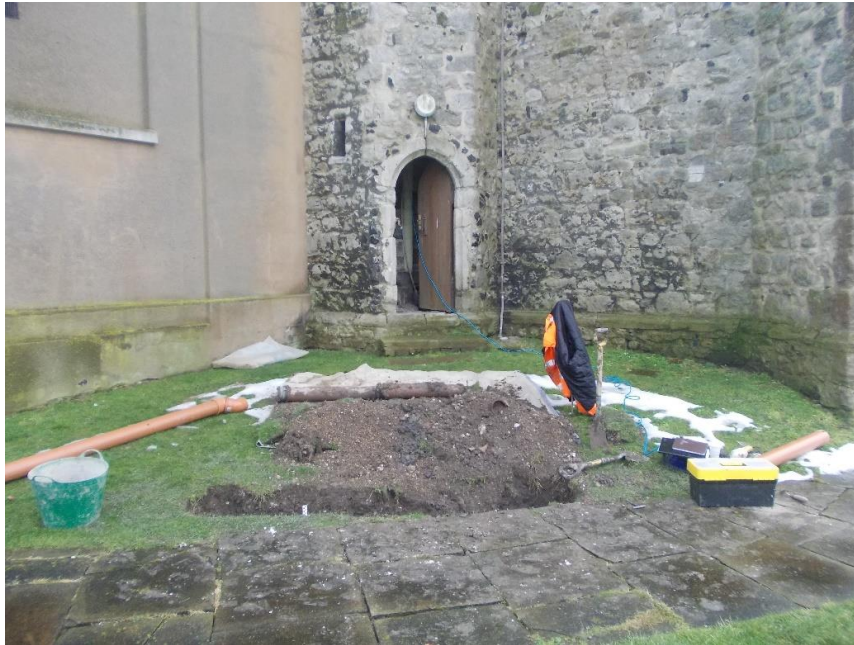
A rectangular trench approximately 2000mm x 300mm, at a varied depth of 250-300mm, was hand-dug and spoil around the existing drain removed. The spoil was deposited next to the trench and

consisted of dark humic topsoil, chalk fragments and compacted pea-shingle; the latter was probably deposited when a previous drain was lain/repared. No archaeological artefacts were observed in the removed spoil (see fig 3).

(Fig 3 – excavation trench in the foreground, looking north-west)

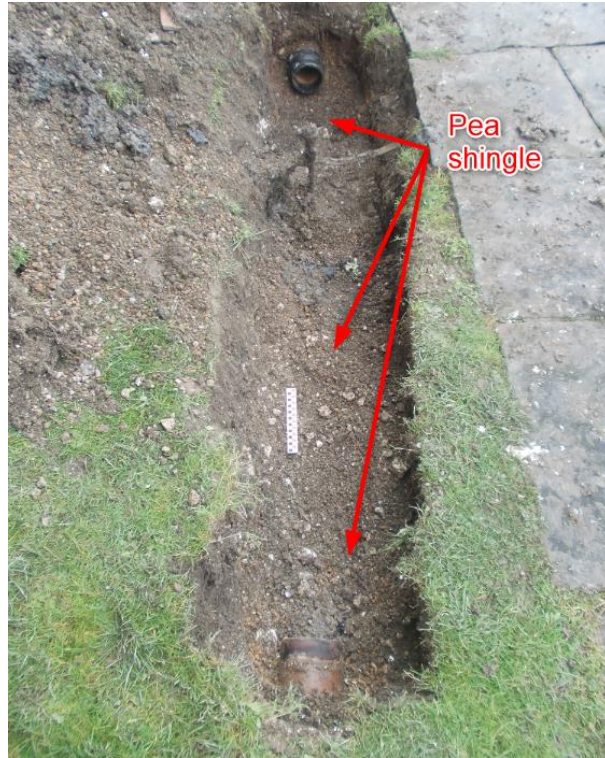
Upon removal of the collapsed drain, the trench base and sides were cleaned, which revealed further compacted modern pea-shingle stratigraphically above a layer of dark humic soil containing numerous chalk fragments; probably an earlier backfill layer (see figs 4&5). No archaeological artefacts were found or observed during the cleaning.

(Fig 5 – trench looking south-east showing compact layer of pea shingle following removal of collapsed drain)
