MINOR CONSERVATION REPORT  
FOR THE SOUTH AISLE STAINED GLASS WINDOW  
AT ST MICHAEL AND ALL ANGELS CHURCH, AVERHAM

## **ST MICHAEL AND ALL ANGELS CHURCH, AVERHAM, NOTTS**

**South Aisle Stained Glass (Historic) window no: s6. Date of window, approximately 18<sup>th</sup> century.**

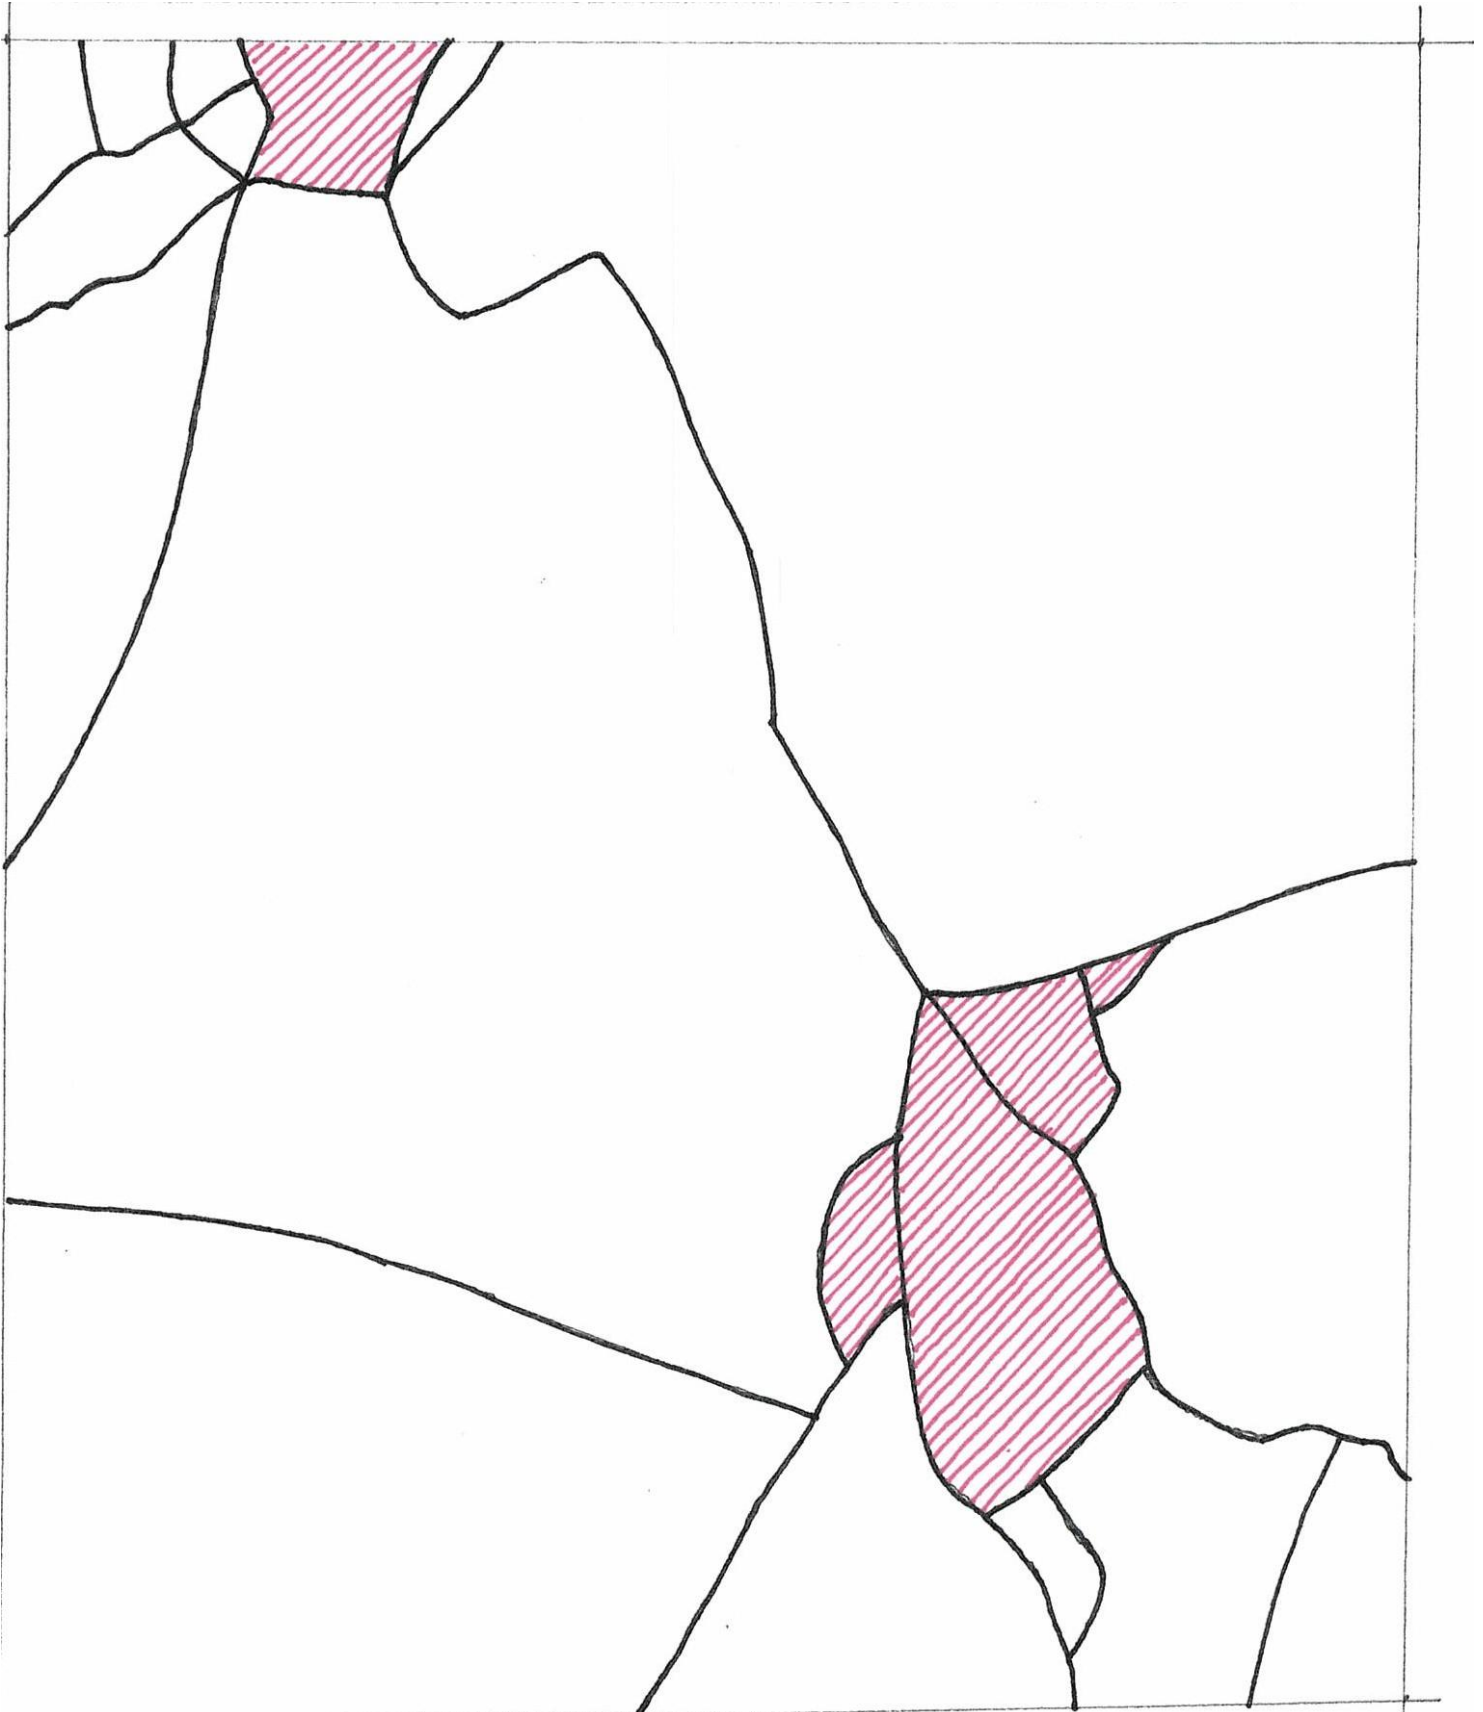
South Aisle Stained Glass conservation of one pane of historic glass. May 2018.  
Glass paint and enamels.  
Actual size.

Conservation diagram key.

Newly painted infills.....Wj

Cracks from vandalism.....[SJ

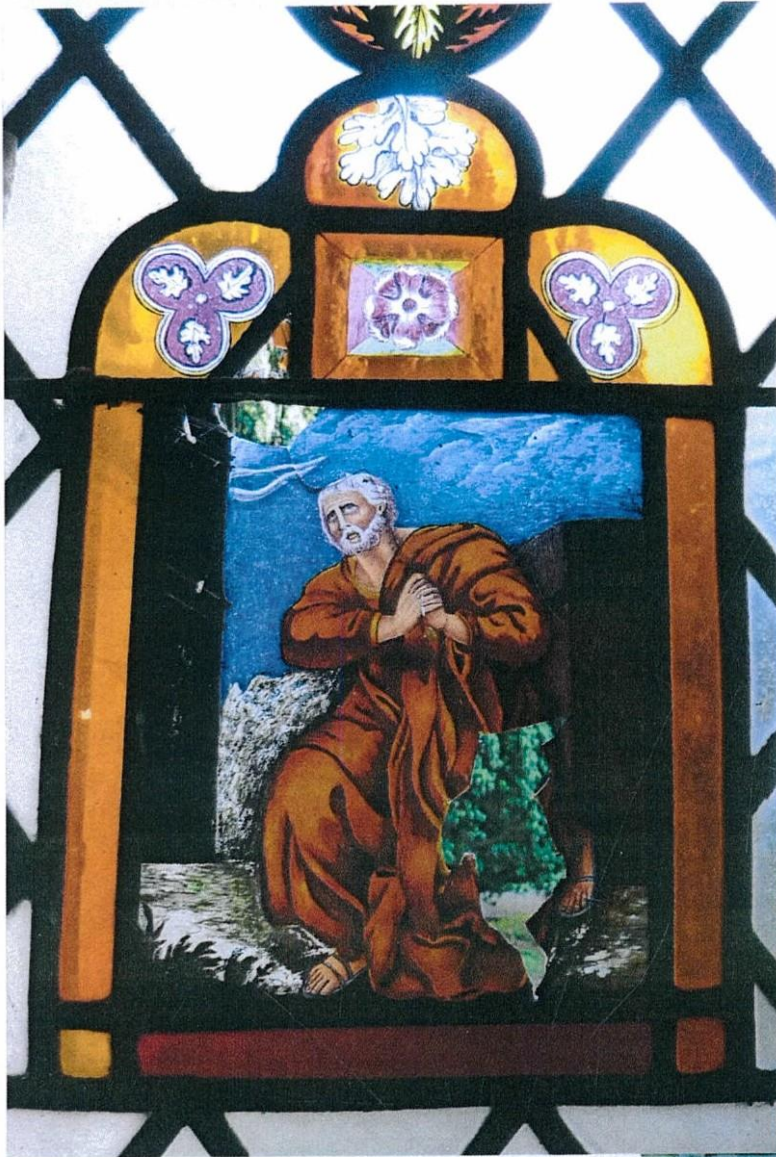
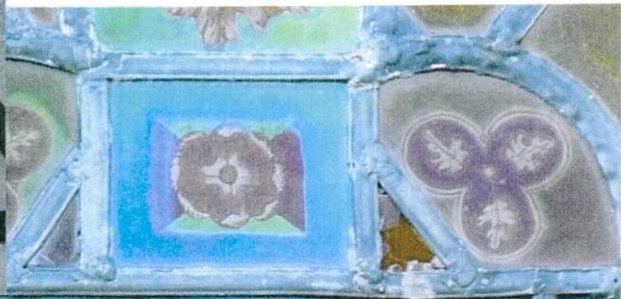
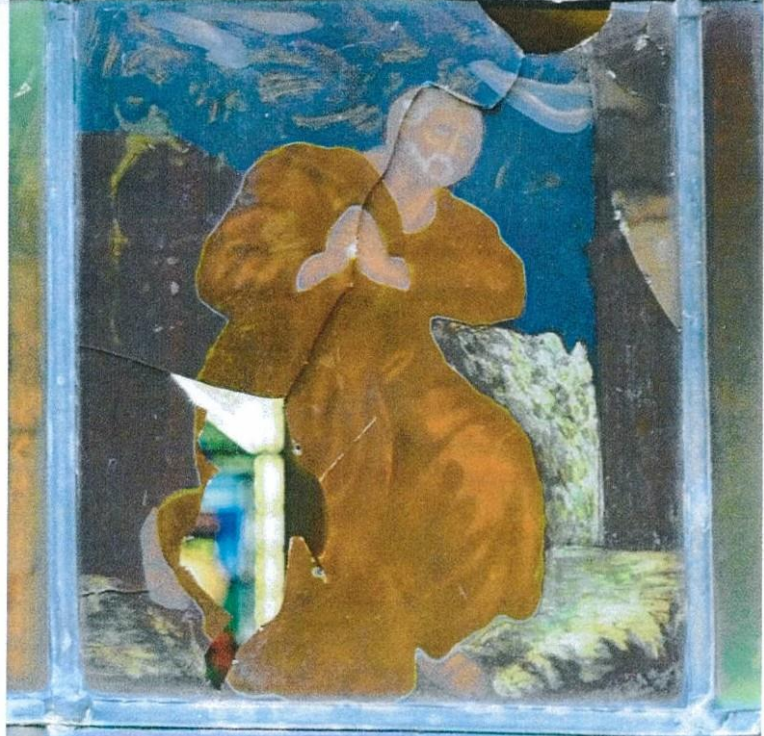
Vandalism damage.

The pane measures 8.75"h x 7"w and portrays a biblical figure (with white beard and deep amber clothing) set in the landscape. This pane is painted, enameled and silver stained and is in a fragile state. Much of the smashed areas are missing. There are several existing cracks from vandalism impact. There is some paint pigment loss, quite normal for a painted pane of this age.

South aisle stained glass pane. St Michael and All Angels Church, Averham, Notts.  
Before removal and conservation.

To remove the existing fragments, inspect all areas around the window for shards, gather up all finds. Insert a matching replacement to the small amber damage and a pane of frosted glass to the larger pane, as a temporary infill. View the fragments on the light box at the studio, assembling the composition and re-use all original glass. Clean all original fragments and set aside for gluing. Then paint new infills to match the missing areas and edge-bond to the original fragments with Silcojet 153. Back plate the figurative pane with 2mm clear float (kiln fired) and seal around the edge with Silcojet 153. Reinstall this pane to the lead matrix. All newly fired painted infills to be initialed MDS and dated 2018.

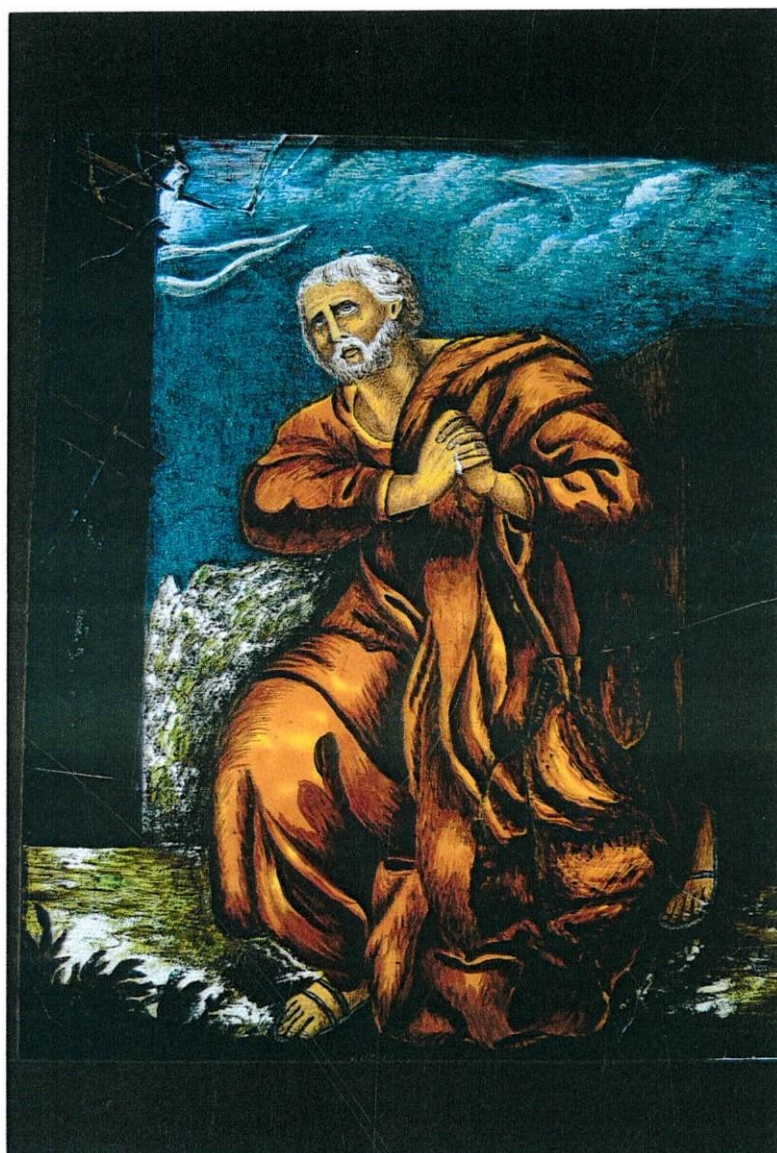
South aisle stained glass pane. St Michael and All Angels Church, Averham, Notts.  
After conservation .

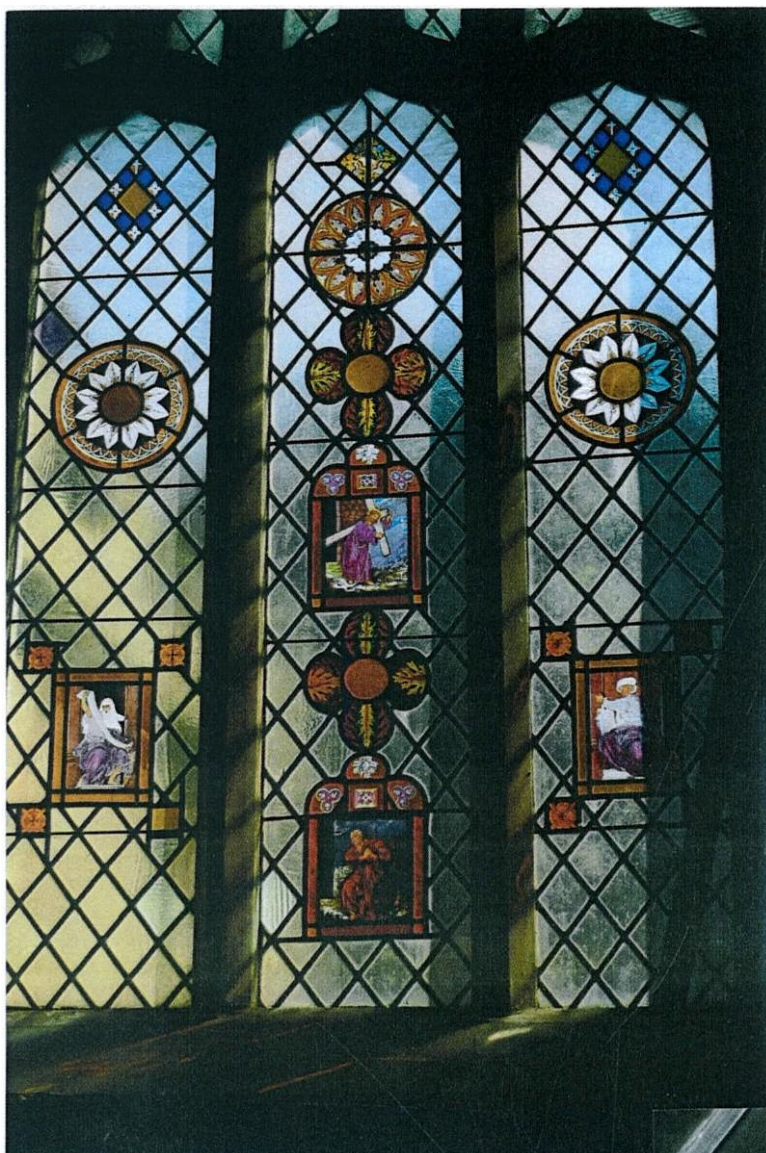
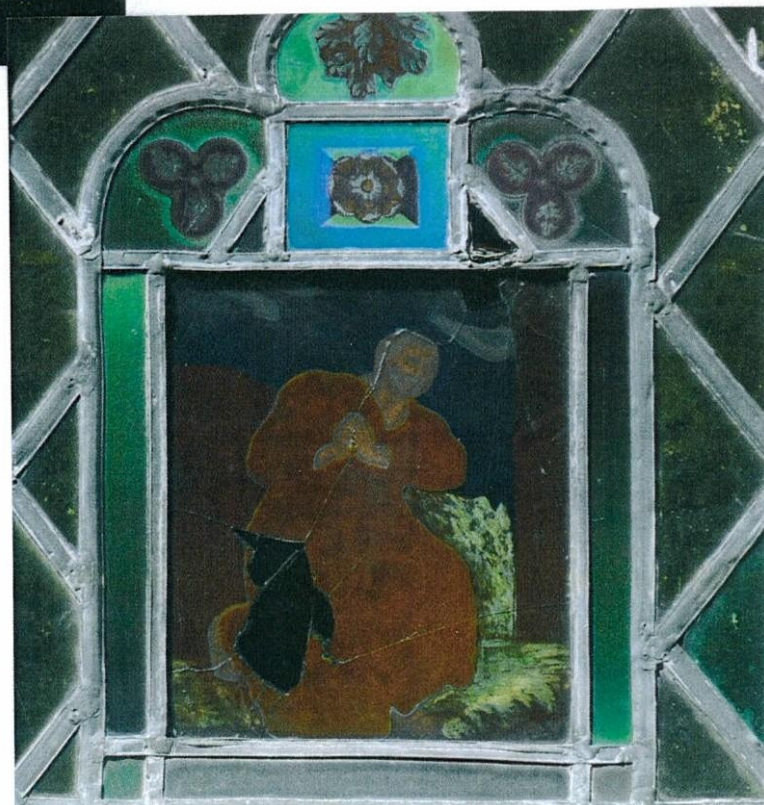
South aisle stained glass pane. St Michael and All Angels Church , Averham, Notts.  
After conservation and reinstallation.
