Church of St Nicholas and St Cyriacus,  
South Pool, Kingsbridge, Devon

Chancel Rood Screen Polychromy  
Pilot Project Report

December 2012  
©Eddie Sinclair BA, ACR

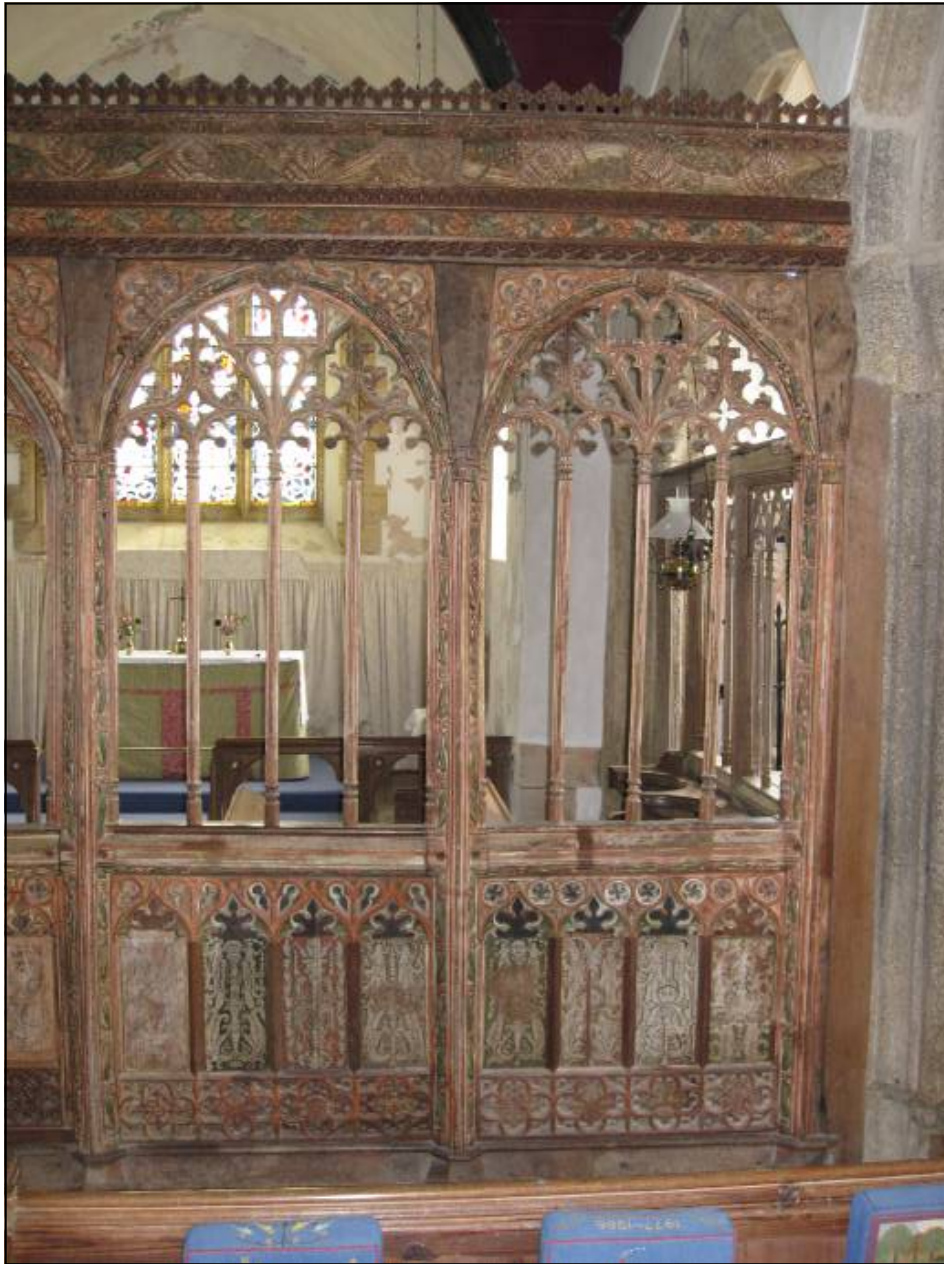
At present (as seen above), the rich vibrant colours of the 16th century painting are muted, in the aftermath of the caustic soda treatment, overlying remnants of overpaint and coatings of brown wax.

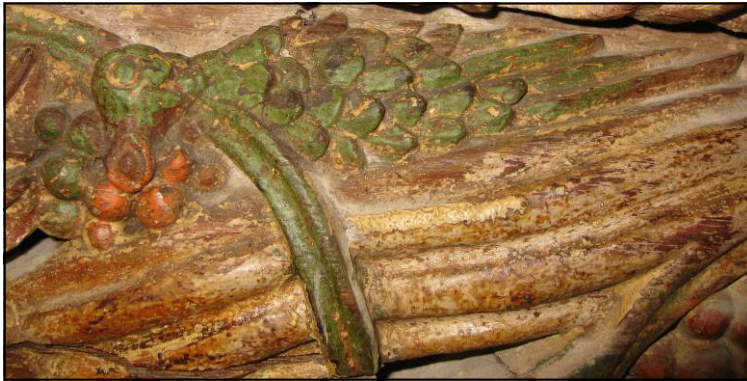
Five birds, all different, can be found on the cornice. Most are green, (see left) but one is gilded.

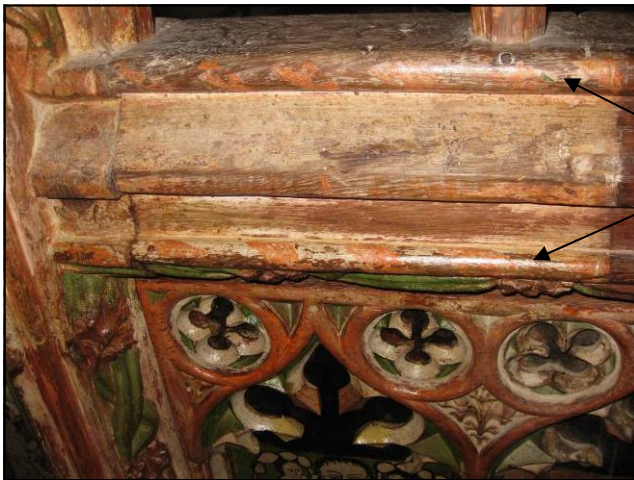
Barbers-pole stripes which enliven the transoms are currently barely noticeable.

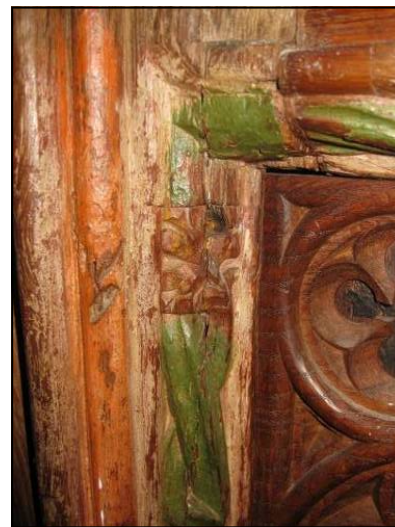
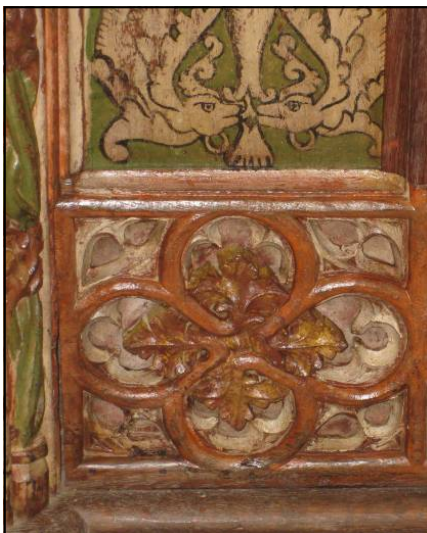
Many bosses and paterae appear to have lost their colour and it is the red ochre primer that is visible. However, careful cleaning reveals many pockets of the golden yellow pigment, orpiment. This problematic pigment, composed of sulphide of arsenic, surprisingly retains its golden colour, when usually it turns brown (see left and above).

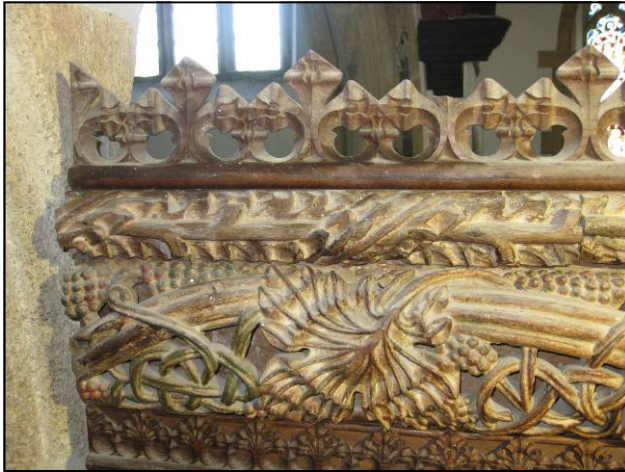
Left photograph, showing north end of cornice. This appears at first glance as largely unpainted, but dust, overpaint and a matt, blached paint surface all make it easy to overlook that a considerable amount of colour actually survives here.

Ideally, the overpaint should be removed, thinned or at least reduced where this can be safely achieved. Alongside a surface clean, with bare wood nourished with microcrystalline wax and paint varnished, the appearance would be dramatically improved.

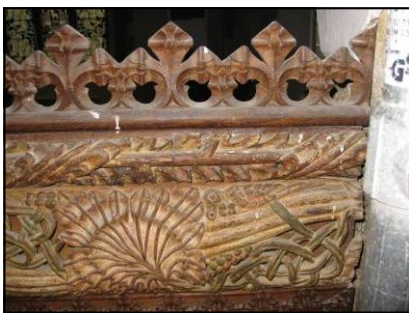
At the south end, bats droppings are more in evidence. If the unpainted wood were given a microcrystalline wax coating it would ensure that any such deposits could be easily removed in the future.

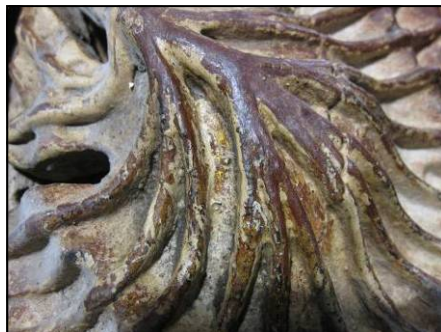
Beneath the dust and the islands of overpaint, many traces of gilding can be seen. There is also evidence of dark paint that is from the second decorative scheme. Sample 17 taken from the Aaron's rod shows a complex mix of black, azurite and red lake in a similar dark layer that must have been a dark purple.

It is clear from tests that not all the overpaint could be safely removed. A compromise would be to remove or thin as much as possible, apply an isolation layer and tone out the remaining islands.

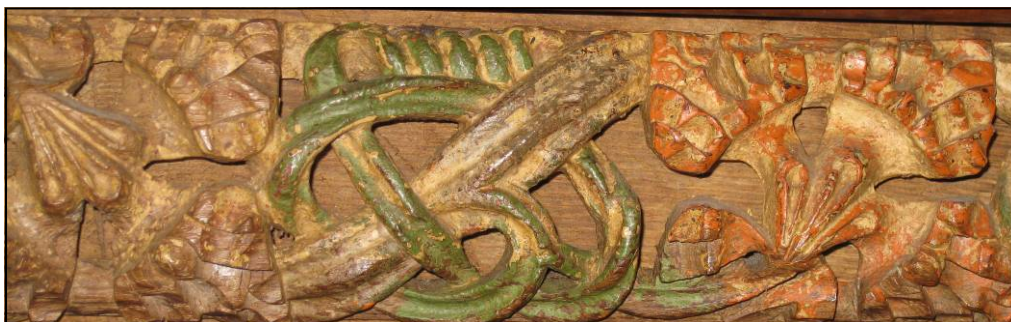
As can be seen in the photograph above, there are solid vibrant areas of bold bright colour surviving on the cornice, visually 'lost' by the presence of the grey overpaint.

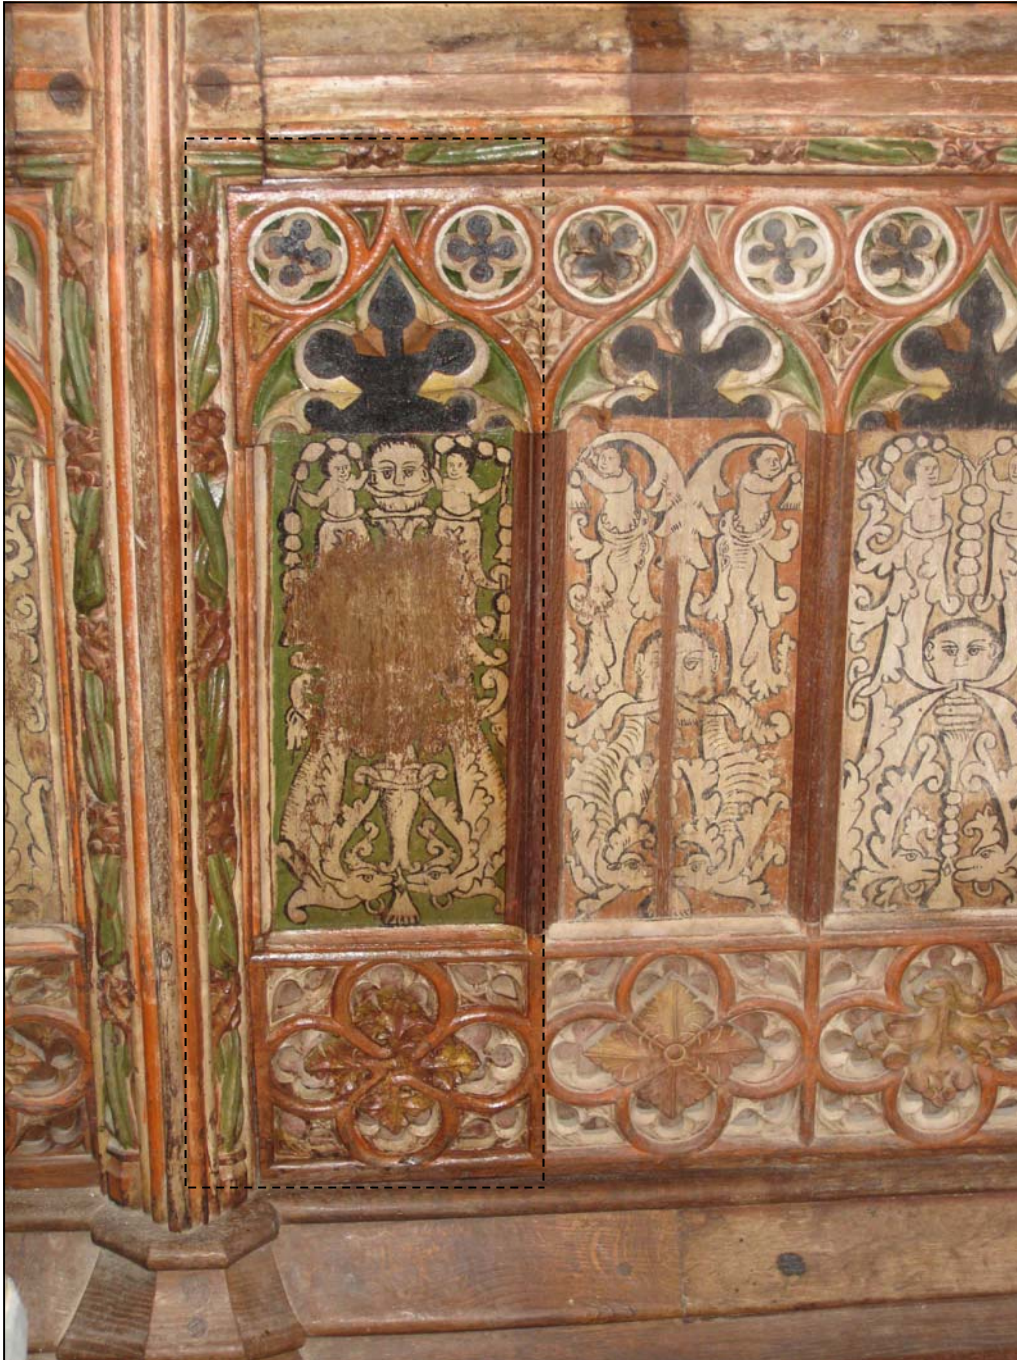
Section of dado, Bay 5, cleaned and varnished.

Within this area, all processes were carried out: surface cleaning, removal or reduction of brown wax, removal of islands of grey overpaint and consolidation of fragile wood. Painted surfaces were varnished with a dammar resin/ cosmolloid wax varnish, after the application of Paraloid B72 as an isolation layer. Unpainted wood was given a coating of microcrystalline wax and buffed to a sheen.

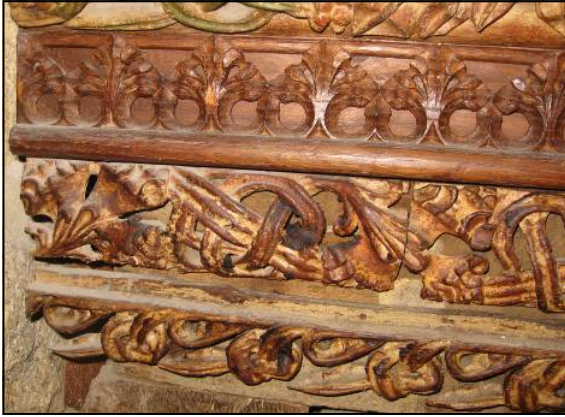
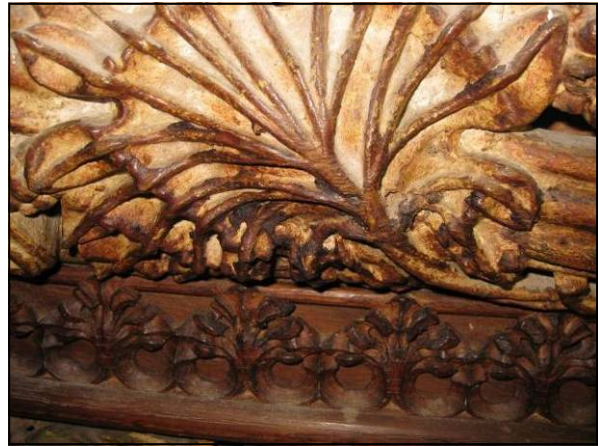
The brown wax highlighted in the 2011 report extends across the whole screen, including the cornice, on painted and unpainted surfaces.

As can be seen in these photographs, the lower foliate trail and the main running ornament are heavily waxed, particularly at the north end.

It is a priority to remove as much of this wax as possible and this is best achieved by the use of solvents, after the thick bulk has been removed by mechanical means. It is unlikely that all wax will be removed, but the appearance can be improved considerably.

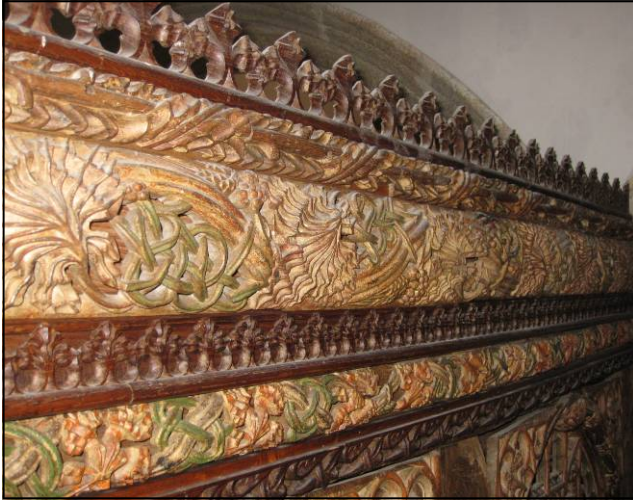
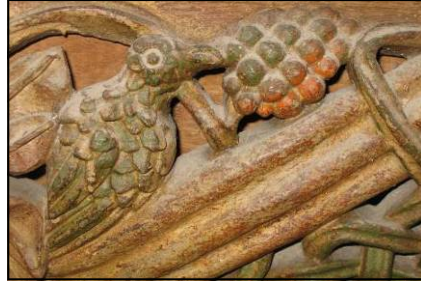
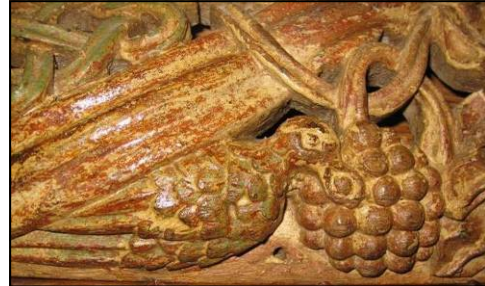
The dark new wood stands out strongly against the muted paintwork. It is therefore easy to miss the fine detail, in the carving as well as the painting.

Most of the birds on the cornice are painted in opaque colours, with apparently only one that is gilded. Detail top right shows how dusty, lack-lustre and lifeless the paint surface presently appears. Detail above right: although there are still islands of overpaint here, the surface has been saturated to show the quality that the medieval paint should have.

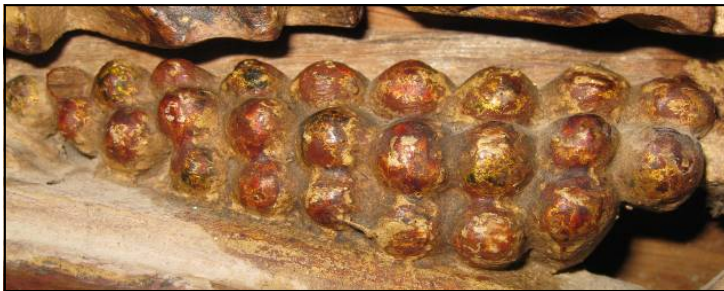
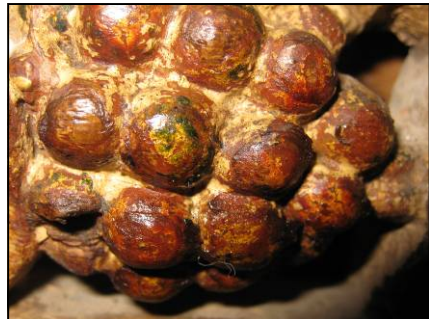
Close observation of the grapes reveals many traces of jewel-like glazes. As can be seen in these photographs, the deep corners of the carving are still clogged with overpaint as well as dirt. Cleaning and removal or reduction of the overpaint would be very worthwhile here.

Tests carried out on individual grapes show how successfully they can be cleaned

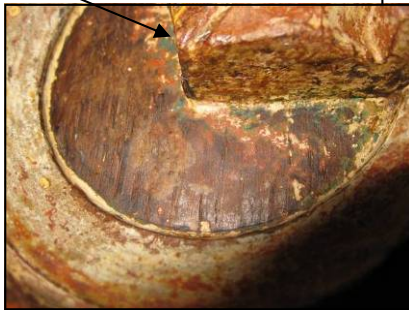
Sample 9 taken in 2011, showed azurite in the backgrounds of the vaulting panels (see above). Over the azurite lies a red ochre layer (above right) that may be an undercoat for the grey stucco overpaint.

These vaulting panels would benefit considerably if the complex mess of overpaint fragments could be tidied up.

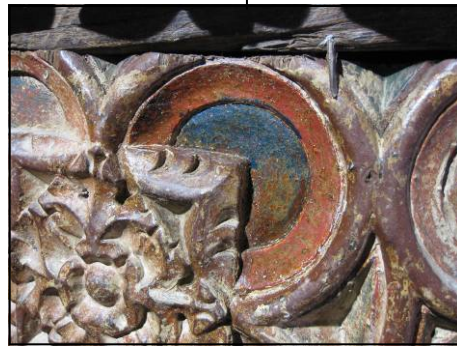
During the pilot project, tests were carried out to see if the red ochre overpaint could be removed safely. It was found to be more easily removed than the grey overpaint, with dramatic results.

Although in many cases the azurite survives in a fragmented state, as can be seen above, there are places where it survives almost intact.

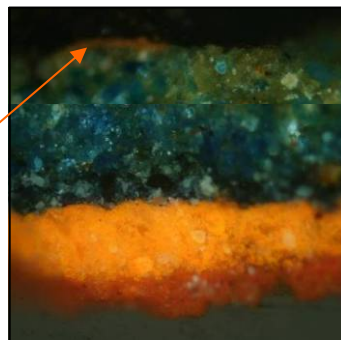
The photomicrograph of sample 9 (see right) clearly shows red ochre overpaint above the azurite.

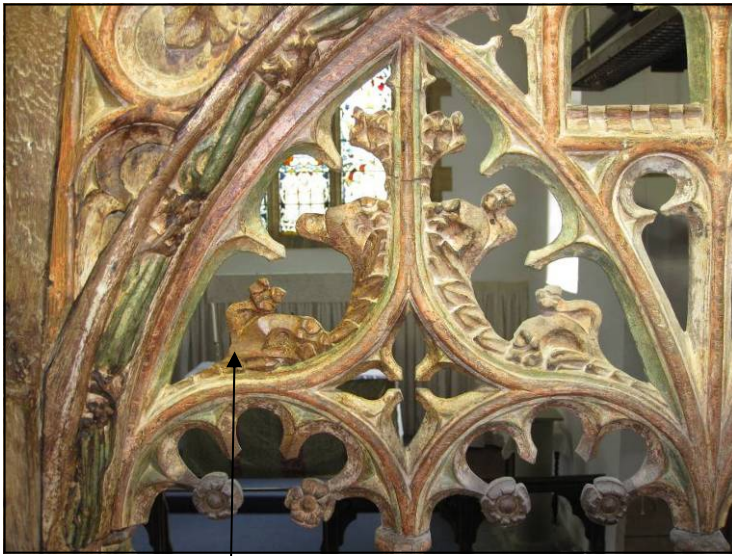
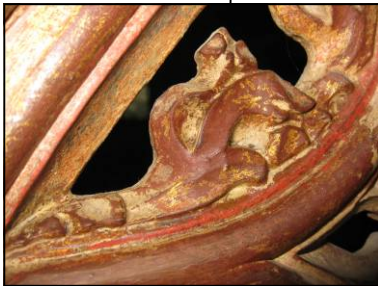
Many cleaning tests produce subtle results, but carried out over large areas will have a pronounced effect (see above and below).

Traces of bright gilding are revealed beneath the dusty surface of the crockets (left).

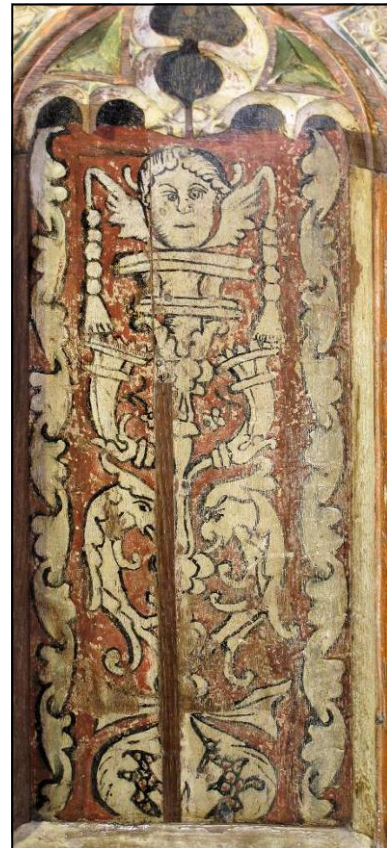
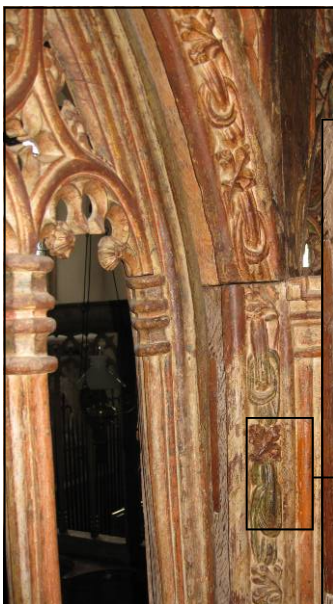
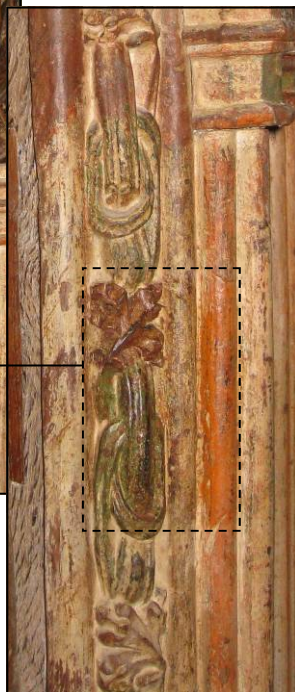
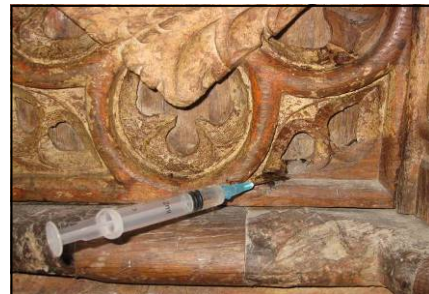
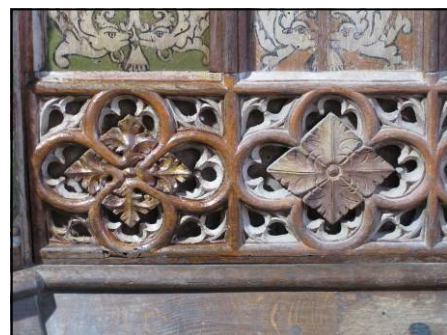
The lower tracery is in particular need of attention. Many corners are in need of consolidation at this level. Cleaning, consolidation and eventually varnishing or waxing will restore the correct balance to the dado panels

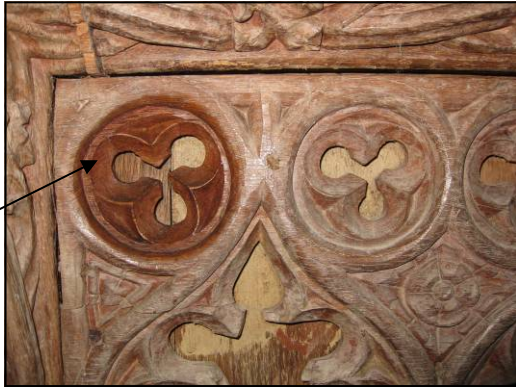
Very little paint survives on the south aisle screen as it was stripped with soda at a time when no-one thought to retain the polychromy.

Much of the wood here appears grey. There is a two-fold reason for this. Close observation of the surfaces reveals that the beeswax applied in the 1990's has become impregnated with dust and become opaque. In places it is also flaking (see below left). It is also possible that in places the soda needs further neutralising.

Tests were carried out to see if the beeswax could be re-buffed but this was not consistently successful as this did not address the issue of the flaking wax.

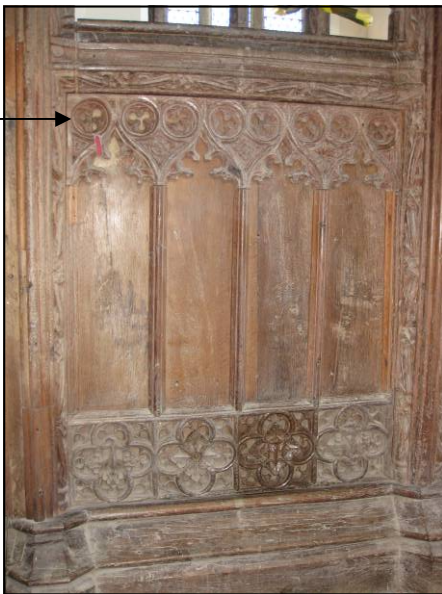
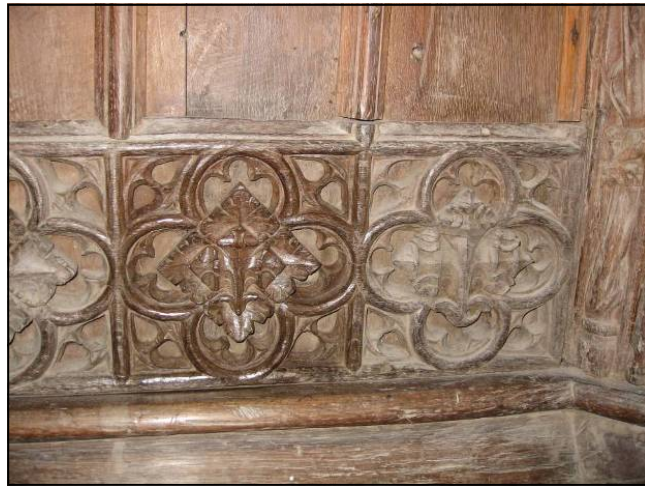
Bay 1 dado.

Test (top left), after feeding 3% dilute linseed stand oil into blanching wood and mopping surface. Photograph bottom left (arrow) shows area once it has dried.

Above, overview after quatrefoil test and above right close-up. The wood here was dusted and cleaned, using white spirit. Once dry the wood was given a coat of microcrystalline wax and buffed to a soft sheen. This will protect it from dust and enable such things as bat's droppings to be more easily removed. Fragments of surviving polychromy will come to light during this process and can be treated as necessary.

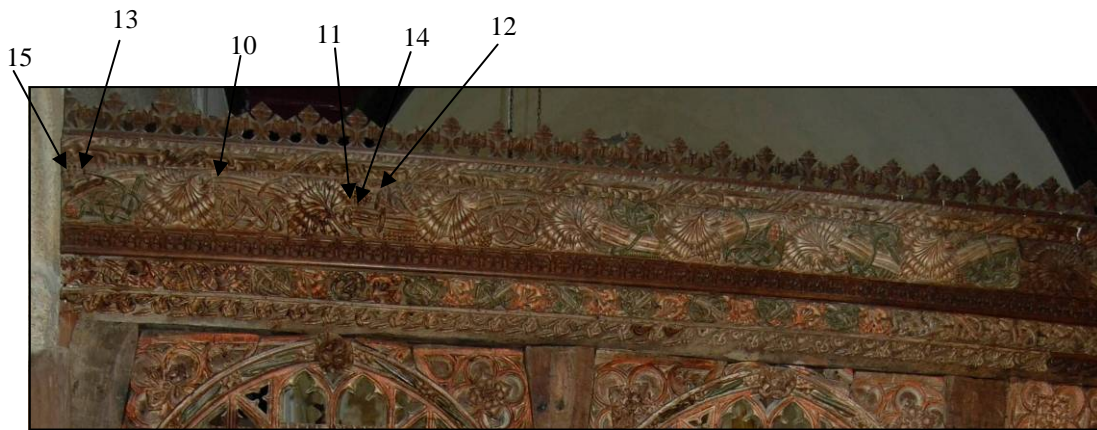
Cornice: Bays 1 and 2

Location of paint samples 10-15

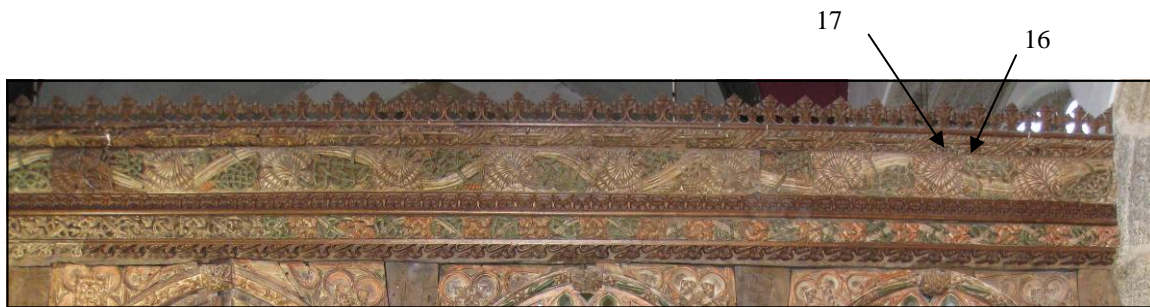
Cornice: Bays 3-5

Location of paint samples 16-17

Paint samples 1-9 were taken in 2011. Samples 1-4 and 9 were taken from below the cornice which at this stage was not accessible. Samples 5-8 were taken from the newly discovered soffit carving.

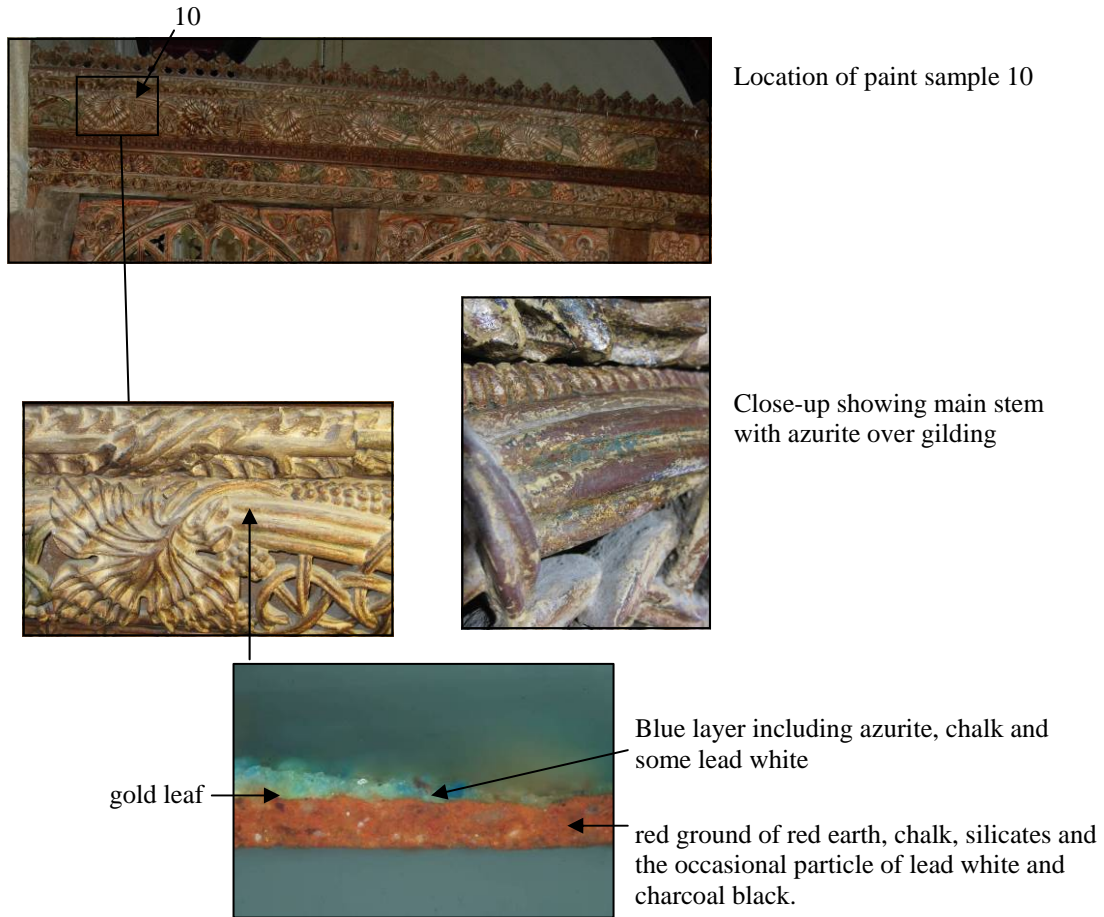
### Photomicrograph of sample 10

Above normal light. Below, left, bright field image, to show the gold layer. Below right, UV examination indicates that the lower part of the sample is more fluorescent, perhaps due to medium separation, or because the red was applied in two layers, not visible in normal light.

Ultra violet fluorescence also highlights possible varnish layer

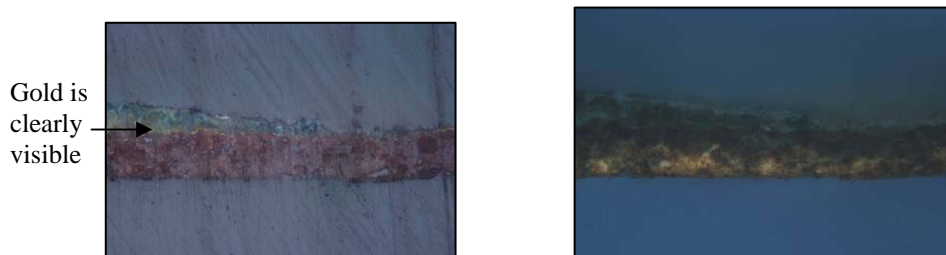
It is unusual to find azurite over gold leaf, as it is not a glaze, in other words it is an opaque pigment. This suggests that it might be an early overpaint and is a fascinating discovery. It is possible that it represents a partial repaint when the Church returned to Catholicism under Mary Tudor. Its presence on the stems however is a characteristic feature of the best cornice polychromy. As can be seen overleaf (see sample 12) other samples also showed evidence of an early re-decoration.

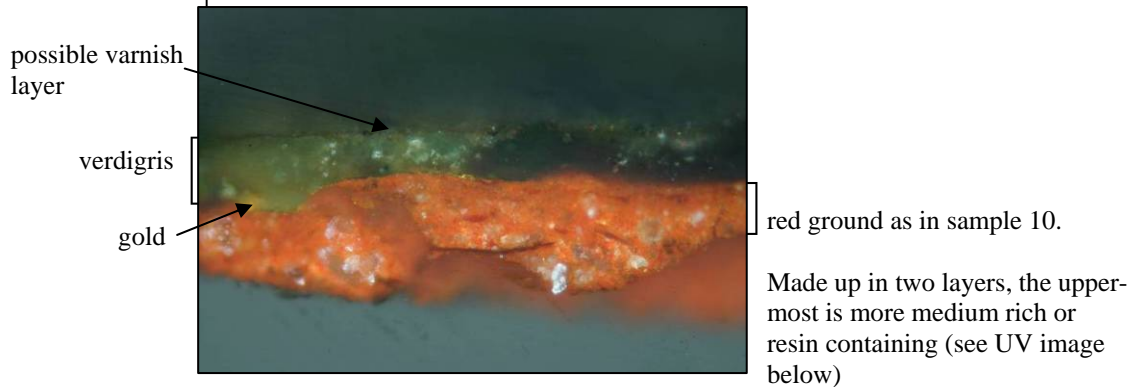
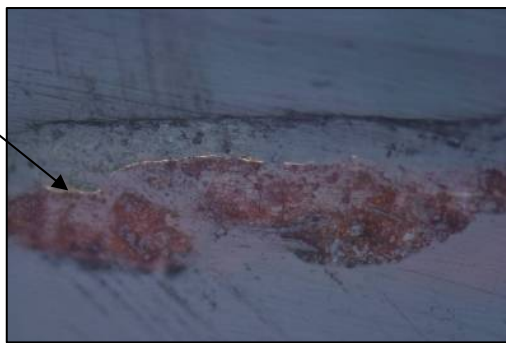
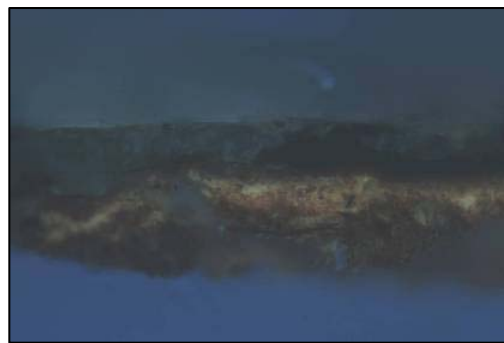
Photomicrograph of sample 11  
x200 Normal light  
Green lustred grapes

x200 Bright field, to show gilding

x200 UV, showing fluorescing medium

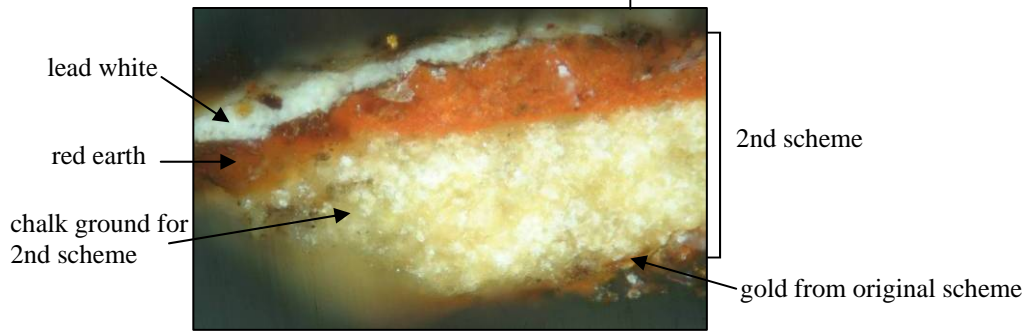
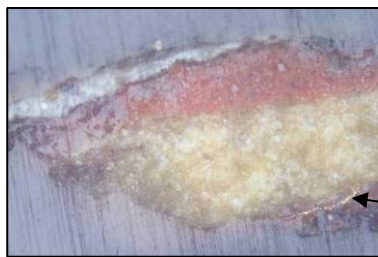
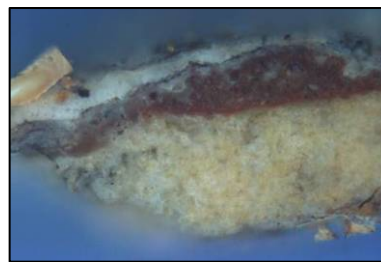
Photomicrograph of sample 12  
x200 Normal light

x200 Bright field

x200 UV

These samples clearly show that there are two decorative schemes. The original layers are fragmentary in sample 12 but present in sample 12b (see below). Both show the original gilding as seen in samples 10 and 11 (previous pages). The indications are that the second scheme is probably early.

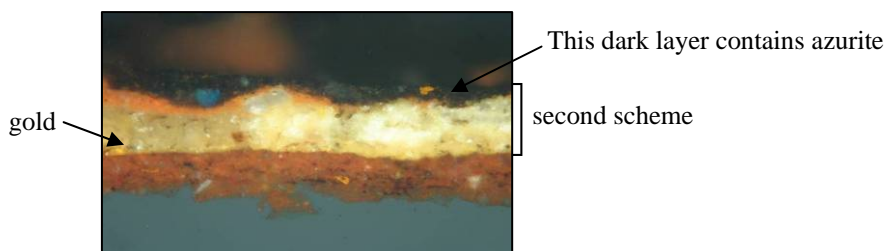
Photomicrograph of sample 12b, second fragment of sample 12  
x200 Normal light

It is unclear how the bird would have appeared in the second scheme. Perhaps some feathers were picked out with this dark blue, whilst others were left as gold. Further cleaning may provide a bigger picture.

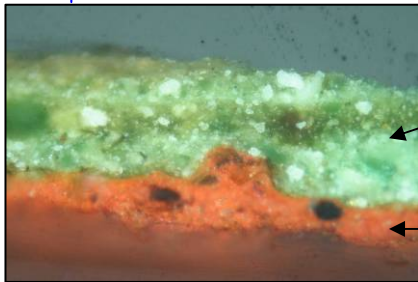
Four layers of synthetic copper greens mixed with varying degrees of lead white or possibly lead tin yellow.

Red ground: this contains red earth, red lead, chalk, silicates and the occasional particle of lead white and charcoal black.

Photomicrograph of sample 13  
x200. Normal light  
Opaque green grapes

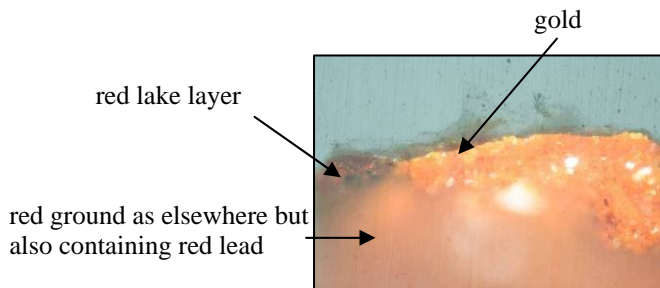
Photomicrograph of sample 14  
x200. Normal light  
Crimson lusted grapes

Two different techniques are used to decorate the grapes on the cornice. Opaque colour, as seen in sample 13 above, or translucent colour applied as a glaze over gold as seen in sample 14 here and in these partially cleaned grapes (see right).

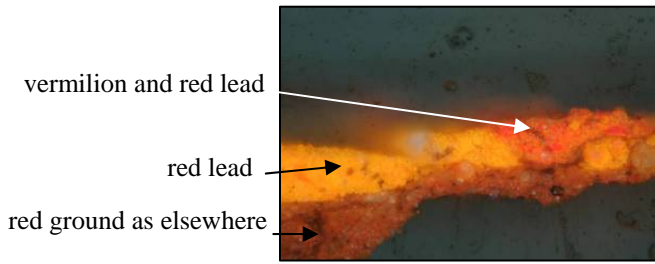
Photomicrograph of sample 15  
x200. Normal light

Opaque red grapes, same bunch as sample 13

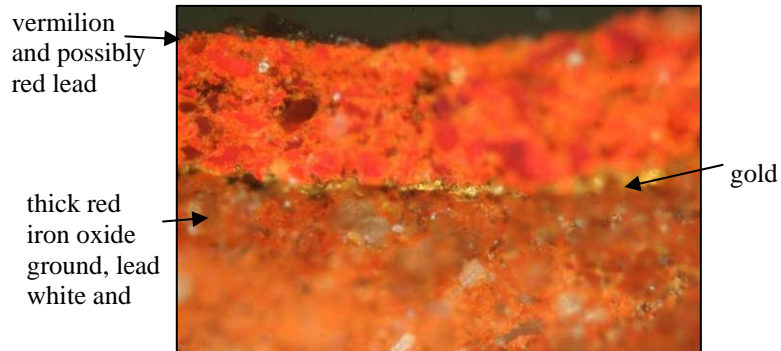
A comparison of sample 13 with sample 6, taken from the soffit (see below), reveals certain similarities. It should be noted that if the soffit originally came from the rood loft, then it could have been through the same relatively early repaint that seems to have taken place on the cornice nearby.

Photomicrograph of sample 6  
x200

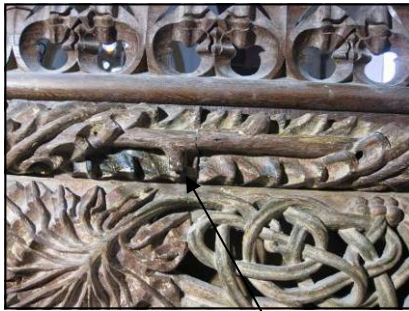
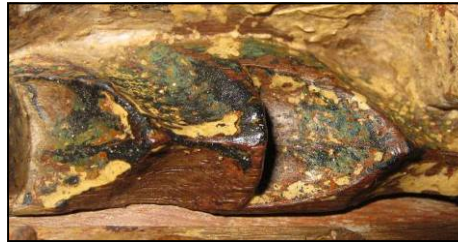
Detail of Aaron's rod and location of sample 16. As can be seen in this detail, the painting here is a complex mix of layers from different decorative schemes. The blue and the black decoration seen on the carving above are clearly visible in the cross-section seen below.

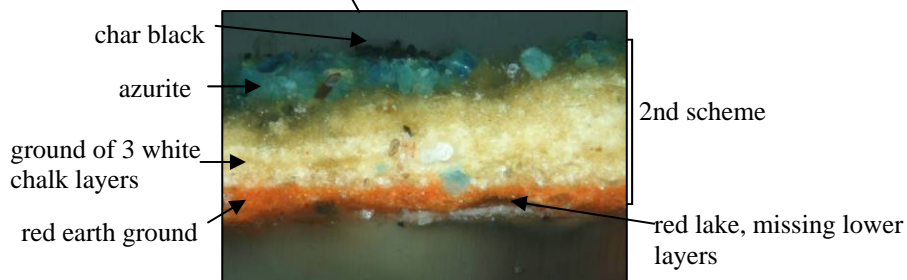
Photomicrograph of sample 16, taken from Bay 5, south end of screen x200. Normal light

As with samples 12 and 12b, sample 16 clearly shows evidence of repainting. The bottom layer, which appears to be red lake, could have been a glaze for gilding or it could in fact be a remnant of a varnish for the original decoration. Either of these could explain the fluorescence seen in ultra-violet light in the photomicrograph below. All the layers above this belong to the repaint and second scheme.

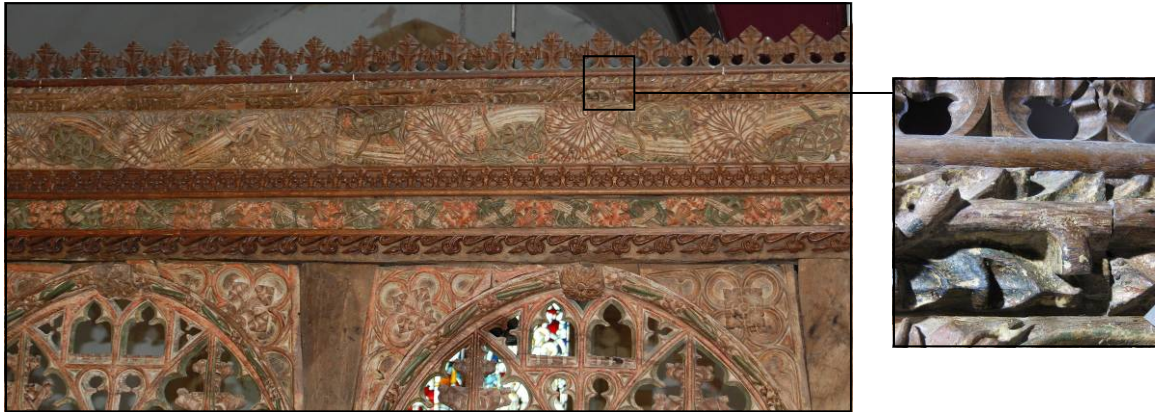
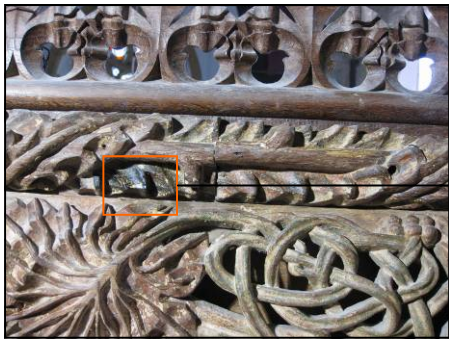
Aaron's rod at south end of screen appears to be painted differently to that elsewhere

lead white, yellow ochre and chalk.

'black', consisting of a char black, red lakes and a little azurite.

yellow, ochre?

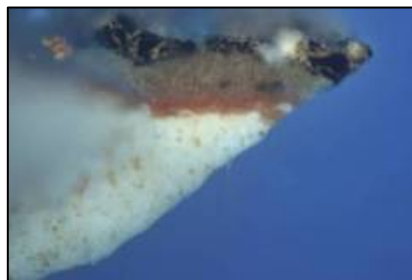
Photomicrograph of sample 17, taken from Bay 5, south end of screen x200. Normal light

Sample taken from the Aaron's rod, where a gritty black was observed. Analysis identified this as a dark purple, consisting of a char black, red lakes and a little azurite. Unlike sample 16 (previous page) there is no distinct azurite layer visible below. With such small paint samples however, its absence in a sample may be because it is incomplete as the layers below may be fragmented. This section of Aaron's rod does appear to be different and removal of overpaint might provide further fascinating information.
