**ARCHAEOLOGICAL INVESTIGATIONS  
AT ST MARY'S CHURCH,  
CONGERSTONE,  
LEICESTERSHIRE  
(CSMC18)**

Work Undertaken For  
**Peter Rogan and Associates Limited**

APS Report No: **39/18**

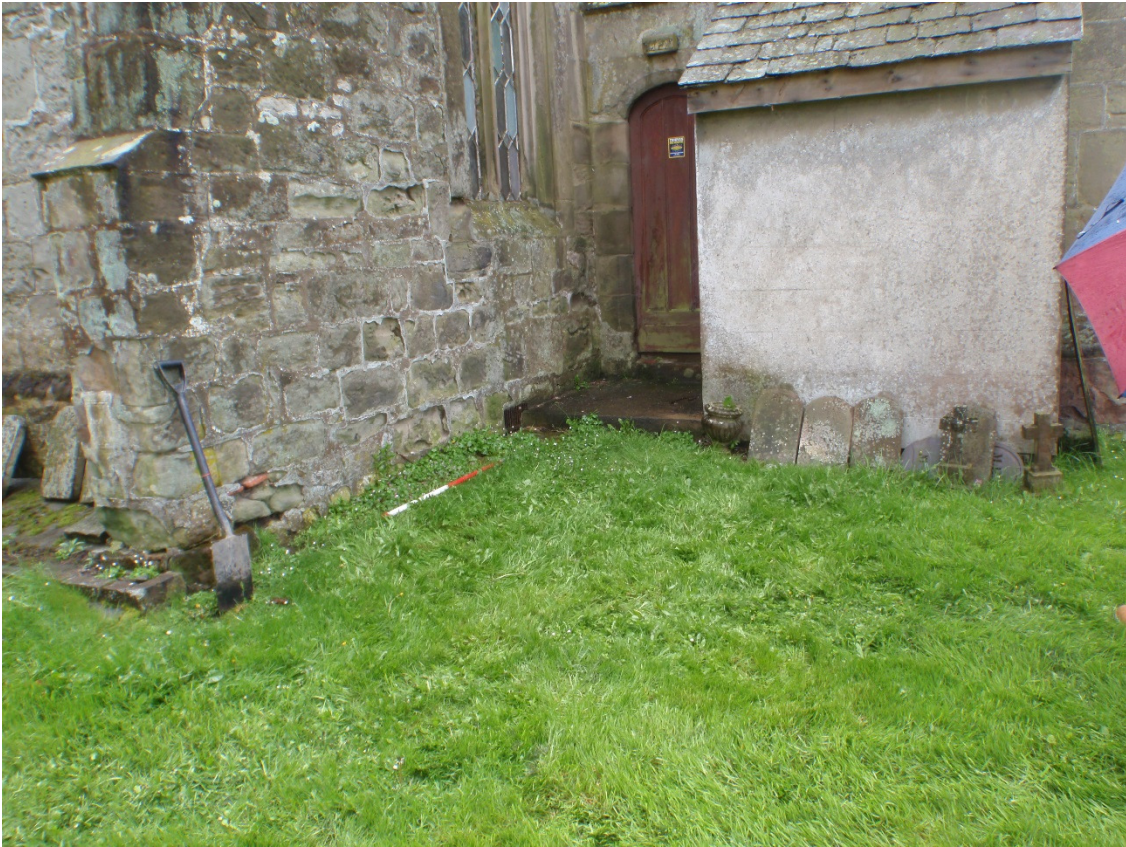
Plate 1. Location of the two test pits prior to excavation looking southeast

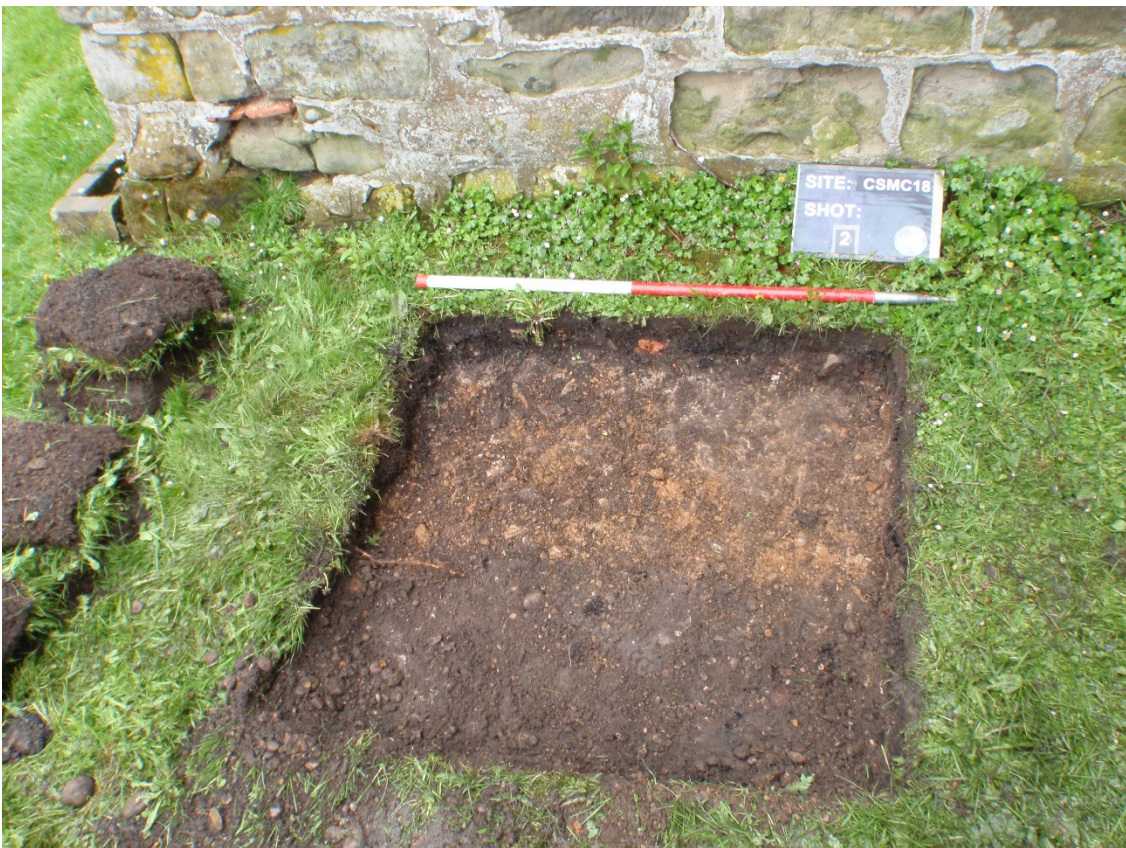
Plate 2. Test Pit 1, probable mortar path (002), looking east

thick hard mortar surface which may have been a former path around the church. There was similar material in the smaller Test Pit 2 adjacent to a stone wall footing. The stone wall hints at an earlier church at the site, probably predating the 16<sup>th</sup> century, although works were carried out in the mid-19<sup>th</sup> century, which may have removed an element of the 16<sup>th</sup> century church.

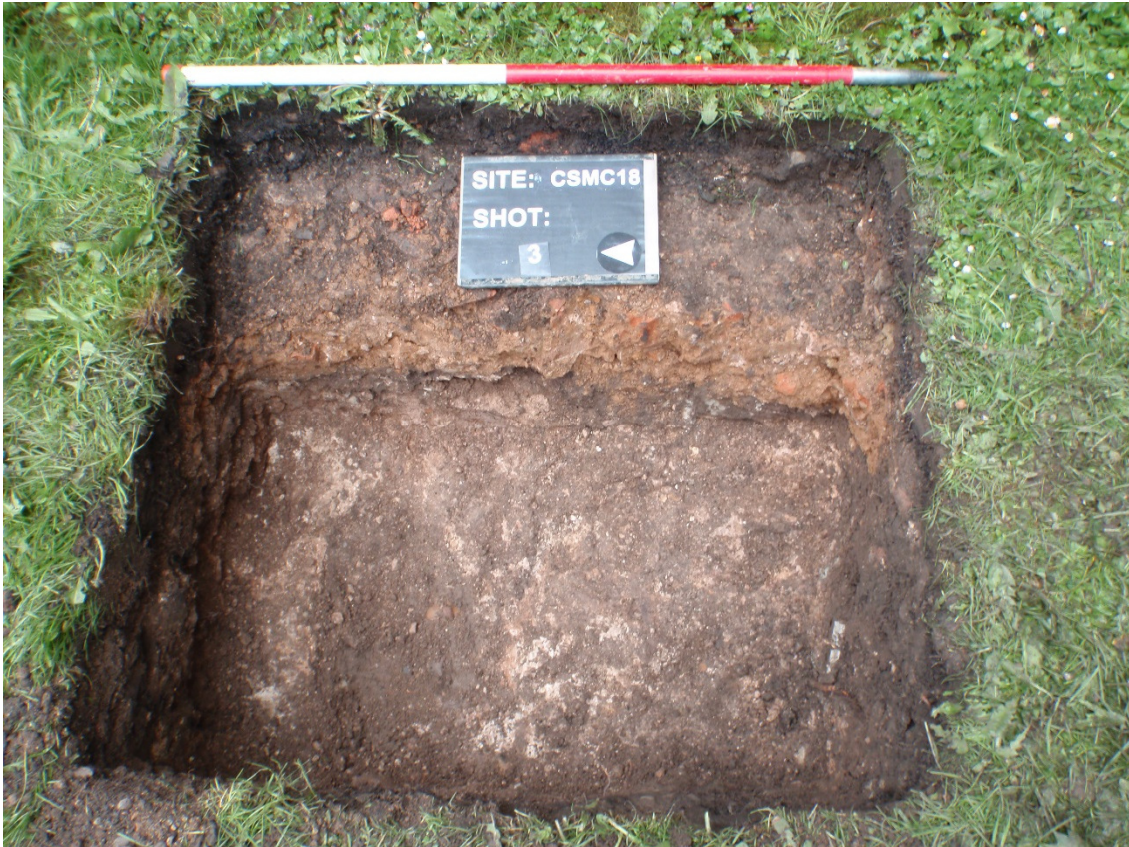
This was overlain by a 0.12m thick cream mortar layer (004), possibly a sub-floor foundation. Above which was a 0.19m thick dry grey soil (003) from which two medieval floor tiles were retrieved. This was in turn sealed by 0.14m thick hard yellow mortar (002) with occasional brick fragments, above which was the current topsoil (001) (Fig. 5, Section 1).

Plate 3. Test pit 1, possible mortar floor (004), looking east

In Test Pit 1, the earliest deposit revealed was the probable general graveyard soil (005). Overlying it was a probable mortar floor or base for a tile floor, two loose tiles perhaps relating to this were retrieved from the overlying deposit and were dated to the 14<sup>th</sup> – 15<sup>th</sup> century. Above this was a

It is probable that the proposed extension will impact the remains of the floor and wall revealed during the test pitting, particularly as the depth of the foundations will be approximately 1m below the current ground level. As such, further mitigatory works are likely to be required, the scope of which will be determined by the archaeological curator.

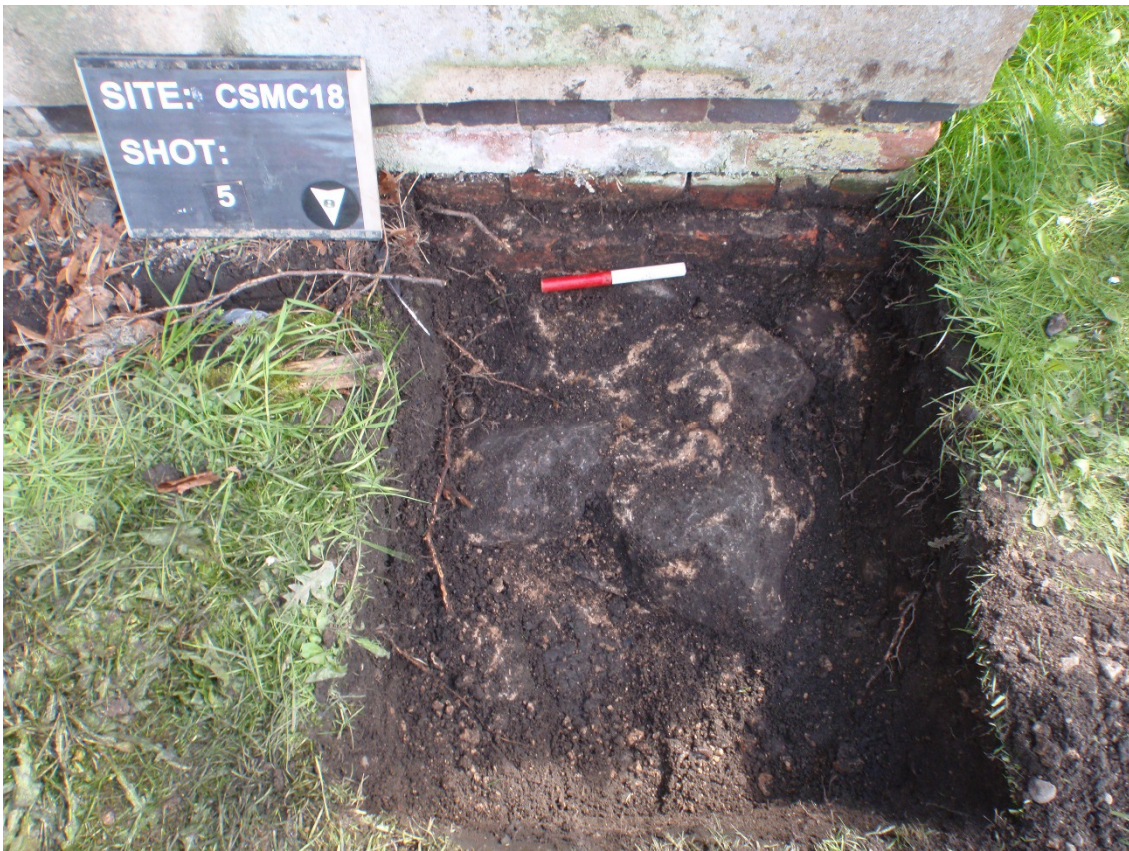
This test pit was excavated to a shallow depth as very solid wall footing (006) was encountered. This comprised large flint nodules, up to 0.22m across, set in hard yellow mortar. The remainder of the test pit, north of (006), was taken up with hard dark yellow mortar (007), similar to (002).

Plate 4. Test Pit 2, wall [006], looking south
