Church of St Bartholomew, Cadeleigh, Devon
Diocese of Exeter

Monument to the Leach Family (1660)

Polychromy investigation, September 2008

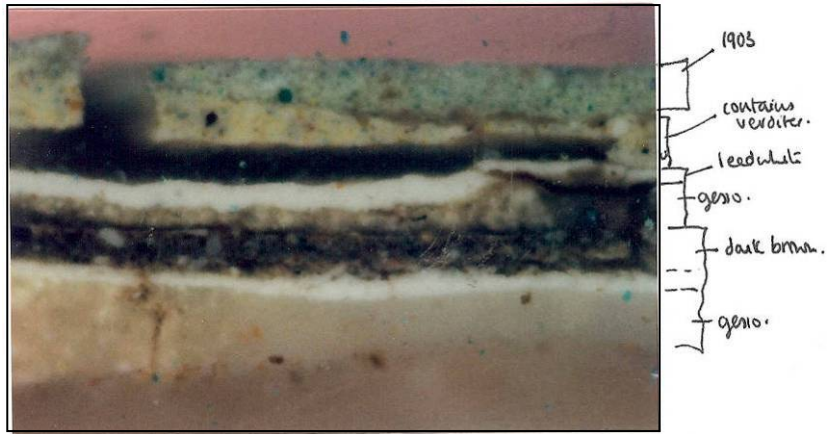
The original scheme had brown
over a pure white ground.

The brown is disturbed.

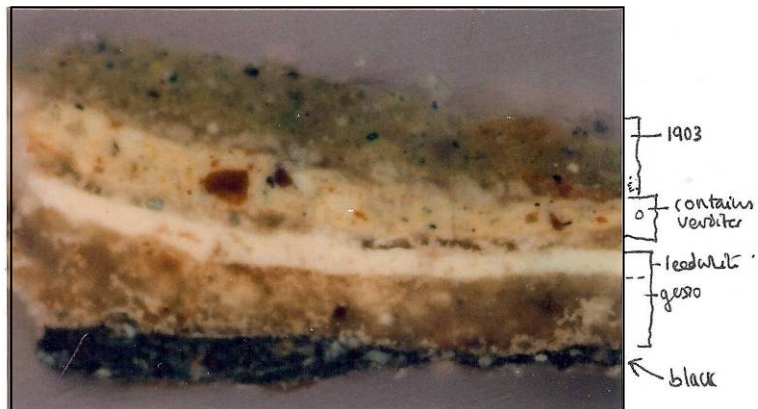
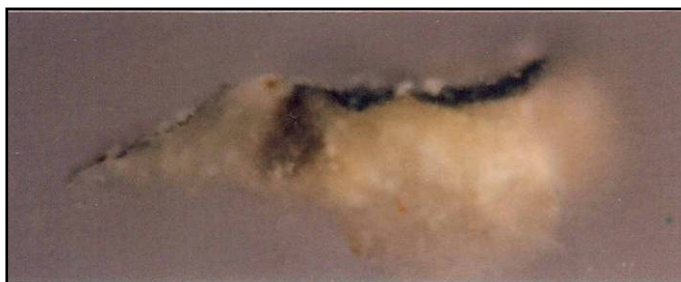
SAMPLE 2

Earlier effigy of Simon Leach —
foot

The same upper layers as in
Sample 1,
but the original colour was black.

Fragment with stone and first
paint layer.

In sample 2, from the top of Simon's armoured foot, and missing a ground, the earliest scheme showed an almost black layer, made of carbon black with a little lead white, depicting the grey of the armour.

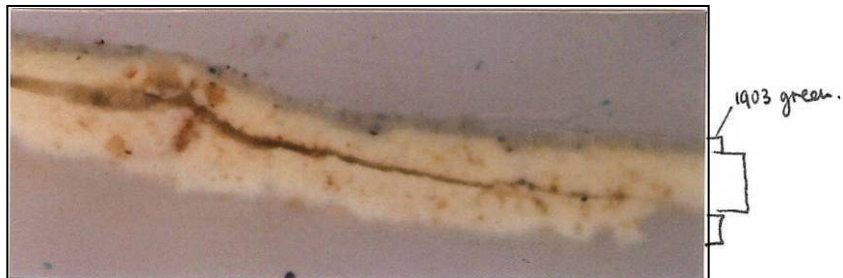
SAMPLE 3

Small kneeling female figure,
delaminated samples

Off-white, under the present greenish
paint on cream.

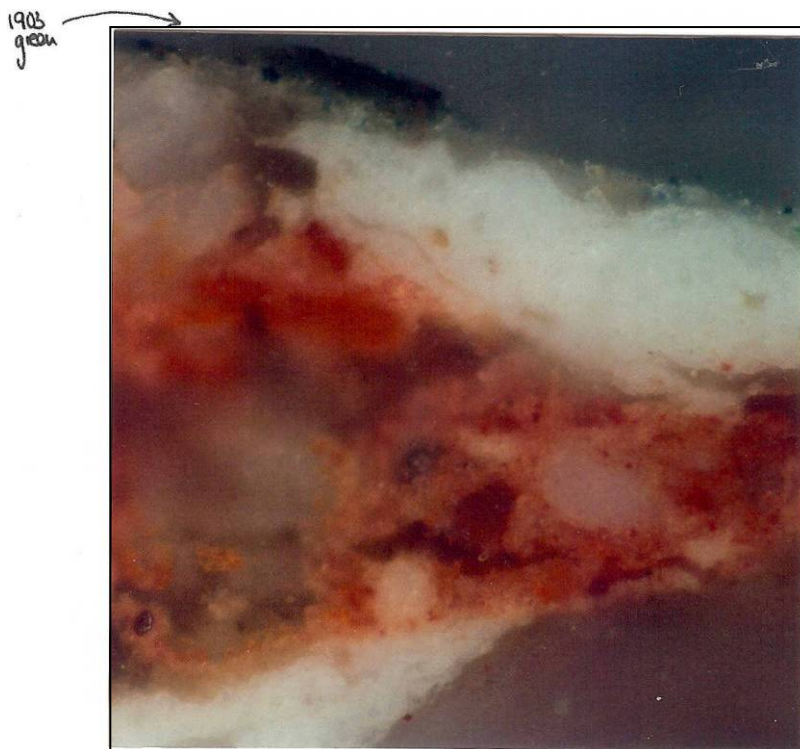
SAMPLE 4

Lady Bridget Leach, dress

The present green is on top.

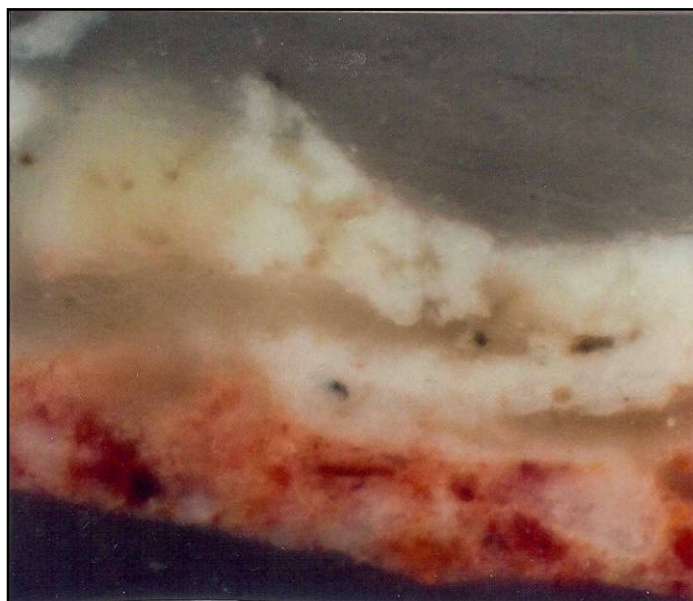
SAMPLE 5

Same area as 4

There seems to be no separation
between
the red and the white layer.

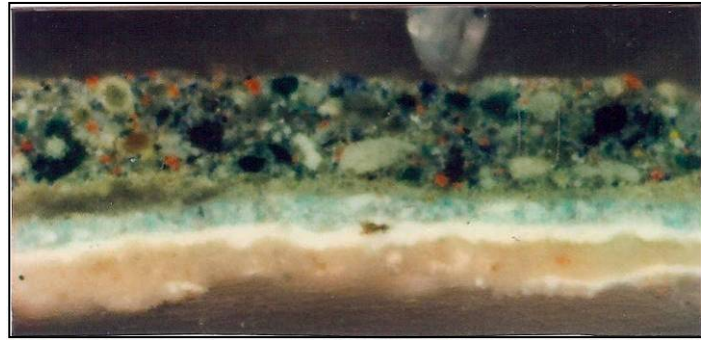
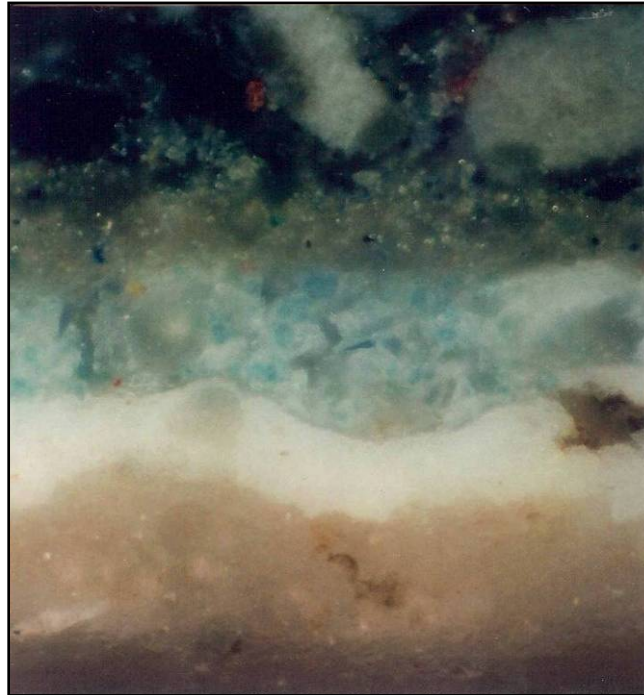
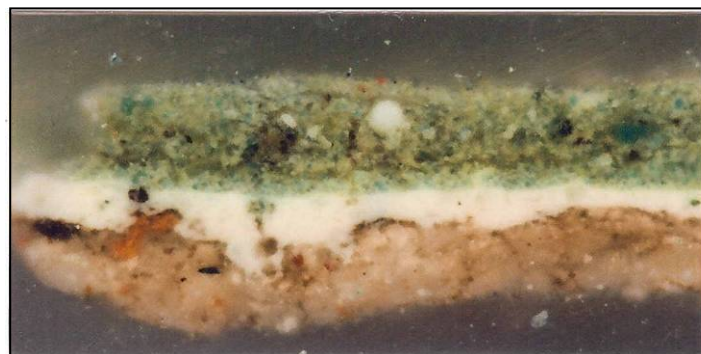
SAMPLE 6

Earlier effigy of Simon, lower cushion

Fragment (i) with thick layer of 1903 green over original blue.

1903 green.
grey undercoat
gesso

Detail of original blue which is mostly smalt, but also contains some blue verditer.

Fragment (ii)

In this piece the original blue is stained and cracked. It looks green.

1903
smalt +
verditer.
lead white
gesso

Close examination of cross-sections of paint fragments from the same location can reveal, for example in sample 6 (Appendix 1), the 1660 blue of smalt and verditer in good condition or stained, cracked and altered to green. Blue verditer was known for its green cast and tendency to become greener¹⁹. Degraded oil will also have enhanced this effect. The greenish tone of the degraded areas may have been a reason why green was chosen for so much of the 1903 repainting.

SEM ANALYSIS of a lump of white in the 1903 green seen in Sample 6

The main features in the spectrum are for zinc [Zn] barium [Ba] and sulphur [S] from zinc sulphide and barium sulphate (lithopone). There is also a significant feature for calcium [Ca]

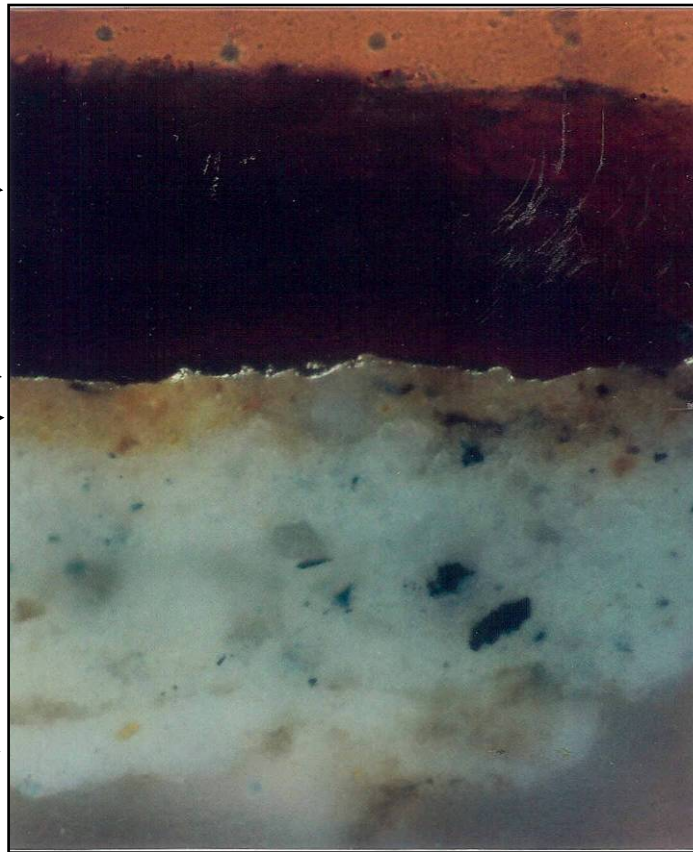
SAMPLE 7
West shield, west beast

- Yellow glaze →
- Silver →
- Yellow underpaint →
- Grey ground →
- White primer →

The glazed silver has blackened and in sample 16 (Appendix 1), from the hair of a cherub, the yellow undercoat, silver and glaze were cracked and damaged by the time they were overpainted. However, samples 7 and 13 show untarnished silver still surviving in places and close-examination also revealed this (Photograph 60), though freshly exposed silver will soon tarnish, and this issue will need addressing, see below.

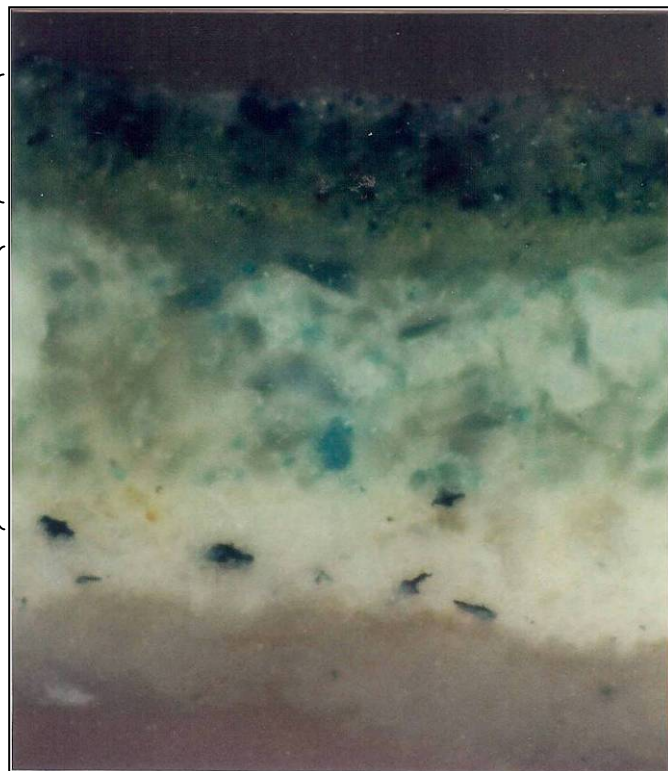
SAMPLE 9
Canopy coffering, background

- Present dark green based on Prussian blue, chrome yellow, →
- French ultramarine & zinc. white
Original blue of smalt, verditer and lead white →

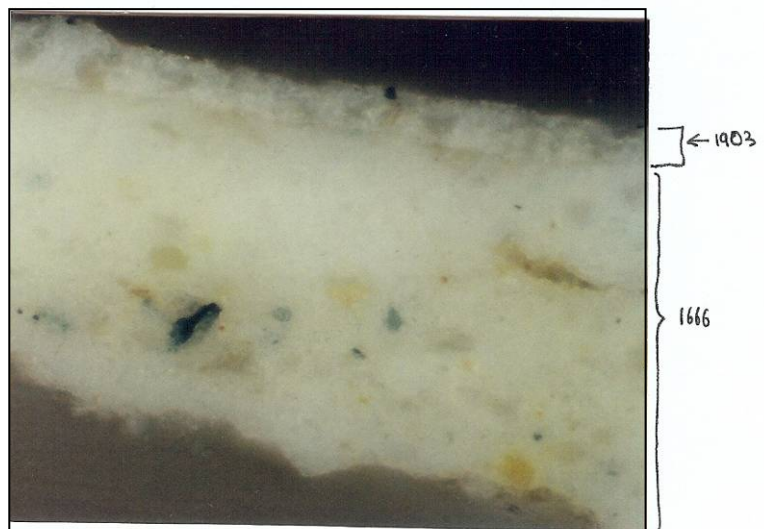
SAMPLE 12
Figure of Time - thigh

1903 white

White primer

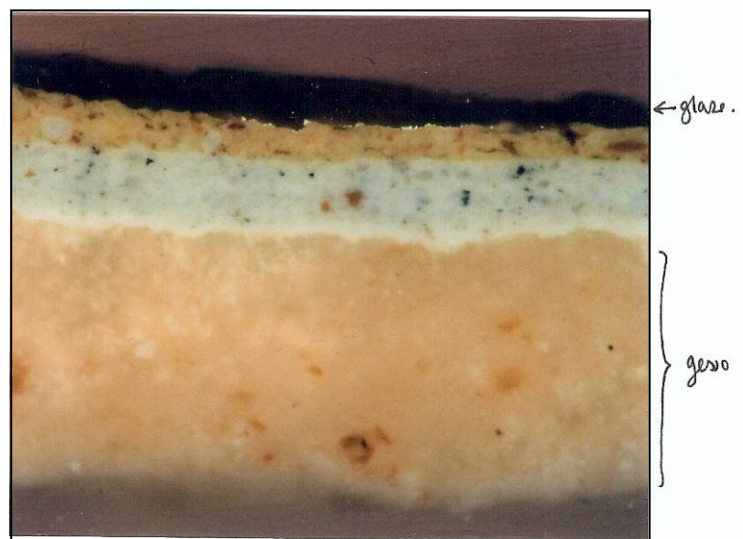
SAMPLE 13
Head of cherub, east side -large
sample of loose paint

Thick gesso, followed by white
priming, grey ground and then the
silvering layers.

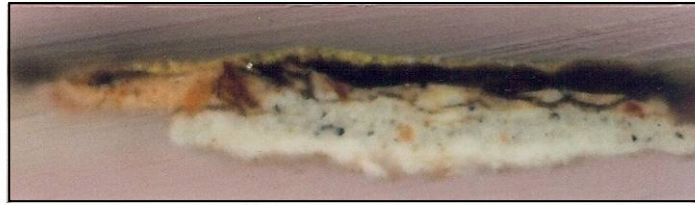
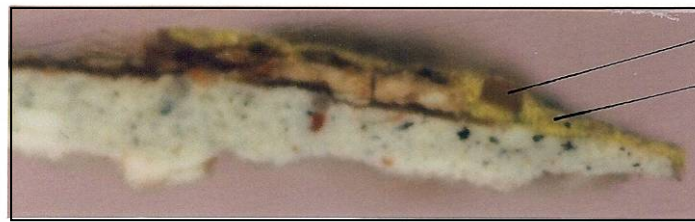
SAMPLE 16

Central putto's head from broken pediment - hair

Two fragments, showing that the original silvering scheme had become damaged by the time it was painted over. The grey ground remained intact but the yellow undercoat, silver, and glaze were cracked and damaged.

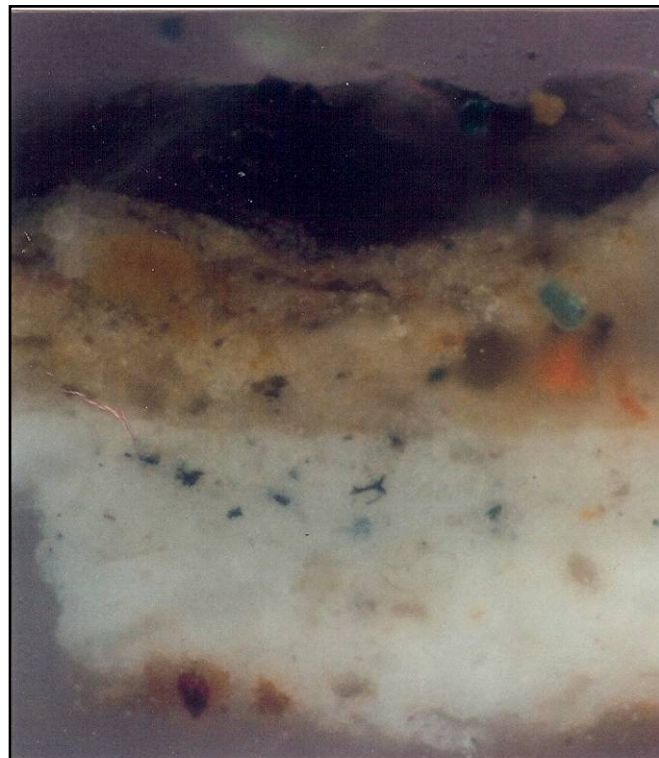
SAMPLE 17

Base of central cartouche, attic

In this piece the layers are intact, but the silver leaf has completely blackened.

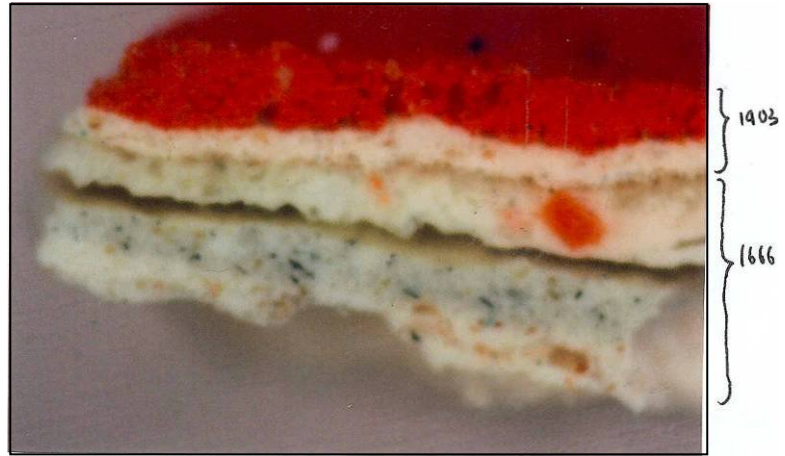
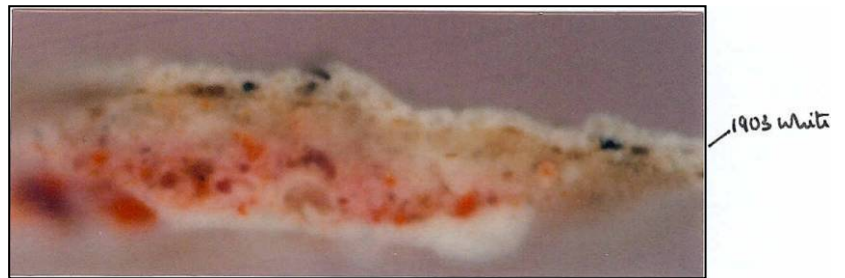
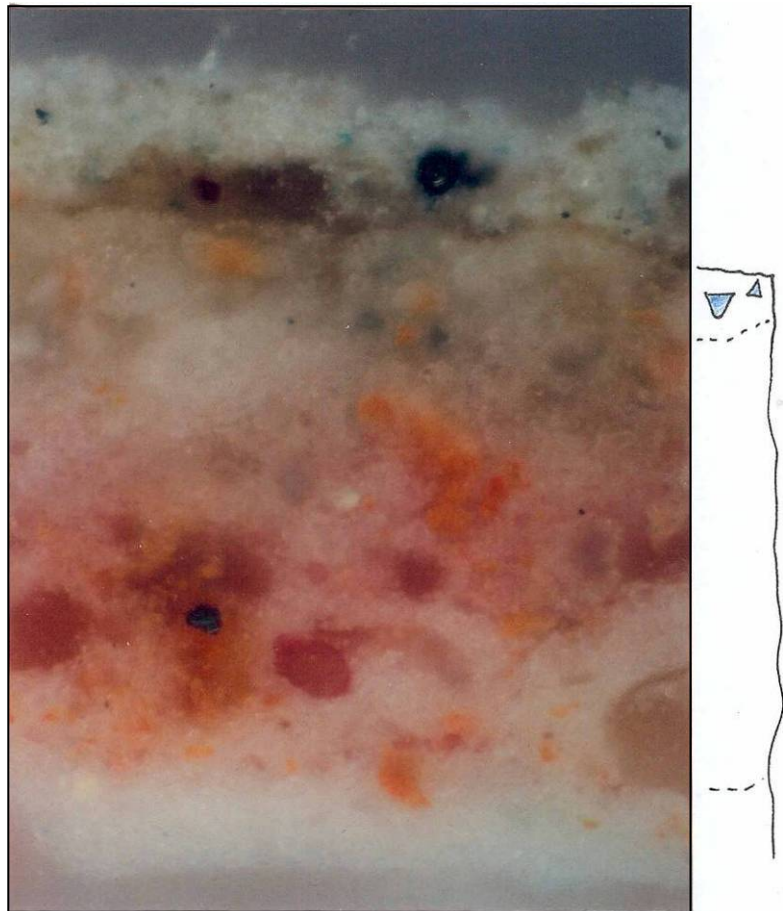
•
SAMPLE 19

The bright red at the top is the 1903 scheme.

Another fragment. This one without the 1903 red, but a better example of the original scheme.

Thin overlap of lead white → and smalt.

Original red of red lead, red lake and lead white

SEM ANALYSIS of the 1903 red in Sample 19

The spectrum shows features for chromium [Cr] and lead [Pb] from the lead chromate.

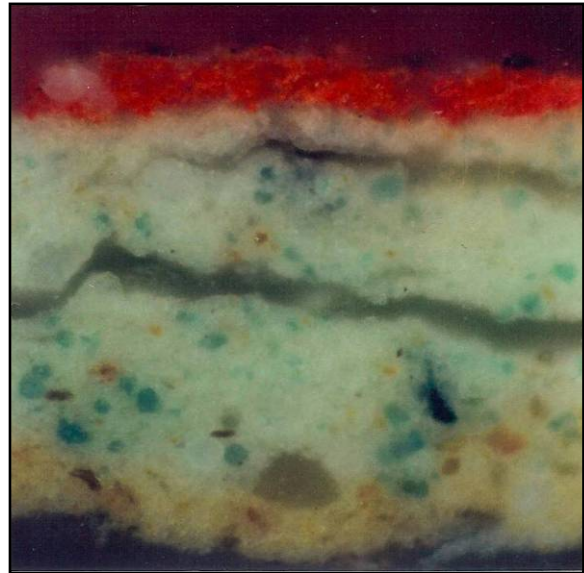
SAMPLE 20

Kneeling Simon Leach, red border
of armour

The dull yellow at the bottom looks
like the undercoat used for the silvering.

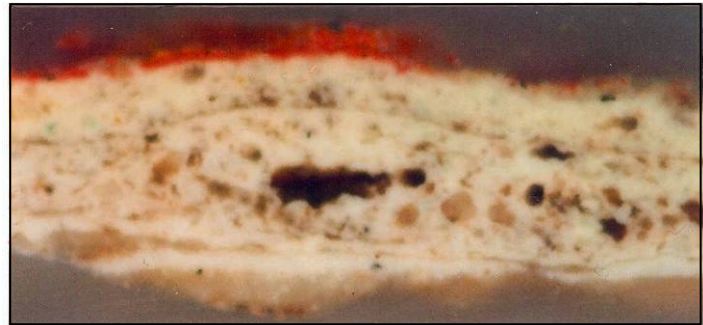
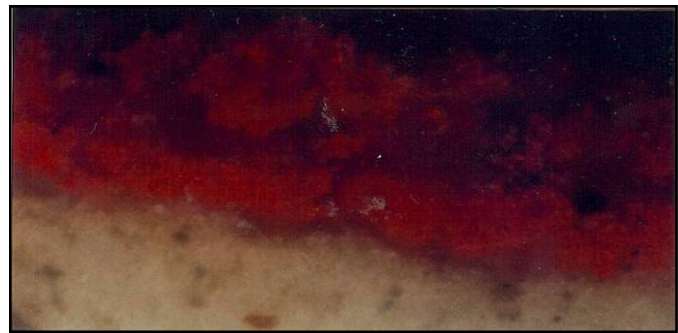
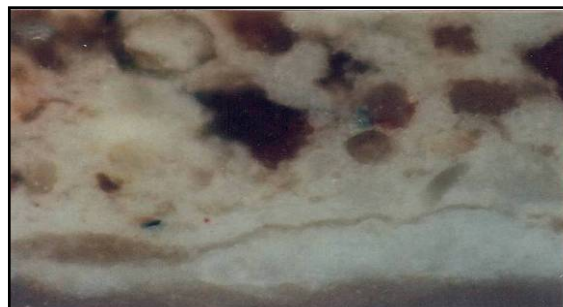
SAMPLE 21

Third kneeling girl, cushion

Three lots of red.

1903 red

Vermilion of
intermediate scheme

Original faded red lake

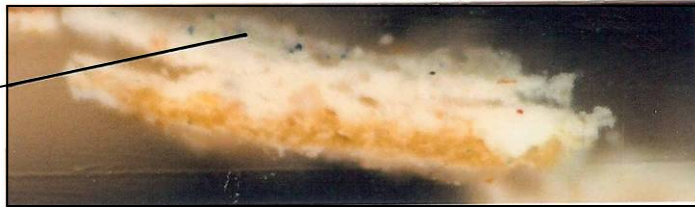
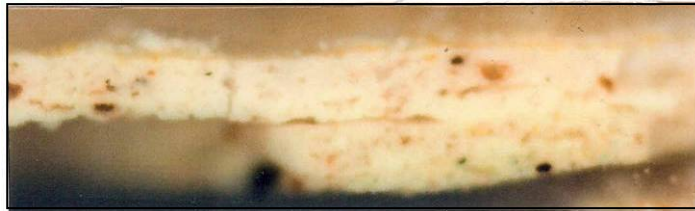
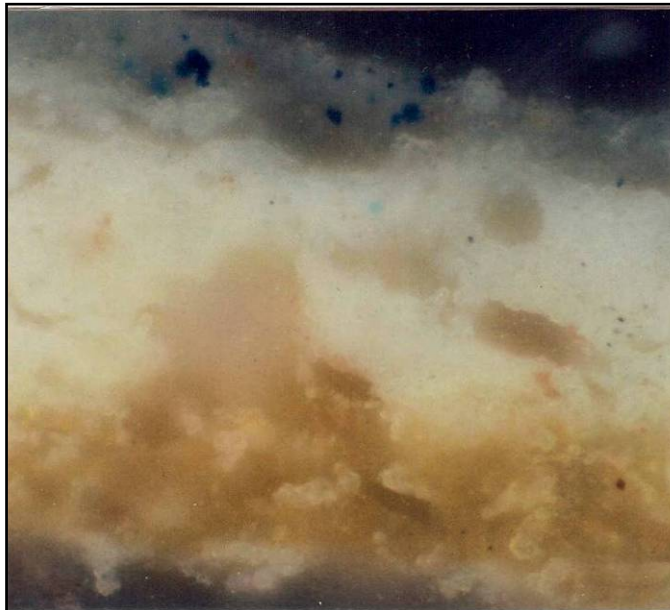
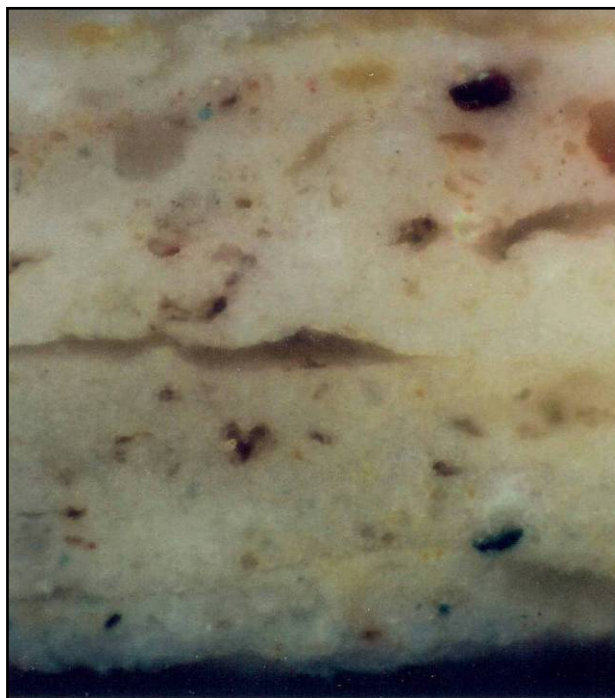
SAMPLE 22

Kneeling boy, back of hose

1903 layers

Original layers

The original paint contained
some red lake, now faded.

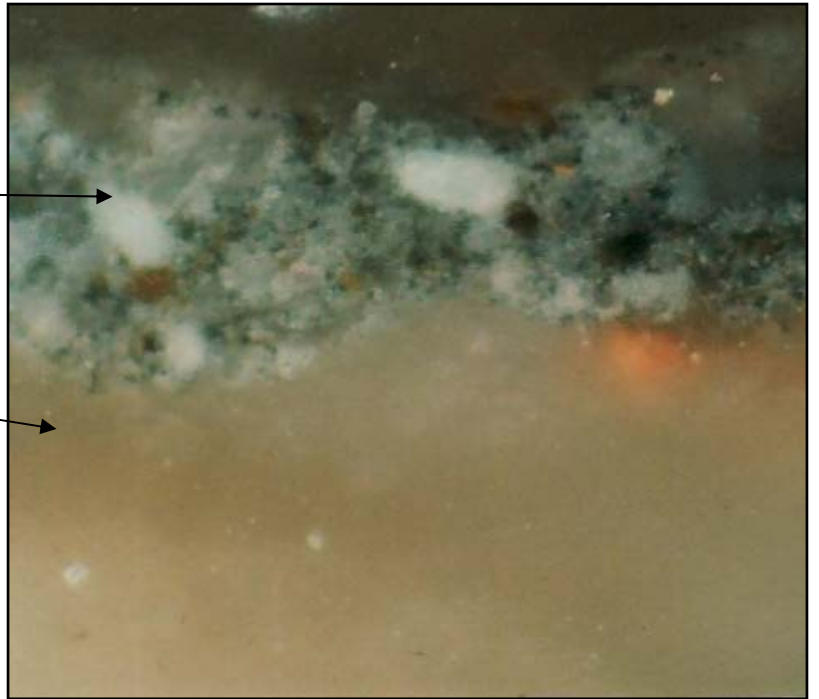
SAMPLE 23

Leg armour

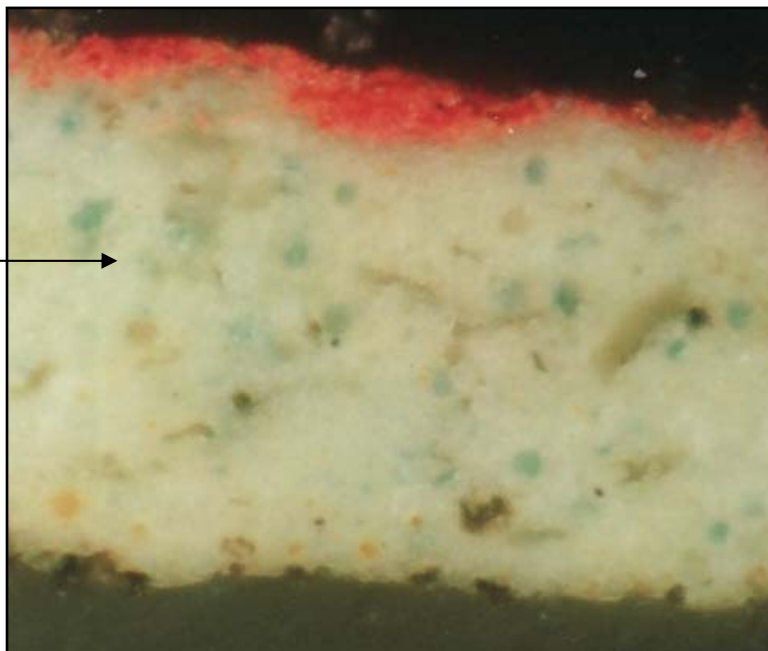
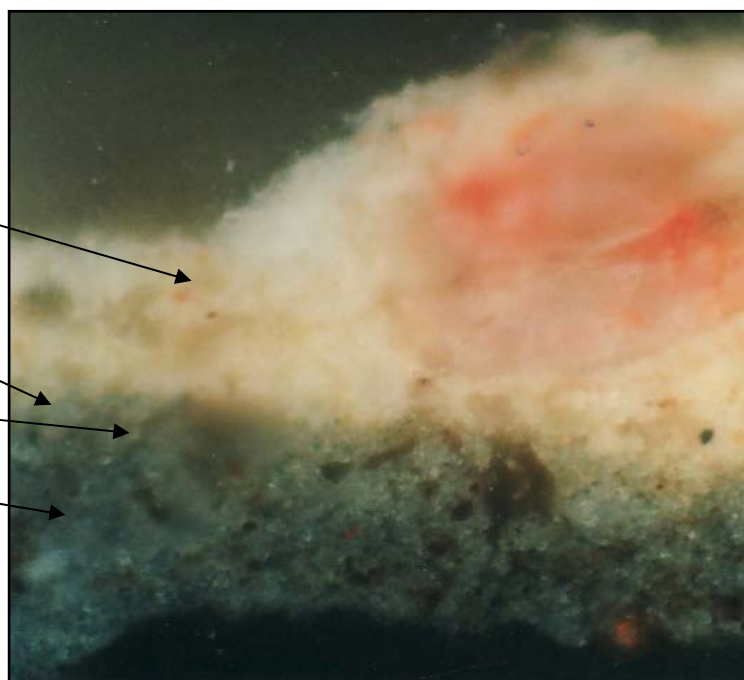
SAMPLE 24
Back of kneeling figure

Upper layers

layer with verditer
particles

Lower layers

buff layer [lead white,
ochre + red lead]

undercoat of grey

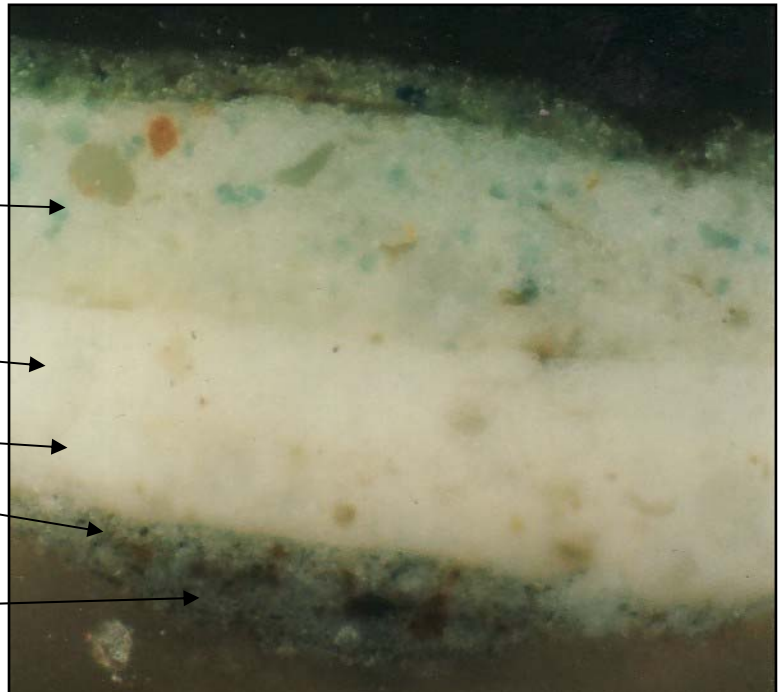
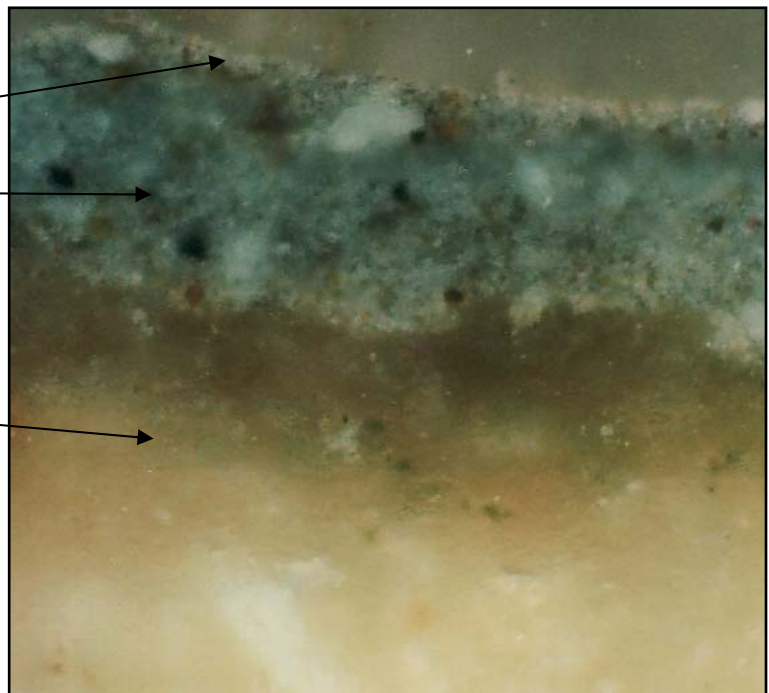
SAMPLE 25

Front of kneeling figure

Upper layers

- layer with verditer →
- white scheme →
- pale grey u'coat →
- top coat of dark grey →
- undercoat of dark grey →

Lower layers

- top coat →
- undercoat →
- gesso →

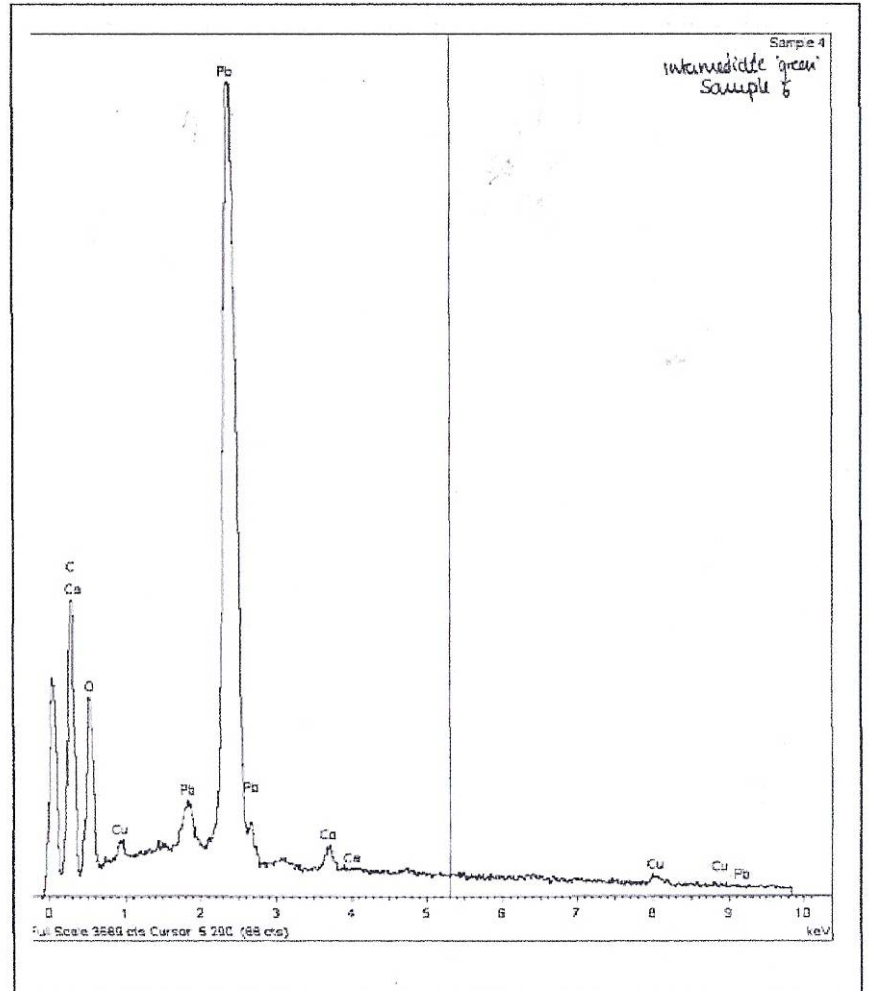
SEM ANALYSIS of the pale greenish paint used in the intermediate scheme.
 The main feature is for lead, but there is also a small amount of copper [Cu] from the blue verditer.

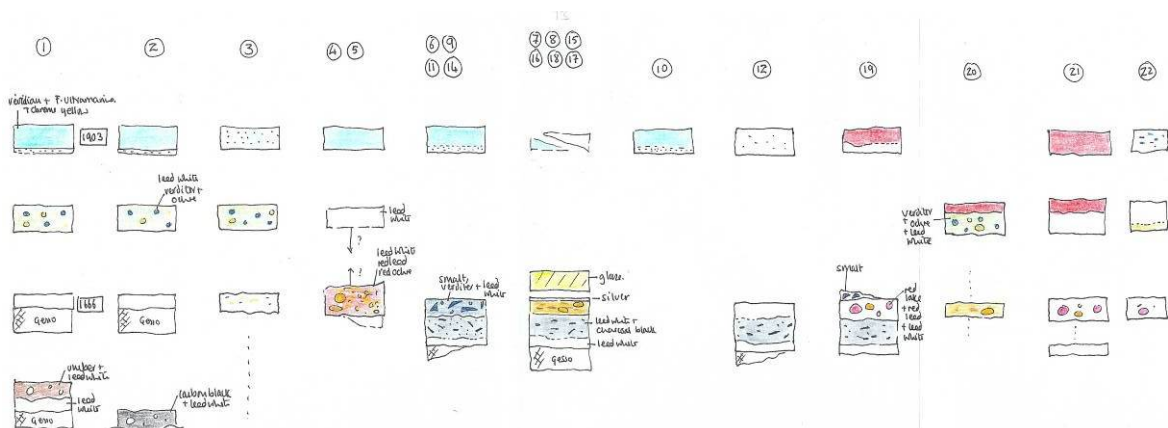
Diagrammatic summary of paint samples, showing the four decorative schemes and how they relate to each other

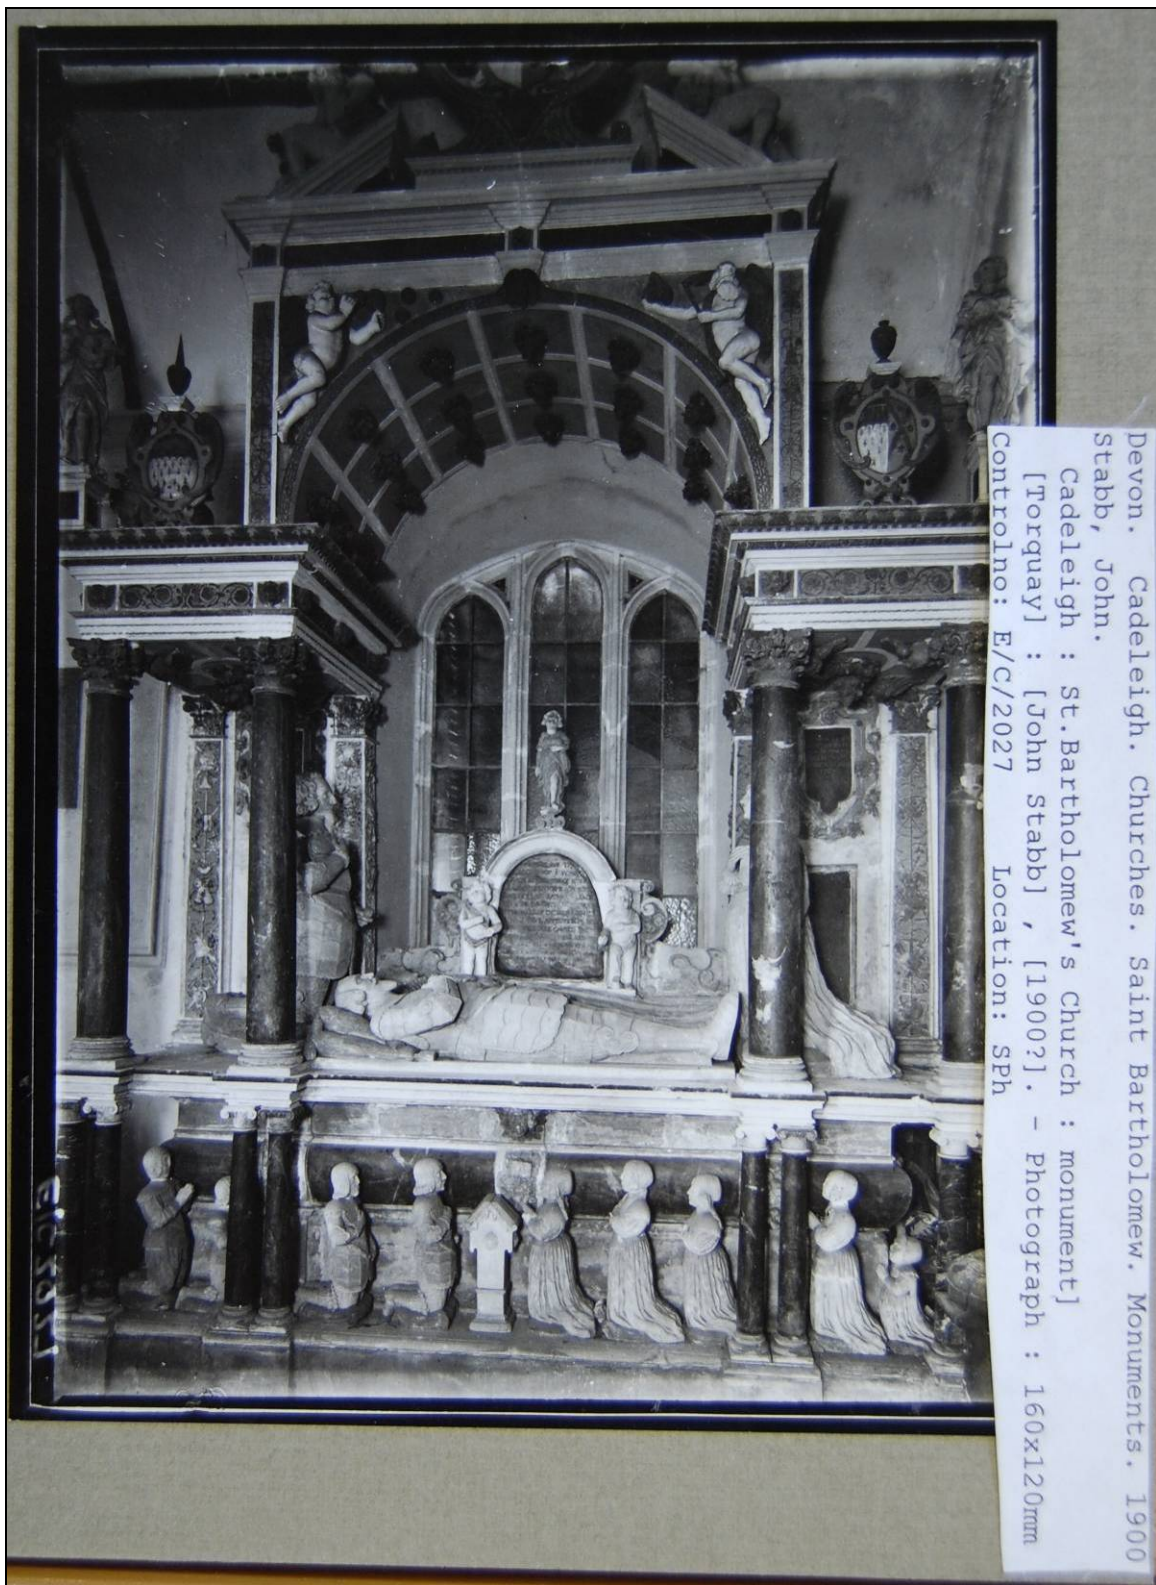
11.4.3 John Stabb

Original photographs used for volume 1 of 'Some Old Devon Churches, their Rood screens Pulpits and Fonts etc' 3 vols pub. Simpkin, Marshall, Hamilton, Kent and Co. London 1908

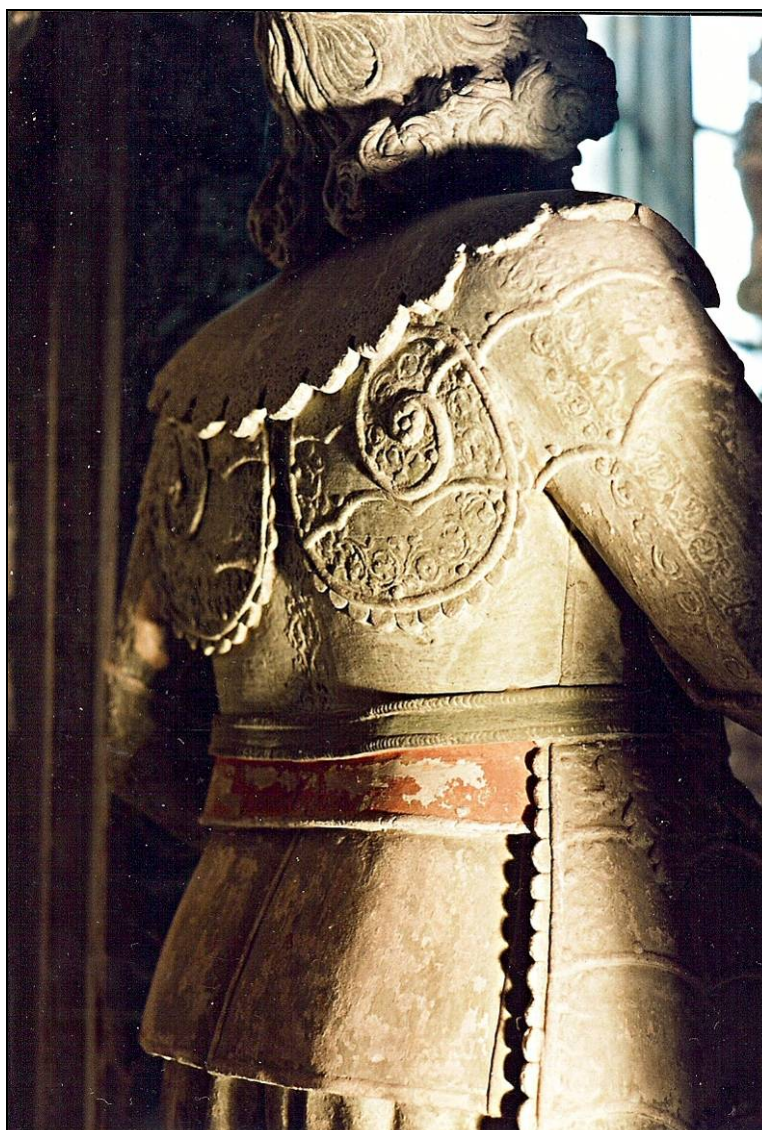
11.4.5 Kneeling Simon Leach. Wells Conservation Ltd, 1994 Report.

A comparison of this photograph with photograph 11 in the current report shows that there have been further paint losses on the red border below the belt, revealing a little more of the dark grey of the armour from the 1660 decoration and the buff-coloured layer above. The flaking, although continuing, is happening gradually. Photograph 13 shows a closer view of the area marked in the box above which indicates that approximately a further 2cm of the red has been lost since 1994.

The red is actually from the intermediate scheme although above this there are fragmentary traces of 1903 red in the corners

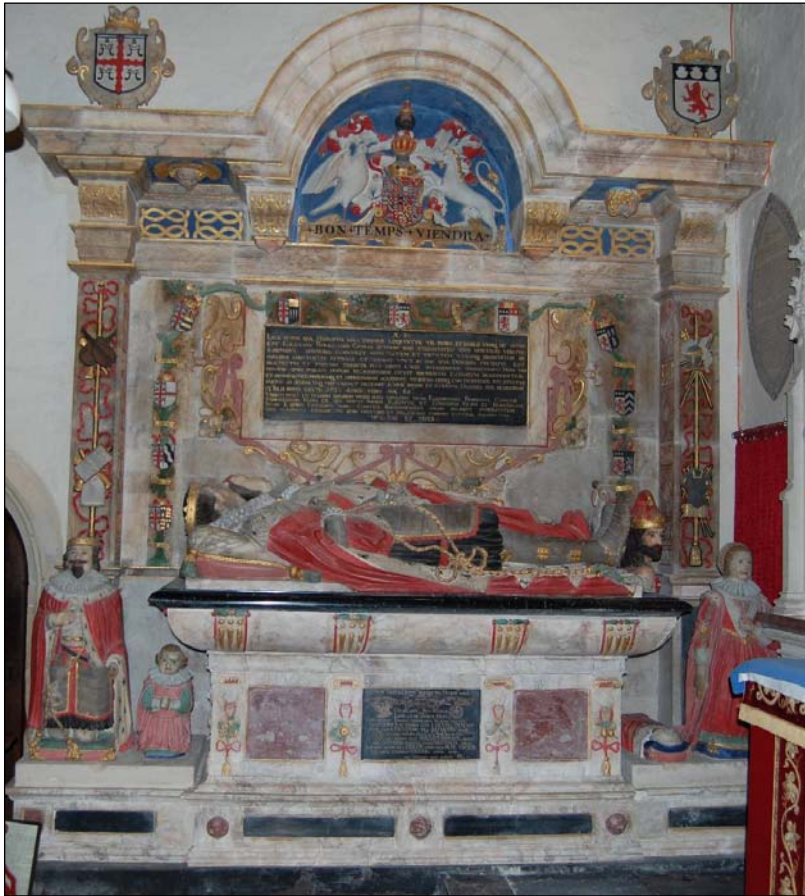
11.5.1 The Bouchier Monument, Tawstock, Devon

The decoration on this monument is very similar to that on the Leach monument, although the Bouchier monument is carved from alabaster and not Beer stone and dating from 1623, it is slightly earlier in date. It appears to have received more interventions than the Leach monument with obvious and obtrusive repainting, perhaps several times over the centuries.

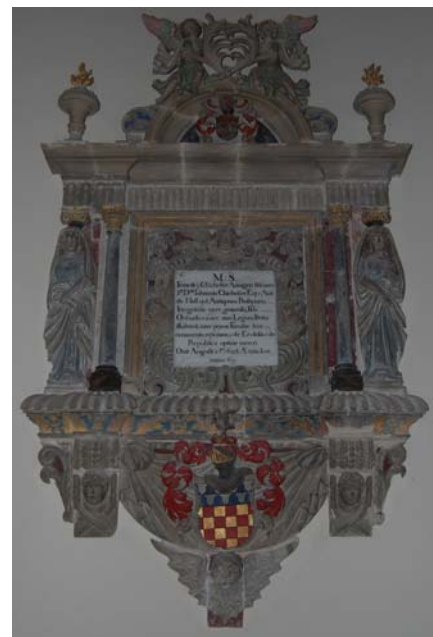
11.5.2 Monument to Sir Francis Chichester, Bishop's Tawton

The paint on many 17th century monuments has been neglected. At Bishop's Tawton, the Chichester monuments are especially obscured with dirt. The monument to Sir Francis Chichester d. 1698, shown on the right, displays features such as the caryatids that could still retain their original paint. The paint on other elements, such as the heraldic devices and frieze looks like overpaint.

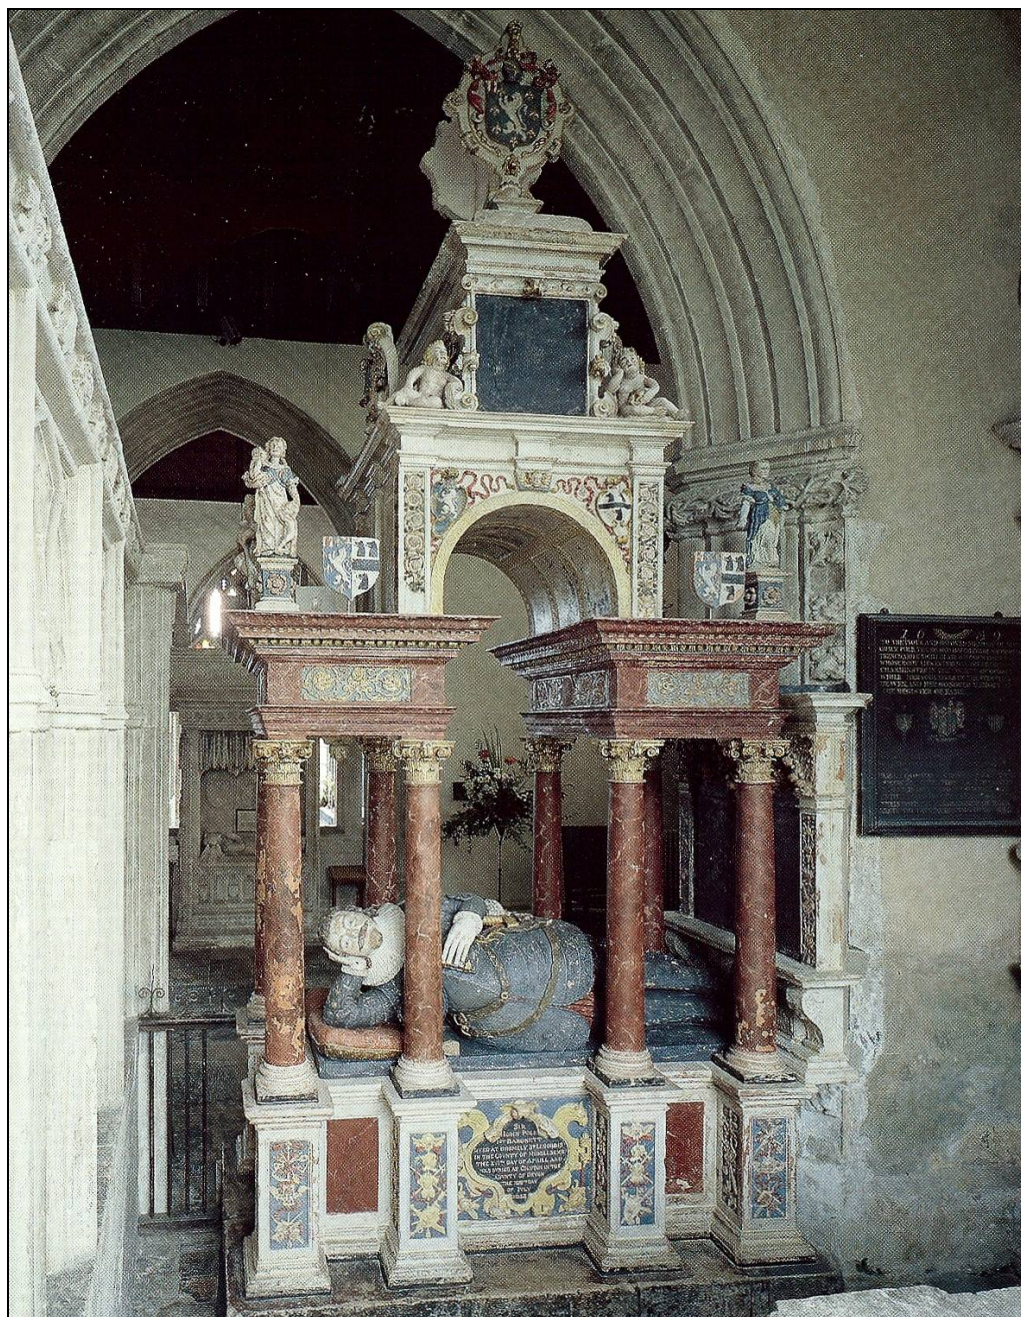
11.5.3 The Carewe-Pole Monument, Colyton, Devon

The monument to the Carewe-Pole family dates from 1630-40 and is of polychromed Beer stone, as is the Leach monument. Although there is also overpaint here, it is more subtle than that used on the Bouchier monument (see 11.5.1 above). Cleaning tests carried out by Anna Hulbert in 1976 revealed two layers of overpaint, with the more recent and inferior decoration only partially applied, thereby incorporating some of the earlier scheme. In this way the appearance of the overpainted Carewe-Pole monument today is not dissimilar to the appearance of the Leach monument with its combination of original paint and overpaint.
