ST HELEN'S CHURCH, HEMSWORTH
WEST YORKSHIRE
ARCHAEOLOGICAL WATCHING BRIEF

August 2017

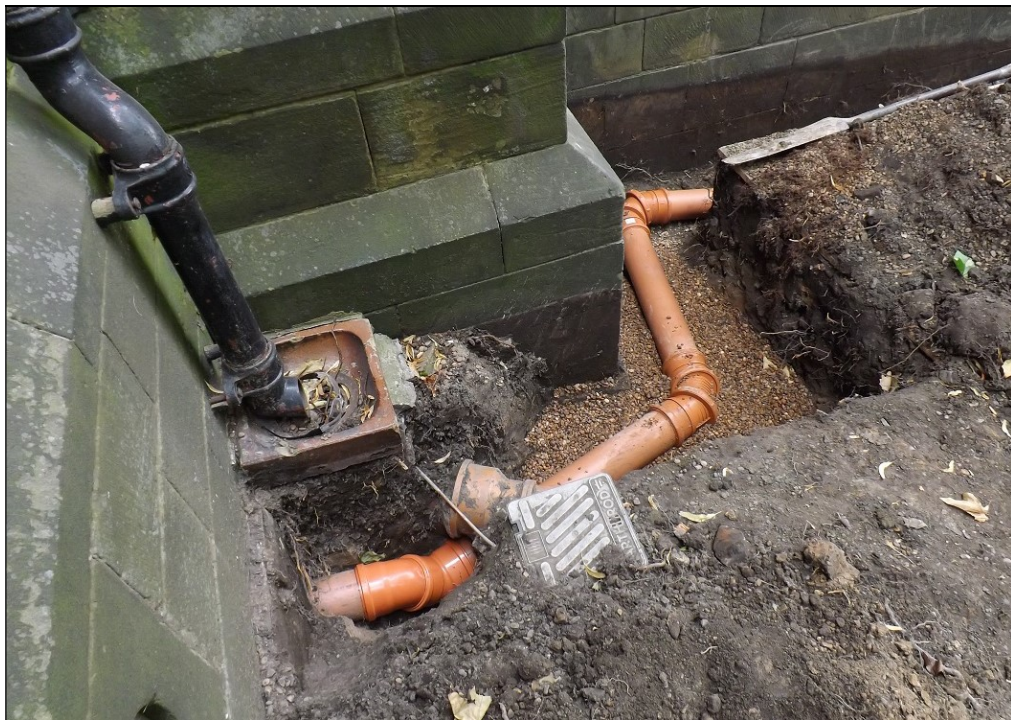
Plate 1. Area of excavation in vestry, looking north-east

- 5.1 Works were undertaken at St Helen's Church Hemsworth by Furness & Sons as part of a scheme of upgrading and refurbishment to the building for St Helen's PCC. The specific ground-works, which were subject to archaeological monitoring, involved the excavation of a pipe trench from the west wall of the north aisle, skirting the northern wall of the west tower through the footpath westwards to the boundary revetment wall of the churchyard. The pipe trench was hand excavated for a length of 6.7m, at a depth of between 0.58 and 0.70m and at an average width of 0.50m. The 4" diameter sewage pipe and its connections from the north aisle and ground floor of the tower ringing chamber were laid in a pea-gravel bed and backfilled in one day (Plate 1).

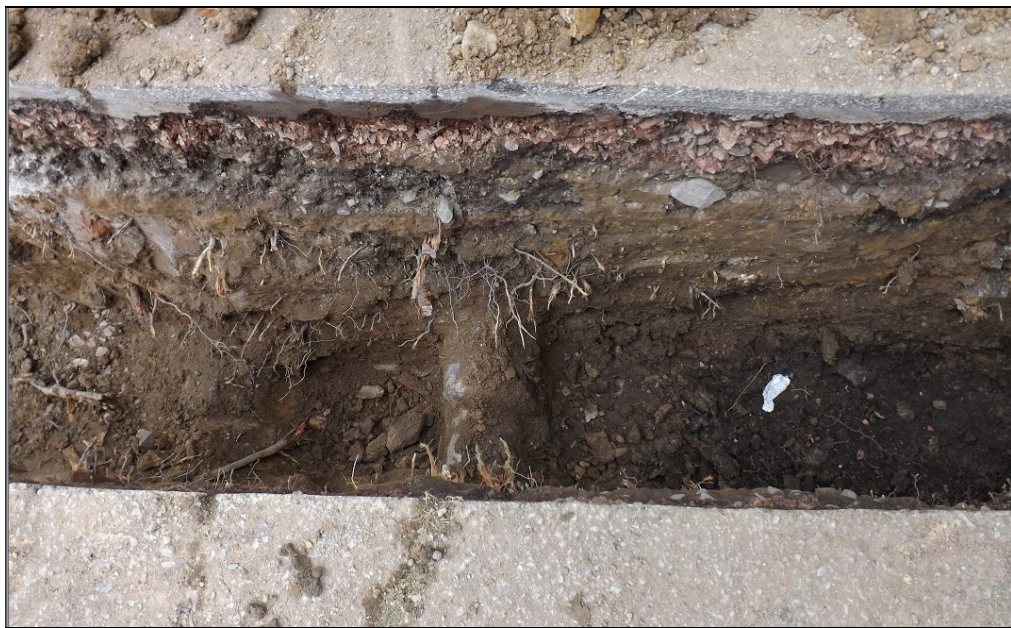
Plate 2. Typical deposits along the drainage run

- 5.3 The adjoining north-south tarmac path to the west was 0.03m thick, retained within concrete kerbs and bedded onto a foundation of crushed red shale 0.06m deep. Below the path a 0.72m thickness of compact, dull yellow, flecky, clay, soft siltstone and sandstone material was observed. This accumulation appeared to be derived from the local geological sequence and was probably part of the upcast from the 19th century west tower foundation

digging (Plates 2 & 3). Recovered from this layer were: one sherd of 19th century Burmantofts black glazed earthenware; two clay tobacco pipe stem fragments - one with a moulded 'THE WORKMAN' inscription; two butchered large mammal bones (cow bone with butcher's saw cuts) and eight small fragments of probable human bone (single fragments of skull and femur were identifiable). All bones were single fragments distributed throughout the layer, none were found in articulation.
