**An Archaeological Watching Brief  
During External Drainage Works at the  
Church of St Leonard, Church Lane,  
Thorpe Langton, Leicestershire**

NGR: SP 7402 9243

Report Number: R-0079

July 2018

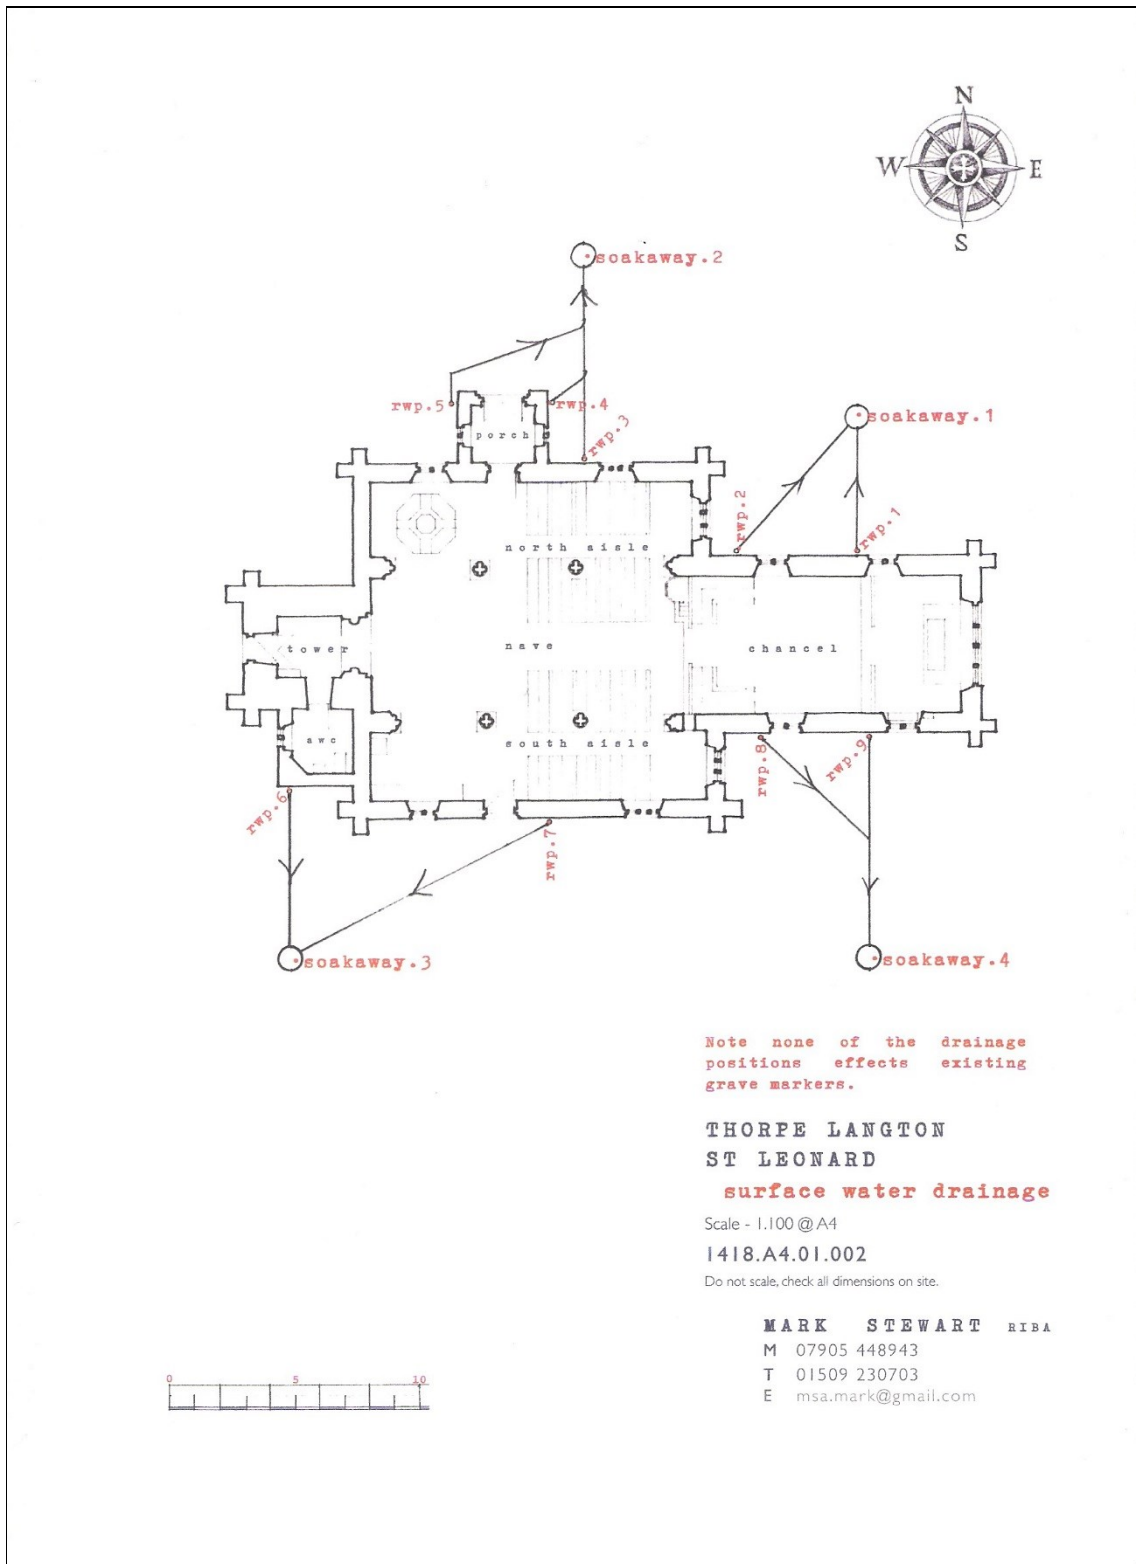
Figure 3. Proposed locations of soakaways and drains. Plan supplied by Mark Stewart.

6.2 The proposed layout plan shows four soakaways, two on the north side of the church and two on the south side (Figure 3).

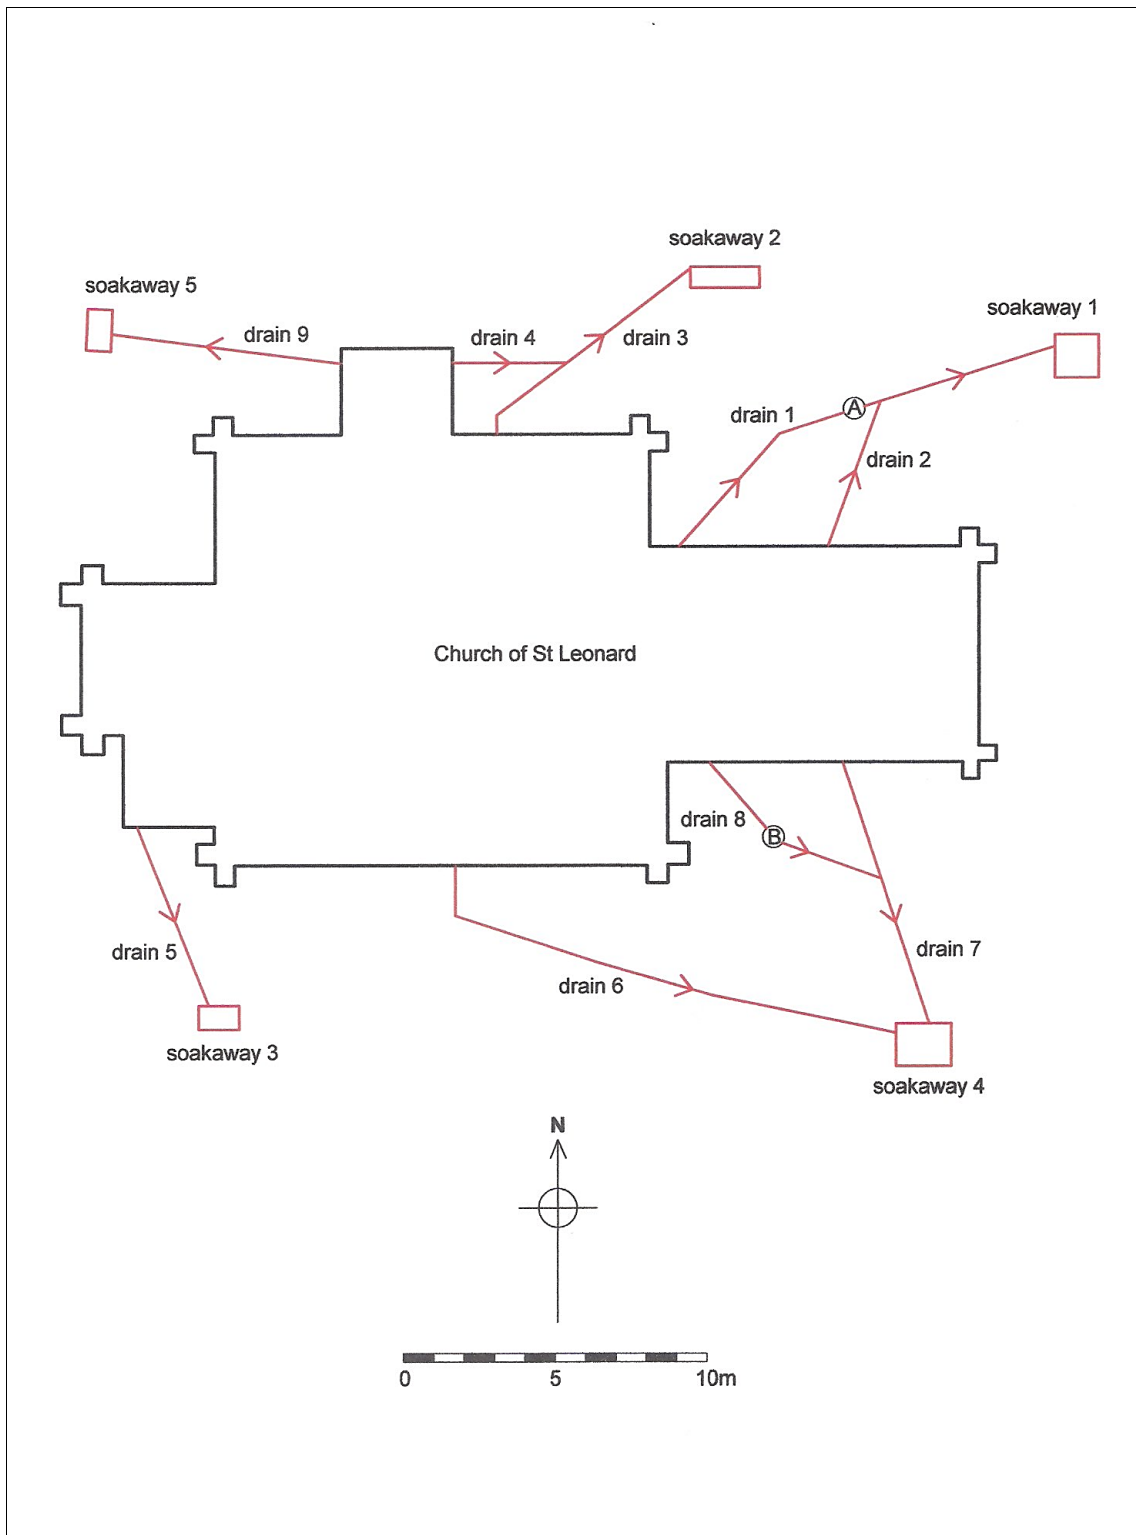
Figure 4. Actual locations of soakaways and drains, as excavated.

6.3 The layout was subsequently revised, with the provision of five soakaways and different drainage routes. The layout as executed is shown in Figure 4.

7.3 The soakaways and drain trenches were numbered in the order in which they were recorded, as described below and illustrated in Figure 4.

*Deposit Sequence:* Topsoil (1) to depth of 250mm, overlying subsoil (2). At point B on Figure 4 a concentration of large waterworn stones in a brown silty clay matrix (8) was encountered at a depth of c. 400mm below the surface (Photos 16-17). The lower horizon of this context was just above the base of the drain trench. Its SE extent was defined by a large, irregular lump of mortared limestone, which may have been part of a structural feature (perhaps a wall foundation), though this could not be confirmed within the constraints of the narrow trench. No finds were recovered and the date and character of (8) are uncertain. The geological natural ground was not exposed.

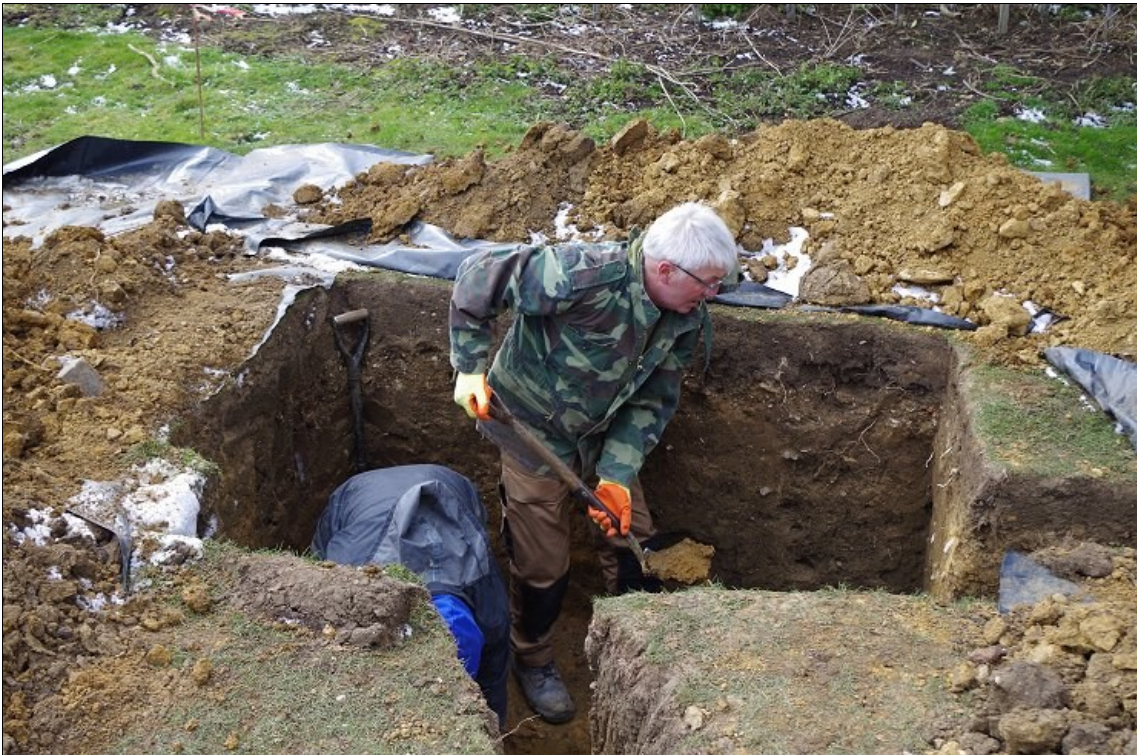
Photo 2. General View of Excavation in Progress (Soakaway 4), looking S.

7.2 The soakaway pits and drainage trenches were excavated by hand under archaeological supervision and were recorded prior to installation of the new drains and soakaways (Photo 2).

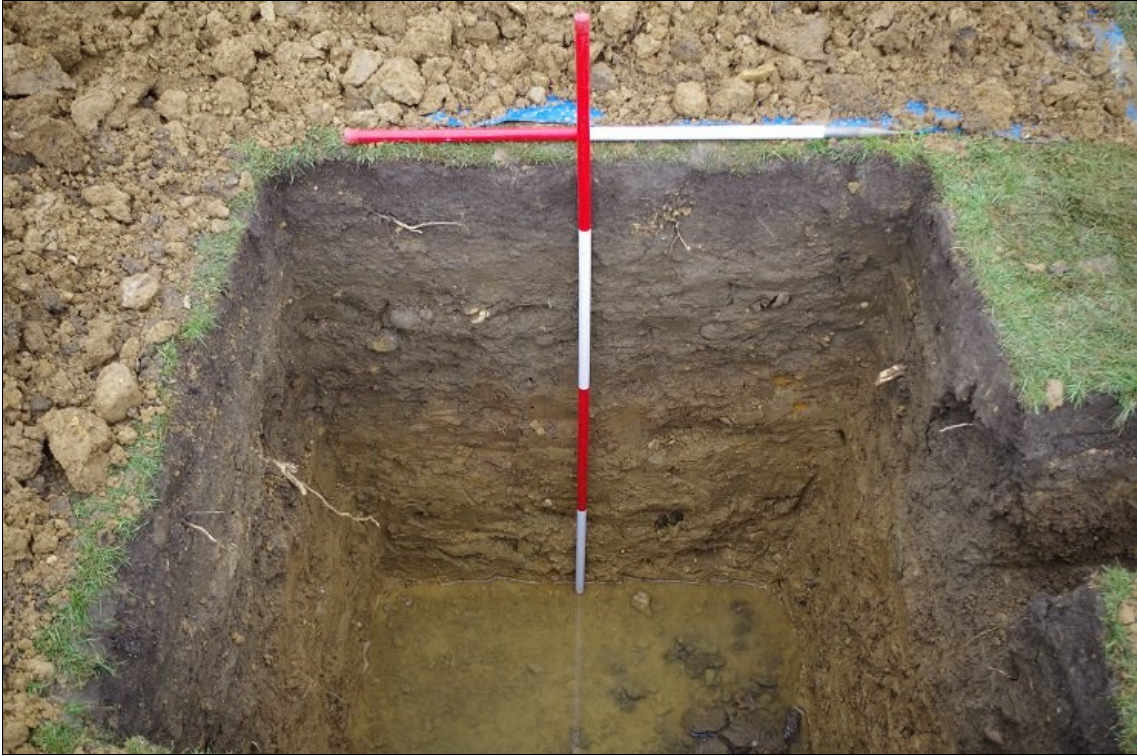
Photo 3. Soakaway 1, looking S (Drain 1 on right of frame).

*Shape and Size:* Square; c. 1400mm x 1400mm x 1800mm deep

*Deposit Sequence:* The topsoil (1) was 200mm deep, overlying subsoil (2) to a depth of 760mm below the surface. Beneath the subsoil was the geological natural ground, an orange brown coloured clay with inclusions of large and small pebbles, angular stone fragments and unmodified flint pieces. No archaeological remains were encountered.

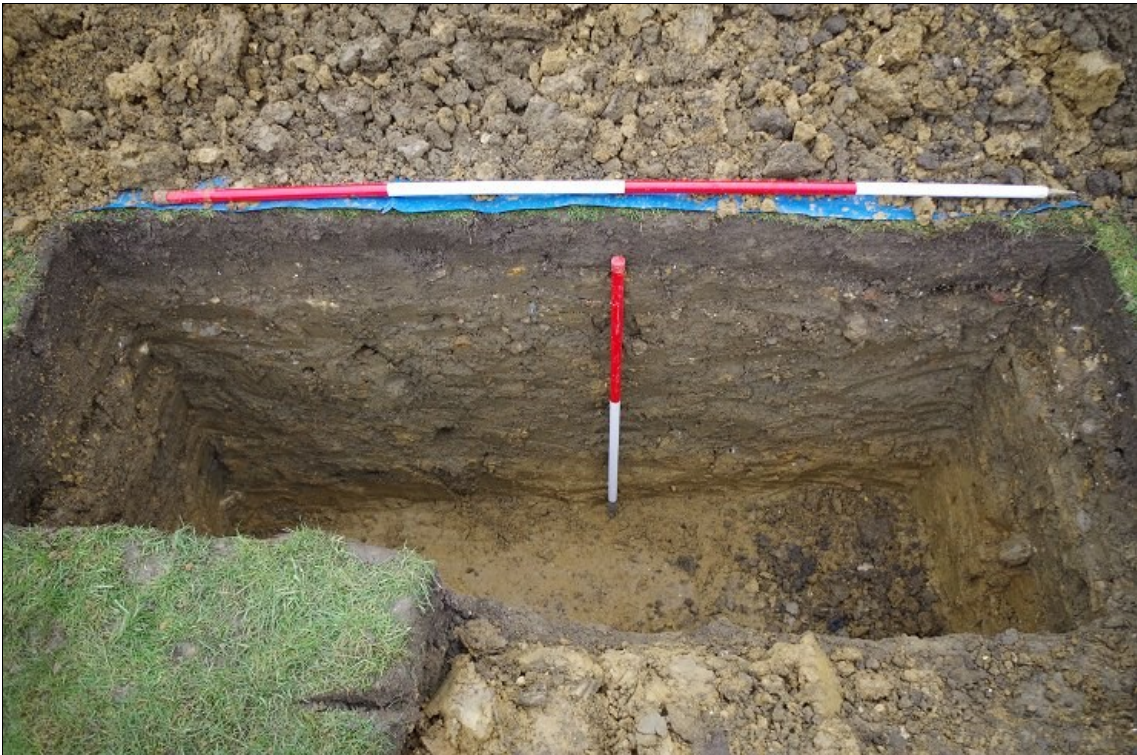
Photo 4. Soakaway 2, looking N.

*Shape and Size:* Rectangular; c. 2200mm E-W x 700mm N-S x 1300mm deep.

*Deposit Sequence:* Topsoil to depth of 230mm, overlying subsoil to depth of 950mm, overlying geological natural ground. Soil descriptions as above. No archaeological remains were encountered.

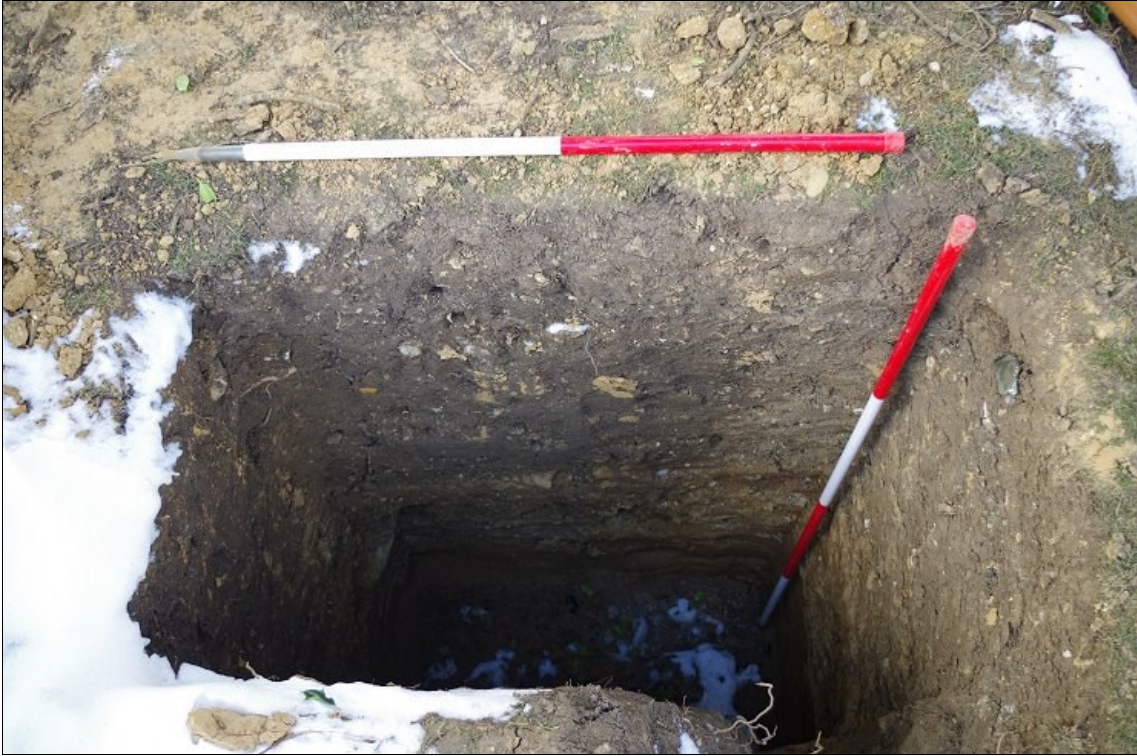
Photo 5. Soakaway 3, looking S.

*Shape and Size:* Rectangular; c. 1400mm E-W x 700mm N-S x 2000mm deep.

*Deposit Sequence:* Topsoil overlying subsoil to a combined depth of 1050mm below the surface, but with no clearly defined interface between the two. There was some root disturbance from an adjacent hedgerow to the south, which may account for the lack of clear differentiation between topsoil and subsoil. Below 1050mm was the

geological natural ground. No archaeological remains were encountered although a sherd of medieval pottery was recovered from the Soakaway 3 spoil heap (see Appendix).

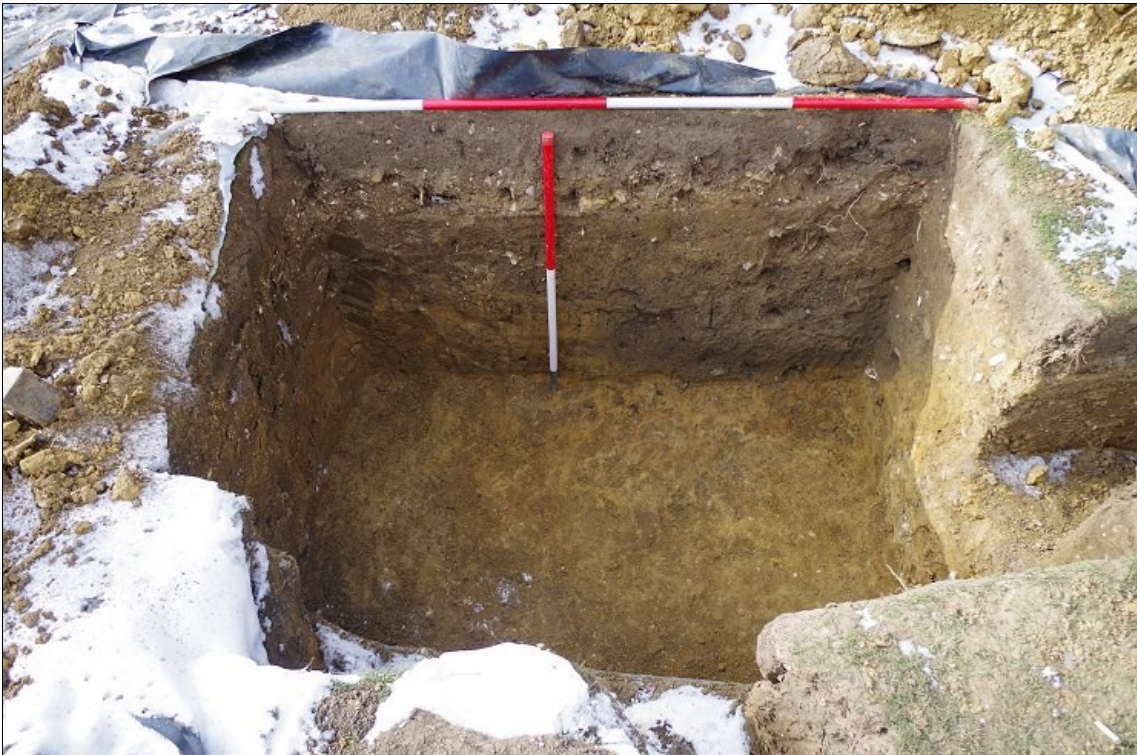
Photo 6. Soakaway 4, looking S (Drain 6 on right of frame).

*Shape and Size:* Rectangular; c. 1900mm E-W x 1300mm N-S x 2000mm deep.

*Deposit Sequence:* Topsoil (1) to depth of 220mm below the ground surface, beneath which was a layer (4), to a depth of 350mm, consisting of mixed orange brown silty clay with common inclusions of pebbles and ironstone fragments, plus some brick and slate. This appeared to be a relatively recent deposit, possibly associated with the installation of a plastic water pipe that ran along the northern edge of Soakaway 4, at a depth of 750mm. Below (4) was a mid brown coloured silty clay deposit (5), to a depth of 750mm below ground level at which point the geological natural was reached.

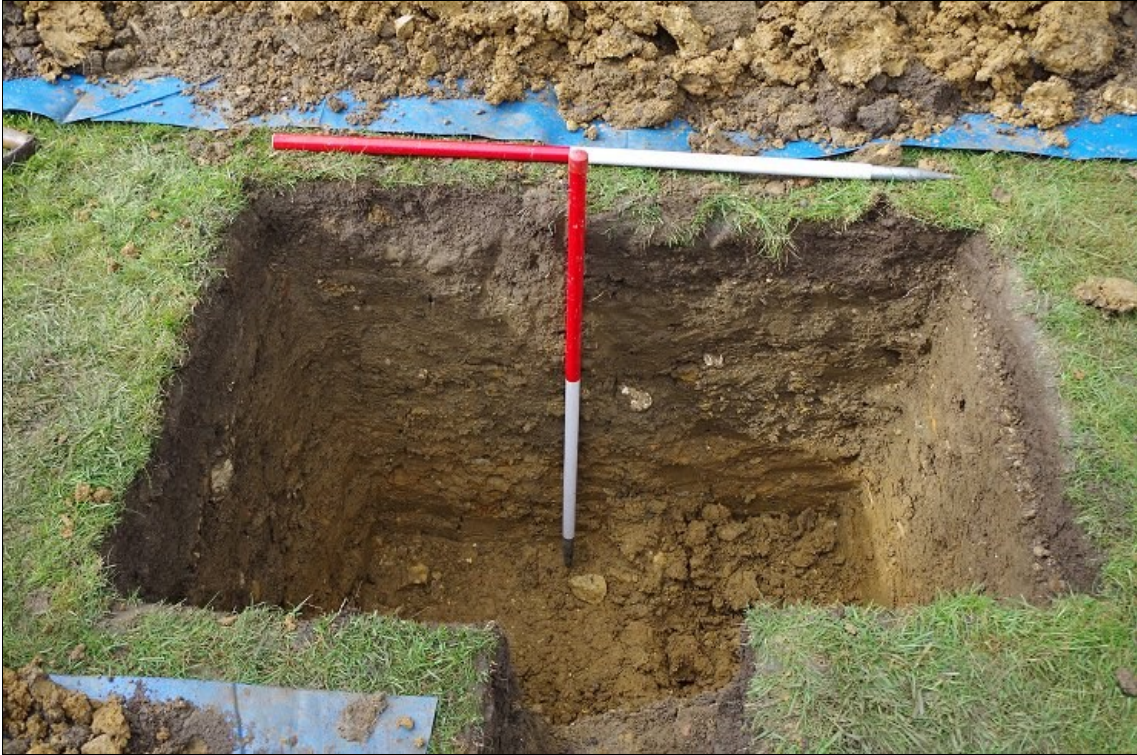
Photo 8. Soakaway 5, looking W (Drain 9 at lower edge of frame).

*Shape and Size:* Rectangular; c. 1250mm N-S x 700mm E-W x 1300mm deep.

*Deposit Sequence:* Topsoil (1) to depth of c. 200mm, overlying subsoil (2) to depth of c. 650mm below the surface, beneath which was the geological natural ground. No archaeological remains were encountered.

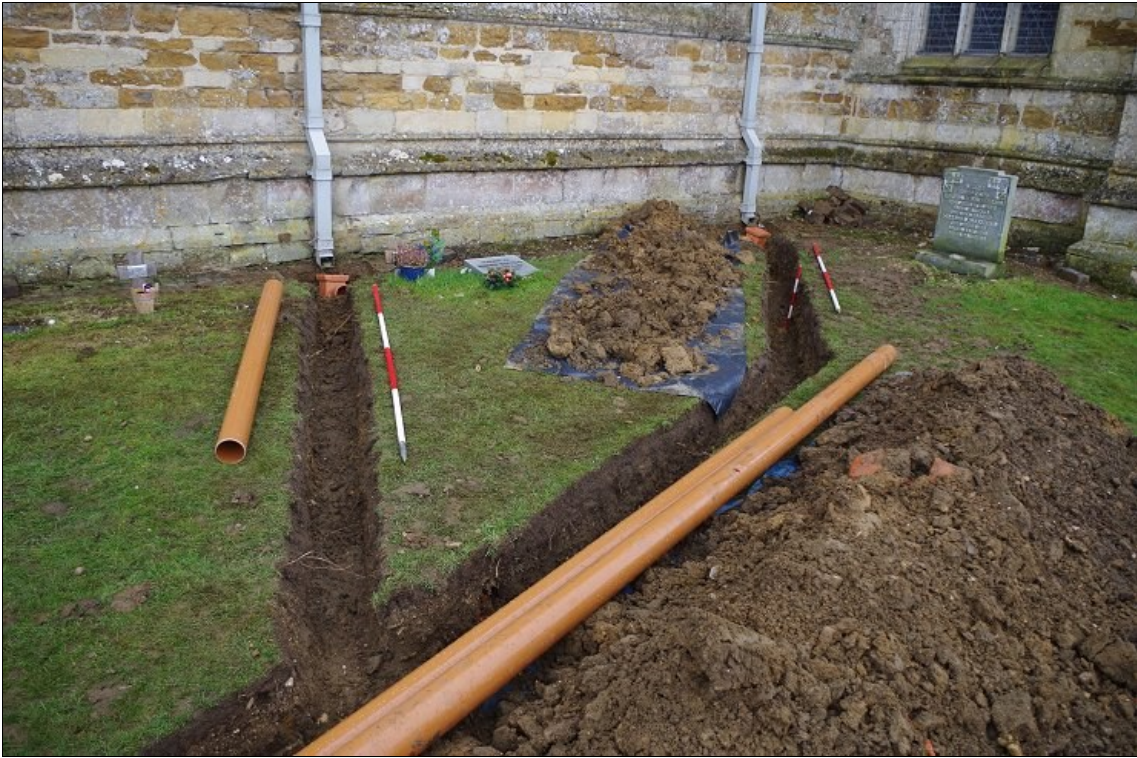
Photo 9. Part of Drain Trench 1 (on right) and Drain Trench 2 (on left), looking SW.

*Dimensions:* Length c. 14.5m; min. depth 350mm; max. depth 550mm; width 300mm.

*Deposit Sequence:* Topsoil (1) to a depth of 200mm, overlying subsoil (2). Subsoil exceeds depth of trench; geological natural ground not exposed. The drain trench crossed the line of an old horseshoe-shaped ceramic land drain (3), at point A on Figure 4. A single sherd of medieval pottery was recovered from the subsoil (2) in this trench; no other archaeological remains were encountered.

*Dimensions:* Length c. 5m; min depth 150mm; max depth 300mm; width 300mm.

*Deposit Sequence:* Topsoil (1) to a depth of 200mm, overlying subsoil (2). Subsoil exceeds depth of trench; geological natural ground not exposed. No archaeological remains encountered.

- 9.4 The only other feature recorded during the archaeological investigation was a ceramic horseshoe-shaped land drain in Drain Trench 1, probably dating from the 19<sup>th</sup> century.

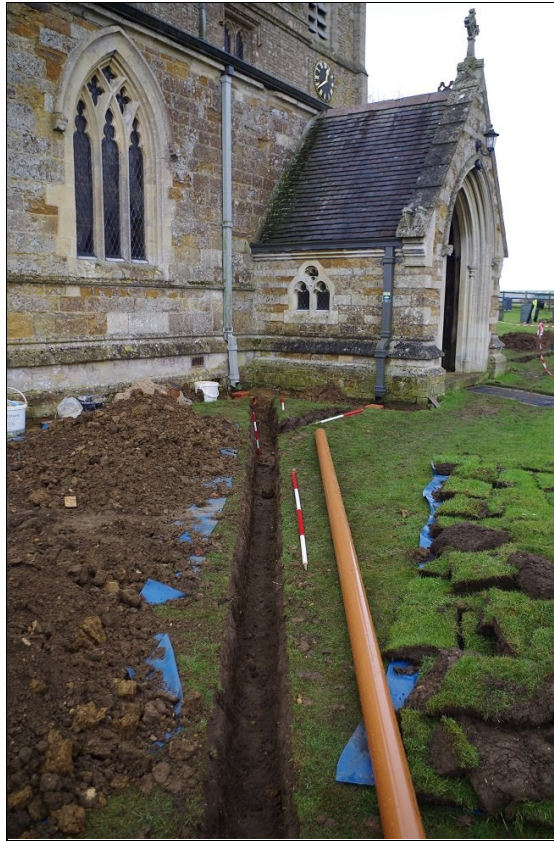
Photo 11. Drain Trench 3 (centre) and Drain Trench 4 (on right, by porch), looking SW.

*Dimensions:* Length c. 8.5m; max depth 400mm; width 300mm.

*Deposit Sequence:* Topsoil (1) to a depth of 200mm, overlying subsoil (2). Subsoil exceeds depth of drain trench; geological natural ground not exposed. No archaeological remains encountered.

*Dimensions:* Length c. 3.5m; max depth 350mm; width 300mm.

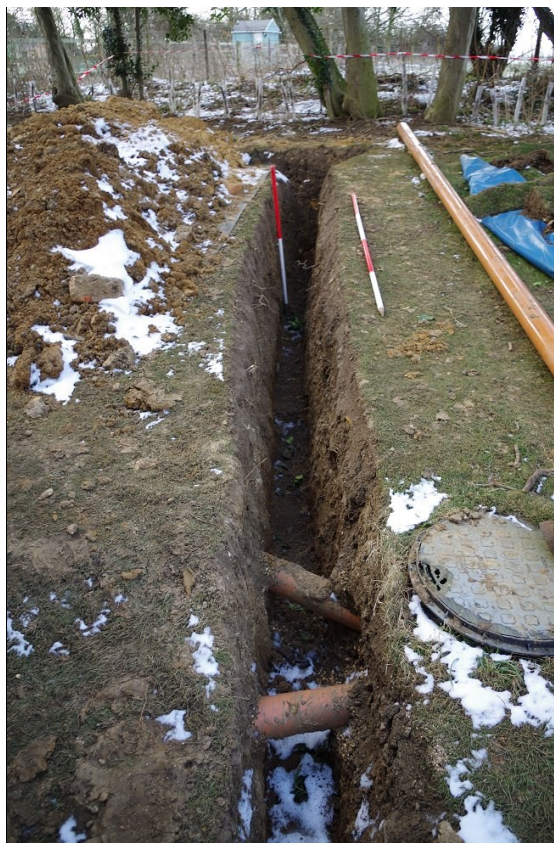
Photo 12. Drain Trench 5, looking SSE towards Soakaway 3.

*Deposit Sequence:* The topsoil (1) was 250mm deep and overlay a mixed orange brown silty clay layer (9) with inclusions of pebbles, charcoal and brick fragments, to a depth of 600mm. Below (9) was a 'clean' orange brown silty clay, corresponding with the subsoil (2). Two modern drainage pipes crossed the trench towards its north end and there was an inspection chamber cover located to the west in a linear depression in the ground surface, marking the position of a trench arch drain serving the W.C. in the vestry.

The brick fragments in context (9) were all similar in size and with the same evenly fired orange-coloured fabric. One complete brick was recorded (but not retained), its dimensions being: 238 x 114 x 76mm (9 $\frac{3}{8}$  x 4 $\frac{1}{2}$  x 3 inches); this and the other brick fragments were probably 19<sup>th</sup> century in date. No earlier remains were encountered.

- 9.6 Brick fragments in Drain Trench 5 may have related to the construction of the vestry, in the angle of the west tower and south aisle, in the 19<sup>th</sup> century. The ground in this vicinity had been disturbed more recently by the installation of drainage serving a W.C. installed within the vestry.

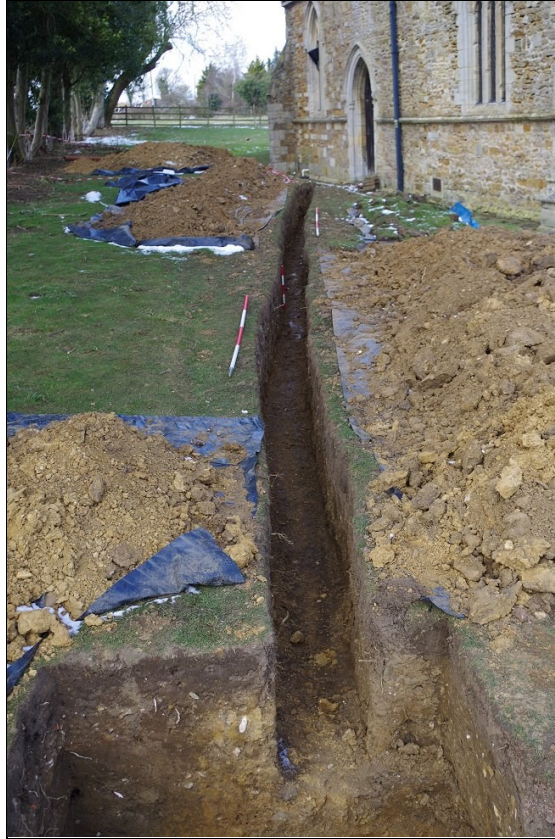
Photo 13. Drain Trench 6 with Soakaway 4 in foreground, looking WNW.

*Dimensions:* Length c. 16.5m; max. depth 650mm; width 350mm.

*Deposit Sequence:* Similar to that recorded in Soakaway 4, consisting of topsoil (1) 250mm deep, overlying a mixed stony deposit (4) to a depth of 380mm, below which was an orange brown silty clay layer (5) that exceeded the maximum depth of the trench; the geological natural ground was not reached. No archaeological remains were encountered.

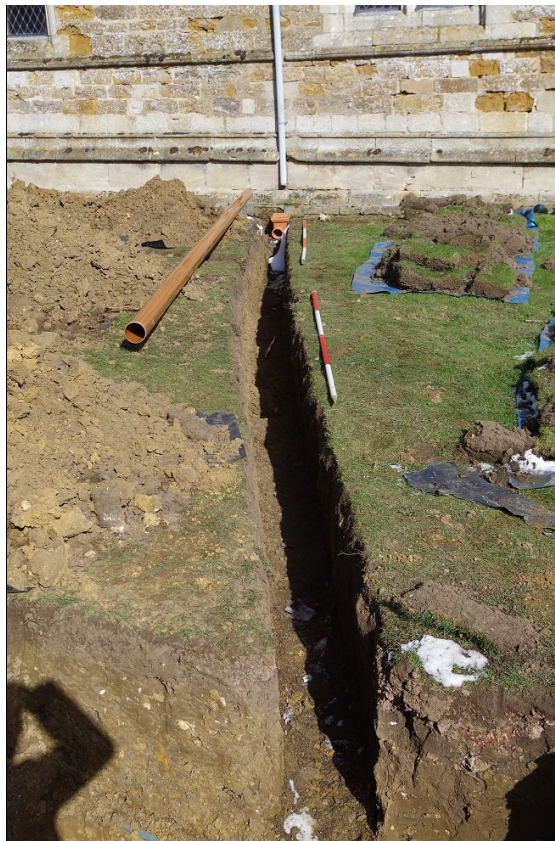
Photo 14. Drain Trench 7, looking NNW.

*Dimensions:* Length c. 9m; max. depth 600mm; width 300mm.

*Deposit Sequence:* Topsoil (1) to depth of 220mm, overlying subsoil (2). Geological natural ground not reached. A clay tobacco pipe stem fragment, of post-medieval or modern date, was found in the topsoil in this trench. No other archaeological remains encountered.

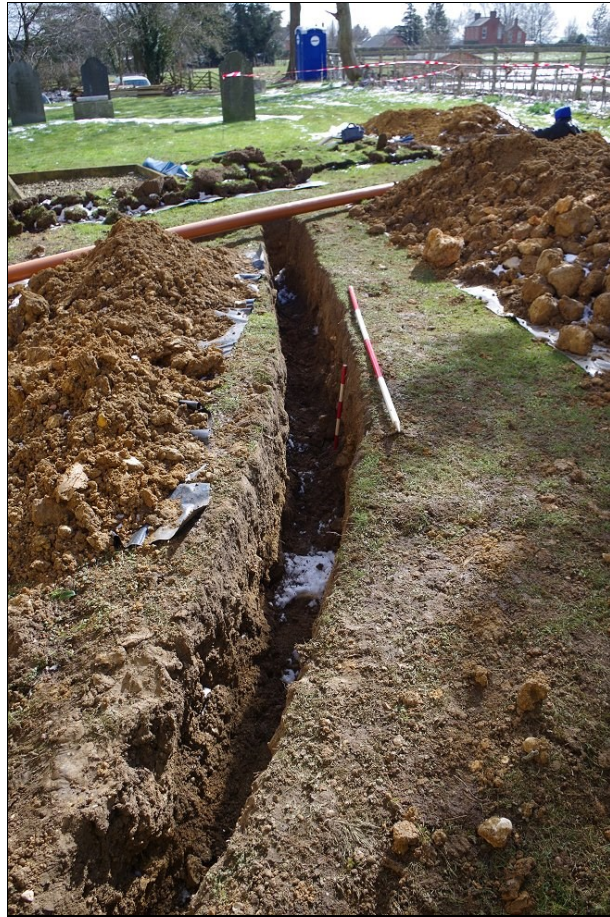
Photo 15. Drain Trench 8, looking SE.

*Dimensions:* Length c. 7m; max depth 700mm; width 350mm.

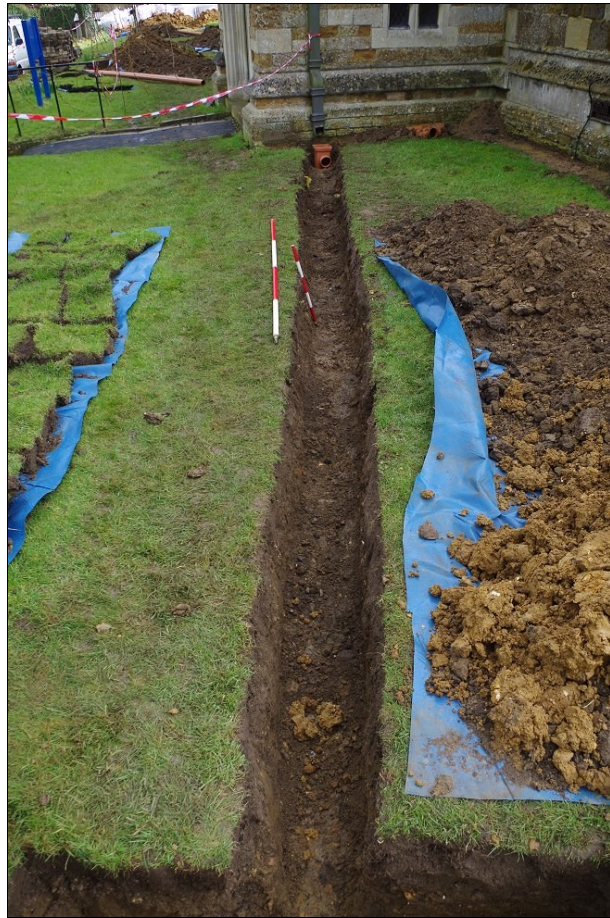
Photo 18. Drain Trench 9 with Soakaway 4 in foreground, looking E.

*Dimensions:* Length c. 7.5m; max depth 500mm; width 300mm.

*Deposit Sequence:* Topsoil (1) to depth of 200mm, overlying subsoil (2) which exceeded the depth of the drain trench. No archaeological remains were encountered.
