**Christ Church  
Harrogate  
North Yorkshire**

**Archaeological Watching Brief**

Report no. 3083  
May 2018

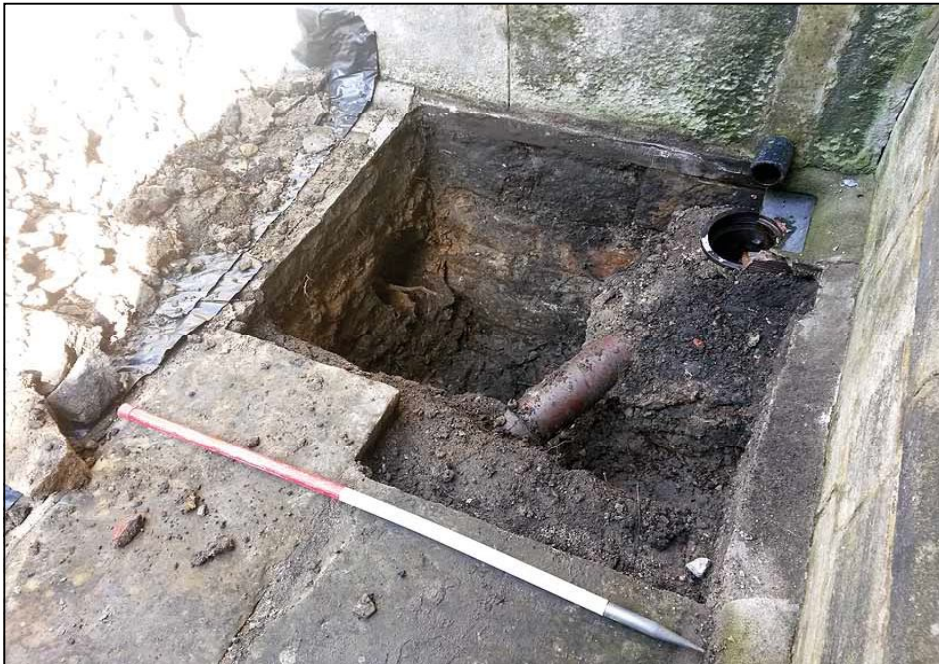
*Plate 2. Test Pit 1, partially excavated, looking north*

pit measured 1m by 1m and up to 1m in depth with its northern edge abutting the exterior church wall and its eastern edge against the south transept. This test pit was placed to investigate structural instability, particularly within the south transept. It encountered a series of structural backfills, drainage and wall footings (Plate 2). Occasional finds including brick fragments and a clay pipe stem were noted but not retained.

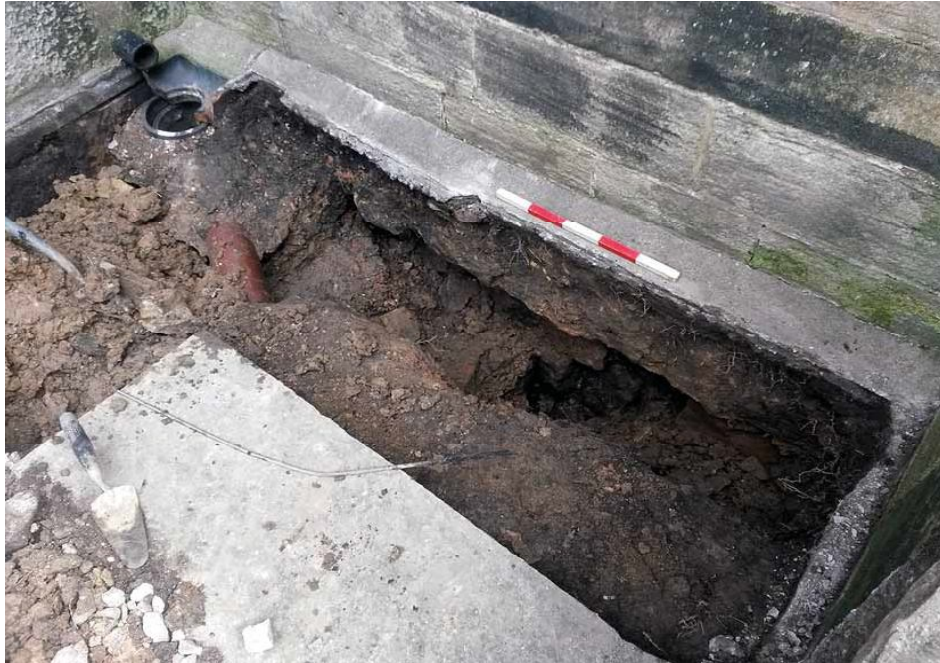
Test Pit 3 was a southwards extension to Test Pit 1, excavated against the western side of the southern transept extension. The test pit measured 1.3m x 0.4m with a depth of up to 1m (Plate 5). As with Test Pit 1, the uppermost deposit (300) consisted of mortar bedded flagstone path. The pit was then excavated through the backfill of the transept's foundation

trench (301) which was the same as a backfill deposit 104. A deposit of stone flags (302) were encountered in a backfill layer and appear to be a tip of unbonded stone used as a base for the foundations. When the foundations (303) were cleaned, the sandstone blocks were roughly shaped and badly placed, bonded with lime mortar in places but voids were seen where the mortar has been washed away.

*Plate 5. Test Pit 3, showing poor condition of foundations, looking north-east*

An archaeological watching brief was undertaken during the excavation of three test pits to assess the condition of the foundations of the south-east corner of Christ Church, Harrogate. The test pits were excavated to an average depth of 1m below the present ground surface. Possible natural deposits were encountered at the base of the test pits.
