**ST MARY'S CHURCH  
BECKLEY, OXON**

**Wall Painting Conservation Record**

**Mark Perry  
June 2019**

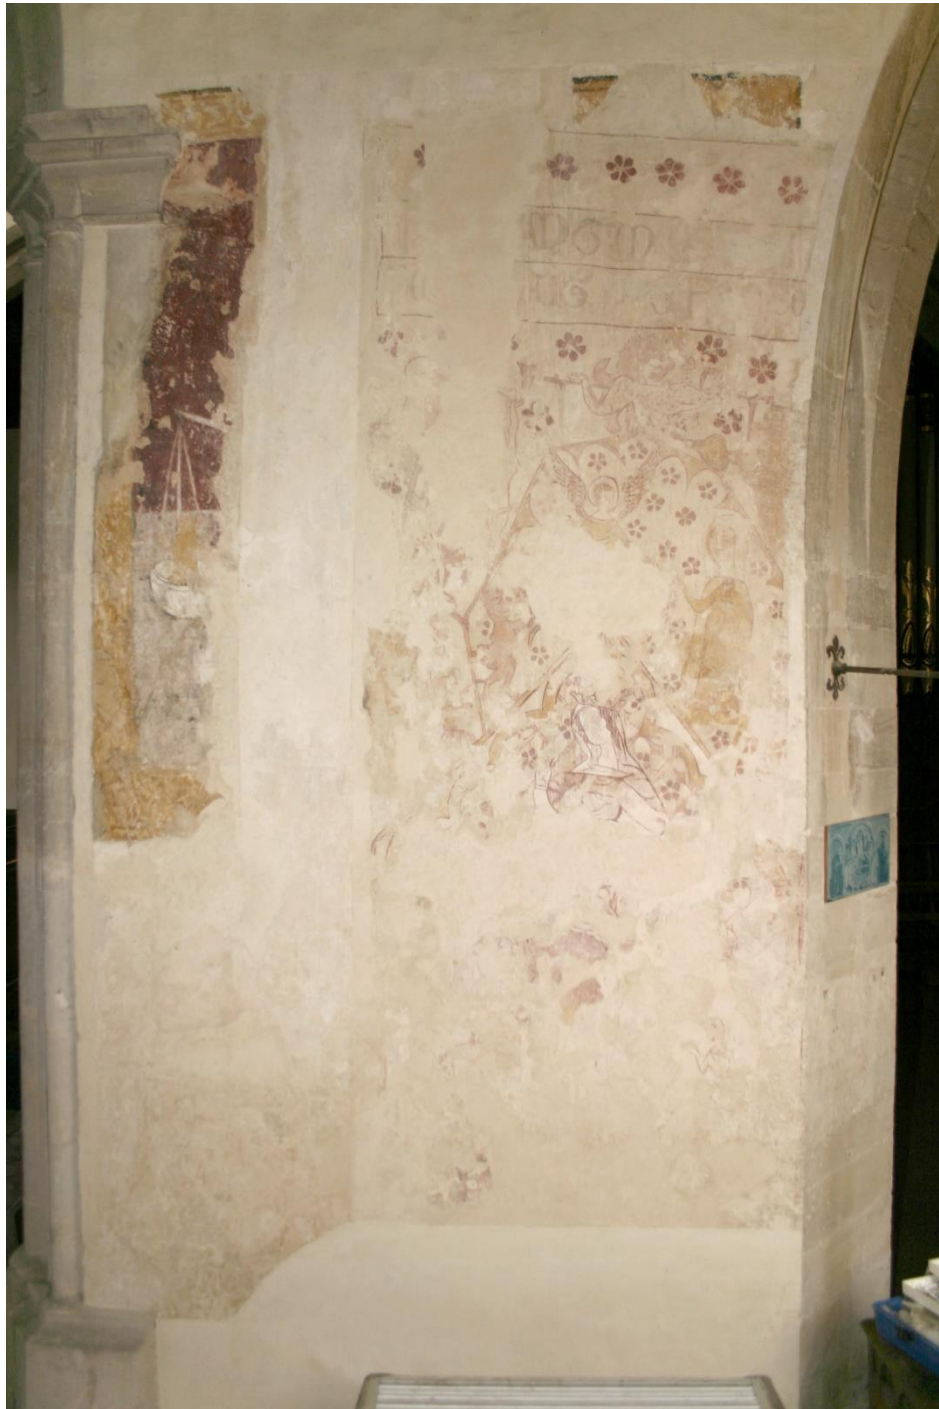
The south-west tower pier contains wall painting from two different periods. The earliest and most important painting in the building is the scene containing the Virgin and Child enthroned beneath a gabled canopy in the lower area, with a Weighing of Souls and Torments of the Damned immediately above. Remains of an unidentified text

scroll are evident at the top of the painting. The background is powdered with red rosettes. The remaining painting covers an area c. 3m H x 1.2m W and probably dates to the late C13<sup>th</sup> /early C14<sup>th</sup>. A white vertical 'shadow' to the left of the scene indicates the original position of a screen that created a Lady Chapel in this part of the aisle.

Fig 2. The South aisle, tower pier – overall view (after conservation)

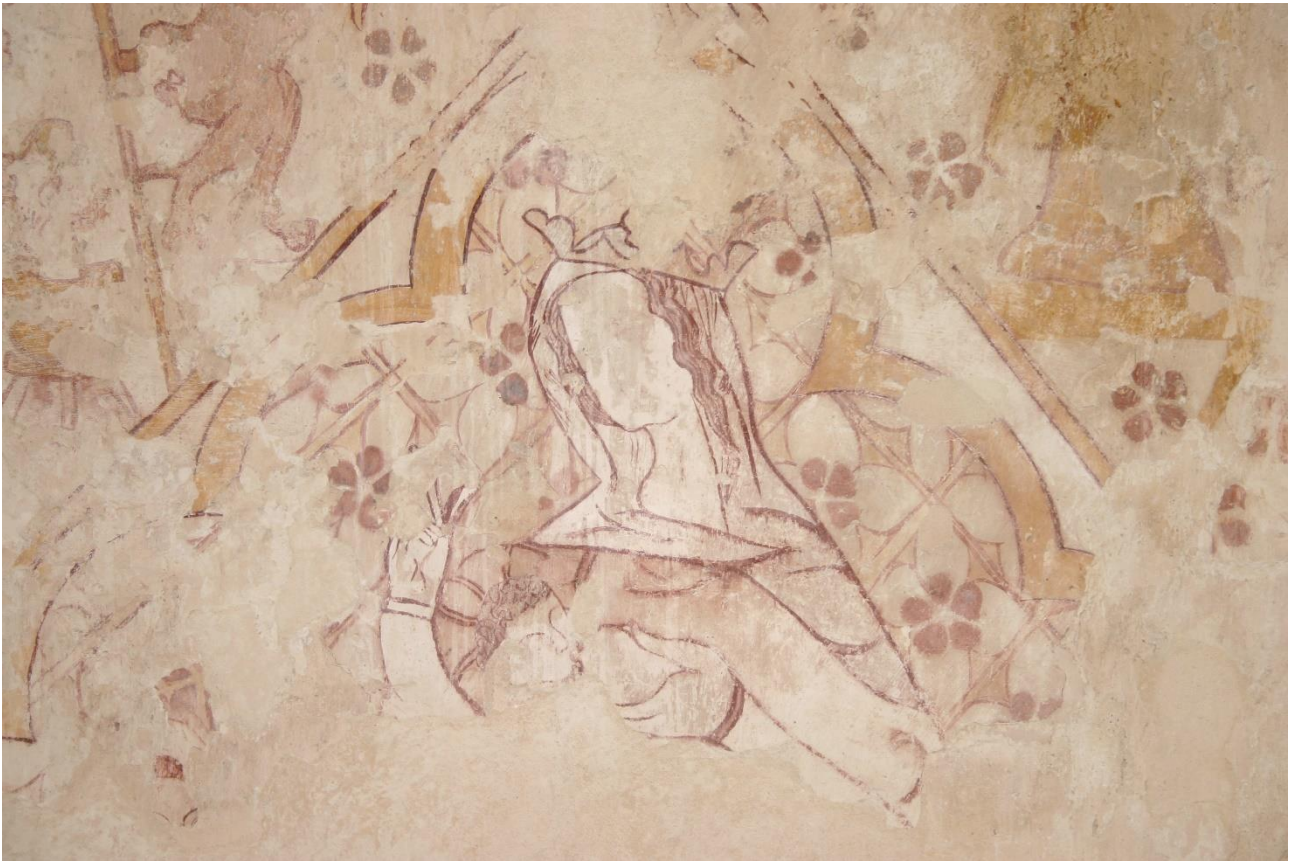
Fig 3. The South aisle, tower pier –detail of the Virgin and Child (after conservation)

The rendition of the Virgin's veiled head is particularly beautiful and is of very high quality. There are several intriguing and very unusual smaller scenes within the overall panel, making this wall painting of great significance within the canon of medieval church decoration.

A small loss of the painted limewash layers measuring 35mm x 25mm had occurred to the chest of the Virgin. The edges of the loss were lifting and fragile. This is in a very accessible area and was therefore extremely vulnerable to further loss. There is nothing to indicate any underlying deterioration factors and the nature of the damage suggests it was due to accidental abrasion/impact. All other areas of this and the adjacent later painting of the Weighing of Souls (C15<sup>th</sup>) to the west are stable.

- Removal of surface accretions using soft brushes to direct the dirt into a vacuum nozzle.
- Further localised and light cleaning using Wishab sponges (granular rubber cakes).
- Reattachment of the damaged area was carried out using a thin lime slurry, injected under the lifting edges.
- The loss was filled with a fine lime mortar and reintegrated with a suitably toned limewash and watercolour washes.

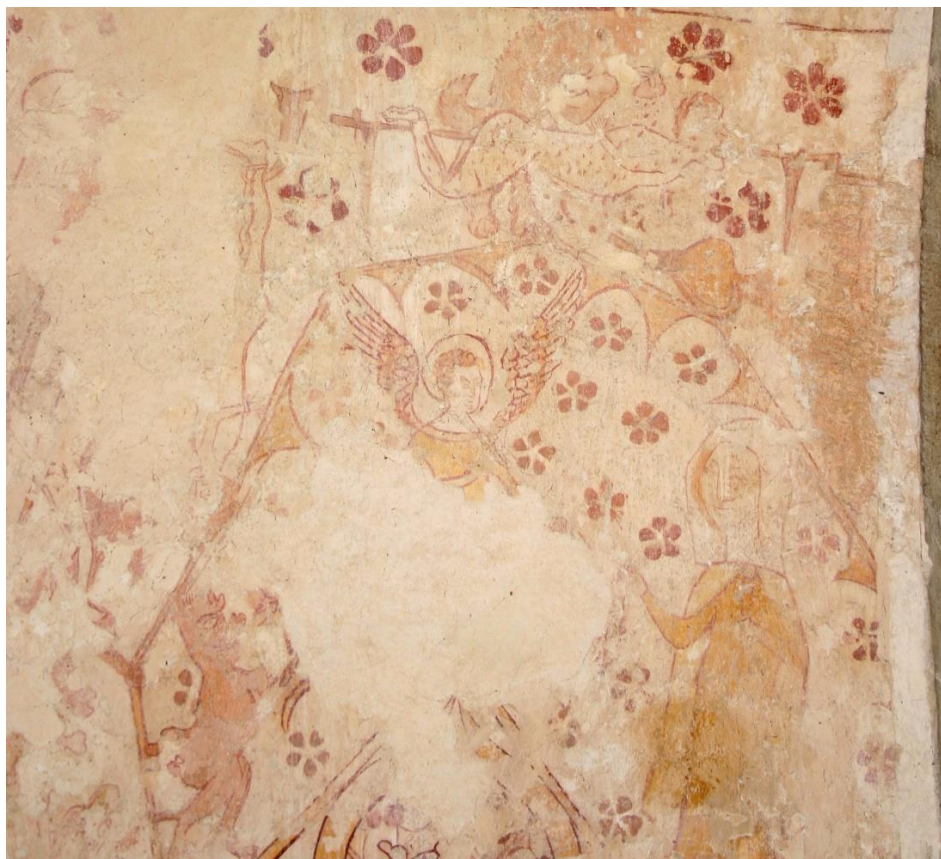
Fig 4. Details of the C14th Weighing of Souls and Torments of the Damned (before surface cleaning)

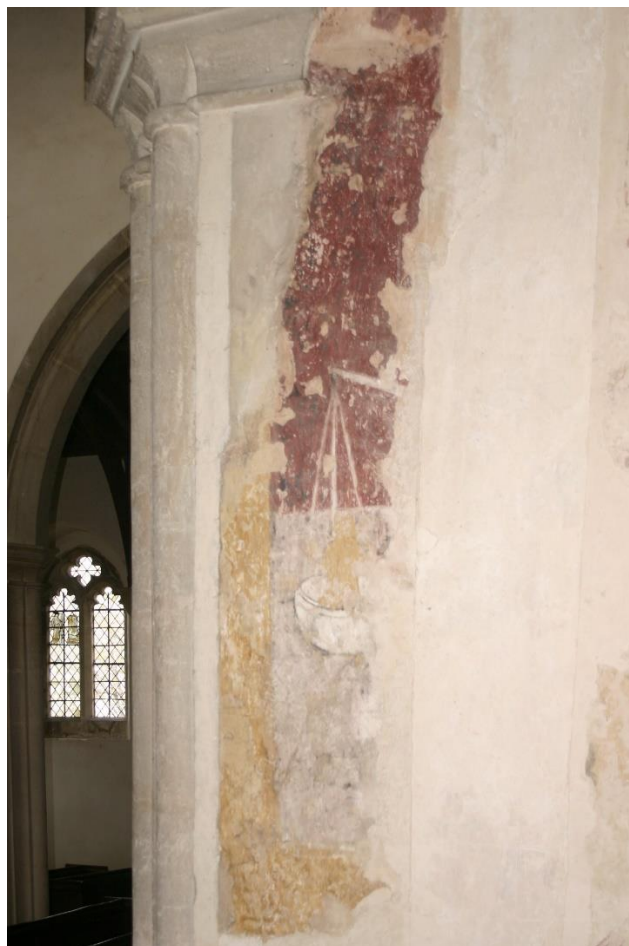
To the west of the Virgin scene is the remains of a later (C15<sup>th</sup> ?) illustration of the Weighing of Souls. This would have been superimposed on the earlier wall painting, completely covering it over. It was partly removed in the major restoration works of 1845 to expose the Virgin and Child painting.

Fig 5 Remains of the overlying C15th Weighing of Souls (right, after surface cleaning). The vertical white 'shadow' marking the location of the Lady Chapel screen is visible to the right of the painting

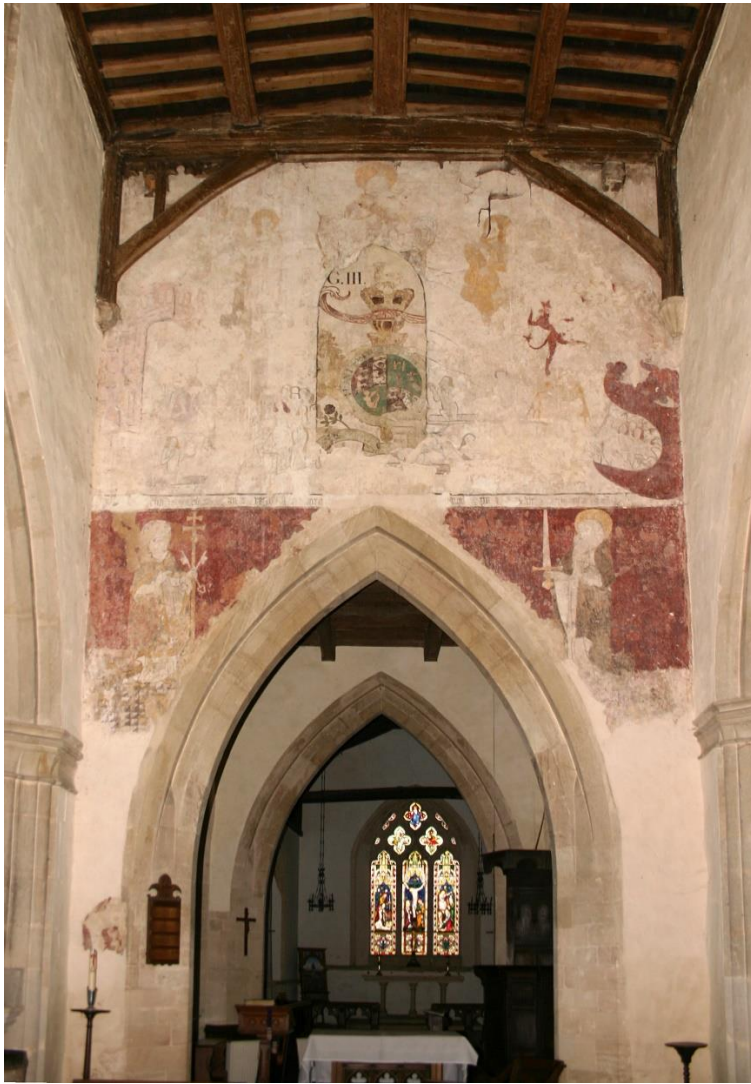
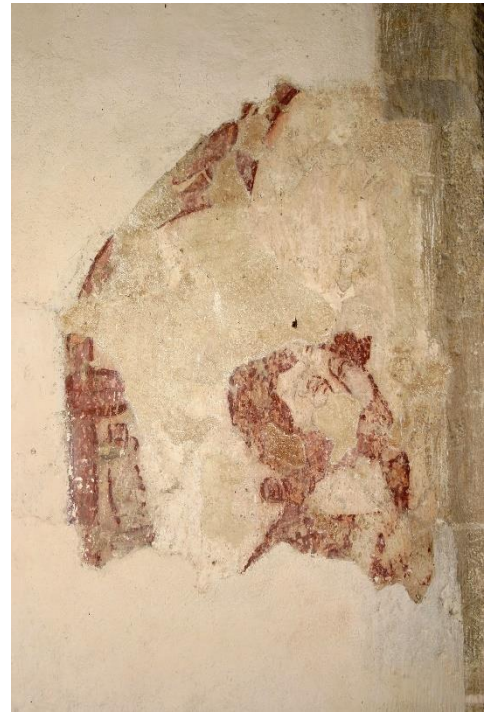
Fig 6. The nave, east wall – the Last Judgement (left) and detail of small figure on the lower north side (above). Both before treatment.

There is the fragmentary remains of a small figure beneath a gabled canopy on the lower north side of the arch. Tristram does not mention this painting and it is presently unclear whether it is connected to the Last Judgement painting above, or a separate and possibly earlier painting. A section of an originally much larger C18<sup>th</sup> royal arms is painted on a blocked-in door/window in the tower wall above the arch.

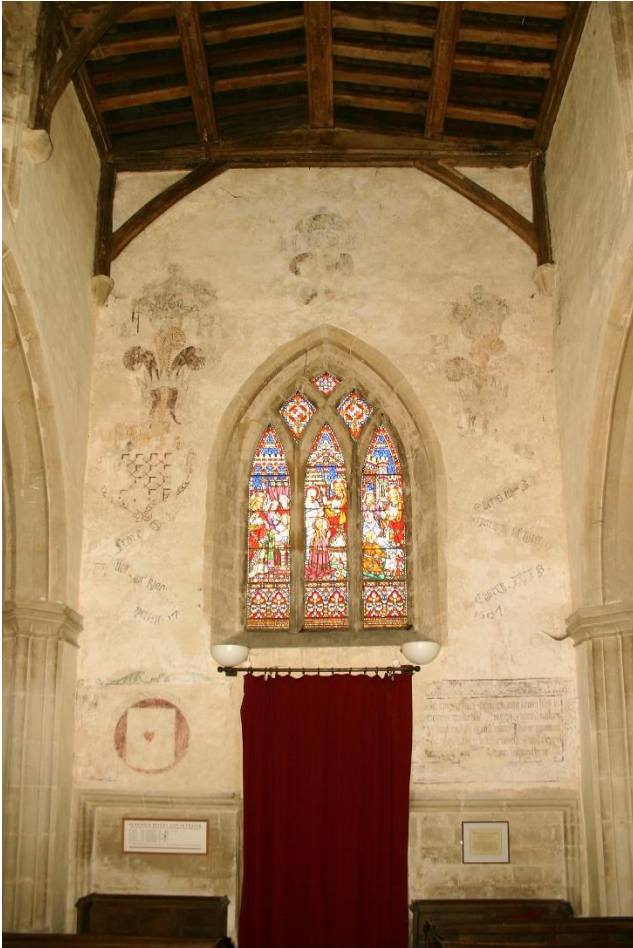
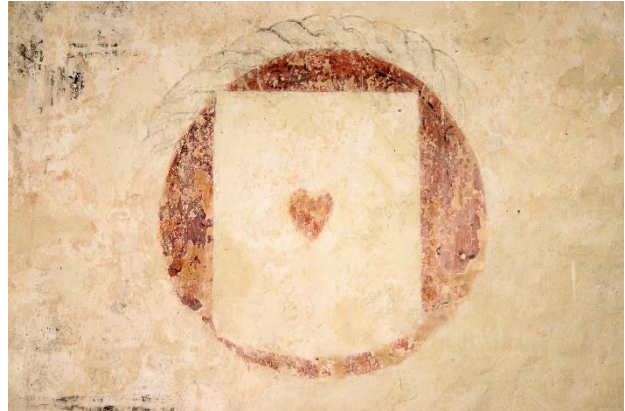
The west wall is painted with an extensive series of royal emblems and badges of several different periods. The earliest painting is the sacred heart emblem on the lower south side. It pre-dates the royal heraldic scheme of 1607 above and is likely to be post-Reformation.

The most extensive scheme is that of the three sets of Prince of Wales feathers, with associated scrolls and texts, arranged on both sides and above the west window. These are dated to 1607 and refer to Henry, eldest son of James 1. On the same layer of limewash, but on the lower north side of the door, is a panel painted with a text from Jeremiah Chapter 18 verse 11. A similar text on the south side was destroyed previously to reveal the sacred heart emblem. The feathers and scrolls have been repainted at least once, one area of which was replaced by a portcullis – also a royal badge – introduced by Henry VII.

Fig 7. The nave, west wall, overall (left); detail of the Sacred Heart Emblem (above) & the Jeremiah text panel (below). All images before treatment.

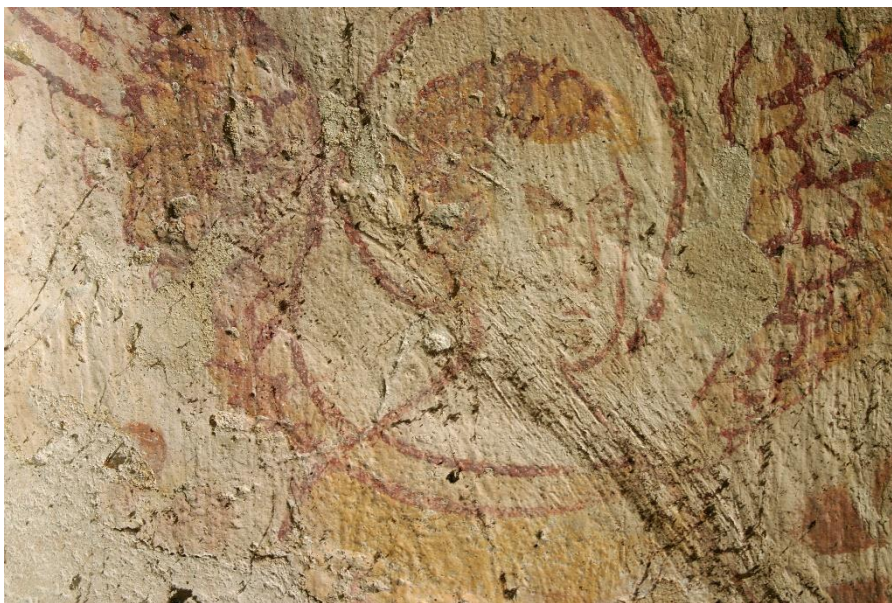
There was extensive surface dirt (dust, cobwebs and bat droppings) that compromised the visual impact of this very important painting. If these deposits were left in situ they can become ingrained over time and more difficult to remove.

Fig 9. Detail of thick surface dirt on St Michael

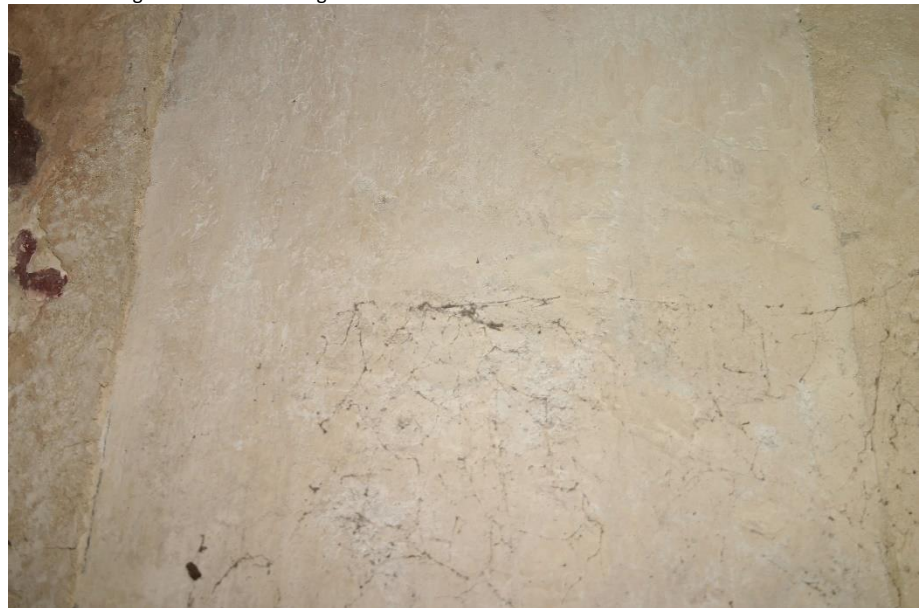
Fig 11. Detail during removal of extensive surface dirt and cobwebs

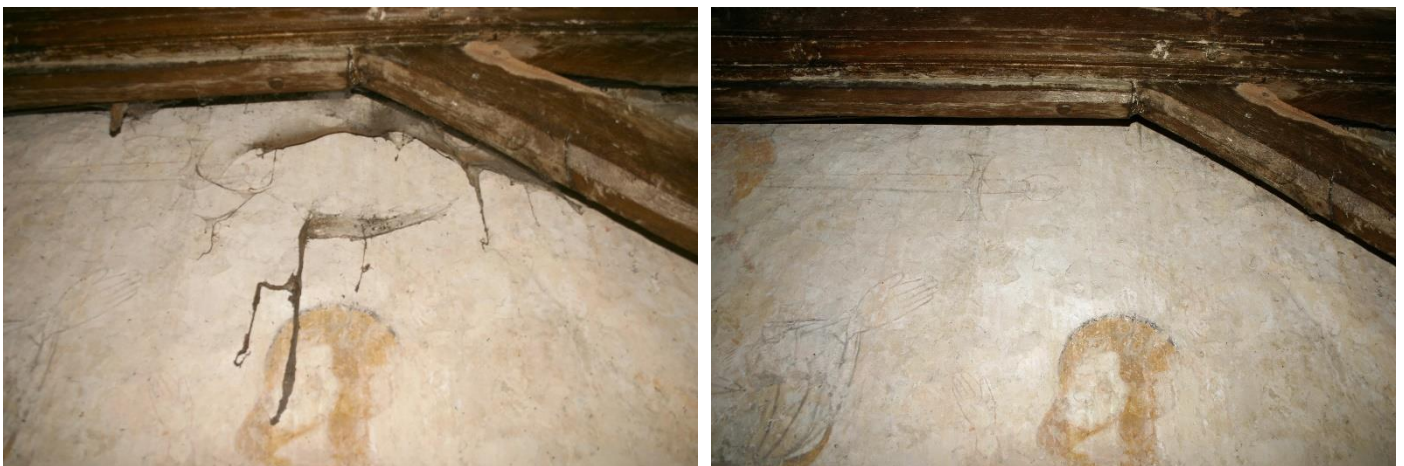
In general, the wall paintings on the east wall are in reasonable condition and required only minimal remedial work. There was extensive dirt overall, with 'ropes' of thick, dirty cobwebs clearly visible at the top, and this was causing a significant diminution in the overall appearance of the painted decoration.

Fig 13. Upper east wall, before and after treatment

- Removal of surface accretions using soft brushes to direct the dirt into a vacuum nozzle.
- Further localised and light cleaning using Wishab sponges (granular rubber cakes).
- Reattachment of the damaged areas was carried out using a thin lime slurry, injected under the lifting edges.
- The paint losses were reintegrated to reduce visual impact using watercolour washes. This will also act as a means of monitoring for future paint losses.

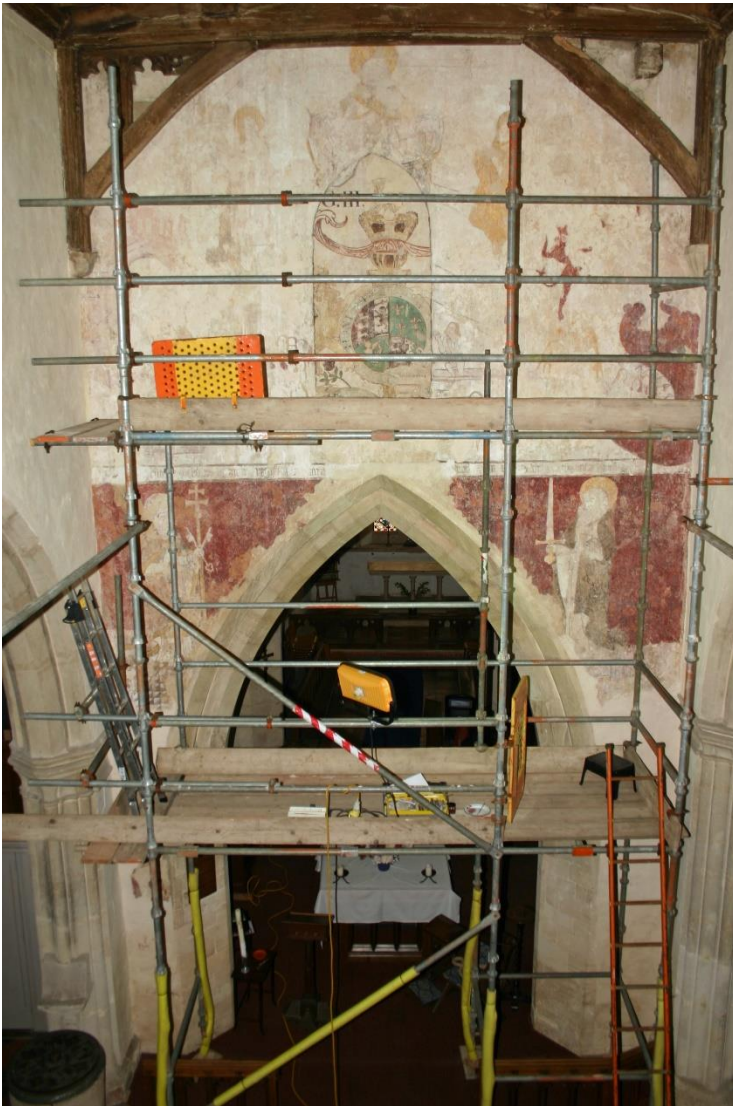
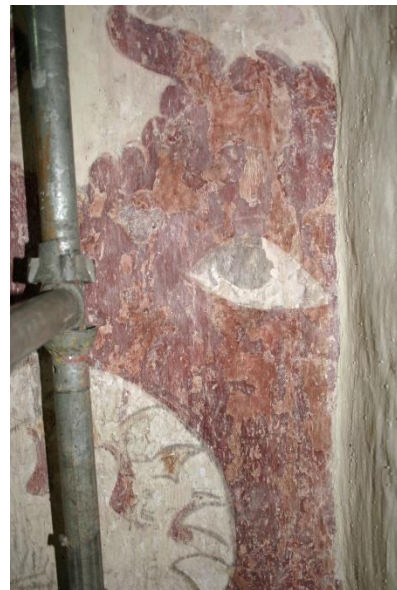
There were several post 1993 losses of paint and ground apparent on the south side of the scheme. These were visible as white losses in the Mouth of Hell and the background to St Paul. Additional and numerous smaller losses were identified from the improved access available during work.

Fig 14. East wall, above, after conservation. Details of damage to the Mouth of Hell before (top right) and after (below right) conservation

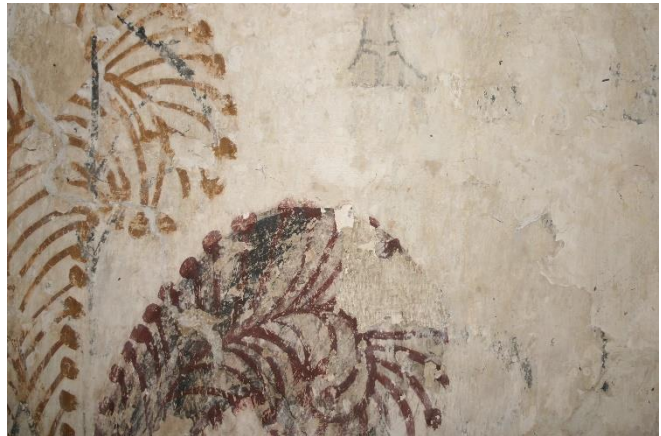
Generally, all the wall paintings on this wall are stable, although there were minor losses evident: e.g. on the right-hand feather on the south side, adjacent to a previous larger loss, and to the crown above. Other smaller losses became evident with the improved scaffold access.

Fig 15. Location of a paint loss to the feathers on the south side (left) and detail below.

- Removal of surface accretions using soft brushes to direct the dirt into a vacuum nozzle.
- Further localised and light cleaning using Wishab sponges (granular rubber cakes).
- Reattachment of the damaged areas was carried out using a thin lime slurry, injected under the lifting edges.
- The paint losses were reintegrated to reduce visual impact using watercolour washes. This will also act as a means of monitoring for future paint losses.

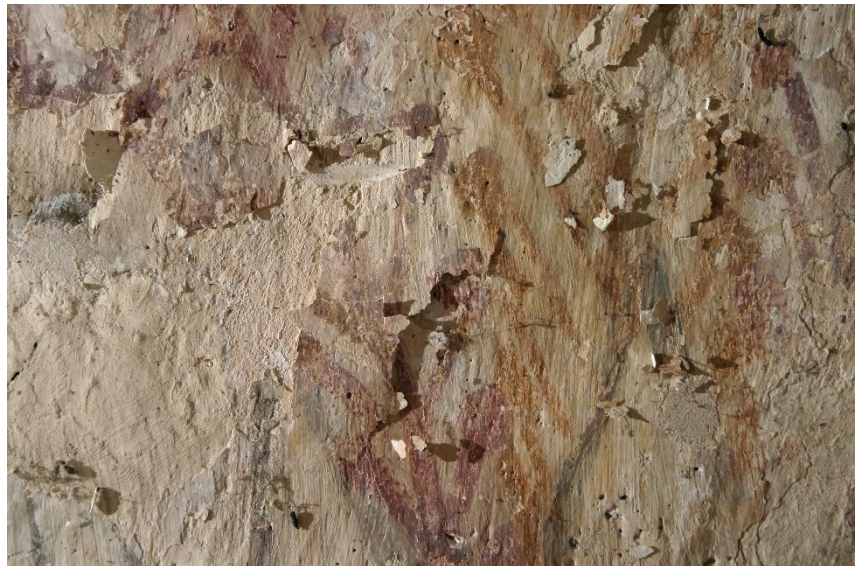
Unfortunately, an area of impact damage occurred to the central north side during erection of the access scaffold. This caused an indent, local delamination and loss of the paint and ground layers. The damaged paint and limewash ground were 'floating' and barely attached, some areas had become completely detached and were caught in cobwebs nearby.

Fig 16. Location of a paint loss on the north side, before treatment

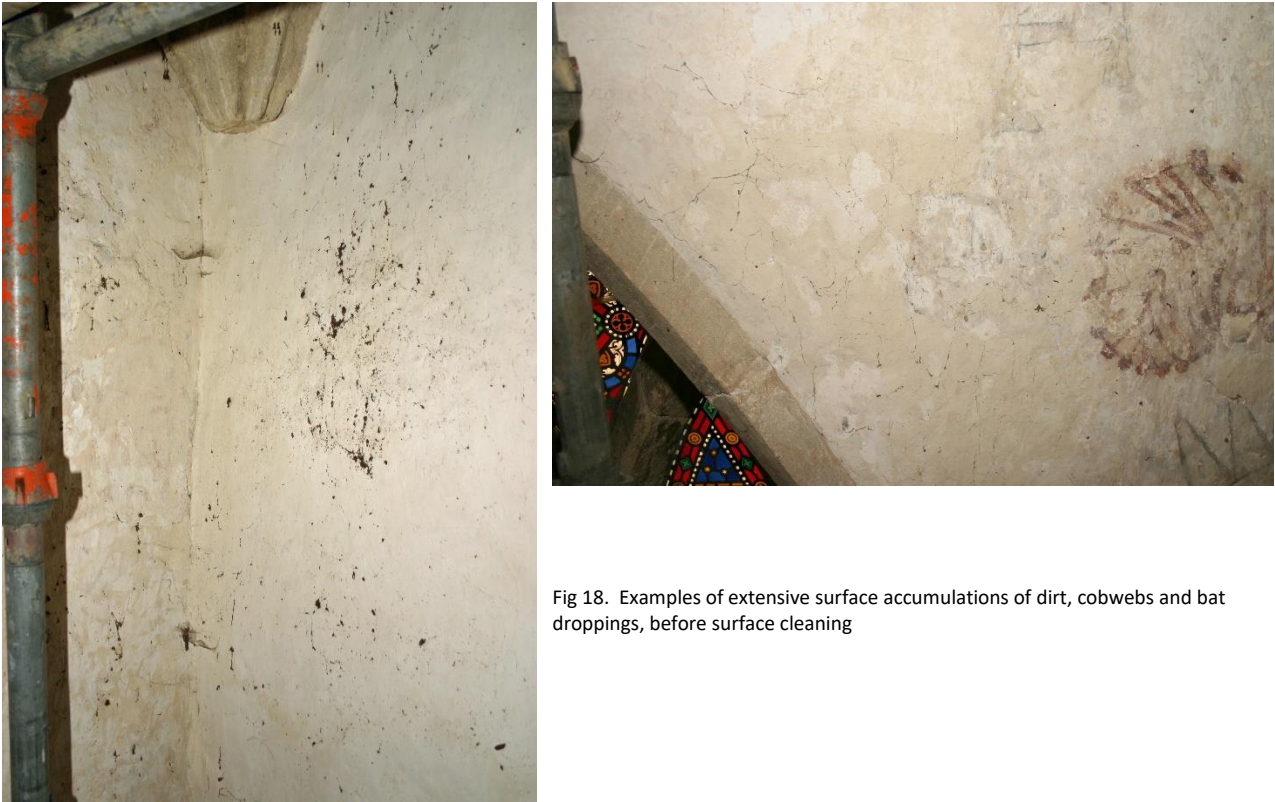
The entire west wall had extensive accumulations of dirt, cobwebs and bat droppings that significantly compromised the appearance.

Fig 18. Examples of extensive surface accumulations of dirt, cobwebs and bat droppings, before surface cleaning

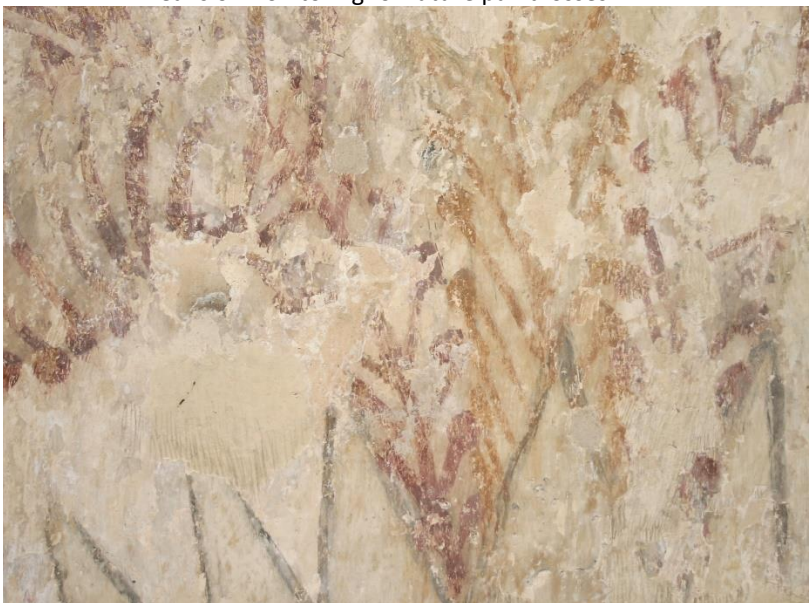
Fig 19. The damaged area after conservation (above) and during reattachment (right)
