**ST MARY'S CHURCH
BECKLEY, OXON**

Wall Painting Condition Survey

**Mark Perry
April 2018**

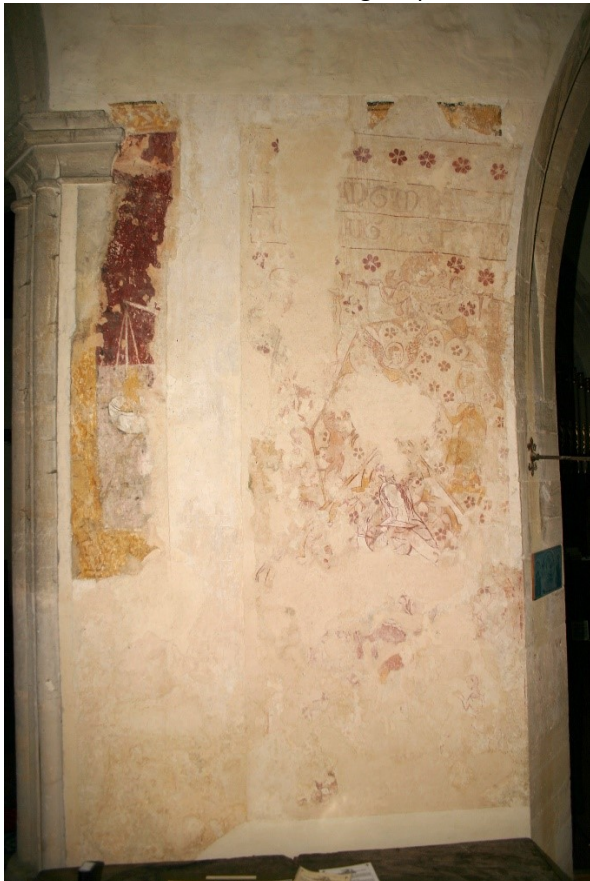
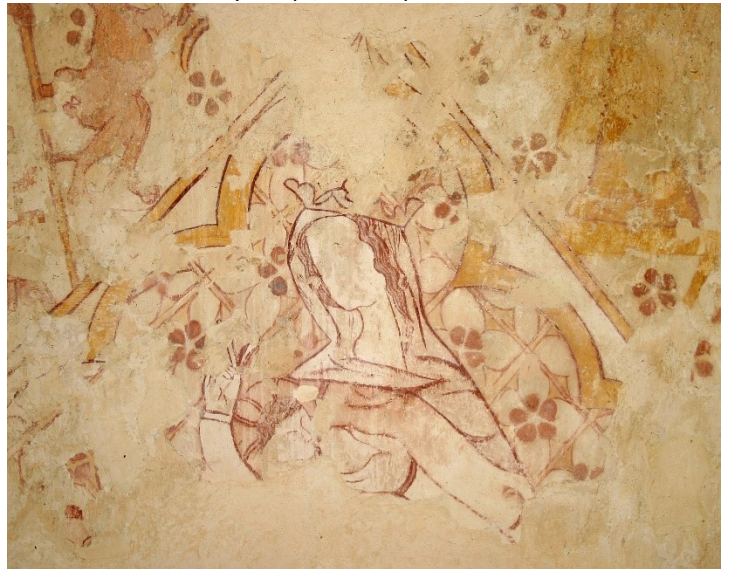
Fig 2. The South aisle, tower pier – overall view (left) and detail of the Virgin and Child (above)

The rendition of the Virgin's veiled head is particularly beautiful and is of very high quality. There are several intriguing and very unusual smaller scenes within the overall panel, making this wall painting of great significance within the canon of medieval church decoration.

A small loss of the painted limewash layers measuring 35mm x 25mm has occurred to the chest of the Virgin. The edges of the loss are lifting and fragile. This is in a very accessible area and is therefore extremely vulnerable to further loss. There is nothing to indicate any underlying deterioration factors and the nature of the damage suggests it is due to accidental abrasion/impact. All other areas of this and the adjacent later painting of the Weighing of Souls (C15th) to the west are stable.

Removal of surface accretions using soft brushes to direct the dirt into a vacuum nozzle. Further light cleaning using Wishab sponges (granular rubber cakes) may also be required. Spot cleaning of any residual staining from bat faeces would be carried out using de-ionised water swabs.

Reattachment of the damaged area(s) would be carried out using a thin lime slurry. The loss would be filled with a fine lime mortar and a suitably toned limewash. The missing detail would not be recreated.

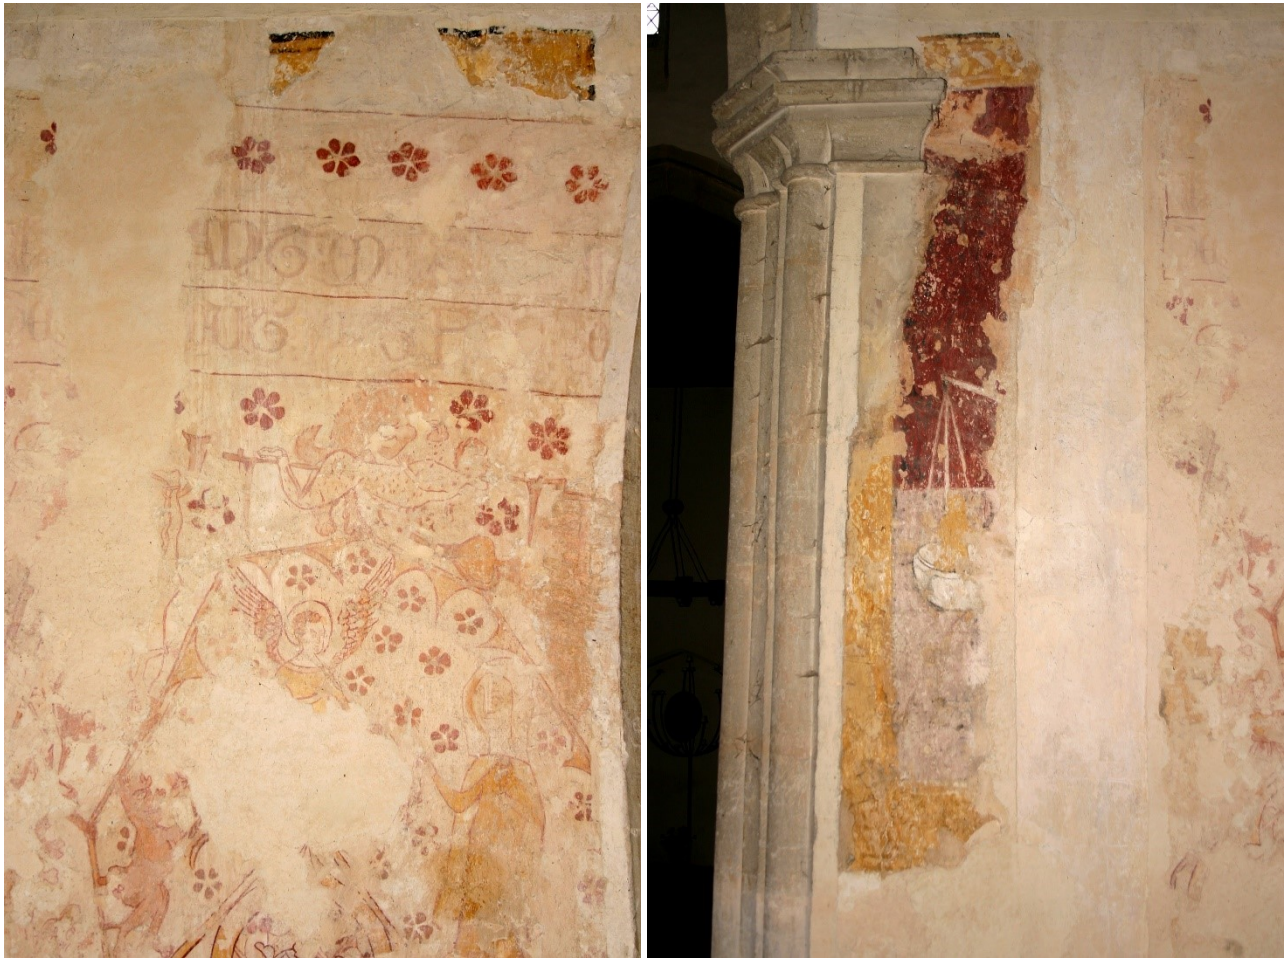
Fig 3. Details of the C14th Weighing of Souls and Torments of the Damned (above left) and remains of the overlying C15th Weighing of Souls (above right). The vertical white 'shadow' is visible to the right of the later painting

To the west of the Virgin scene is the remains of a later (C15th?) illustration of the Weighing of Souls. This would have been superimposed on the earlier wall painting, completely covering it over. It was partly removed in the major restoration works of 1845 to expose the Virgin and Child painting.

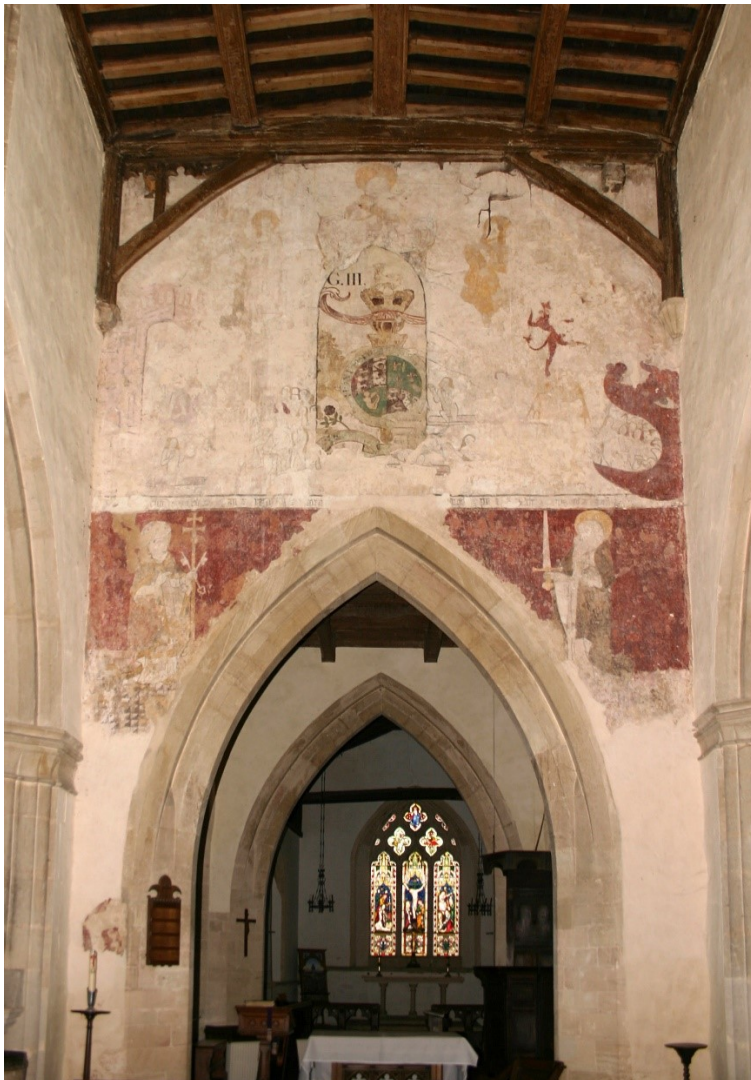
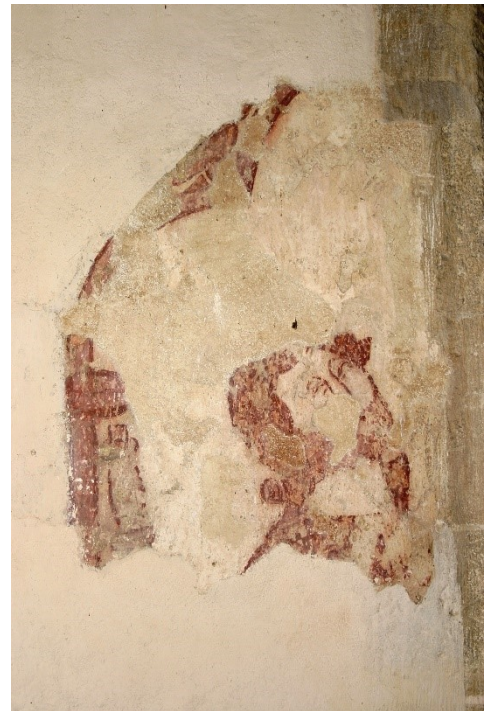
Fig 4. The nave, east wall – the Last Judgement (left) and detail of small figure on the lower north side (above)

There is the fragmentary remains of a small figure beneath a gabled canopy on the lower north side of the arch. Tristram does not mention this painting and it is presently unclear whether it is connected to the Last Judgement painting above, or a separate and possibly earlier painting. A section of an originally much larger C18th royal arms is painted on a blocked in door/window in the tower wall above the arch.

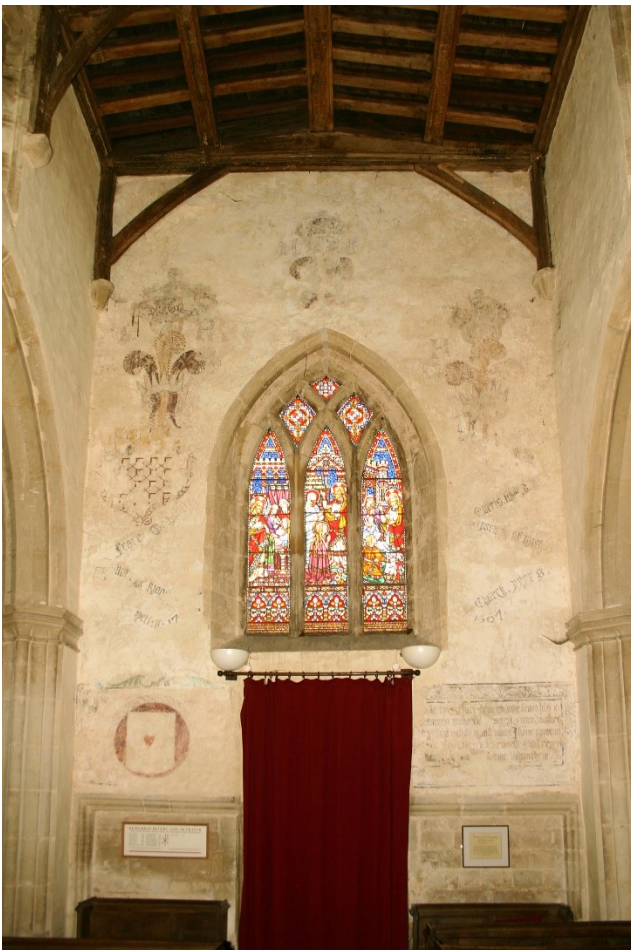
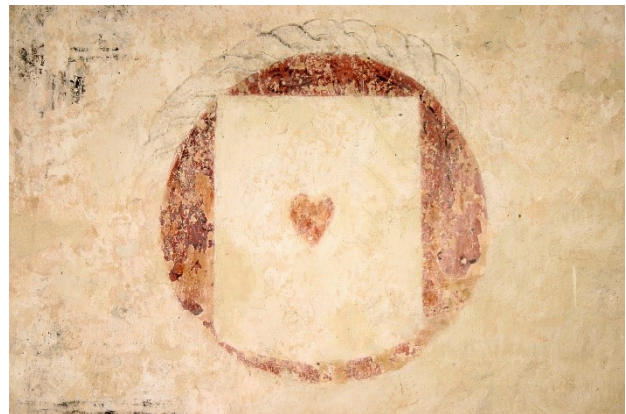
The west wall is painted with an extensive series of royal emblems and badges of several different periods. The earliest painting is the sacred heart emblem on the lower south side. It pre-dates the royal heraldic scheme of 1607 above and is likely to be post Reformation.

The most extensive scheme is that of the three sets of Prince of Wales feathers, with associated scrolls and texts, arranged on both sides and above the west window. These are dated to 1607 and refer to Henry, eldest son of James 1. On the same layer of limewash, but on the lower north side of the door, is a panel painted with a text from Jeremiah Chapter 18 verse 11. A similar text on the south side was destroyed previously to reveal the sacred heart emblem. The feathers and scrolls have been repainted at least once, one area of which was replaced by a portcullis – also a royal badge – introduced by Henry VII.

Fig 5. The nave, west wall, overall (left); detail of the Sacred Heart Emblem (above) & the Jeremiah text panel (below)

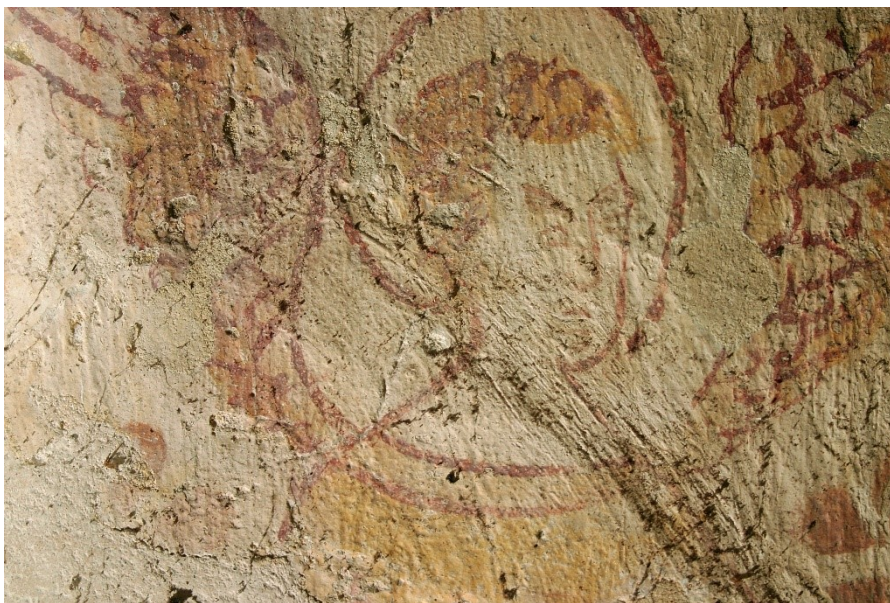
Fig 7. Detail of thick surface dirt on St Michael

There is extensive surface dirt (dust, cobwebs and bat droppings) that currently reduce the visual impact of this very important painting. In addition, if these deposits are left in situ they can become ingrained over time and more difficult to remove. Surface cleaning would also allow the opportunity to treat any other potentially fragile areas.

Cleaning would include all areas of painted decoration on the pier.

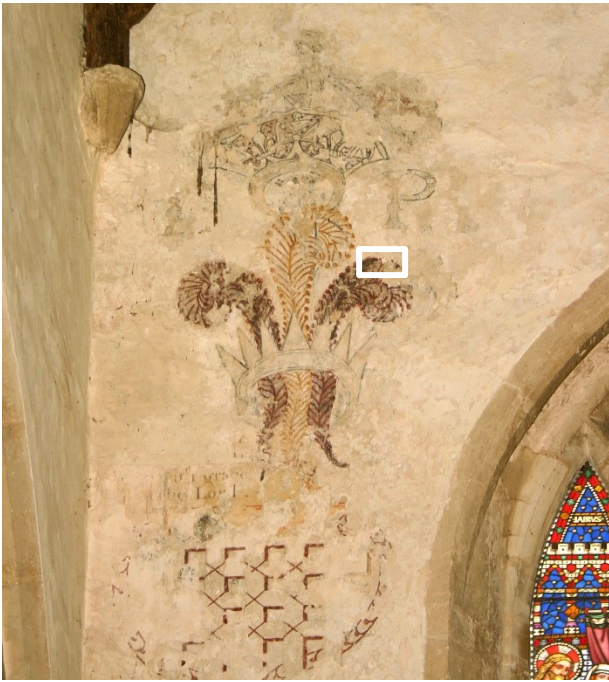
Fig 9. Location of a paint loss to the feathers on the south side (left) and delaminating paint and limewash ground to the Jeremiah text panel (above)

Generally all the wall paintings on this wall are stable, although the upper areas were only inspected using binoculars. By comparing the present condition with photos taken post-treatment in 1993, there appears to have been a small paint loss on the right hand feather on the south side, adjacent to a previous larger loss.

There is an area of local paint and ground delamination in the lower left hand corner of the painted text. There has been no apparent loss but the area is very vulnerable to abrasion from the curtain and is in an accessible position. There are also two small areas of slightly lifting painted ground in the centre of the text painting that require stabilisation to avoid further deterioration.

Reattachment of the damaged areas identified in Fig 9 would be carried out using a thin lime slurry and/or an acrylic dispersion such as Primal B60A, depending on the thickness of the delamination. The losses would be filled with a fine lime mortar or thick and suitably tinted limewash. The missing detail would not be recreated.

A fixed scaffold would be required for treatment.
