HEXHAM MEMORIAL GARDEN HEXHAM ABBEY

REPORT ON AN ARCHAEOLOGICAL WATCHING BRIEF

OCTOBER 2019

PROJECT: Archaeological mitigation at a Development Site
LOCATION: Hexham Abbey
CLIENT: Hexham Abbey PCC
SITE GRID REF: NY 93533 64068
FIELDWORK: September 2019
OASIS REF: thearcha2-373421

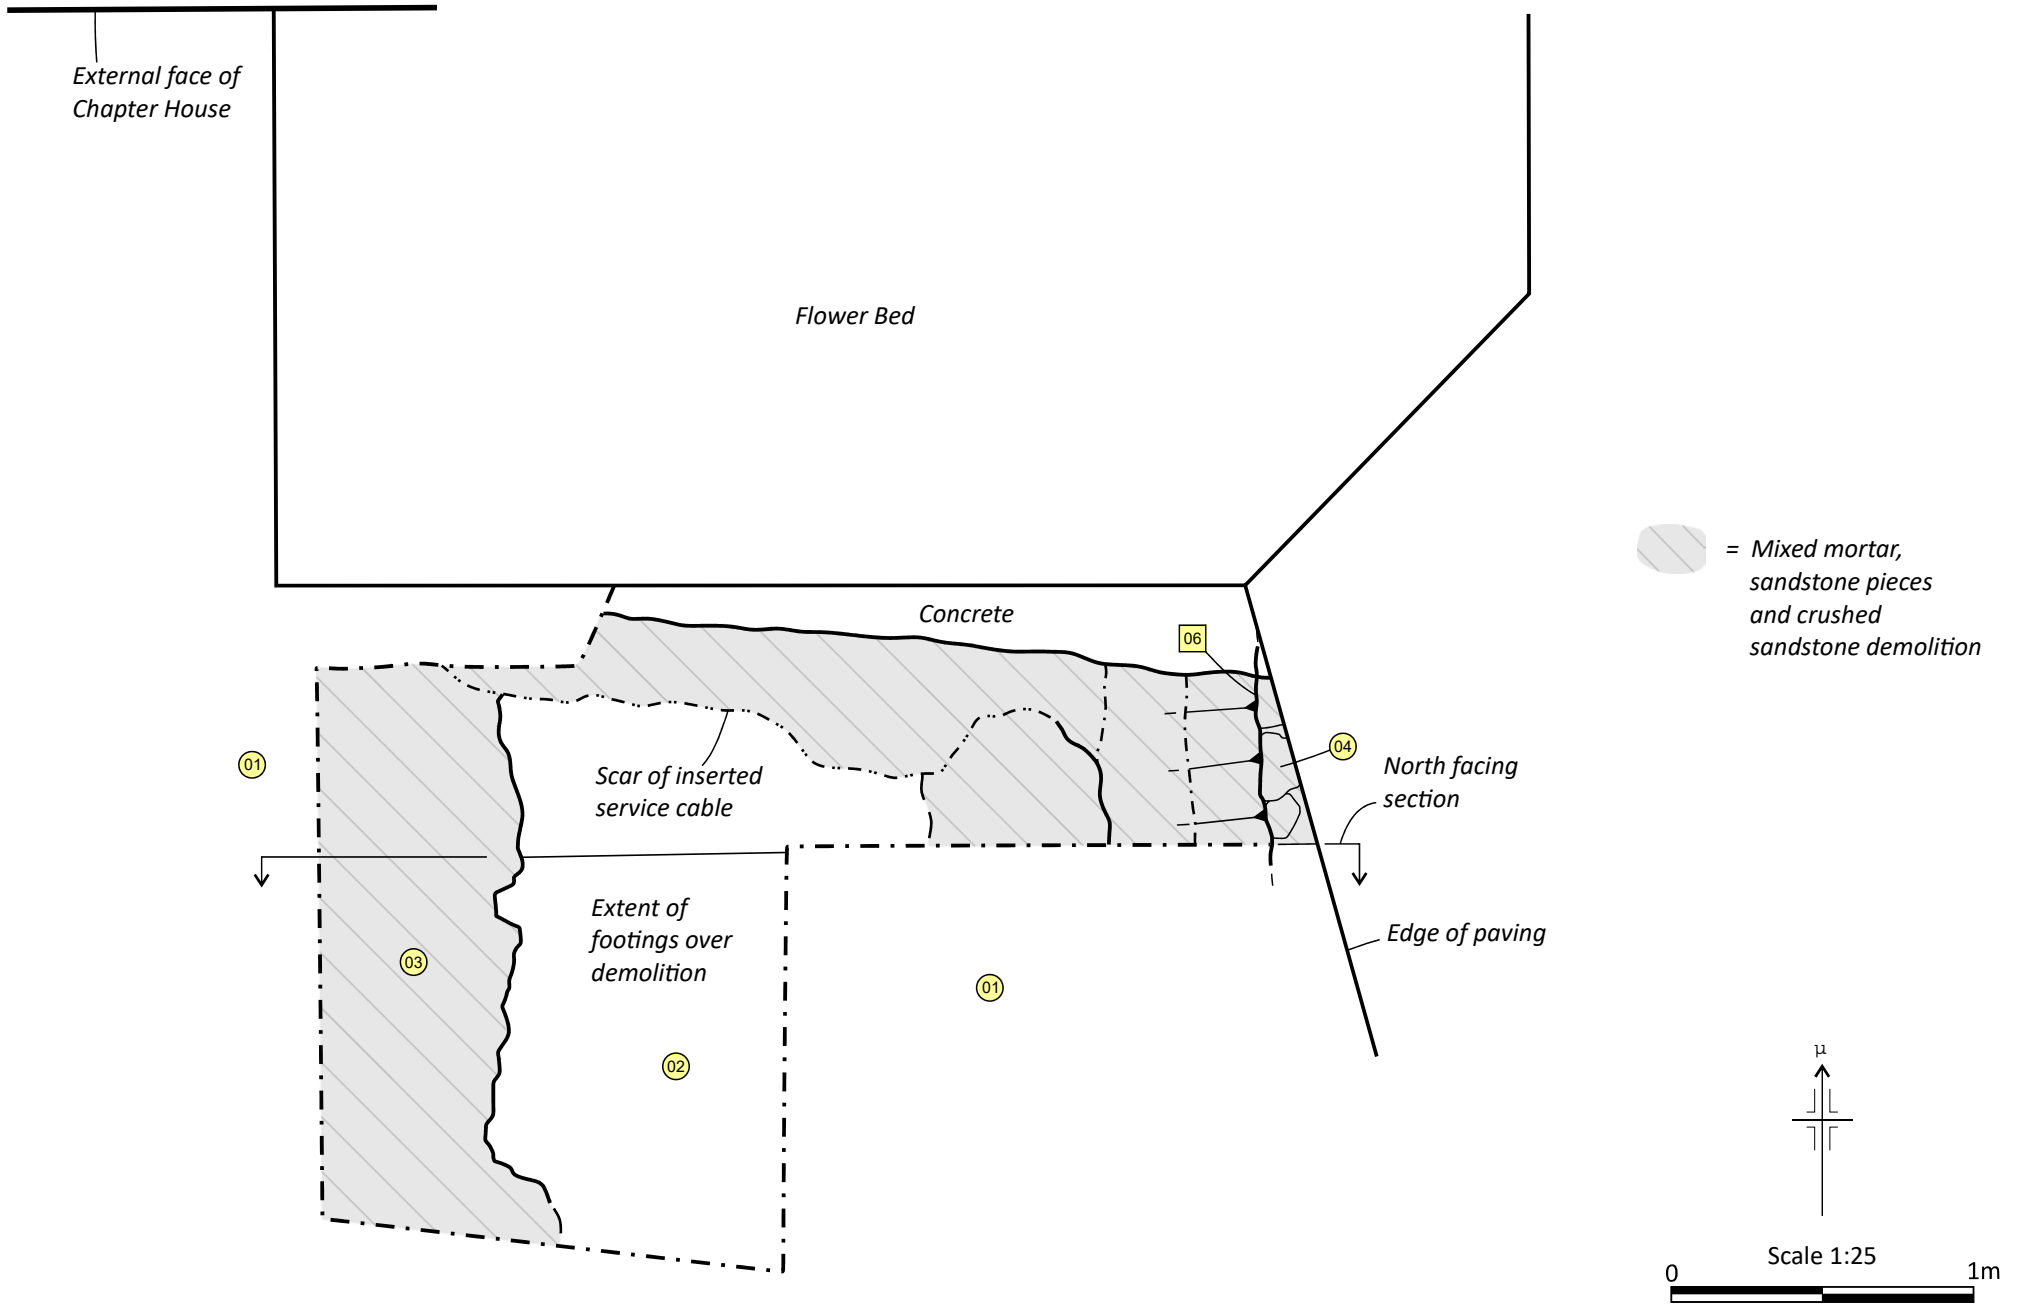
Illus. 16: Plan of archaeological features adjacent to flower bed at northeast corner of plot.

The focus of archaeological watching brief centred upon NGR: NY 93533 64068, located on the south side of Hexham Abbey in a triangular shaped plot extending southwards from the Abbey Chapter House for approximately 15 metres in length, and eastwards from the Calefactory Wall of the Abbey for approximately 13 metres in length, before reaching the Beaumont Street pavement on the east side and following the southwestern alignment of the street, tapering to approximately 4 metres in width at its southern extent (*see Illus. 03, 15 & 16*).

Beneath the present paving was a layer of loose small sandstone (s/s) rubble and black sandy loam overlaid by a 0.02 m deep dressing of fine black ash and spent coal [01] which appeared to be of 19th/20th century character. Beneath this was a layer comprising loose s/s pieces and occasional riverine cobbles interpreted as the footings [02] of a building shown on the town maps of 1826 and 1844. The possible building foundations [02] sat within and may be considered part of a wider spread of demolition material [03] which contained two fragments of late medieval green-glazed pottery. On the east side of the excavated area a cut [06] had been made through [03], perhaps representing the robbing of the east wall of the Calefactory, or 'warming room', while a deposit of small sandstone pieces forming a surface on its east lip [04] may represent the remains of the external surface east of the East Range, or 'Calefactory' [05] which appeared to sit upon natural boulder clay [07]. The suspected robbing cut [06], containing a fill of sandy loam containing mortar and crushed s/s pieces but no dateable artifacts, had also been cut into the natural boulder clay deposit [07].

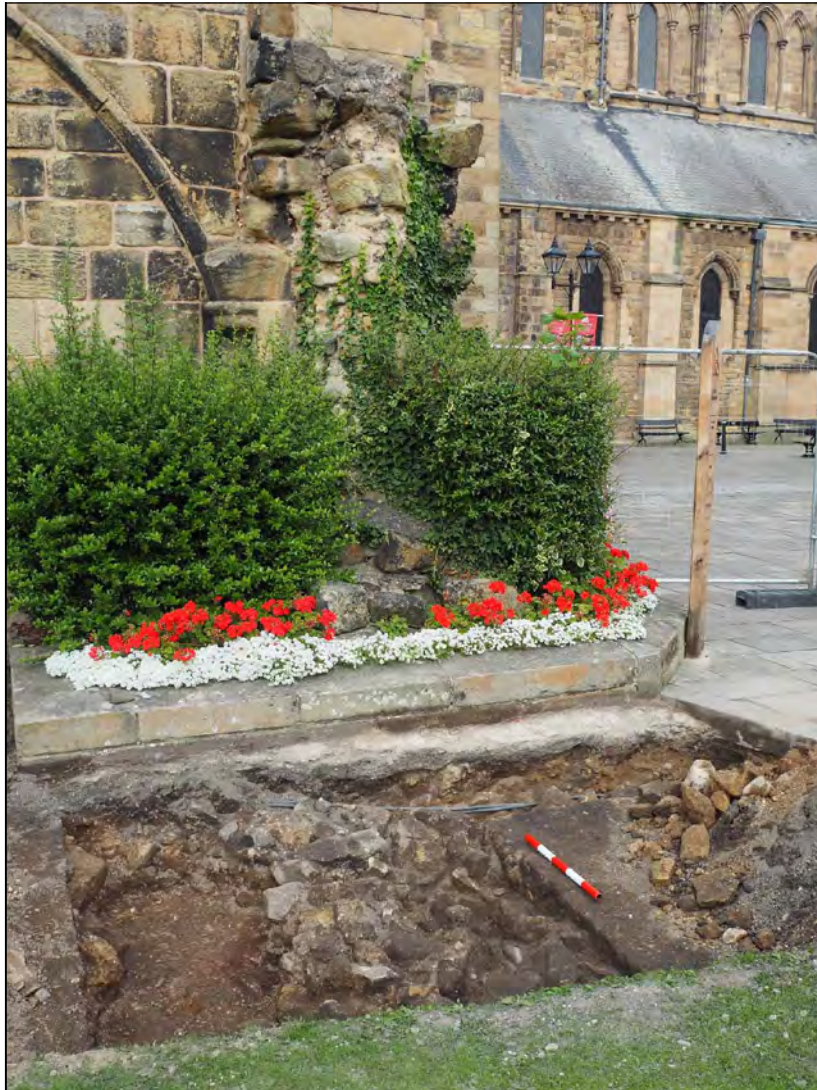
Photo 1. View looking north across archaeological features in the northeast corner of the development plot.

Within this plot, two distinct areas were excavated to depths in which archaeological features were revealed. The first area was located towards the northeast corner of the plot, extending southwards from a walled plant bed attached to the southeast corner of the Abbey Chapter House (*see Illus. 15 and 16; Photos 1-3*). In plan this was an L-shaped trench, with the east-west arm measuring approximately 3 m (length E-W) x 0.85 m (width), and the north-south arm measuring approximately 2.30 m (length N-S) x 1.50 m (width). The maximum depth of the trench was approximately 1 metre (*see Illus. 18*).

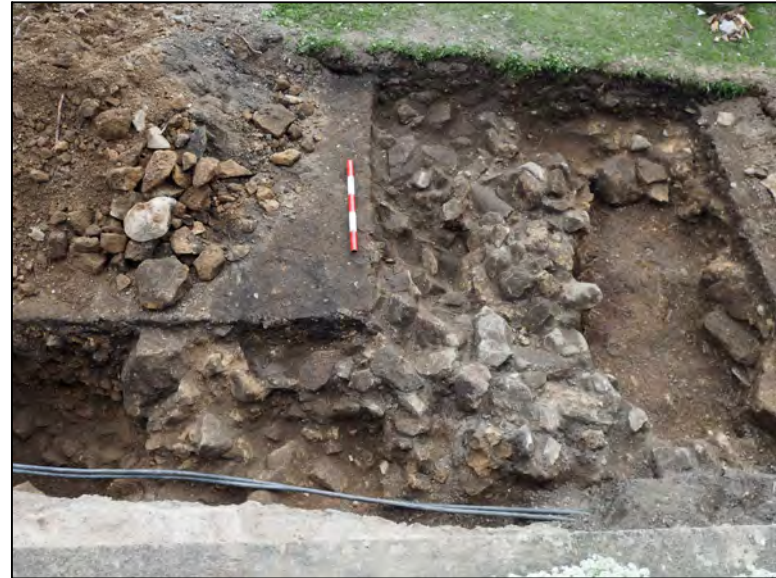
Photo 2. View looking south at detail of archaeological features in the northeast corner of the development plot.

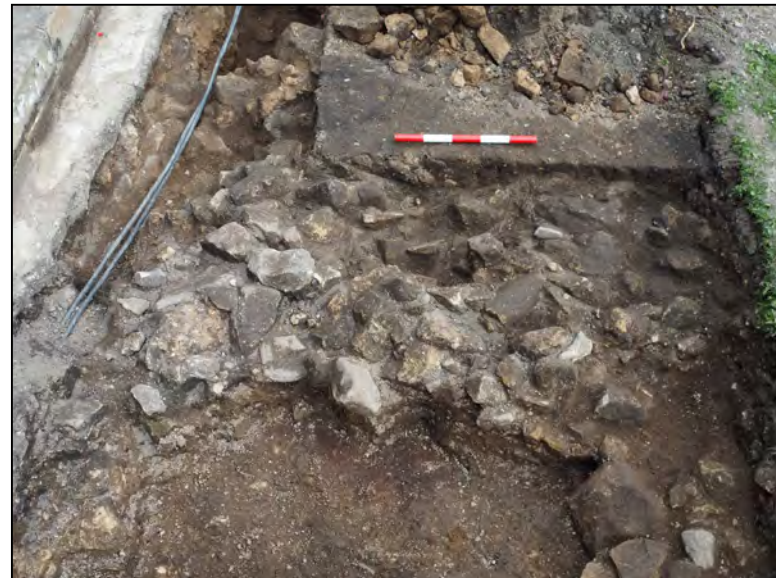
Photo 3. View looking east at detail of archaeological features in the northeast corner of the development plot.

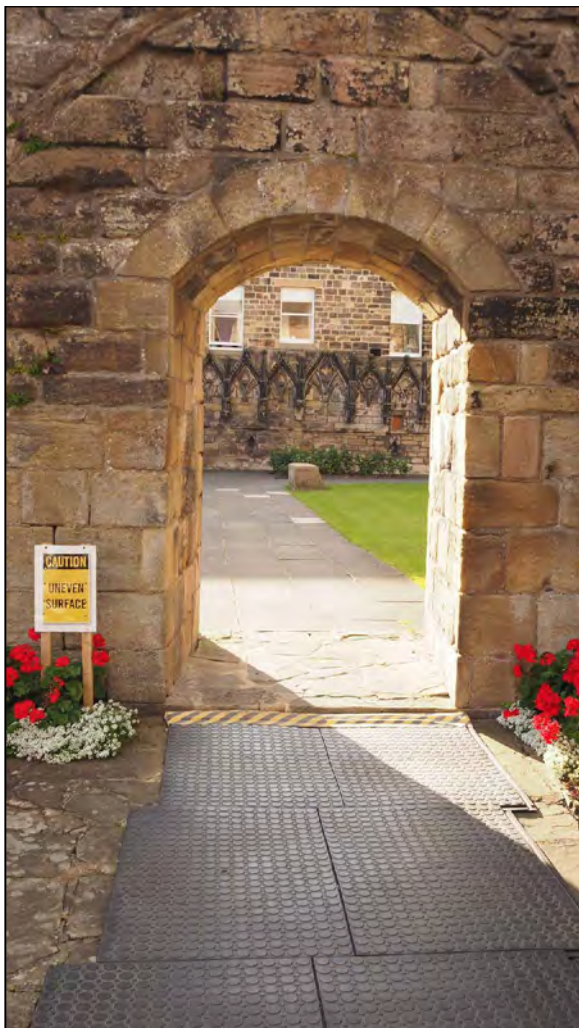
Photo 4. View looking west through an opening in the Calefactory Wall, shown prior to works.

The second area of excavation was located towards the northwest corner of the plot, in the entrance gap through the Calefactory Wall (*see Illus. 15 & 17; Photos 4-6*). The excavation measured 1.70 m (length) x 1.50 m (width) x 0.10 m (depth).

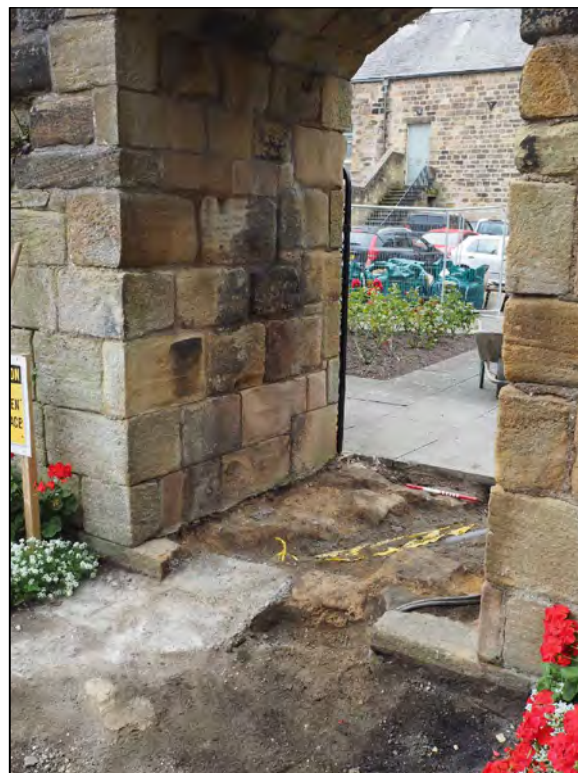
Photo 5. View looking SW through an opening in the Calefactory Wall, shown during the works.

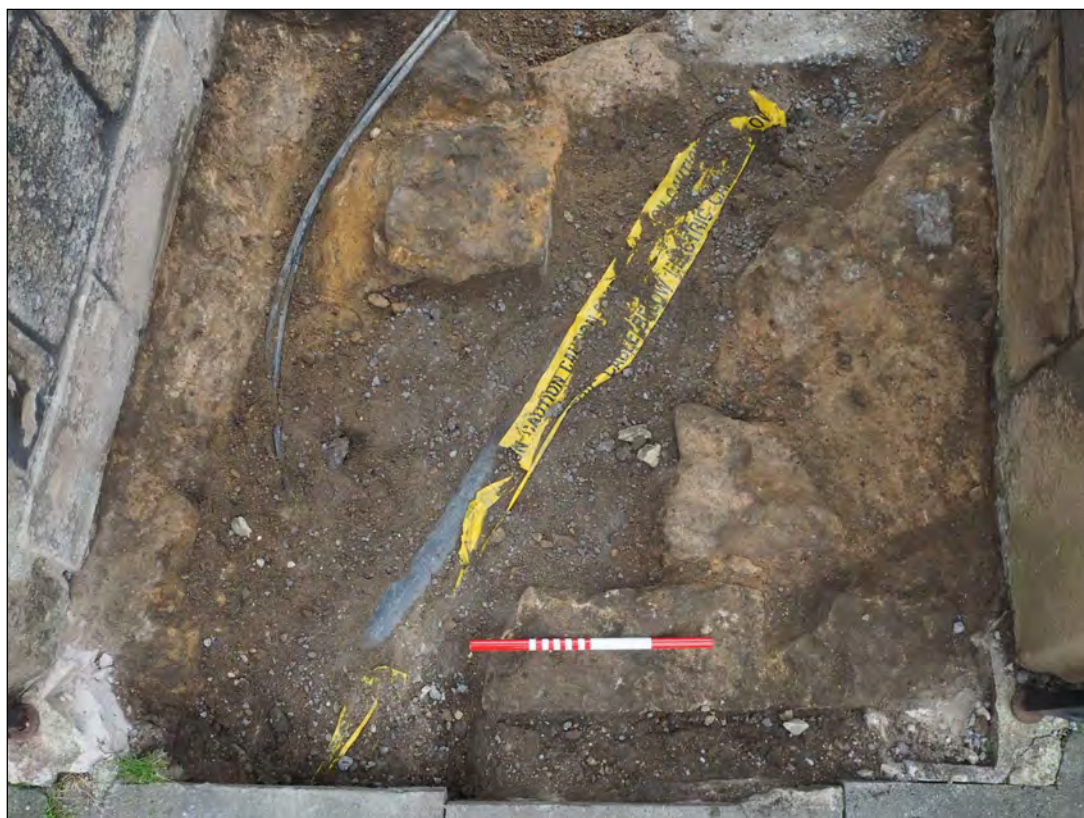
Photo 6. View looking west through an opening in the Calefactory Wall, showing services truncating the wall foundations.

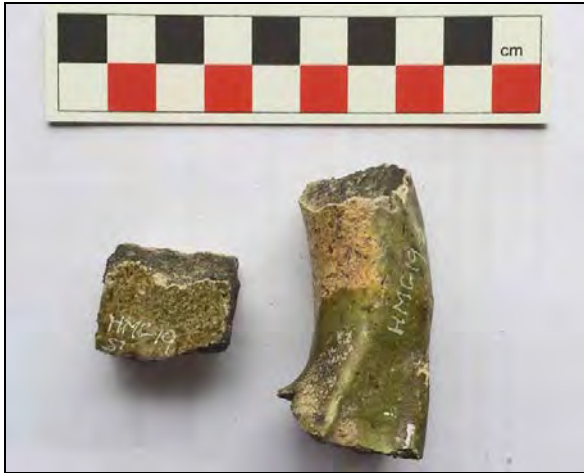
In addition to several fragments of modern pottery from the upper deposits of the excavations, two fragments of late medieval green-glazed pottery were also recovered from rubble in the fill [05] of a suspected robbing trench. This pottery is of little significance other than attesting to medieval activity close to its findspot.

Photo. 07: Body and handle sherds of late medieval green-glazed pottery found amongst medieval rubble in the Hexham Memorial Garden.

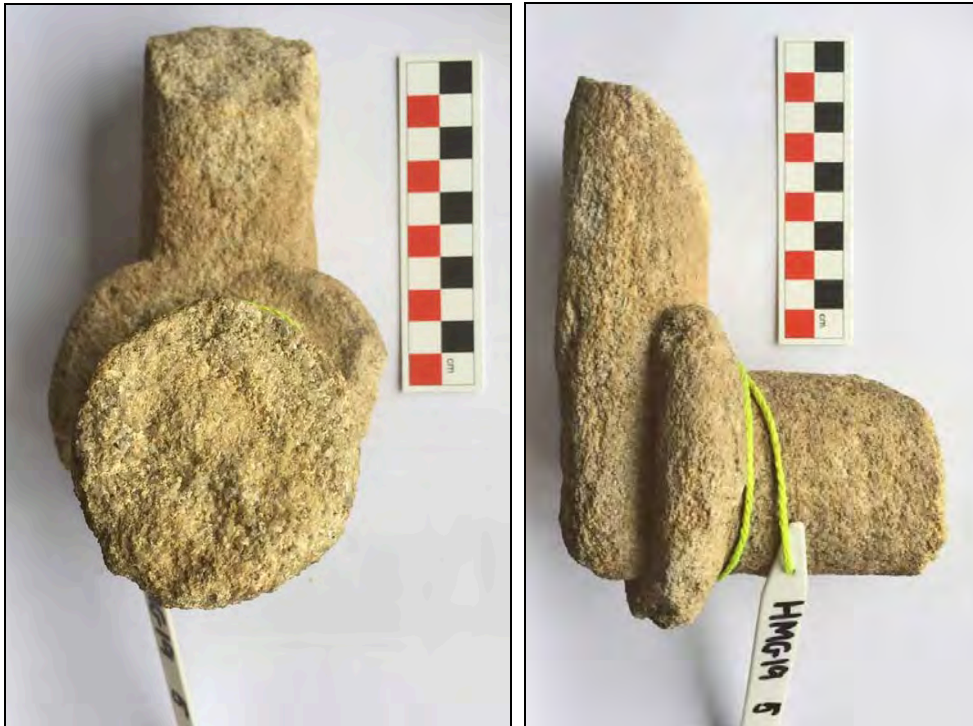
Finds from the groundworks were restricted to pottery and a single piece of carved stonework in rather coarse sandstone, in the form of a shaft, forming a right angle, the longer branch 13.1 cm long and 4.8 cm diameter, the other 10.0 cm long and 5.7 cm diameter, the latter topped with a rounded rolled capital, 1.5 cm deep and extending 2 cm beyond the shaft, which actually forms part of the narrower shaft. This well-made but slightly worn fragment seems best fitted to the role of architectural ornament, perhaps forming part of a seat rail or other largely decorative feature.

Photo. 08a&b: Views of a fragment of worked stone, perhaps part of a decorative rail, frame or handle, found amongst medieval rubble in the Hesham Memorial Garden.
