**Archaeological test pit evaluation at  
St Andrew's Church, Carlton,  
Leicestershire**

**NGR: SK 3964 0498 (centre)**

ULAS Report No. 2020-015v3  
©2020

**For: Peter Rogan & Associates Limited/Carlton PCC**

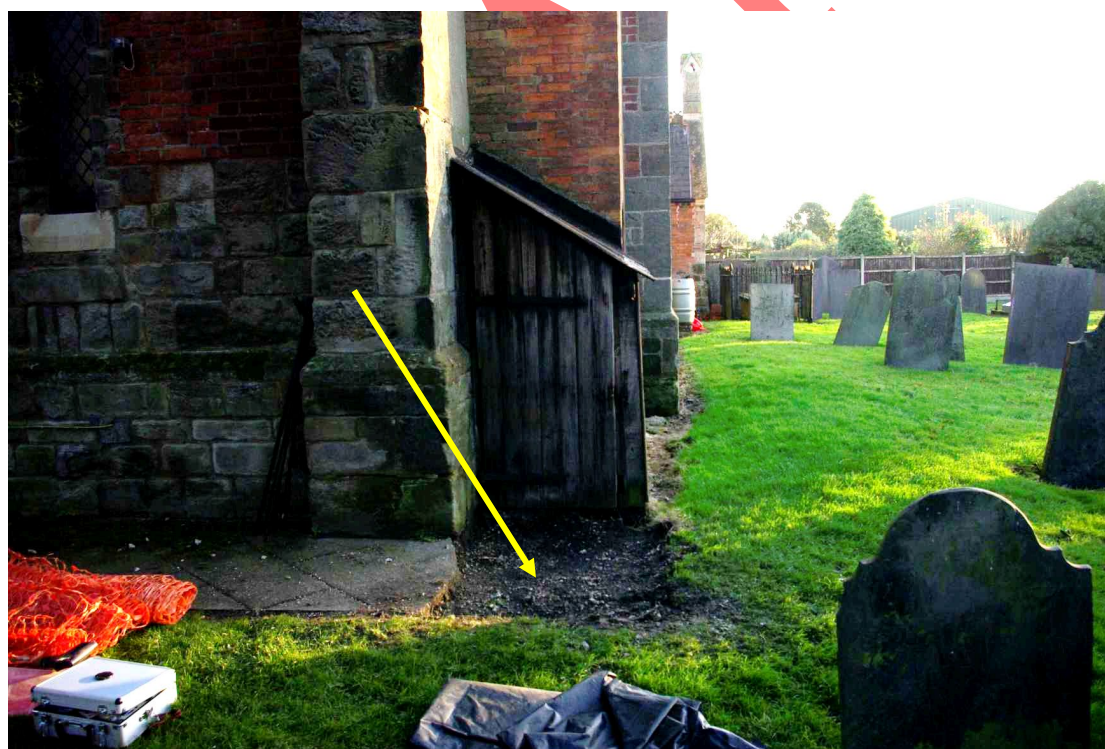
Figure 5 Test Pit 1 location

Test pit 1 was placed adjacent to the south-western corner of the tower. A storage shed has been built into the corner of the church and the tower which meant that the pit had to be moved slightly further west than the specified location. A concrete pathway covered the pit location but this was kindly removed by local volunteers prior to the start of the evaluation (Fig. 5). A thin (0.08m) layer of bedding material supported the concrete path.

Yellow arrow points to location after removal of concrete path. Looking east

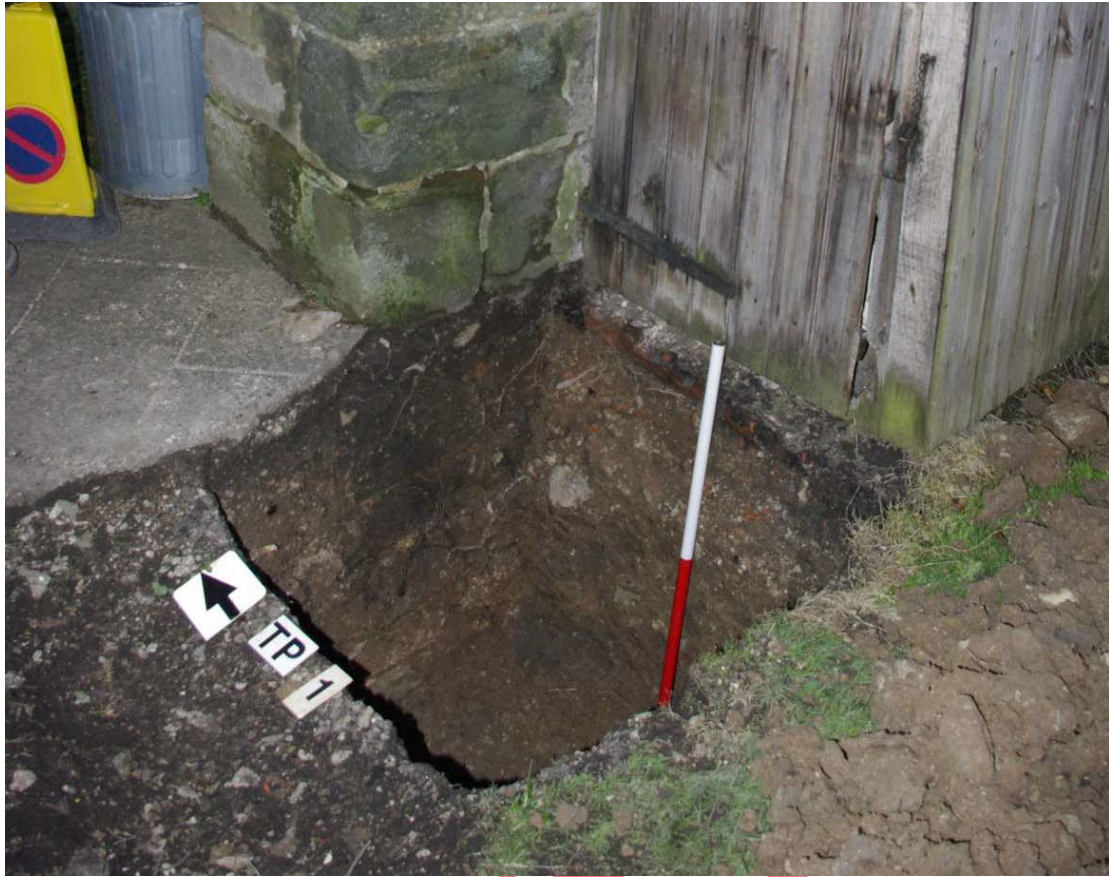
Figure 6 Fully excavated Test Pit 01  
Tower foundations continue below base of test pit

design in its entirety would have consisted of a circular band decorated with small lozenges and containing four branches of oak leaves radiating from the centre. Formal leaves fill the outer corners (a photograph of the full tile is shown in Appendix 1). This design appears to be relatively uncommon and is not recorded in the Eames Catalogue (1980), but has been found at Gaddesby Church and at Burton-on-Trent Abbey, Staffordshire and, more recently, at the lost chapel of Saint Morrell in Hallaton, Leicestershire. The tile would have formed the lower left hand side of a four-tile design (Sawday 2020). It seems likely to have originated from the church and is probably of 15th century date. A short length of clay pipe stem from the late 19th century was also recovered from (01). A similar mixed layer was exposed beneath (01) which contained the same mid-orange brown sandy clay but with very little building material within it (02). Layer (02) continued down to, and beyond, the base of the test pit at 1m below current ground level (Fig. 6).

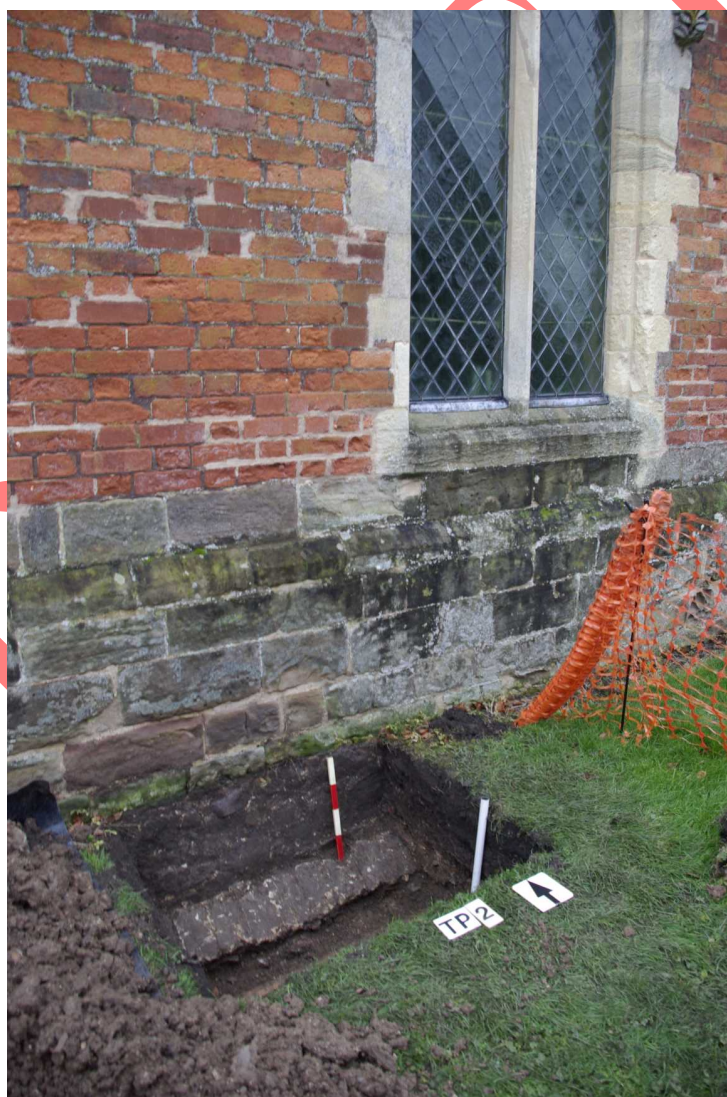
Figure 8 Test Pit 02 location

Test Pit 02 was placed alongside the church wall close to the eastern edge of the proposed extension (Fig. 8). Removal of turf and topsoil exposed a band of mid-orange brown mixed sandy clay layer containing fragments of plaster and other stony rubble as seen in Test Pit 01. This 0.12m thick layer was given the same context number (01). Beneath this layer was the same mid-orange brown sandy clay but with very little building material within it (02) as seen in Test Pit 01. Layer (02) continued down to, and beyond, the base of the test pit at 0.8m below current ground level. Close to the church wall was a cut full of heavily disturbed sandy clay (04), [05]. The cut extended down to a line of angled slates laid to deflect rainwater away from the wall towards a ceramic land drain running parallel to the church (Figs 9 and 10). The drain was left in-situ during the test pit excavation. After discussion with the architect it was decided to stop excavating at 0.8m below current ground level.

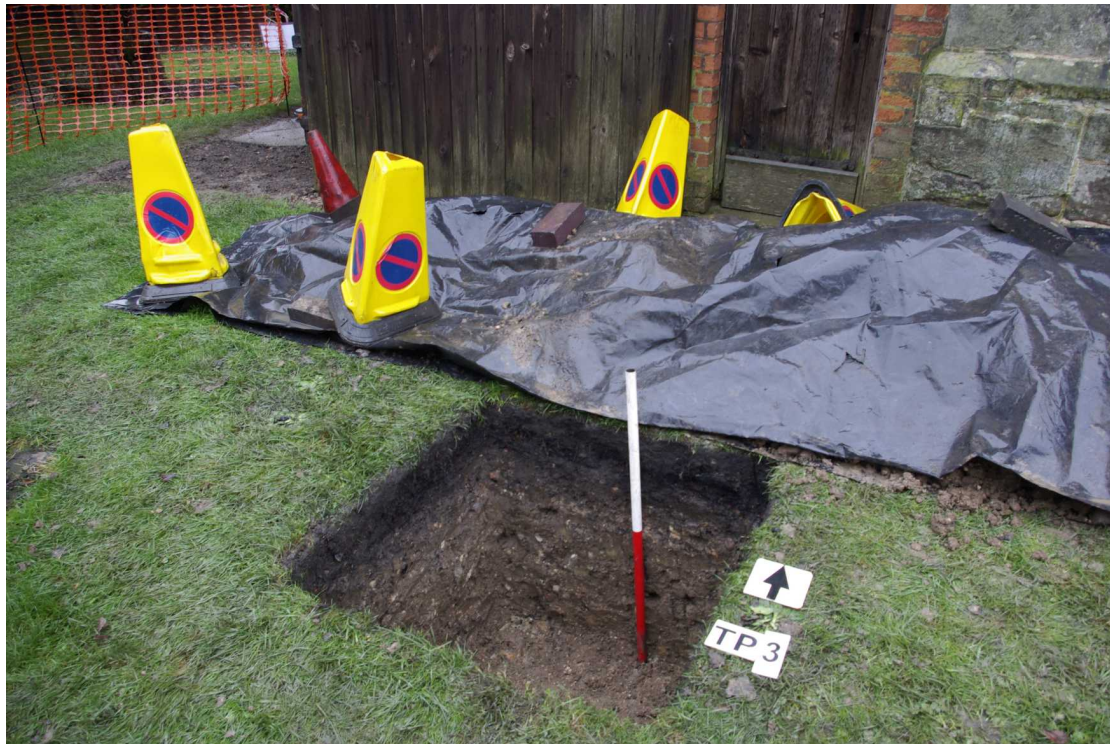
Figure 11 Test Pit 03 fully excavated

Test Pit 03 was placed to cover the proposed southern wall foundation line of the extension. The location was quite close to a headstone but no grave cuts or grave contents were observed during the work. A 0.3m thick layer of turf and topsoil was removed to expose the same disturbed layers (01) and (02) seen in the first two test pits (Figs 11 and 12). Another medieval tile made of Swithland slate was recovered from layer (01). This test pit was excavated down to 0.8m below current ground level.

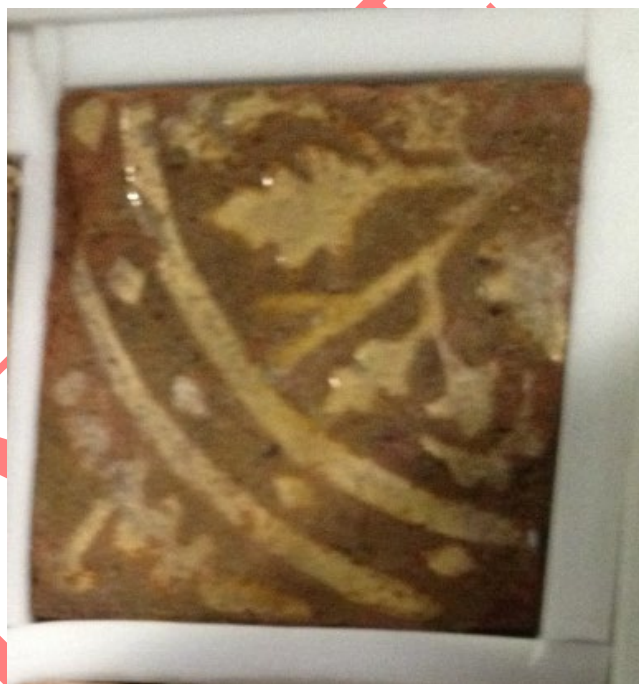
The ceramic assemblage was made up of part of a printed (or stamp over slip) medieval floor tile from TP1, context 1. The fragment, which is abraded, is 17mm (5/8") thick, with the remains of a white slip and traces of a yellowish brown and greenish glaze over the red body, which is in a coarse sandy fabric. The tile would have formed the lower left hand side of a fifteenth century four-tile design, Whitcomb number 196 (Whitcomb 1956). Whitcomb describes the design as 'in entirety a circular band decorated with small lozenges and containing four branches of oak leaves radiating from the centre. Formal leaves fill the outer corners' (*ibid.* 1956, 111). This design appears to be relatively uncommon and is not recorded in the Eames Catalogue (1980), but has been found at Gaddesby Church and at Burton-on-Trent Abbey, Staffordshire and, more recently, at the lost chapel of Saint Morrell in Hallaton, Leicestershire (Sawday 2014). A complete and less abraded example of the same tile design, but of unknown provenance, is in the Leicestershire County Council's collections.

Example of the full tile held in the Leicestershire County Council's collections
