# Upton Magna, Shropshire Church of St Lucia

## Conservation and Recovery of the Wall Painting Scheme:

### Phase 2

April 2020

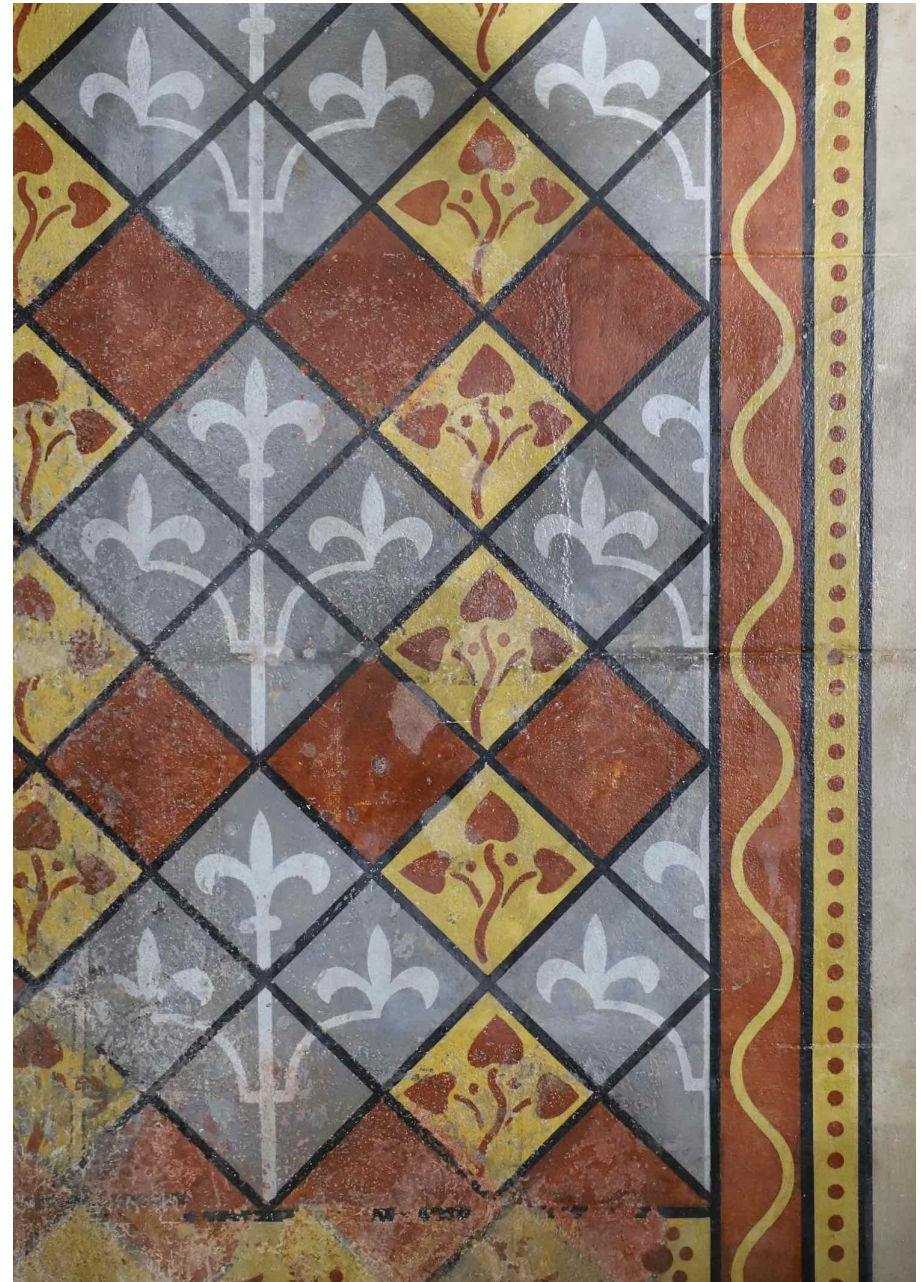
*Above: detail of the newly exposed decoration on the north wall of the chancel.*

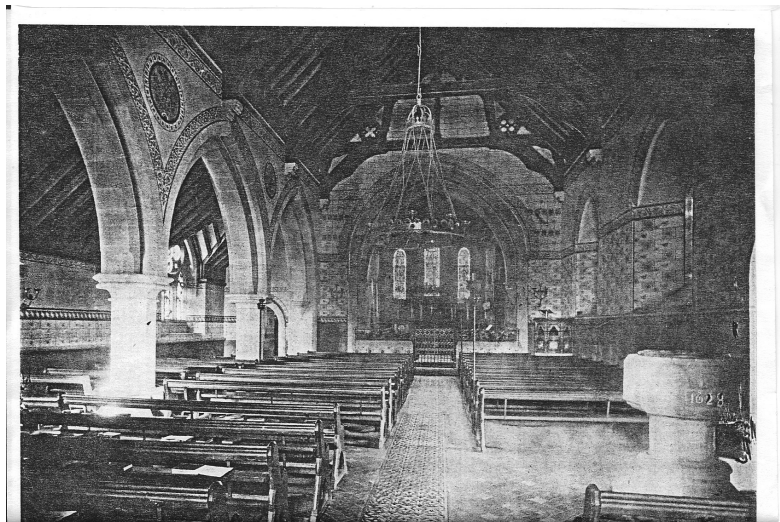
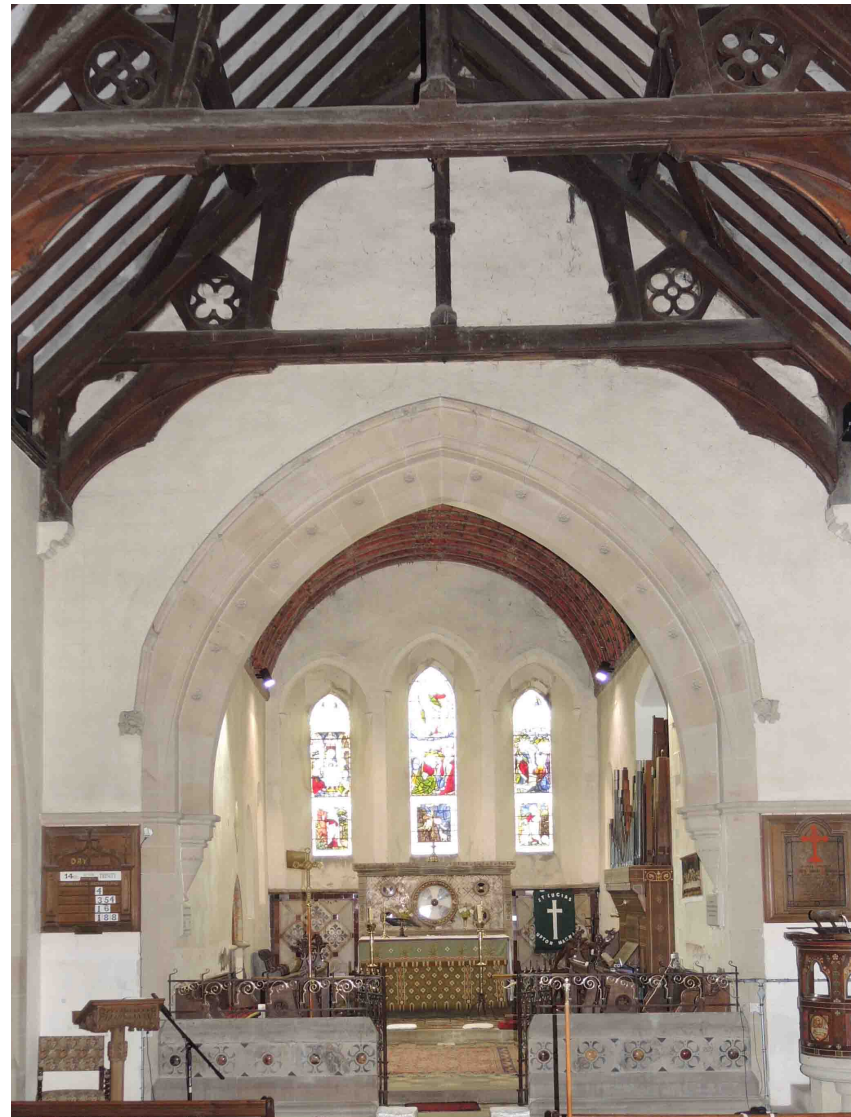
**Plates 1-3:** archival photograph of the nave taken before the interior of the church was whitewashed shows the appearance and comprehensive extent of the wall painting scheme (**top left and bottom left**). Today, the scheme is concealed from view, although indications of its presence remain apparent beneath the covering whitewash (**right**). Unfortunately, no archival images are known that show the appearance of the decoration and figurative painting in the chancel before their concealment.

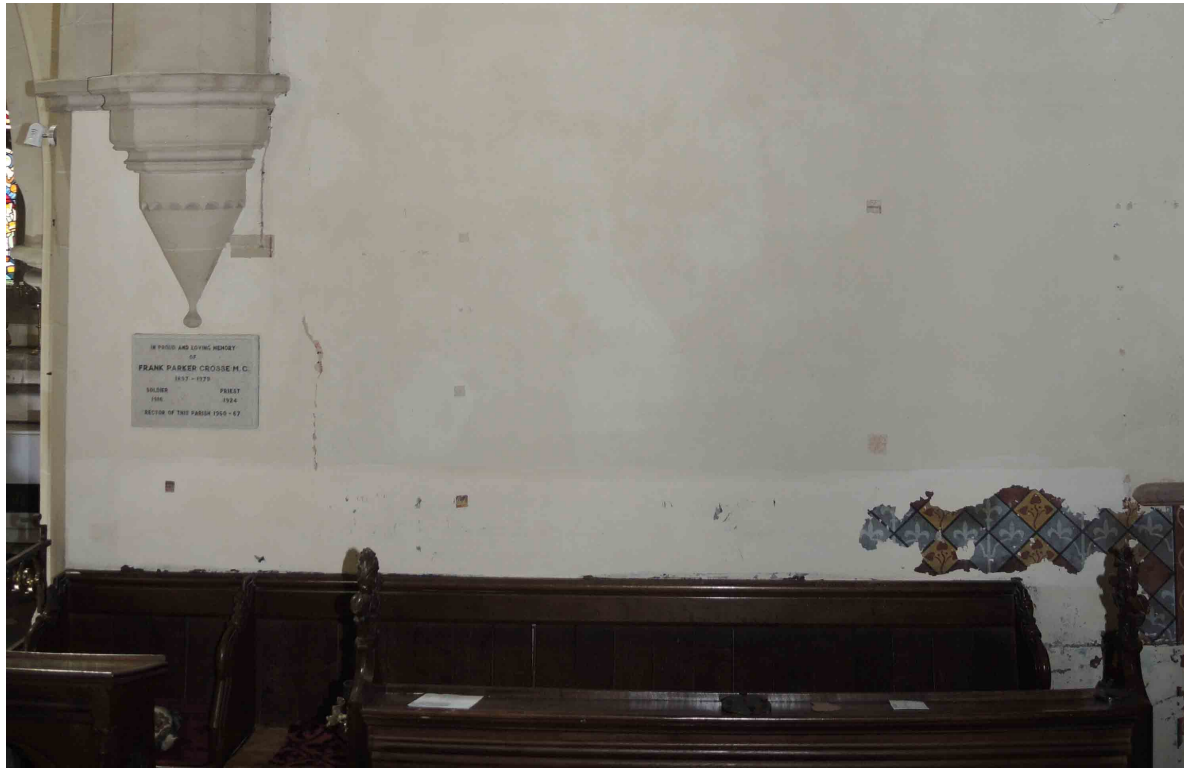
**Plates 5-6:** a brightly coloured lozenge design and other decorative painting survives along the bottom of the north wall, and around the doorway to the vestry, parts of which were visible where overlying paint had flaked away. Painted in a more durable technique than other areas of painting in the church, uncovering this decoration was one of the main aims of Phase 2.

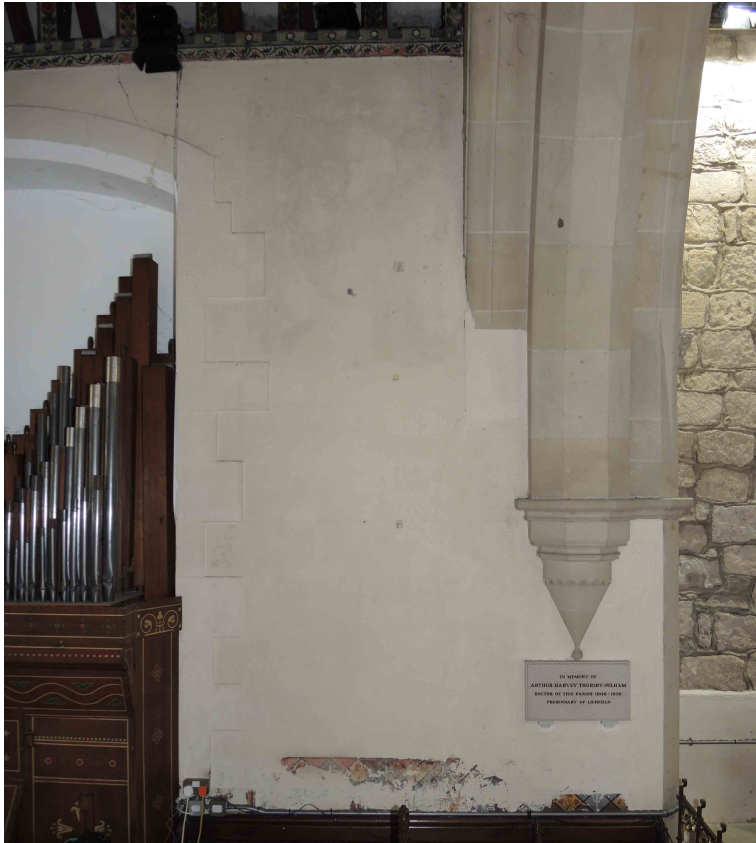
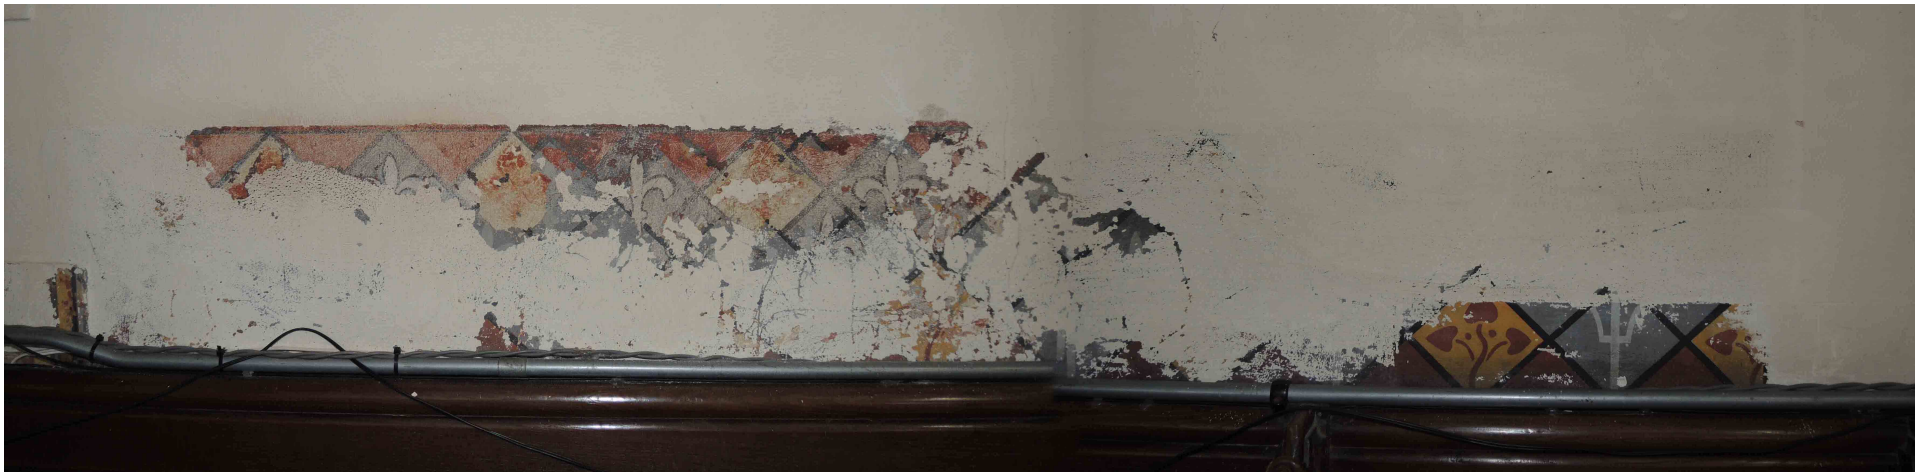
**Plates 7-8:** the lozenge design is repeated along the bottom of the south wall, while figurative painting survives in the upper part. The condition of the decorative painting here is more damaged and abraded. It is not known what the figurative paintings depicted, but presumably they were scenes from the Life of Christ.

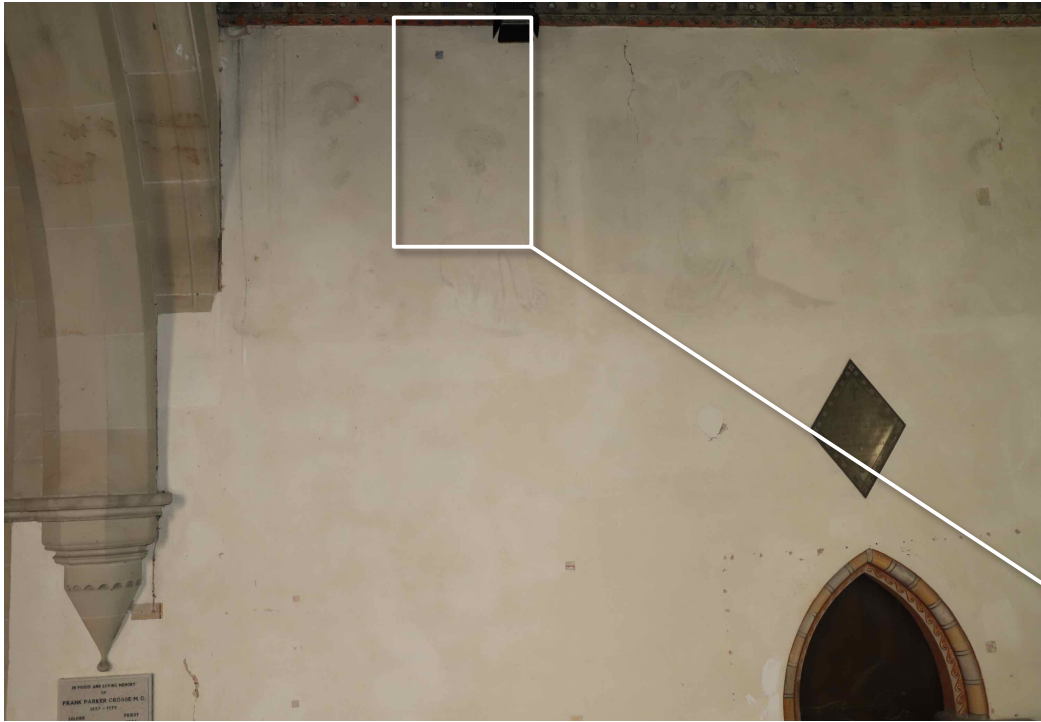
**Plates 9-10:** while it was hoped that there was considerable scope for uncovering the figurative painting, this did not unfortunately prove to be the case. A number of large uncovering 'windows' were opened up to demonstrate the presence of painting, but wide-scale uncovering was not carried out. It seems likely that the tops of the walls suffered considerable deterioration in the past, probably from rainwater infiltration. In this area, from the *Annunciation*, the Angel Gabriel can be seen. Most of the upper paint layers have already been lost.

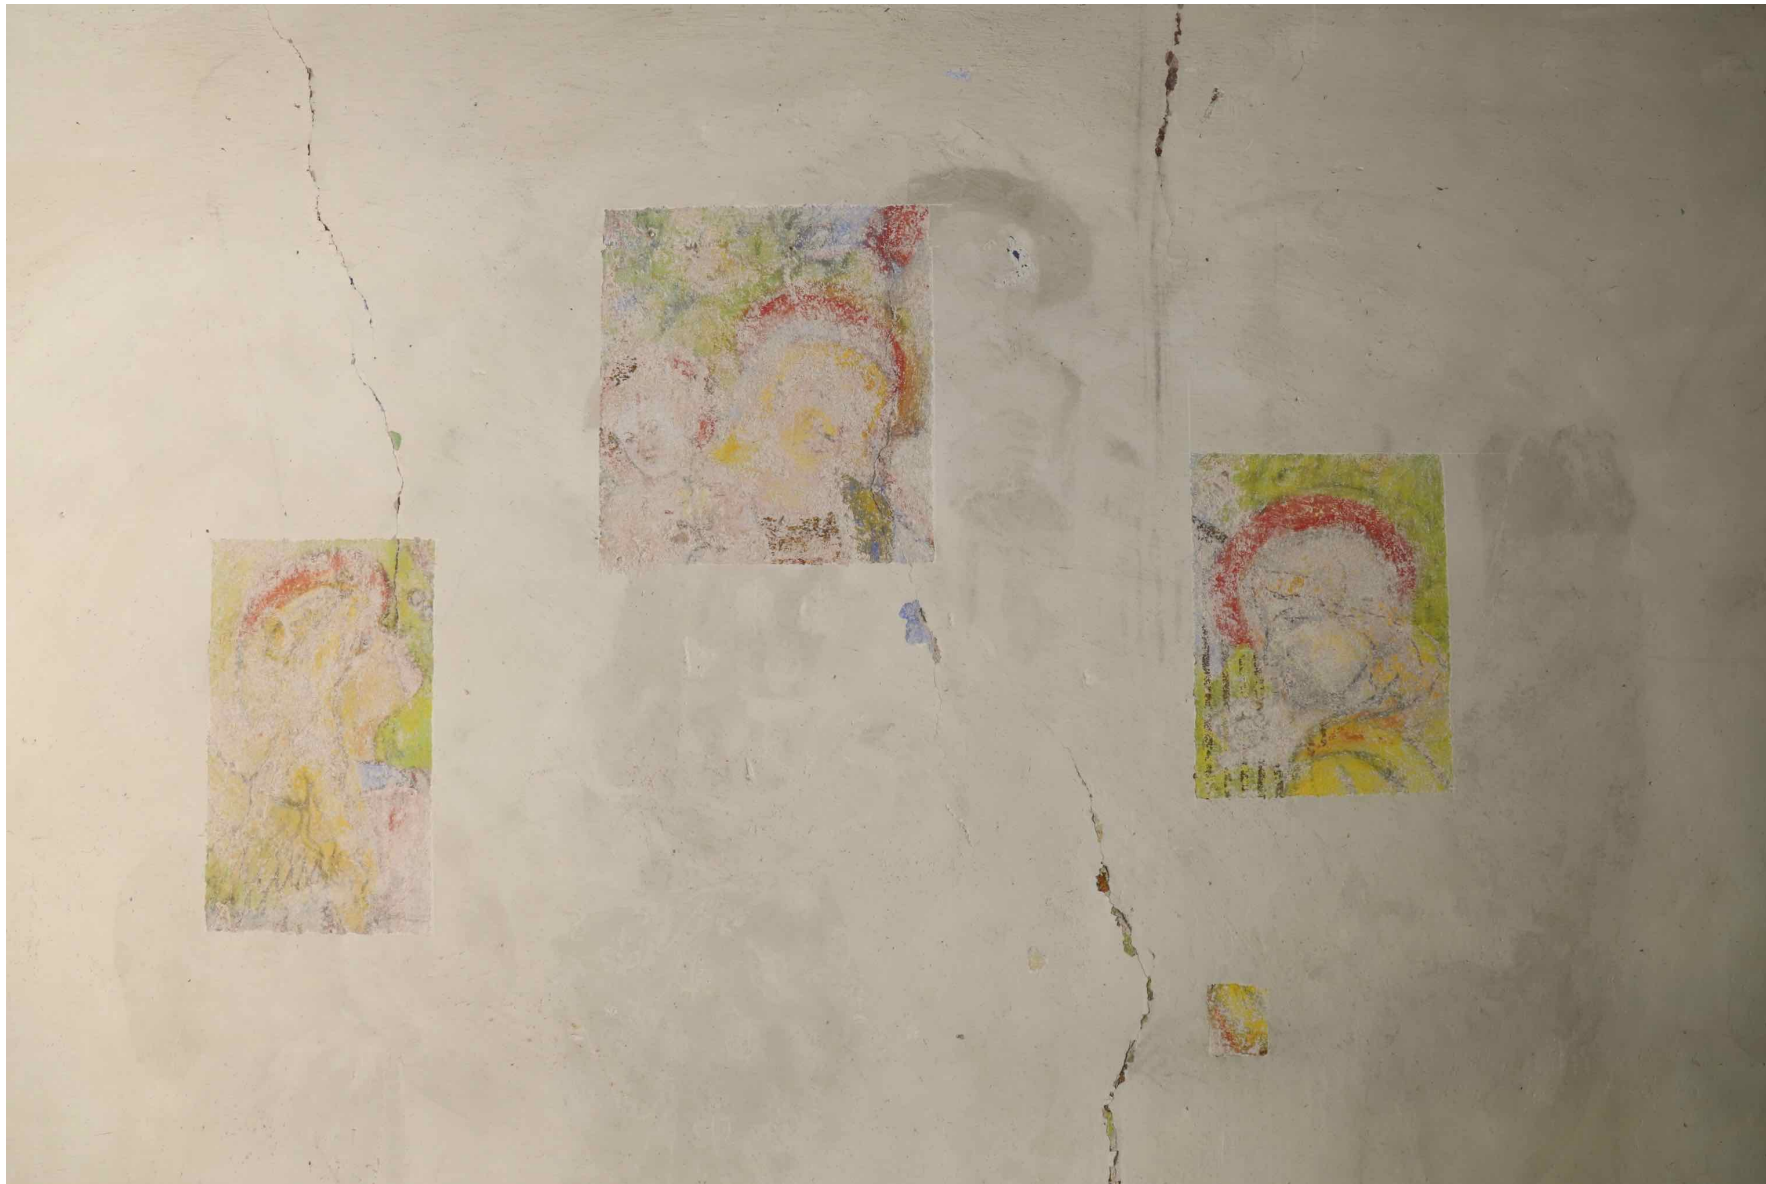
**Plate 11:** three more uncovering 'windows' were made on the *Nativity* scene.

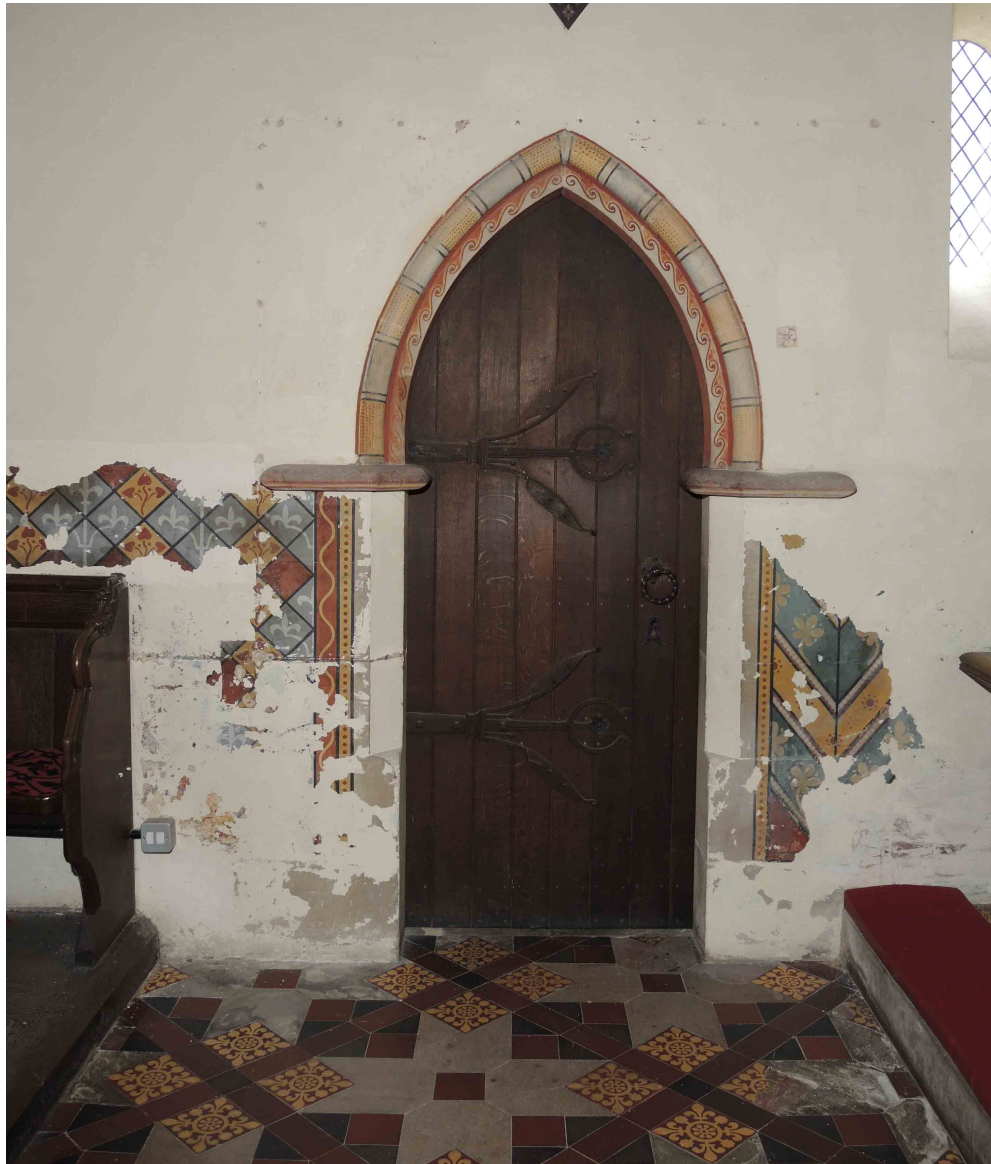
Plates 15-16: having decided not to uncover the upper north wall, efforts were concentrated on the decorative painting lower down. Here the results were rewarding, as a comparison of images before (above left) and after (above right) treatment show.

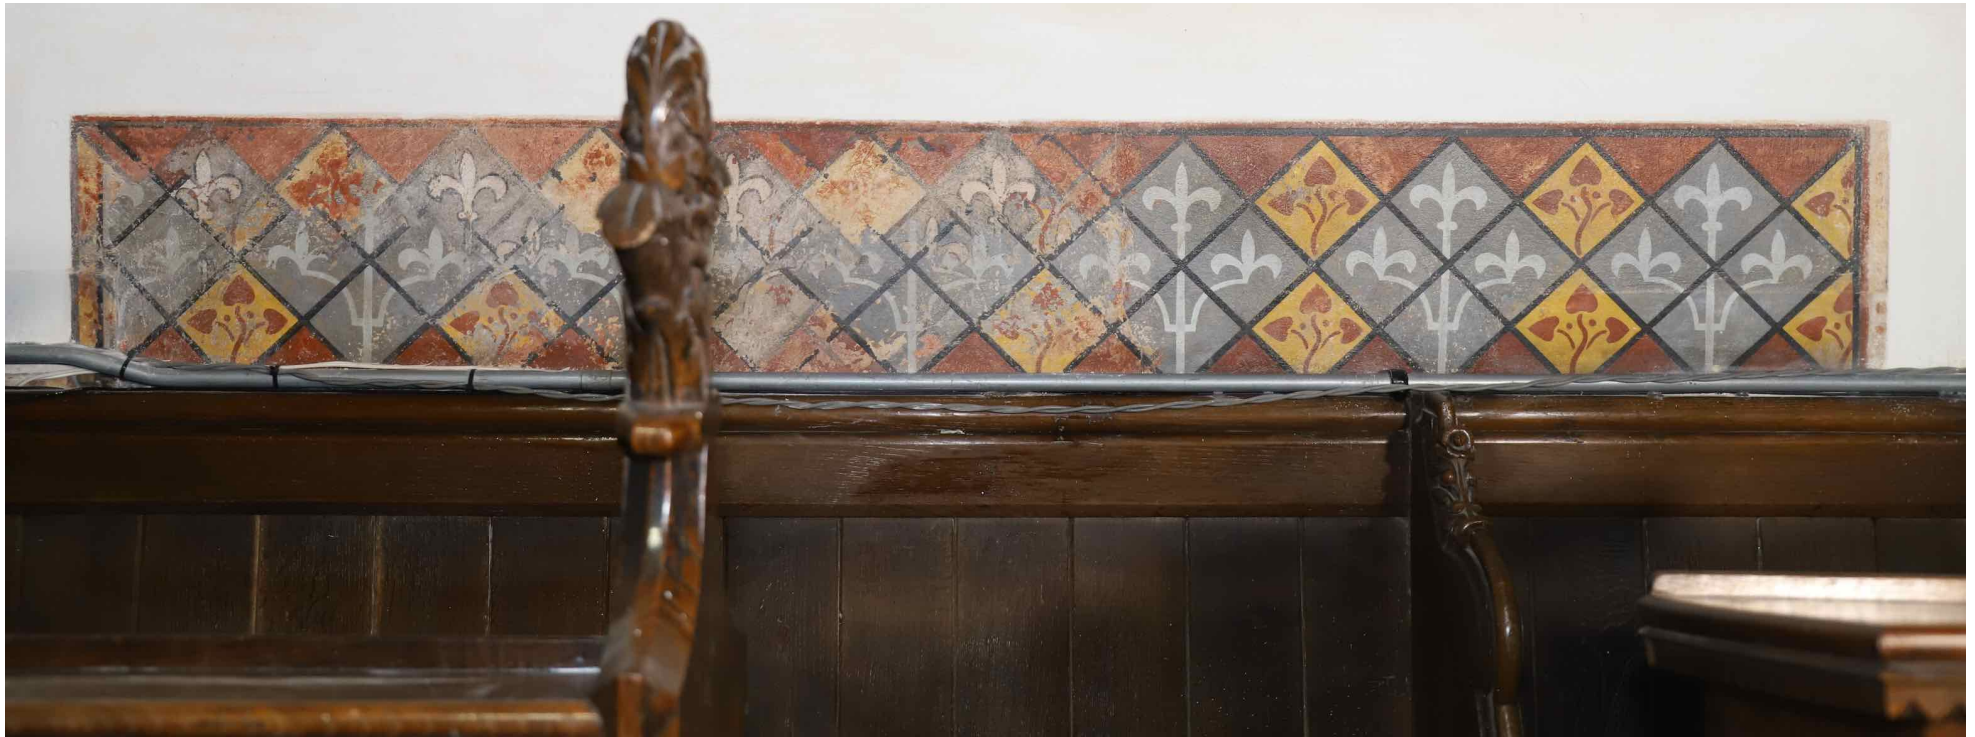
**Plate 17:** the lozenge decoration on the west side of the south wall was also fully revealed (cf, **plates 7-8** for its appearance before treatment).

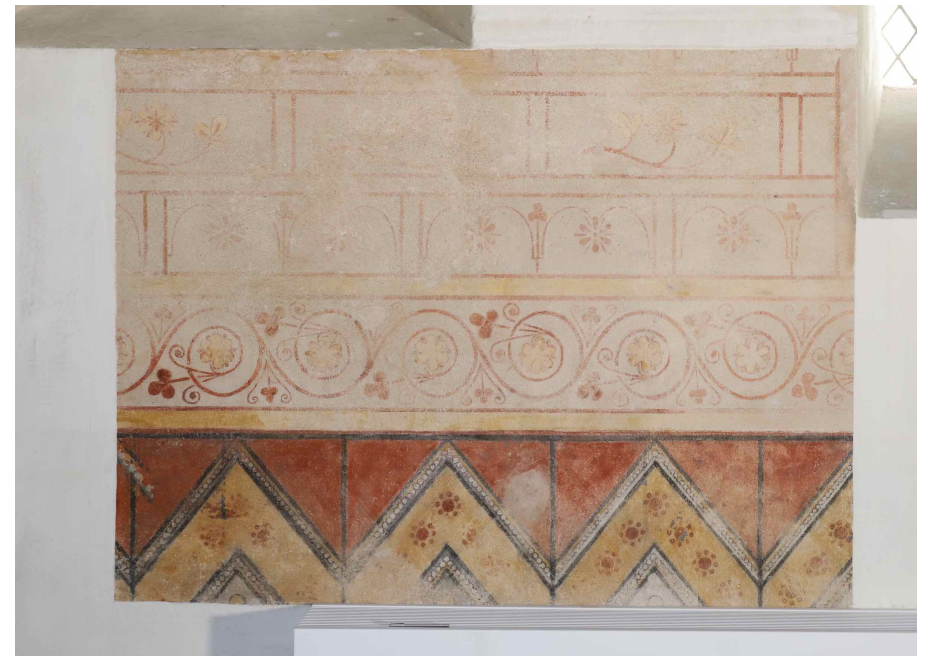
before uncovering

after uncovering (November 2019)

**Plates 18-19:** some selective uncovering was carried out at the east end of the south wall in November 2019. This was extended in Phase 2, as shown in the images on this page.

after completion of uncovering and conservation in 2020

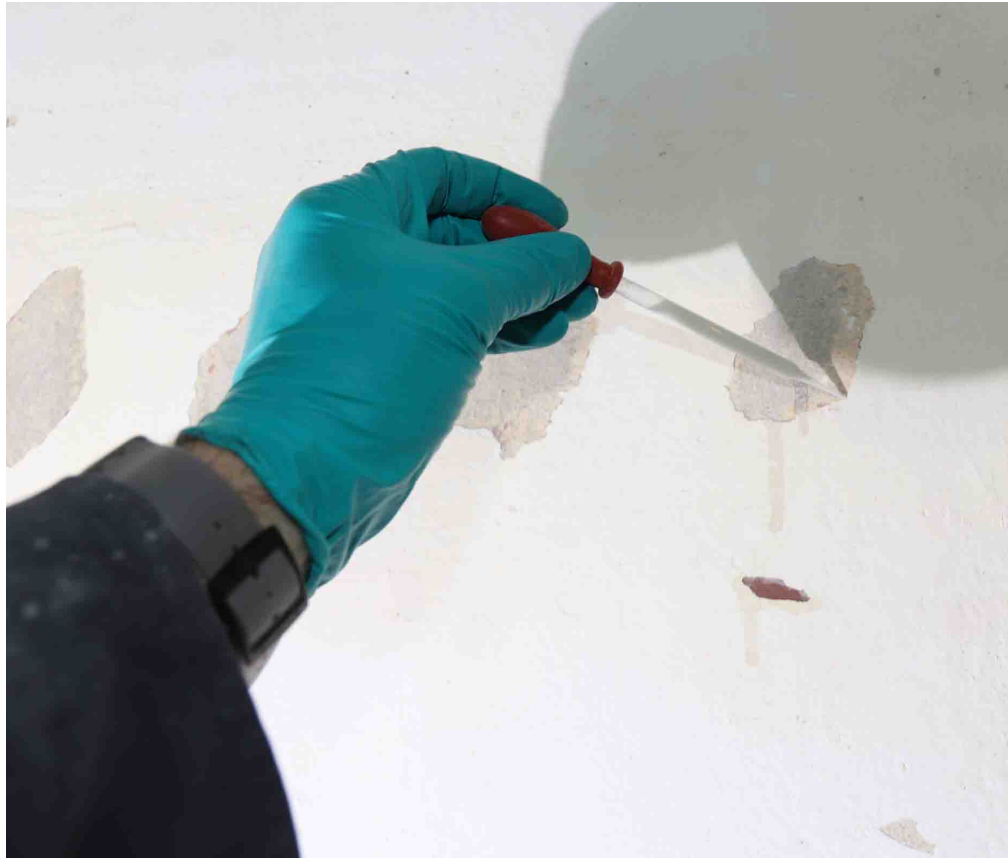
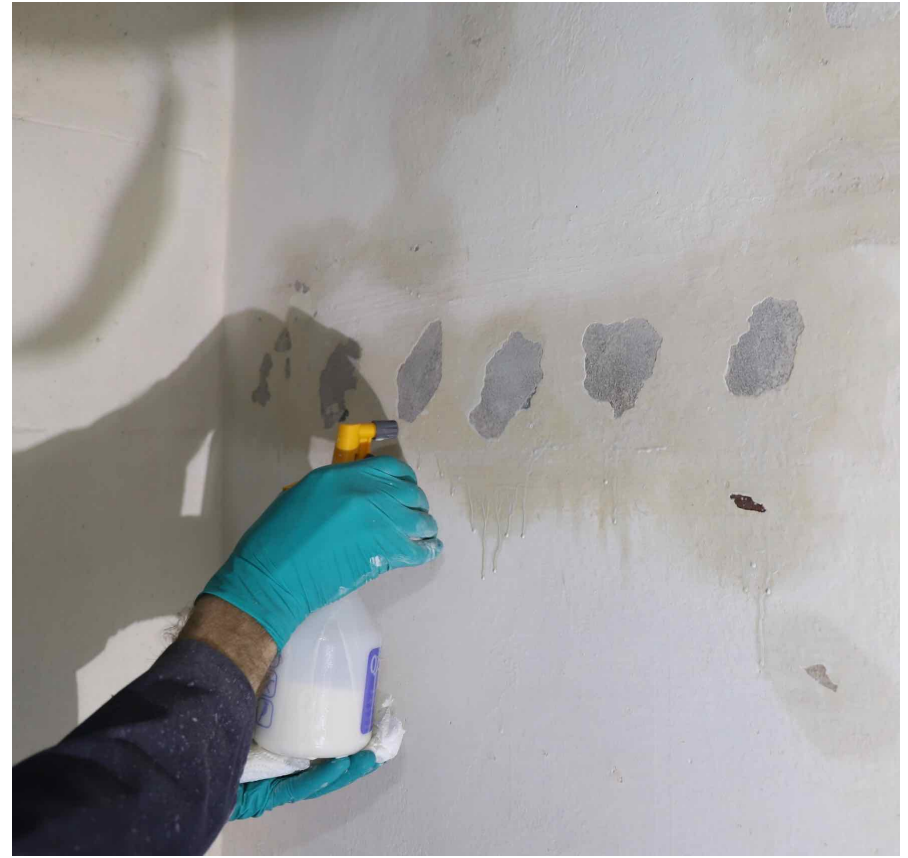
**Plates 20-21:** although a major objective of the treatment programme was to reveal representative areas of painting (where safe to do so), it was also necessary to stabilise and protect vulnerable painting that had already been partly exposed as result of damage and deterioration, in preparation for the general redecoration of the chancel. Areas of exposed and powdering original painting were first consolidated with the conservation-grade adhesive, AcrilME® (5-10% in water), delivered by pipette (**above left**). The next stage was to provide an appropriate inert covering layer. A suspension of chalk powder in industrial methylated spirit (IMS) was prepared to a smooth consistency. The IMS reduces the surface tension of both the chalk particles and the wall surface, allowing a smooth and even application. Its fast evaporation rate also allows for speedier application of successive layers. The mixture was spayed evenly over exposed painting and allowed to dry (**above right**). This was repeated several times to produce a thick chalk covering. Over this, limewash was then applied, initially by spray, then by brush. In this way, contact of the lime with the underlying painting is avoided.

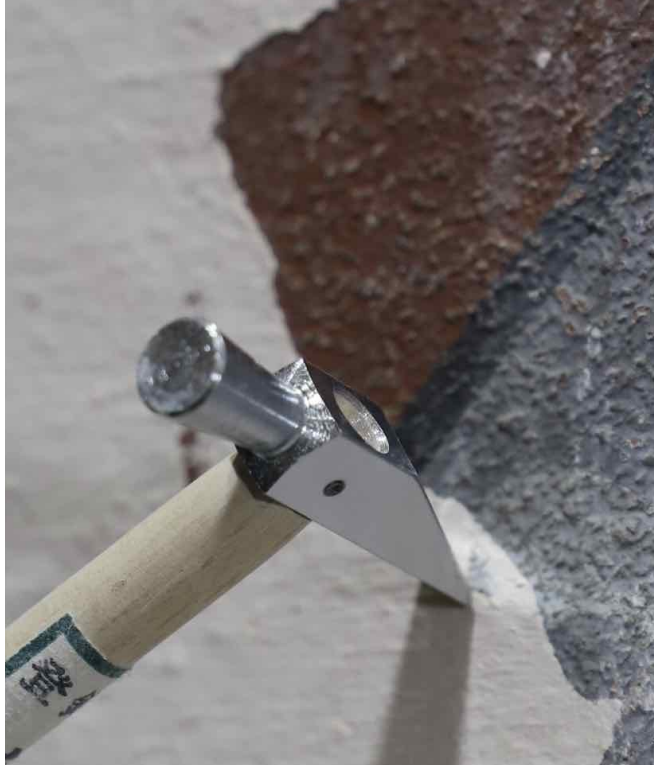
Plates 22-24: uncovering was carried out manually, using small hammers and scalpels, as shown in the images above.

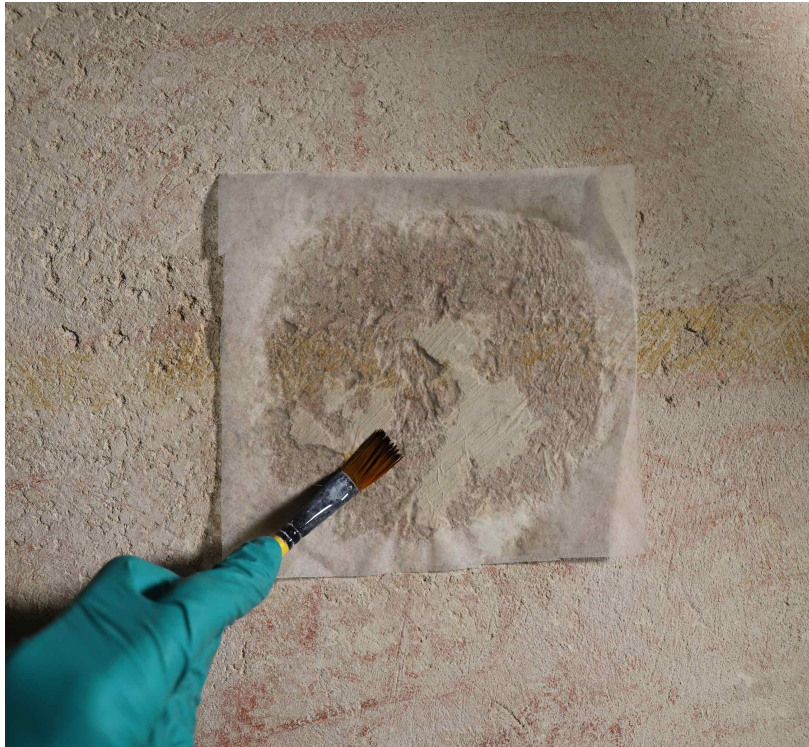
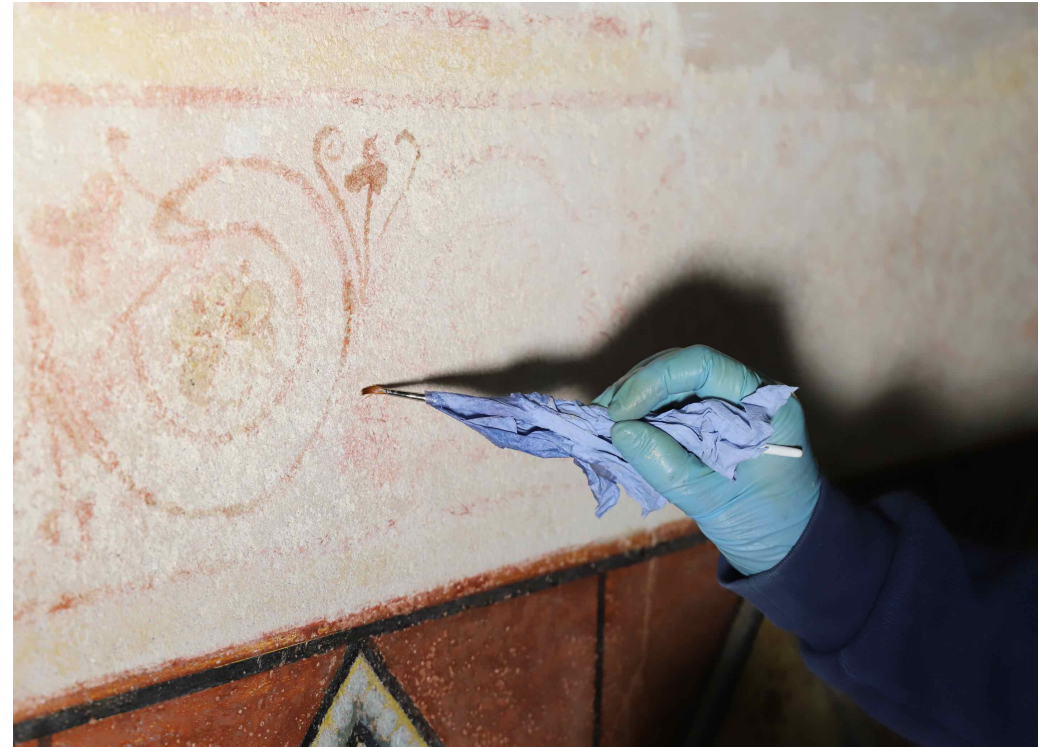
**Plates 25-26:** consolidation was required for different purposes and was carried out at different stages of the treatment programme. During uncovering, some areas of concealed painted plaster required pre-consolidation, to enable covering layers to be removed without causing damage. For this, the conservation-grade adhesive, AcrilME® (5-10% in water) was applied through an intervention layer of lens tissue (**above left**). After uncovering, areas of powdery pigment were consolidated with the acrylic resin, Paraloid B72®, [10% solution in methyl proxitol : acetone (60: 30 parts v/v)] (**above right**).

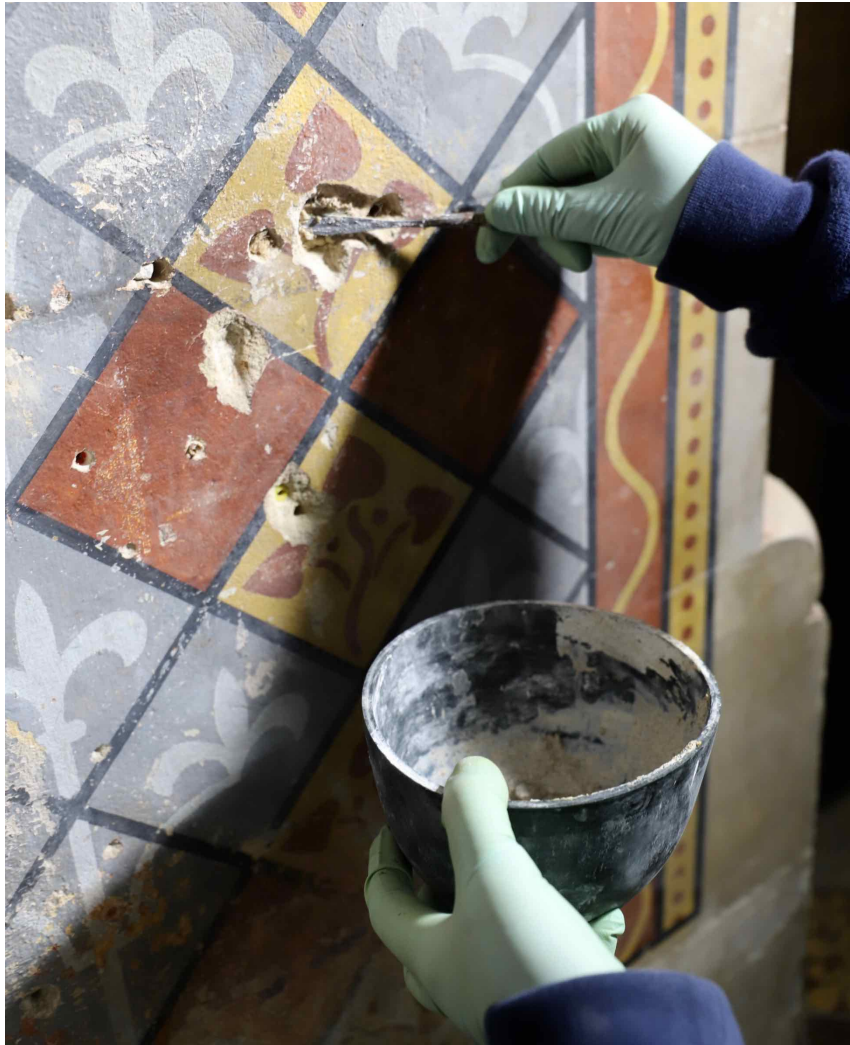
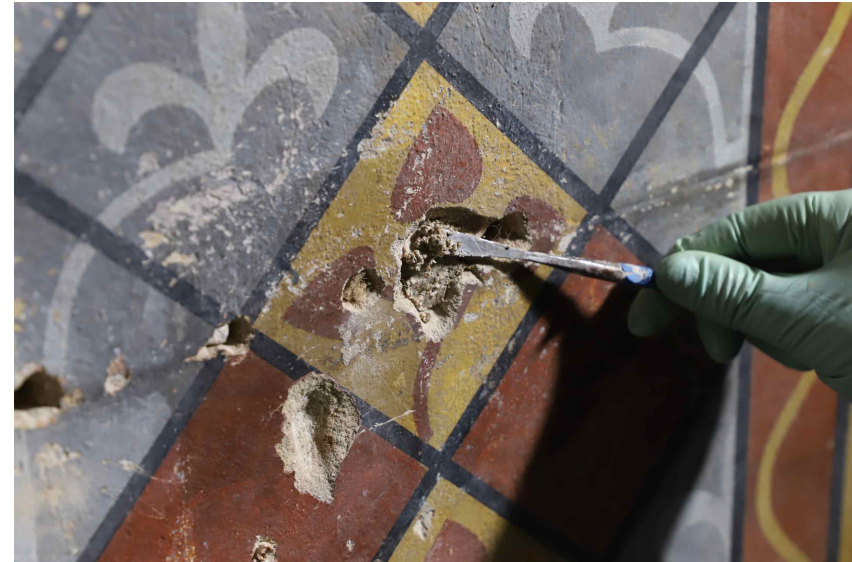
**Plates 27-29:** losses and damages in the painting were repaired with lime plaster. For deep losses, a coarse base-layer was first applied (1 part lime: 4 parts lime v/v). When this had set, a finer upper layer was next applied (1 lime : 2 parts fine sand : 1 part marble powder v/v). For shallow losses, only the fine plaster was used.

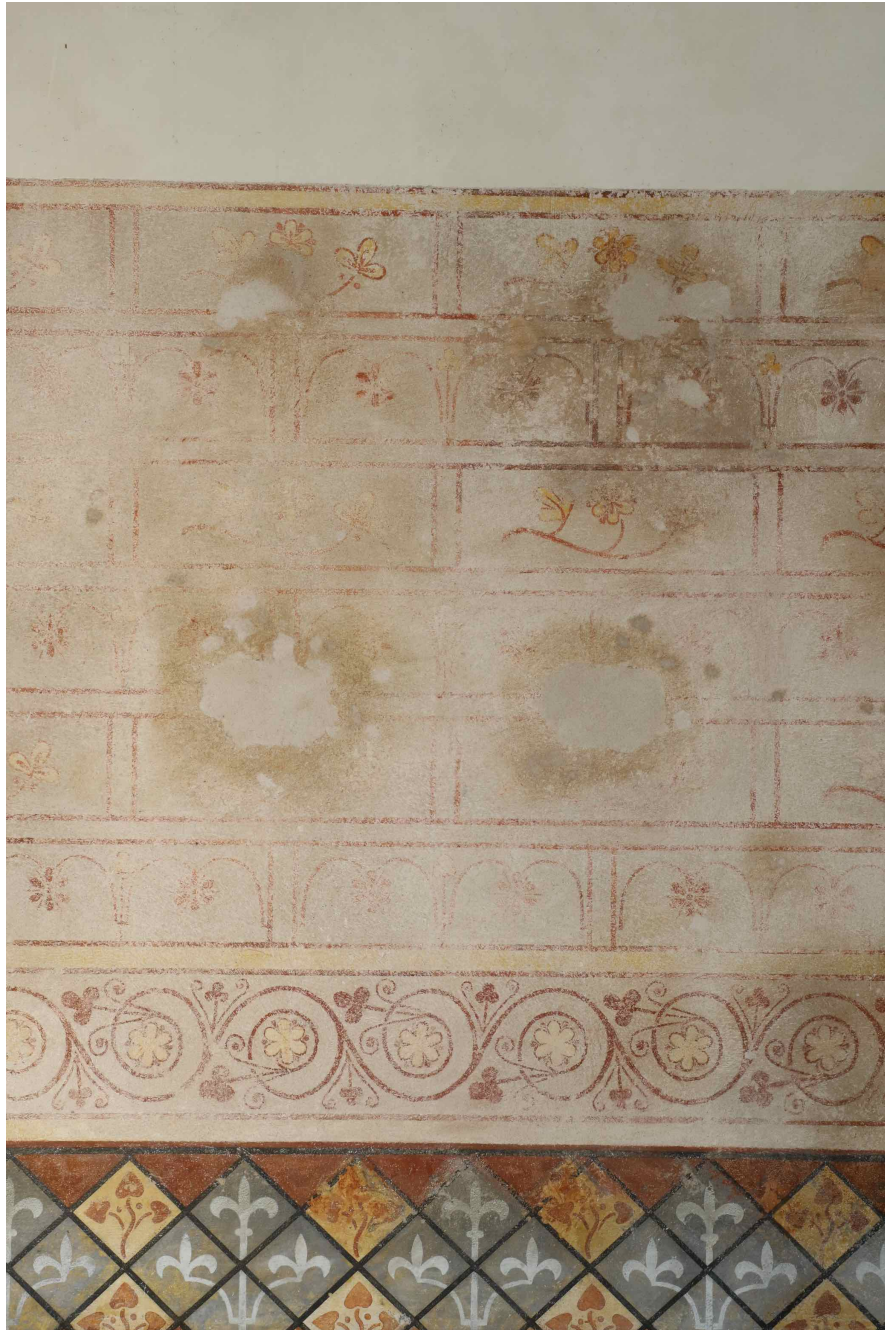
**Plate 30:** uncovering revealed damages associated with fixtures for a now lost wall monument. This image shows the damages after their repair with lime plaster.

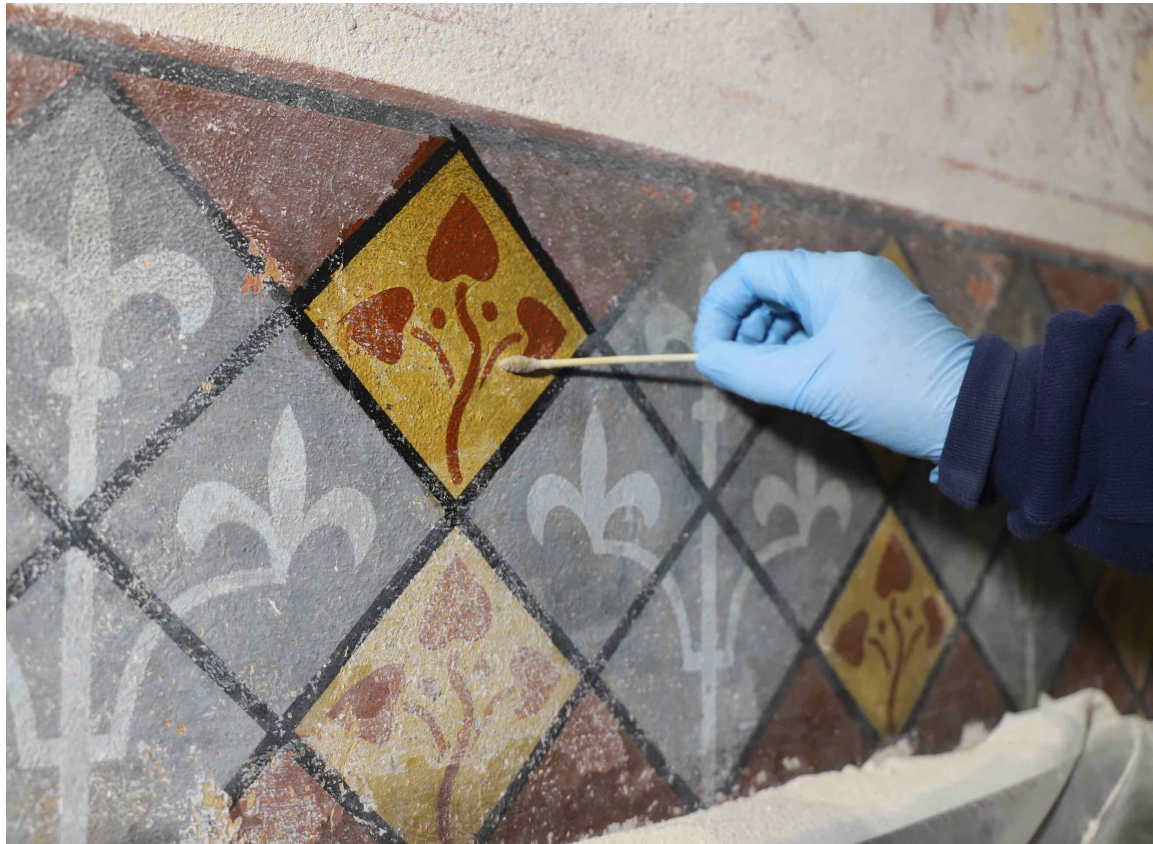
**Plates 31-32:** there is evidence from other 19C ecclesiastical wall painting schemes that hard-wearing oil paints were used at dado level, and distemper paint was employed on the less accessible upper walls. This appears to have been the case in the chancel at Upton Magna. The lozenge decoration on the lower part of the wall has a shiny compact appearance, and generally survives in better condition than the simpler decorative painting higher up. It had also imbibed a lot of dirt. Synperonic A7® was selected to clean the painting. Synperonic A7® is a 100% active water-soluble alcohol ethoxylate, used as a non-ionic detergent, wetting agent, surfactant, emulsifying and dispersing agent. It is readily biodegradable, and effective at higher dilutions than earlier formulations, making it an extremely environment-friendly cleaning agent. To address the particular conditions of the chancel paintings, a dilution of 0.5% Synperonic A7® in H<sub>2</sub>O was employed.

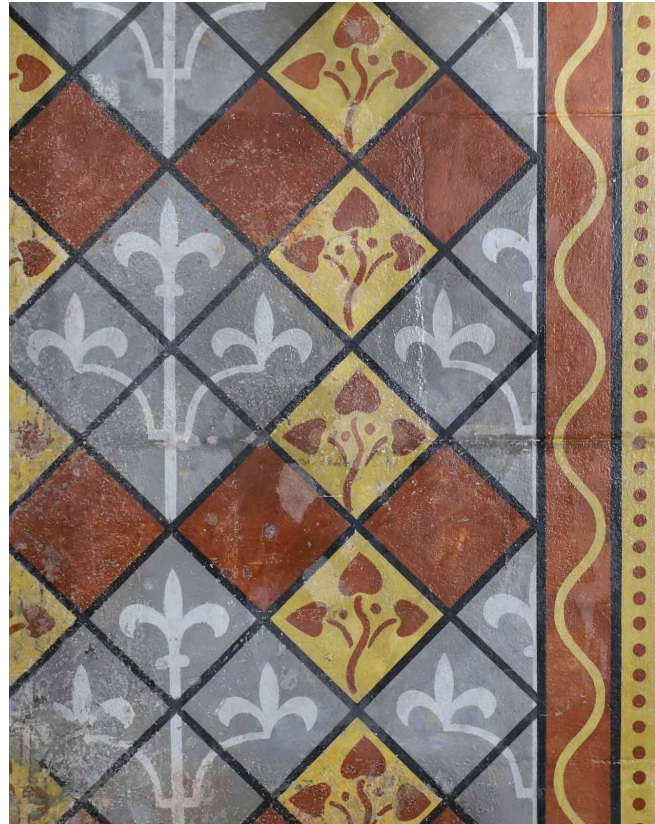
before reintegration

after reintegration

**Plates 33-35:** distracting losses and damages in the painting were reintegrated with reversible water-colour paints, applied either on new plaster repairs or over the original exposed plaster. New colours were matched to the original paint, but on close inspection original and added paints remain distinguishable. Where necessary and appropriate, limited reconstruction was done to enhance interpretation and appreciation of the painting.

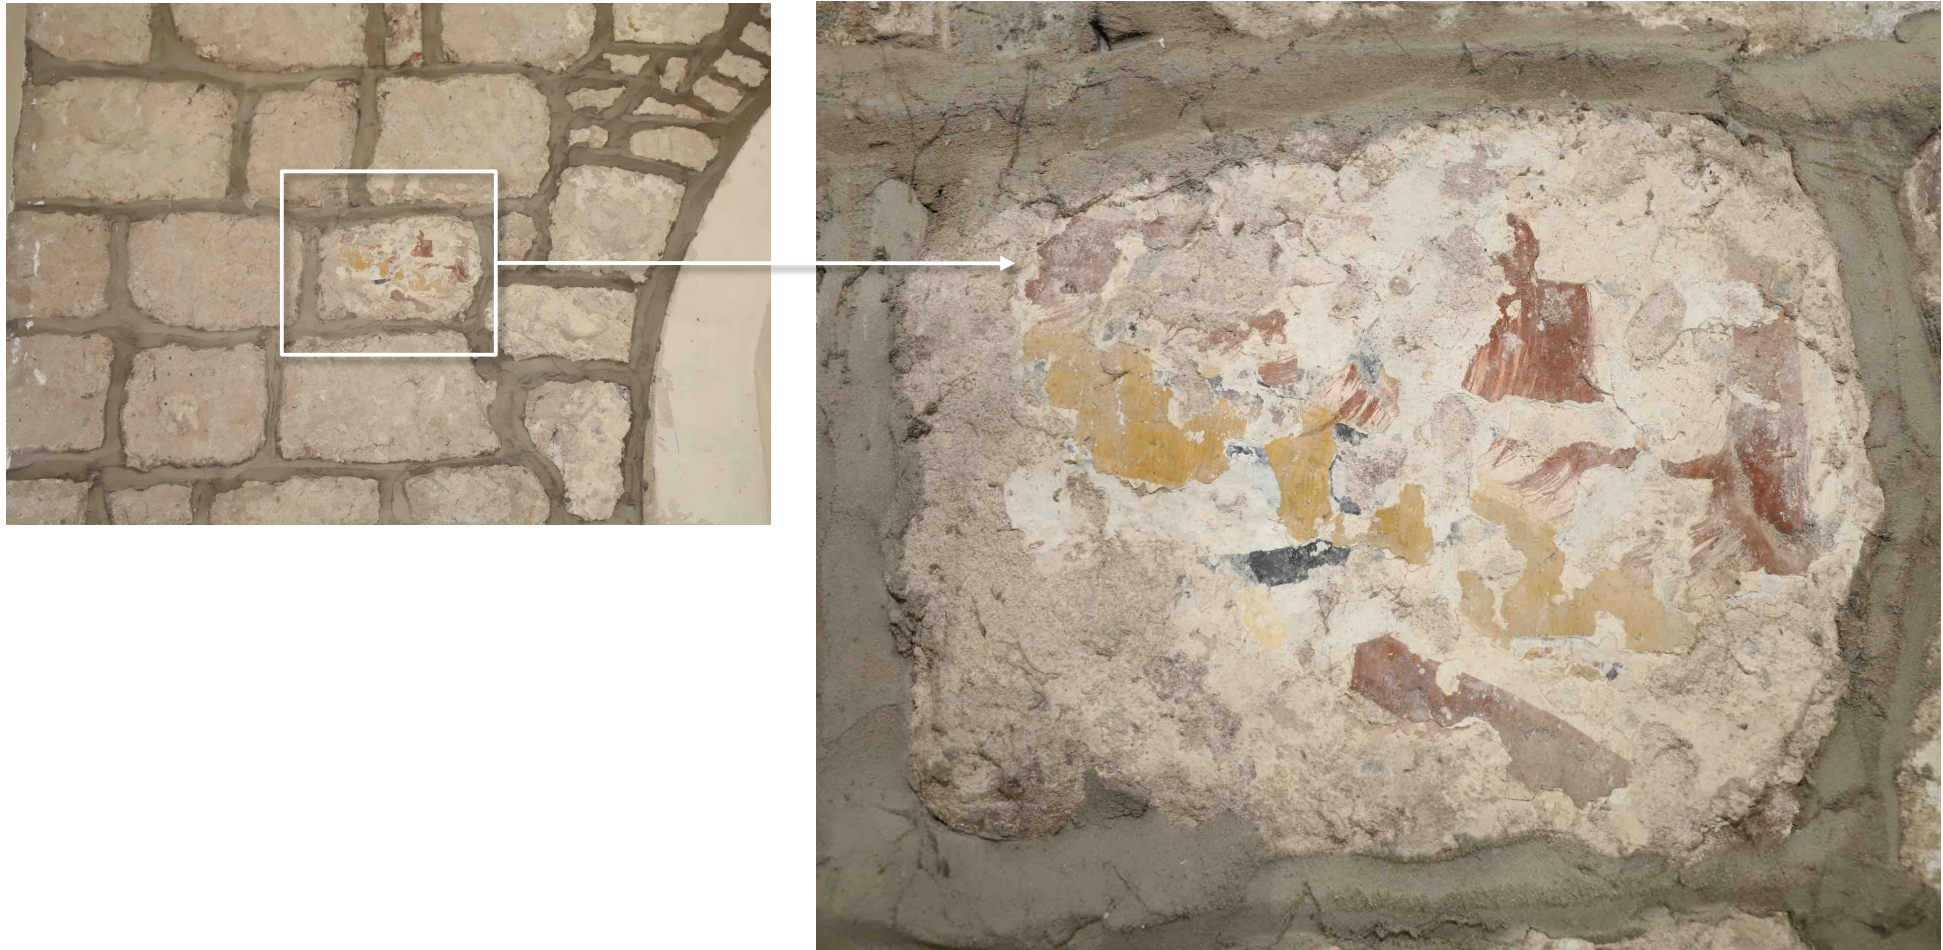
**Plates 36-37:** other than in the tower, the nave south wall is the only part of the church where the medieval stone fabric is preserved and exposed. At the east end of the south wall, a few stones retain traces of painting. The main paint remains are on one large stone (**above**). At least two phases of painting are present: on the lowest level are traces of painting in black and white; above this, there is a separate period of painting in red and yellow. Both phases must pre-date the Victorian restoration of the church, and could be of medieval date or belong to the post-Reformation period when the walls of church interiors were typically painted with framed biblical texts. Unfortunately the surviving painting preserves hardly any distinguishing features. However, post-Reformation text paintings were usually executed quite simply, typically on limewash layers rather than on plaster. These characteristics accord with these paint traces, which have been recognised here for the first time.
