# Upton Magna, Shropshire Church of St Lucia

## Conservation and Recovery of the Wall Painting Scheme:

### Phase 2

April 2020

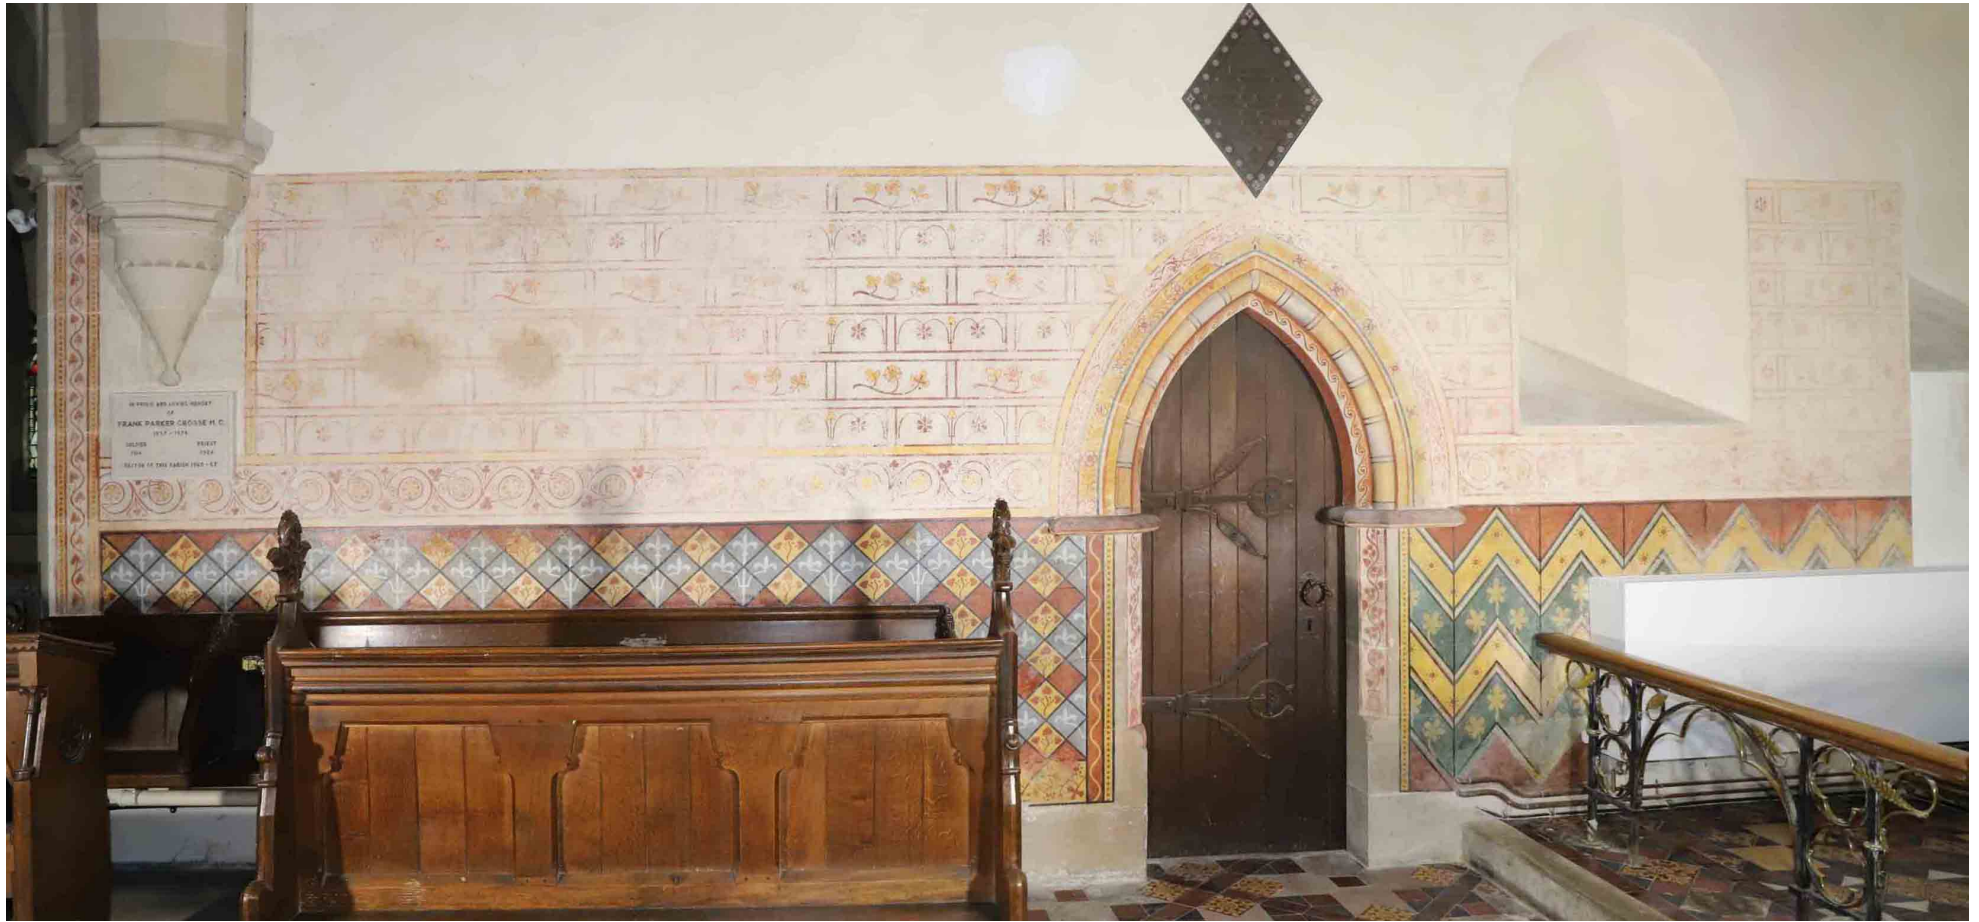
**Plate 38:** although the newly revealed areas of painting in the chancel are only a partial reflection of the original appearance of the decorated interior, they serve an important function in maintaining awareness of the presence, variety and significance of the original painting and decoration in different parts of the church interior. The painting uncovered and conserved on the lower part of the chancel south wall is the largest expanse treated in the conservation programme, and provides vivid testimony to G. E. Street's original decorative scheme.
