Upton Magna, Shropshire Church of St Lucia

Conservation and Recovery of the Wall Painting Scheme:

Phase 1

December 2019

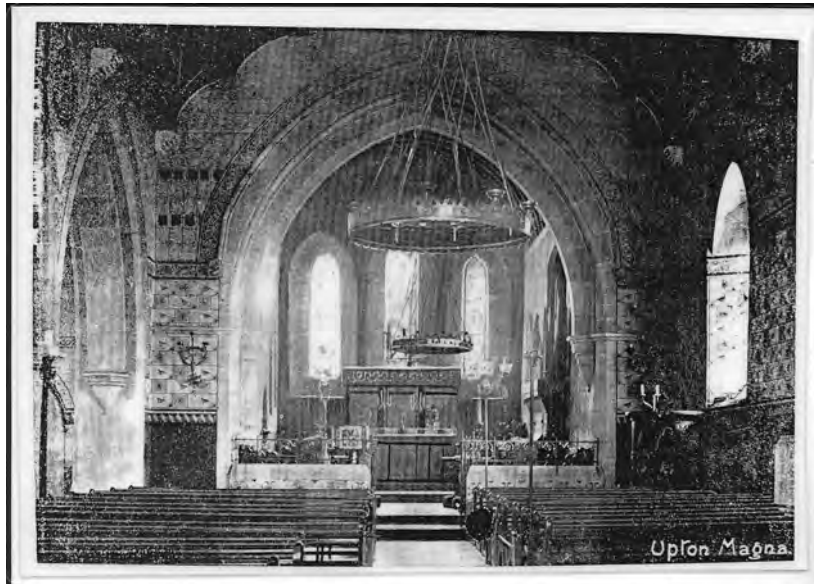
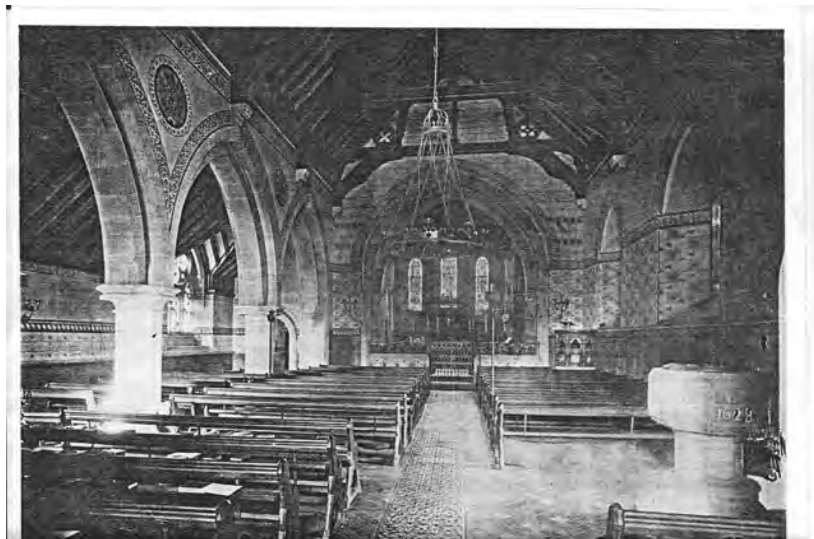
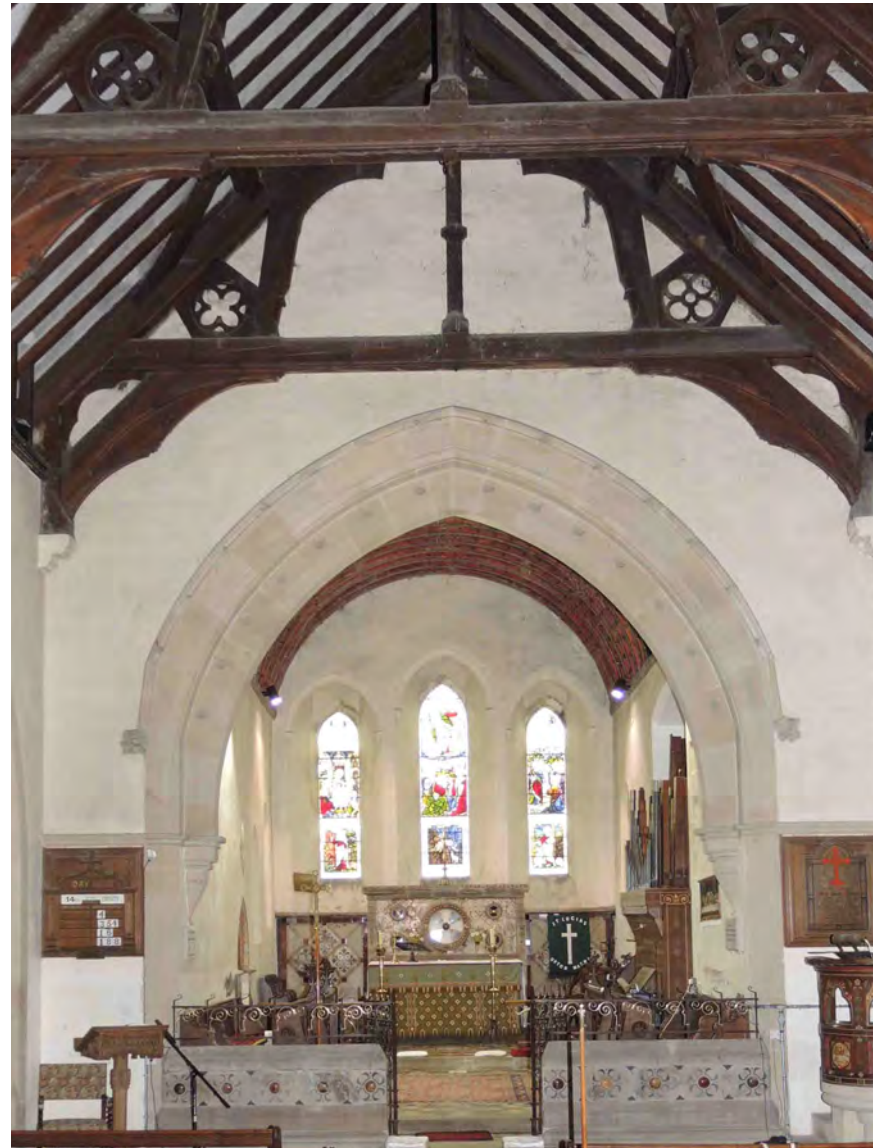
Plates 1-3: archival photograph of the nave taken before the interior of the church was whitewashed shows the appearance and comprehensive extent of the wall painting scheme (top left and bottom left). Today, the scheme is concealed from view, although indications of its presence remain apparent beneath the covering whitewash (right).

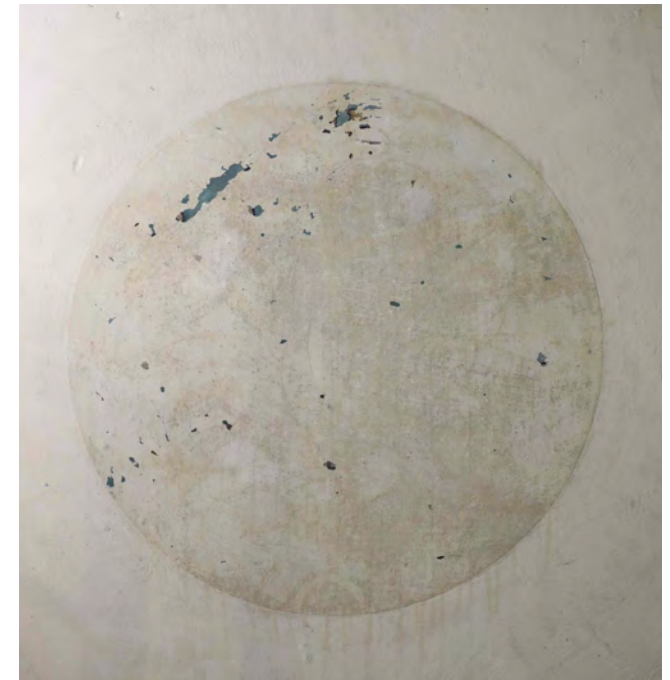
Plates 4-6: some painting at Upton Magna was done on canvases that were adhered to the walls. At the west end of the nave is a fine **Baptism of Christ**, which is still visible. However, two canvas roundels that decorate the nave arcade had been whitewashed over (**middle and right images**). Their foliate designs are known from archival images (**top left**). Tests carried out in 2017 demonstrated that the roundels could be safely uncovered.

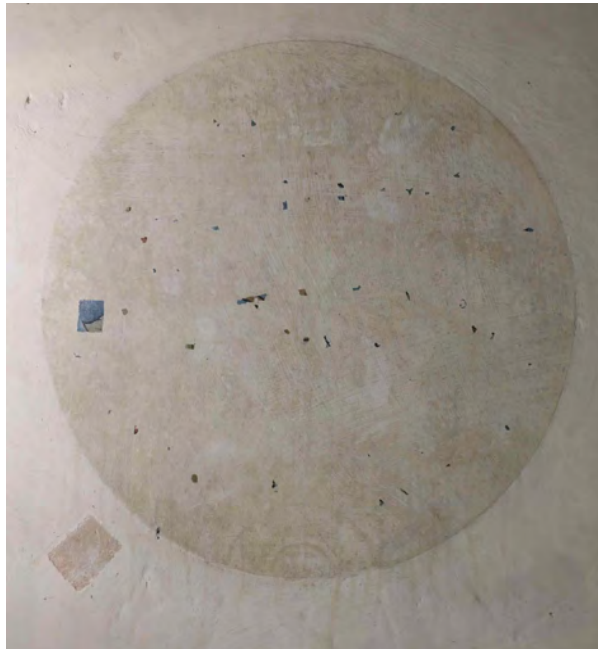
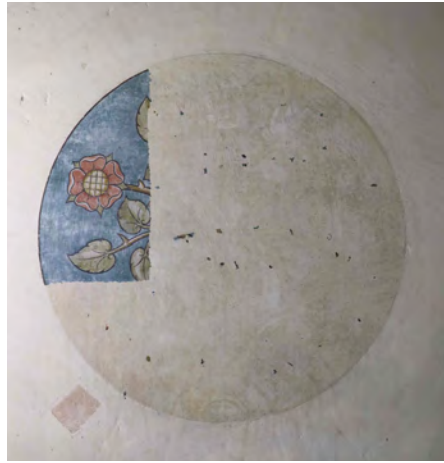
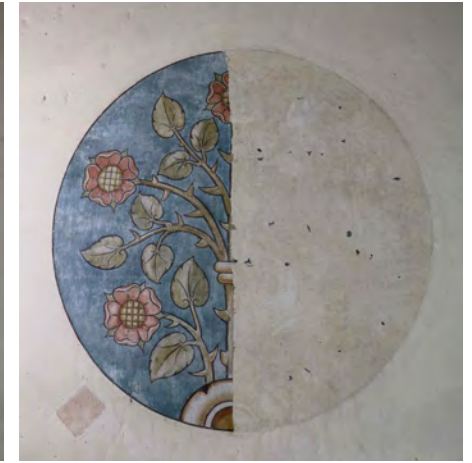
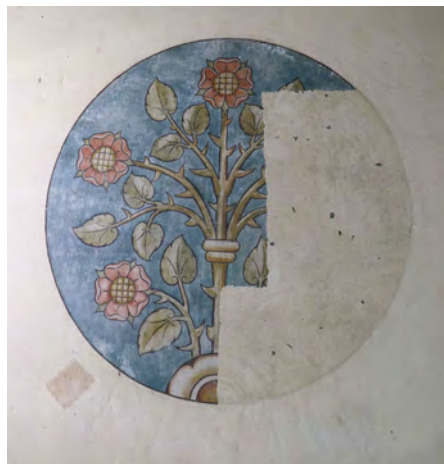
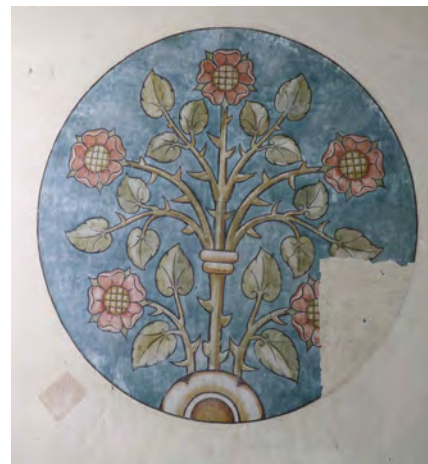
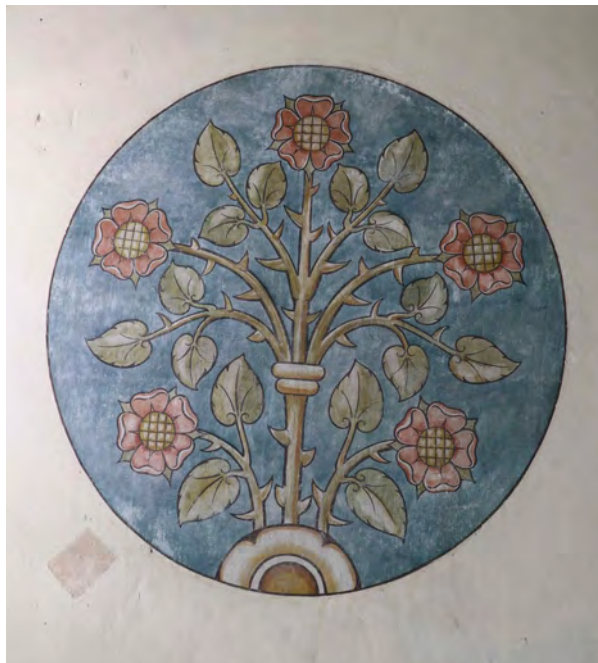
Plates 7-13: stages in the uncovering of the westernmost roundel. Uncovering was carried out by mechanical methods, using scalpels and small spatulas.

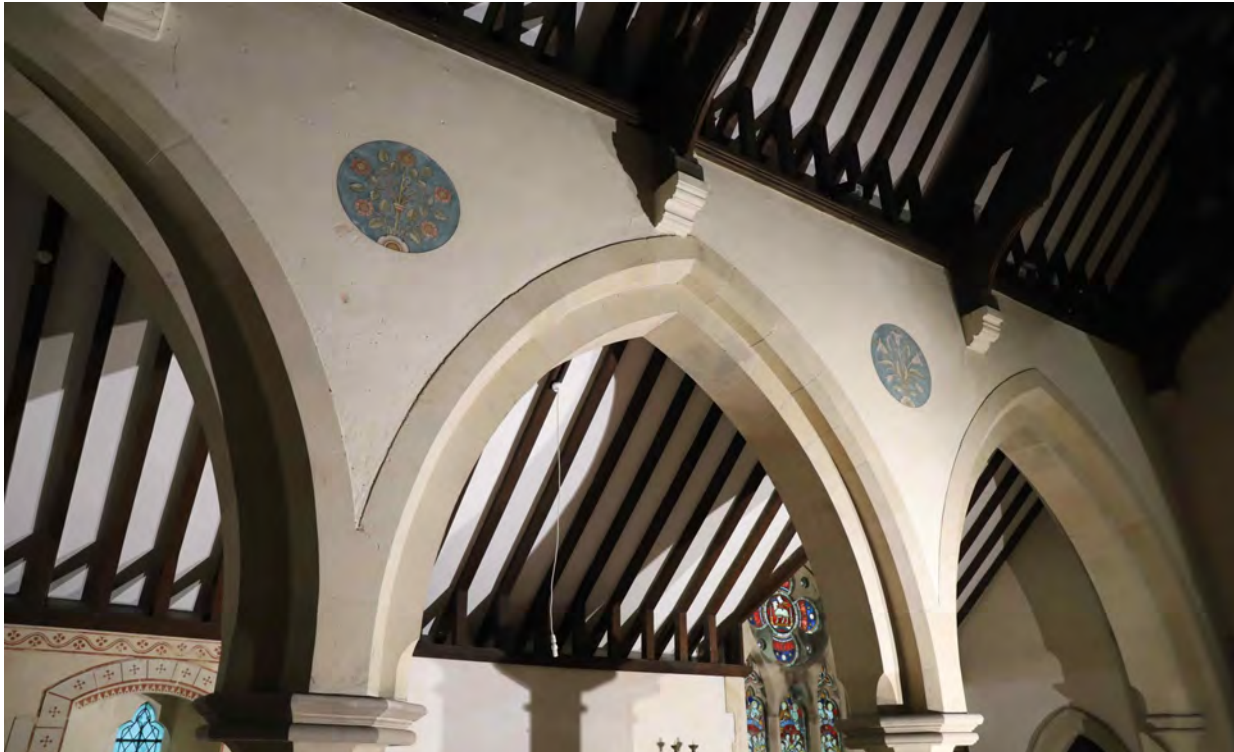
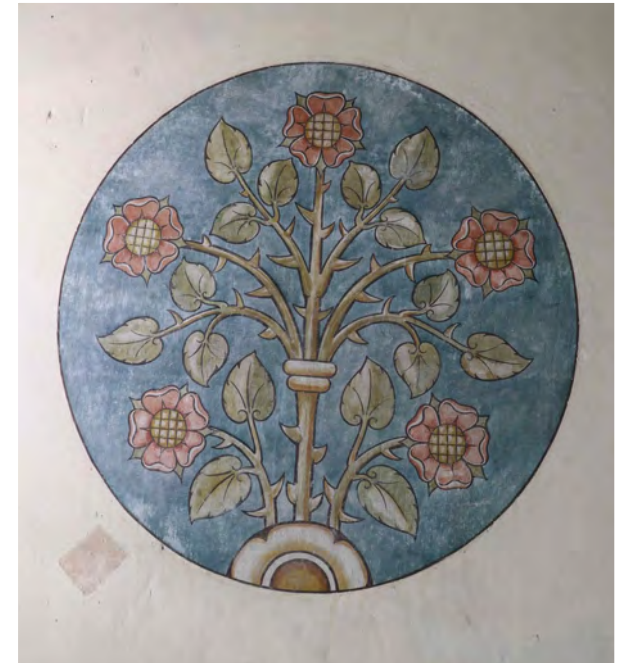
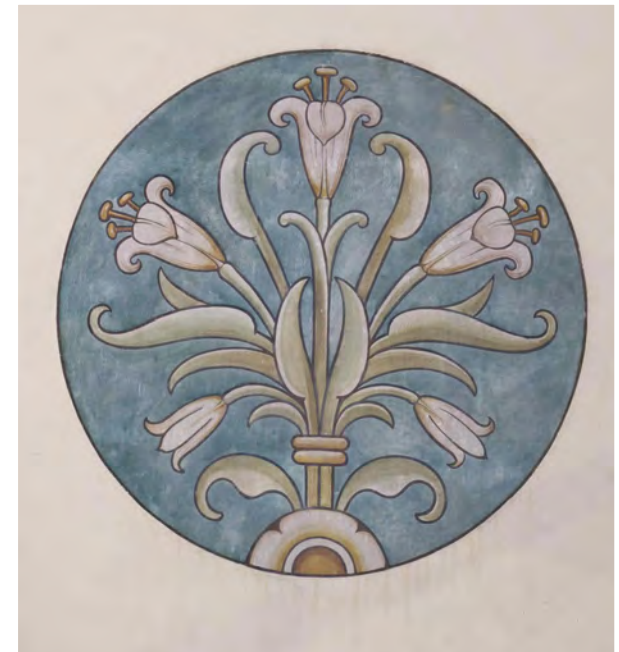
Plates 14-16: the roundels enclose arrangements of red roses and white irises. Given G. E. Street's preoccupations with religious symbolism, these were probably not meant to be simply decorative in intent, but also to convey meaning. They probably refer to the purity of the Virgin Mary.

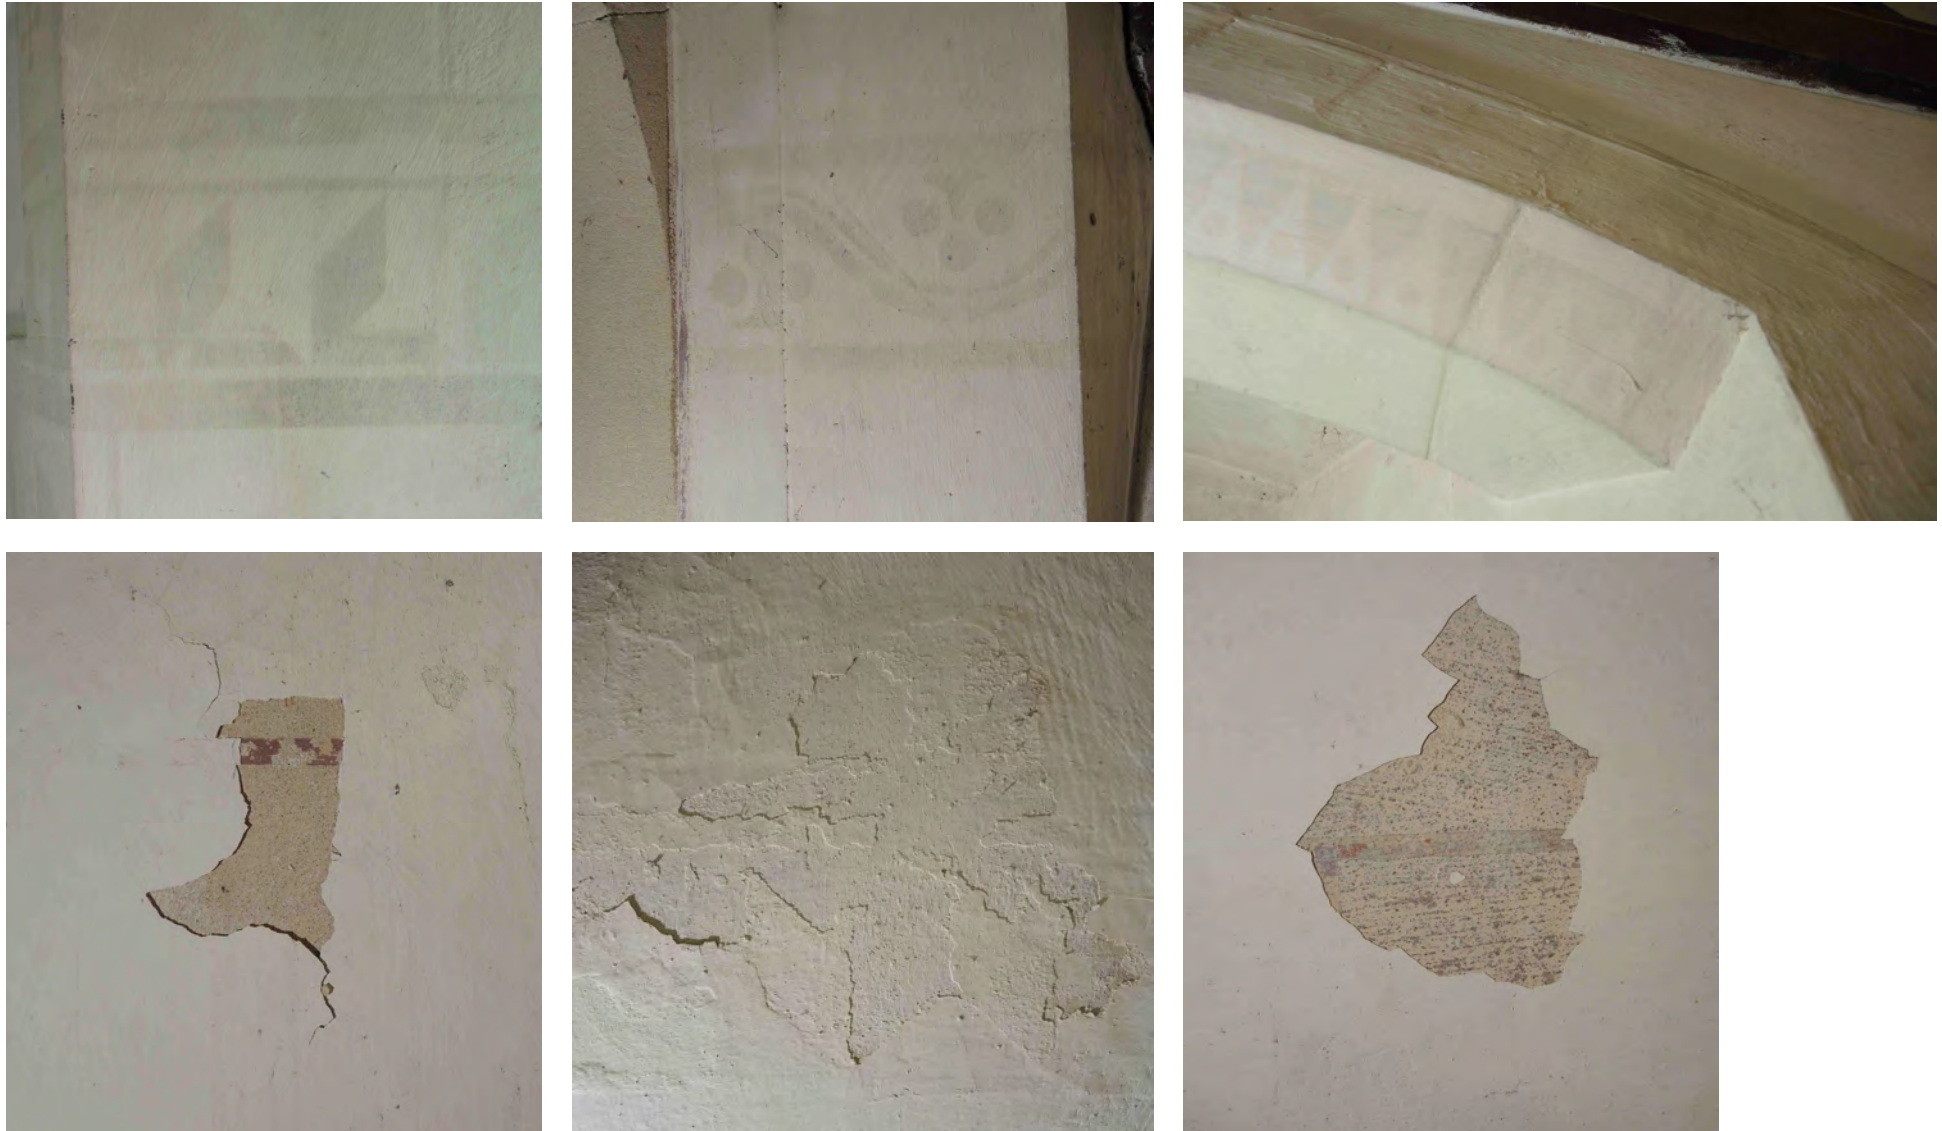
Plates 17-22: as elsewhere on the interior of the church, concealed painting in the north aisle is extensive, and much of it is still preserved beneath the whitewash (**top images**). However, damage and deterioration also mean that some areas of painting have either been lost or are too fragile to be safely uncovered (**bottom images**).

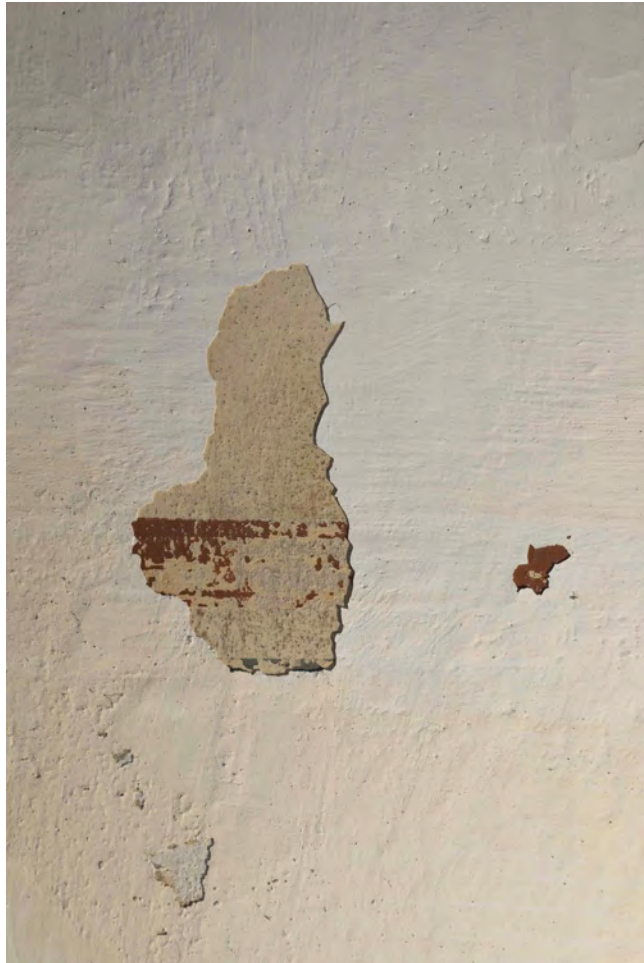
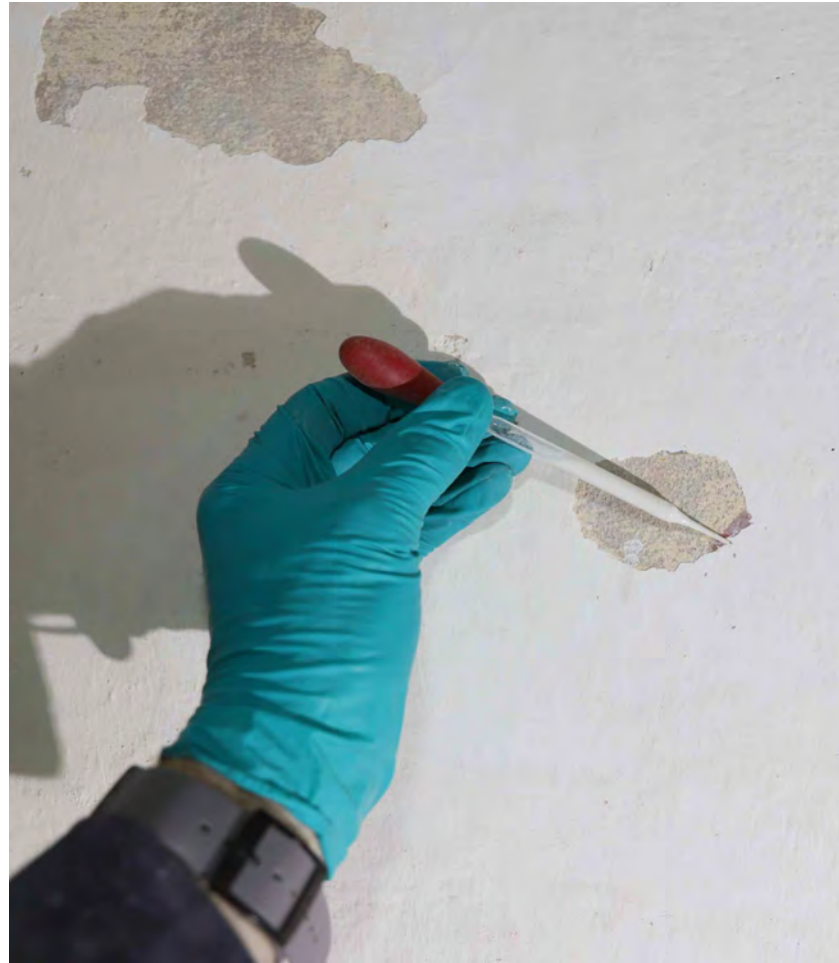
Plates 23-24: although a major objective of the treatment programme was to reveal representative areas of painting (where safe to do so), it was also necessary to stabilise vulnerable painting that had already been partly exposed as result of damage and deterioration throughout the aisle (**above left**), in order to make these safe for the planned general redecoration of the interior. Areas of exposed and powdering original painting were first consolidated with the conservation-grade adhesive, AcrilME® (5-10% in water), delivered by pipette (**above right**).

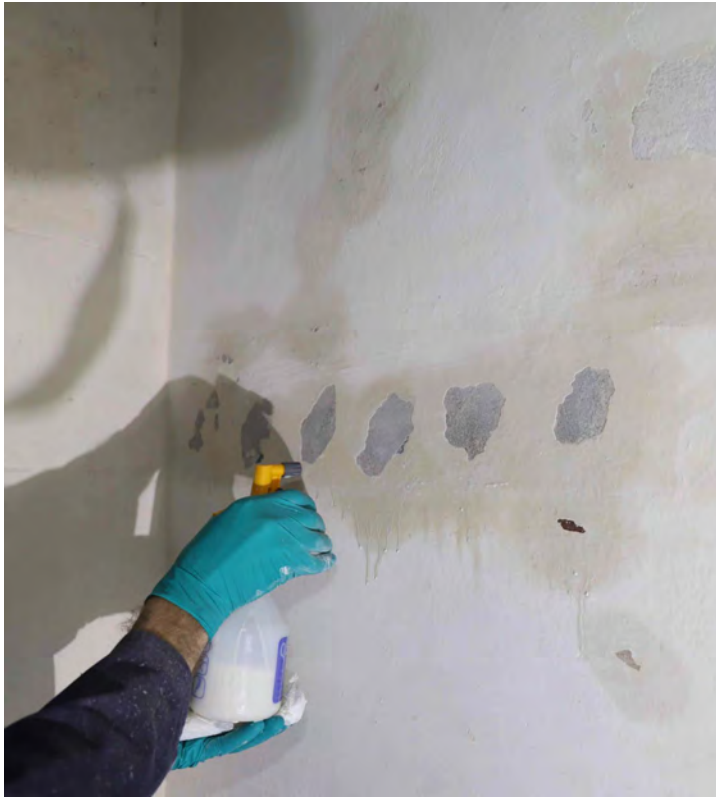
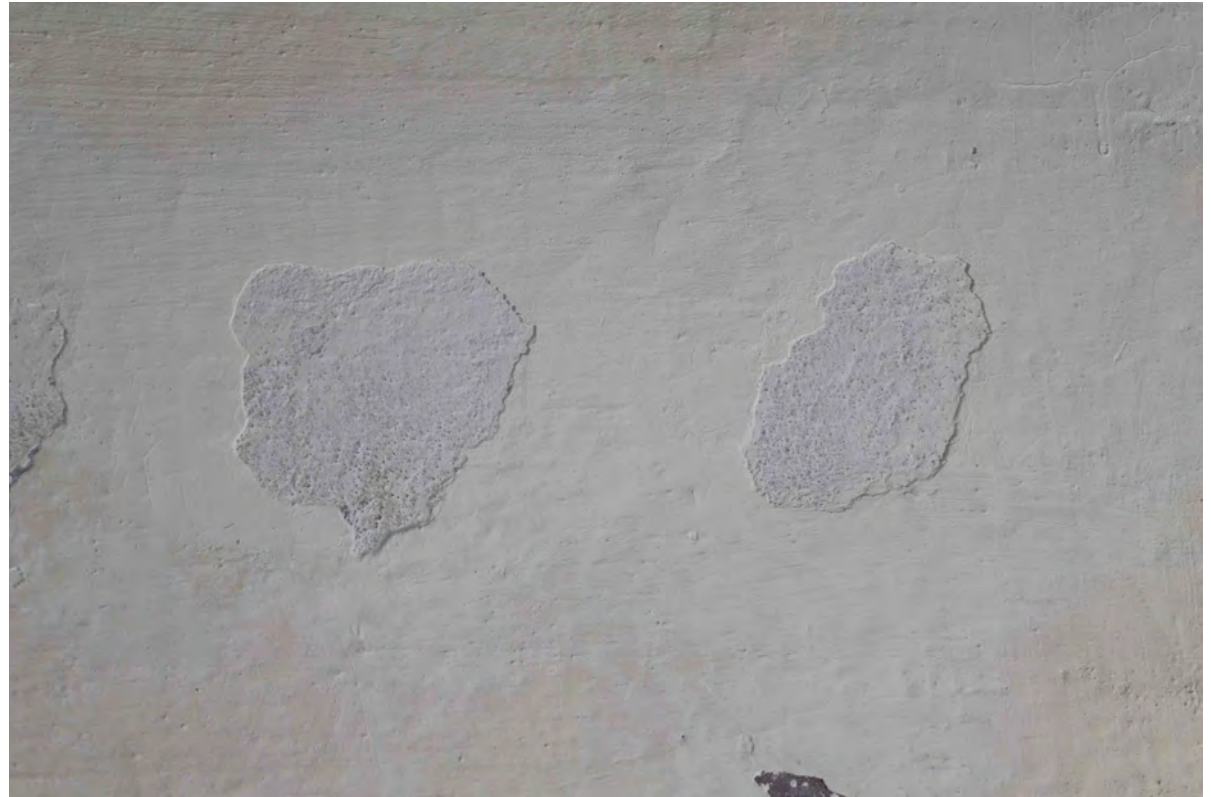
Plates 25-26: following the consolidation of areas of vulnerable exposed painting, the next stage was to provide an appropriate inert covering layer. A suspension of chalk powder in industrial methylated spirit (IMS) was prepared to a smooth consistency. The IMS reduces the surface tension of both the chalk particles and the wall surface, allowing a smooth and even application. Its fast evaporation rate also allows for speedier application of successive layers. The mixture was spayed evenly over exposed painting and allowed to dry (**above left**). This was repeated several times to produce a thick chalk covering (**above right**). Over this, limewash was then applied. A suspension of slaked lime putty and water was passed through a 100-mesh sieve to produce a mixture that also could be easily sprayed, so that the chalk layer would not be disturbed. In this way, contact of the lime with the underlying painting is avoided. Several layers of limewash were spayed, allowing drying in between in each layer. Final layers were applied by brush.

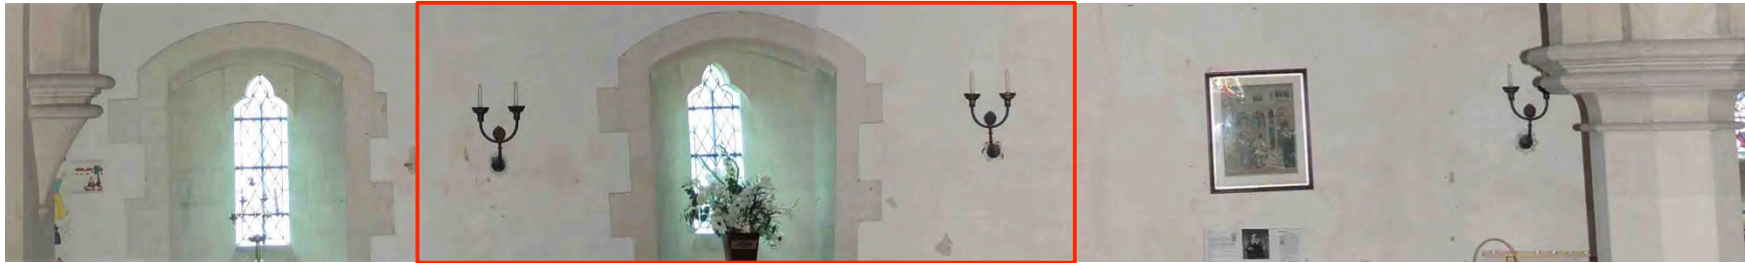
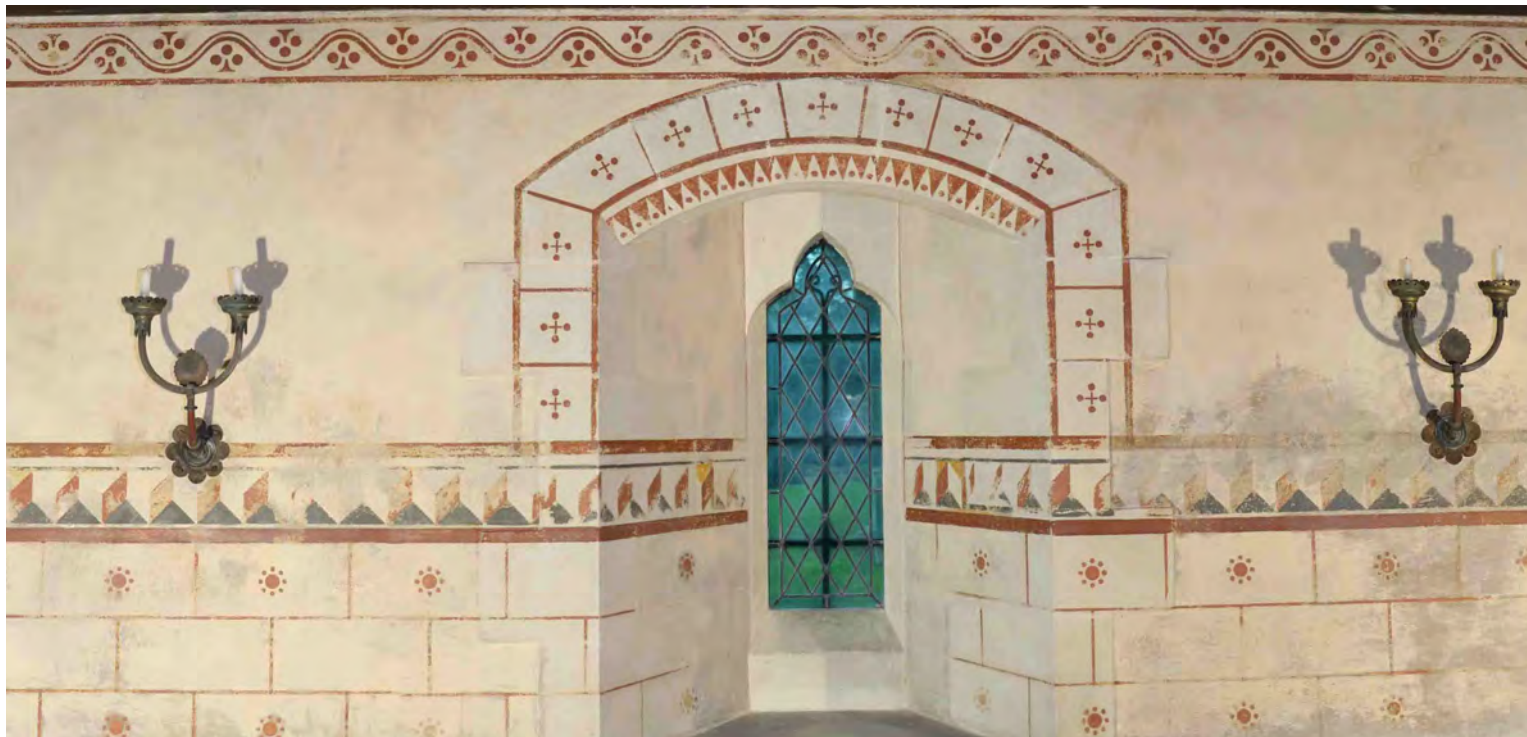
Plates 27-28: since uncovering was not safe or feasible in all areas of the north aisle, a representative area was carefully selected, indicated by the red box in the **top image**. Previous investigations had shown that the concealed painting survived in reasonably good condition here. Results of the uncovering are shown in the **bottom image**. The architectural decoration revealed here is consistent for the entire north aisle.

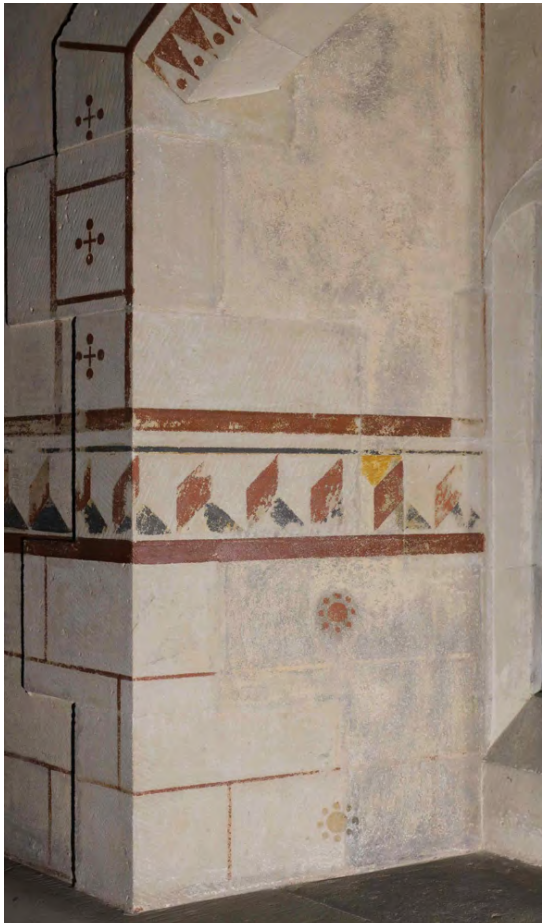
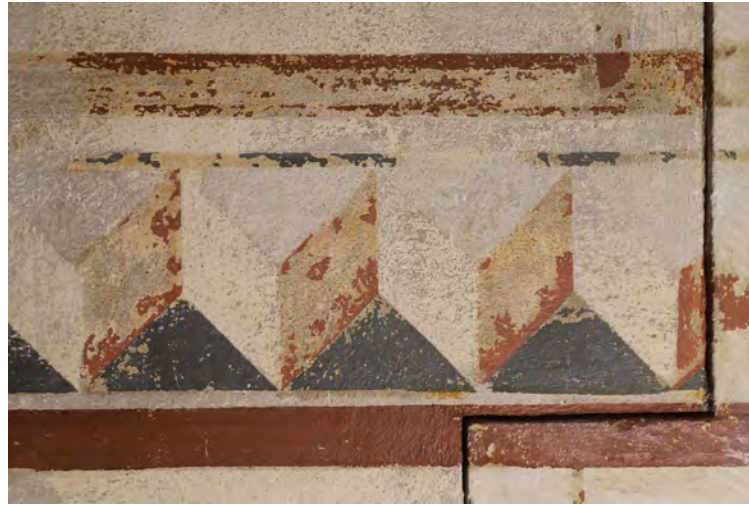
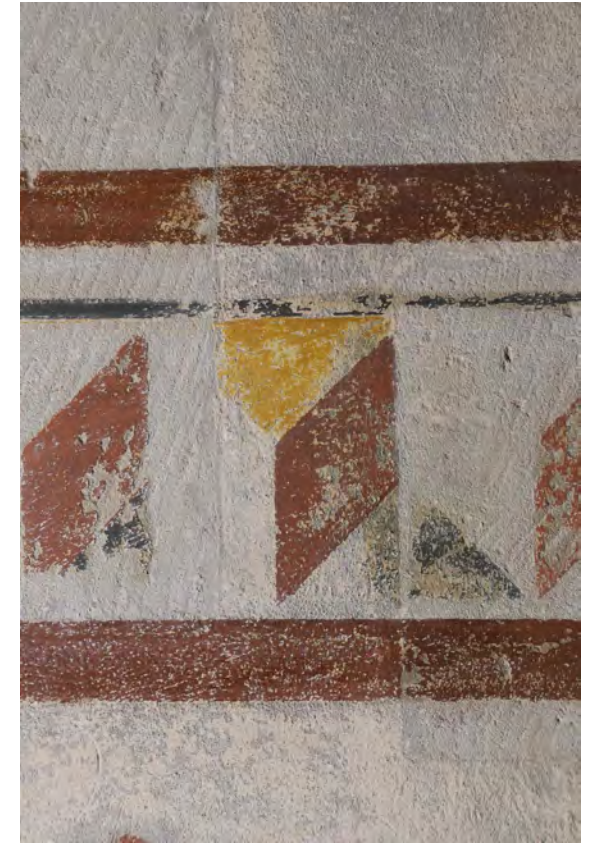
Plates 29-31: the architectural decoration includes a border of tumbling block cubes, their three-dimensionality rendered by the use of four colours, cream, grey, red and yellow. For the most part, the yellow paint has preferentially deteriorated. It is only present on a few of the cubes, as illustrated above.

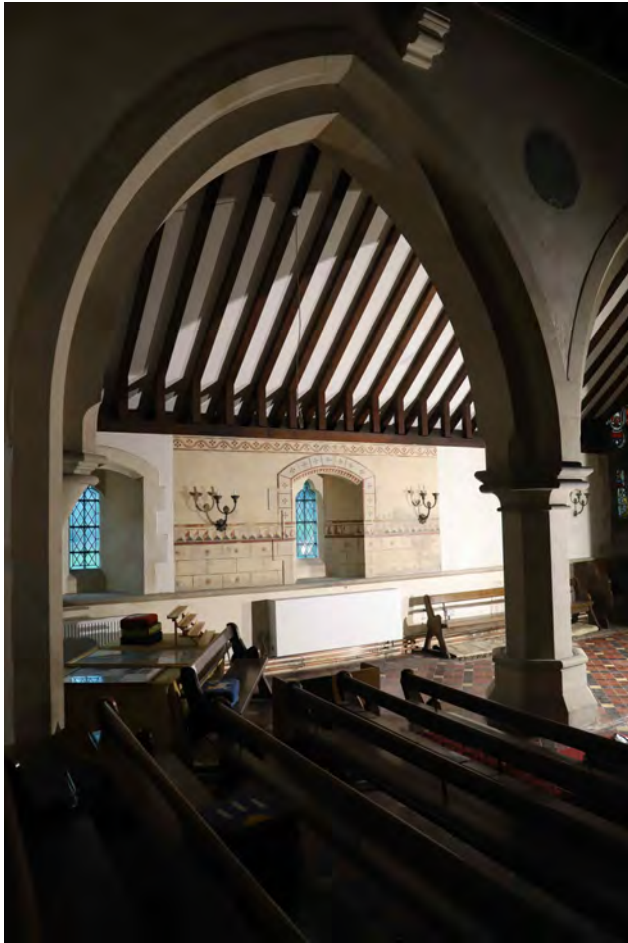
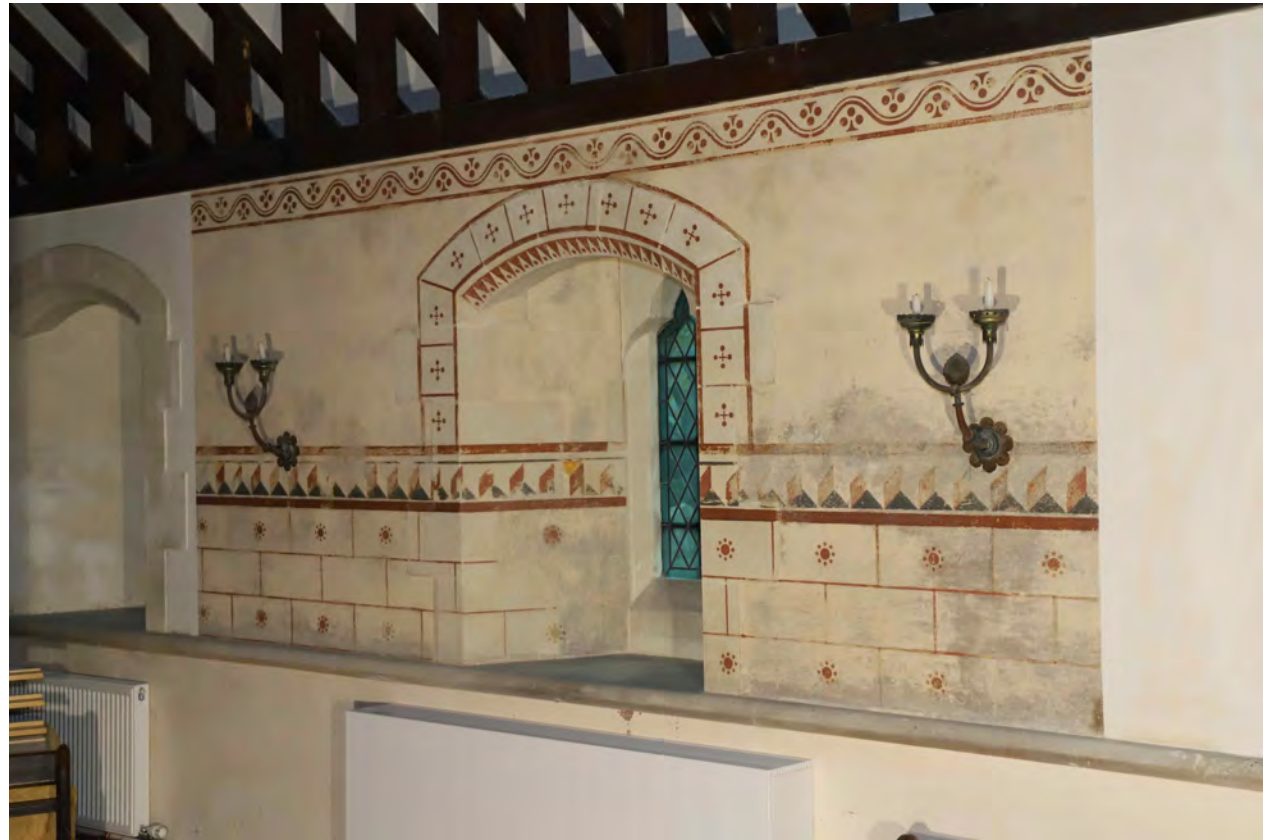
Plates 32-33: the scope of uncovering exceeded expectations. Initially it was thought that only relatively small uncovering 'windows' could be made, but being able to reveal a large area fully demonstrates the nature and quality of the original decoration.

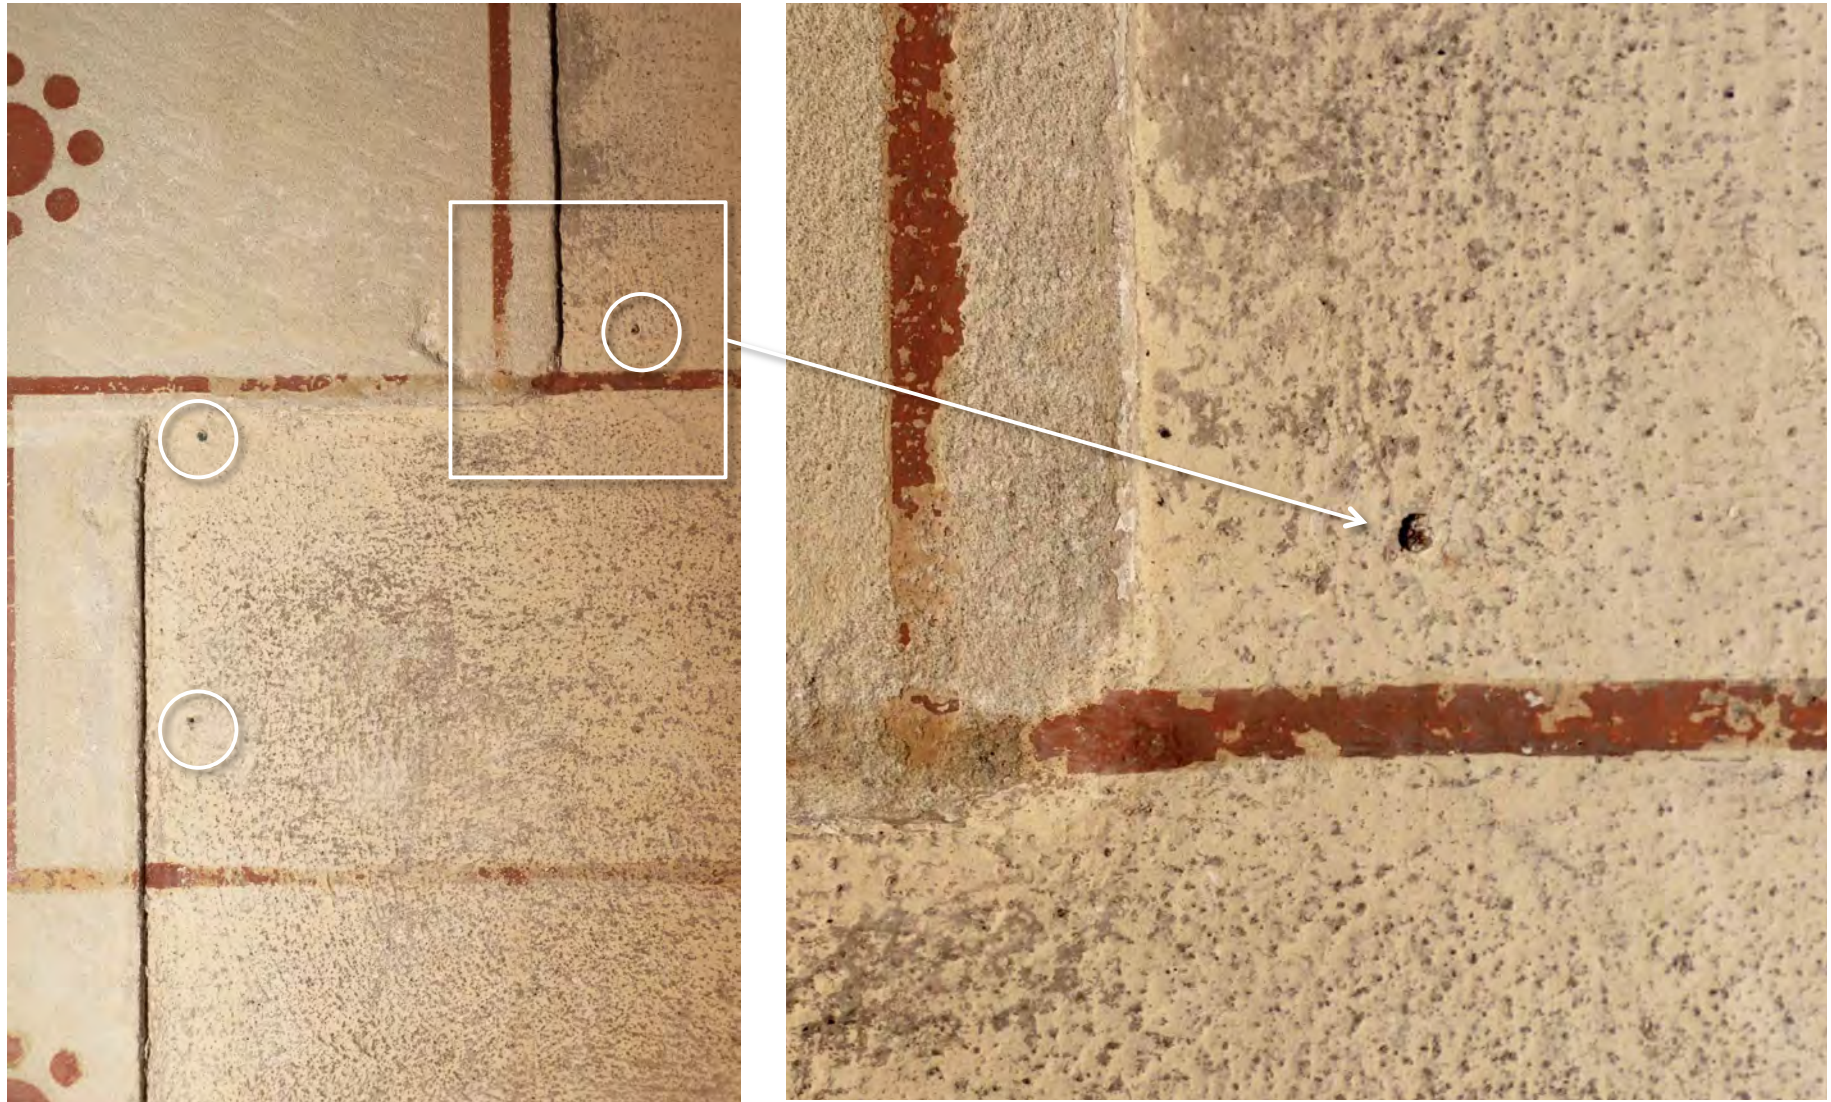
Plates 34-35: some evidence for how the painting designs were transferred to the wall are preserved. They were traced from large cartoons, which were fixed in place by small nails. Tacking holes – and in some places the small nails (circled in the **images above**) – can still be found at regularly placed intervals.

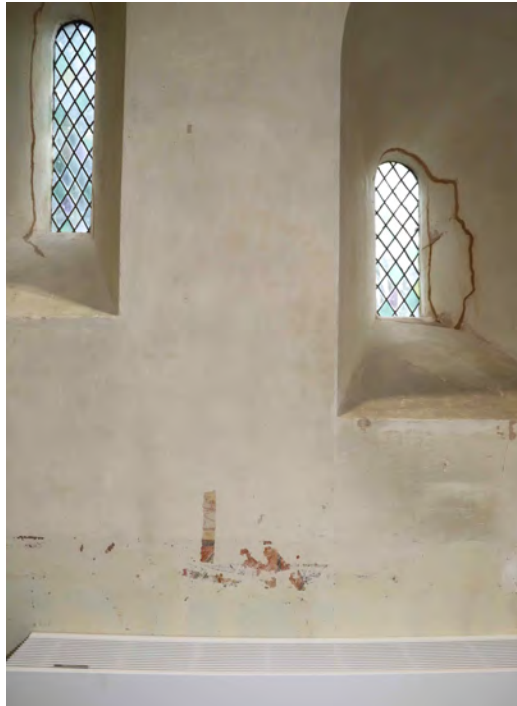
before uncovering

Plates 36-38: some selective uncovering was also carried out in the chancel, on the south wall, as shown in the **images above**. As in the nave and north aisle, the condition of the chancel walls is not uniform, and there are substantial areas where uncovering is not safely possible. Nevertheless, this area demonstrates again the sophistication of the decorative painting, and its subtly varied nature, and it is hoped that in the next phase of treatment, more such painting can be recovered here. Substantial stabilisation of the painting scheme is also required in the chancel.

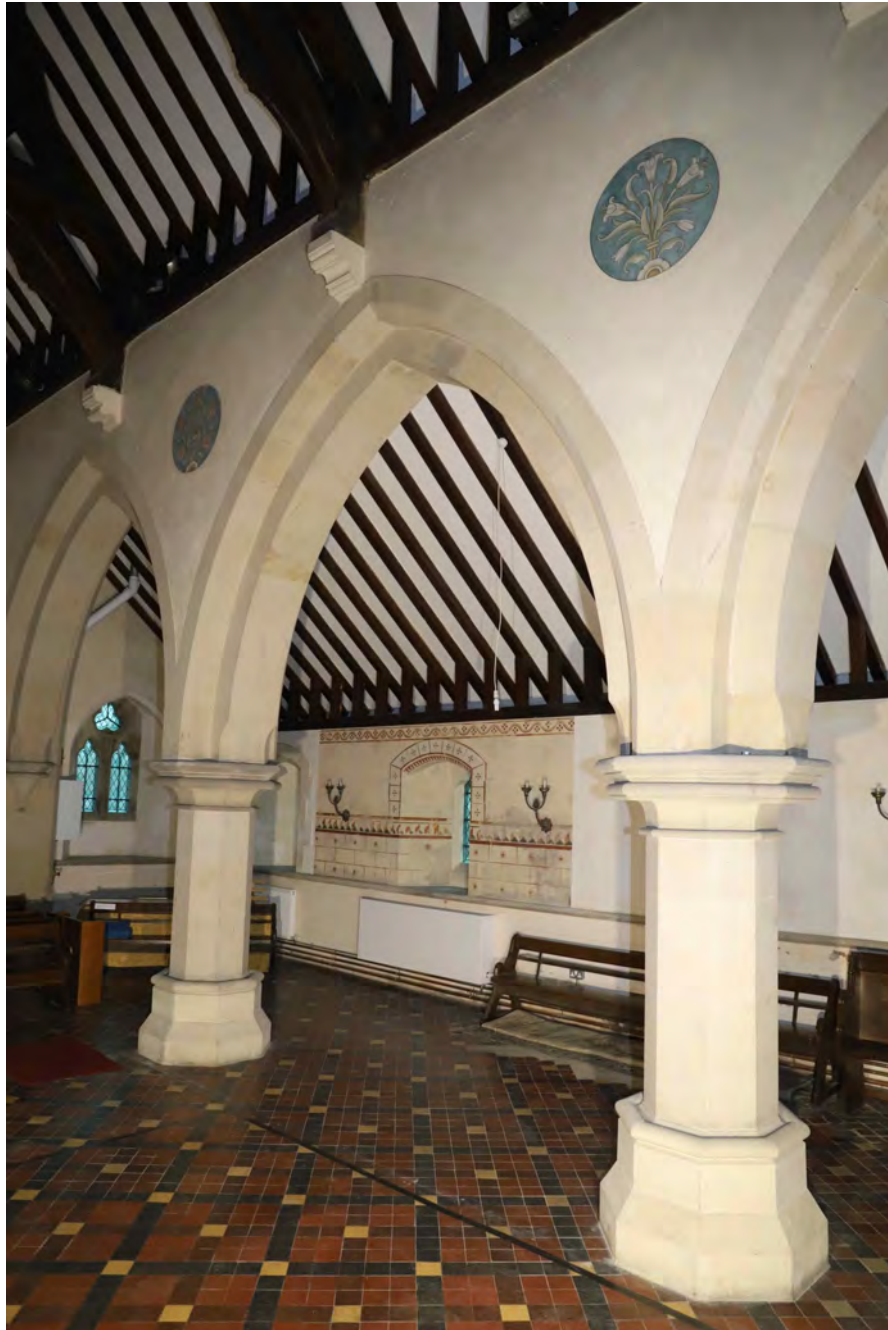
Plate 36: although the newly revealed areas of painting in the nave and north aisle (**left**), and in the chancel, are only a partial reflection of the original appearance of the decorated interior, they serve an important function in maintaining awareness of the presence, variety and significance of the original painting and decoration in different parts of the church interior.
