Energy Audit Report for St. Cuthbert Church, Red House

| Site Address | St. Cuthbert Church, Red House, Sunderland, SR5 5QS | |
| Date | 11 th December 2019 | |

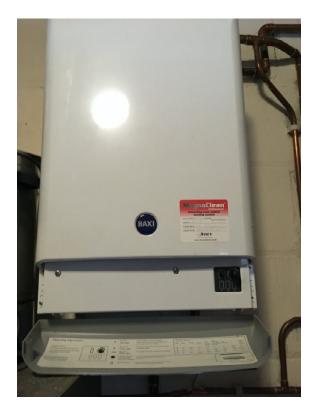
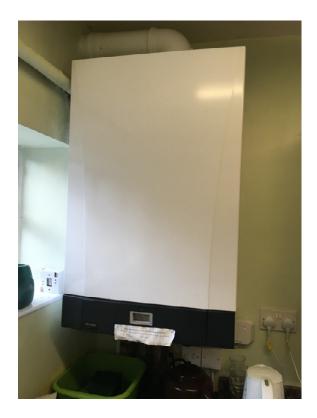
Photographs 2 & 3: Church Boilers

Heating is provided to the church via 2no. gas combination boilers. A Baxi gas combination boiler (photograph 2) is located in the main kitchen. It is unclear how old the boiler on-site is, however during the site visit it was noted that the unit is in good condition and well maintained.

A Potterton gas combination boiler (photograph 3) is located in the smaller kitchen. It is unclear how old the boiler on-site is, however during the site visit it was noted that the unit is in good condition and well maintained.

While the boilers appear to be in good order, and are not at the end of their expected lifetimes the client may wish to explore the possibility of installing an air source heat pump heating system in order to move towards the goal of decarbonising energy consumption.

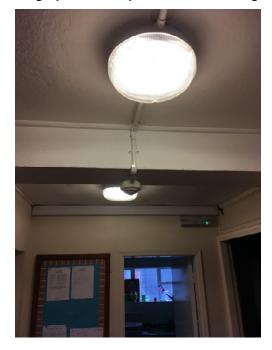
Photograph 11: Compact Fluorescent Lights

4no. 36W compact fluorescent lights with 3no. PIR motion sensors – recommended to be replace with 7.5W LED alternatives.
