ARCHAEOLOGICAL WATCHING BRIEF

ST MARY THE VIRGIN CHURCH,

CHURCH LANE, ASHBURY,

OXFORDSHIRE

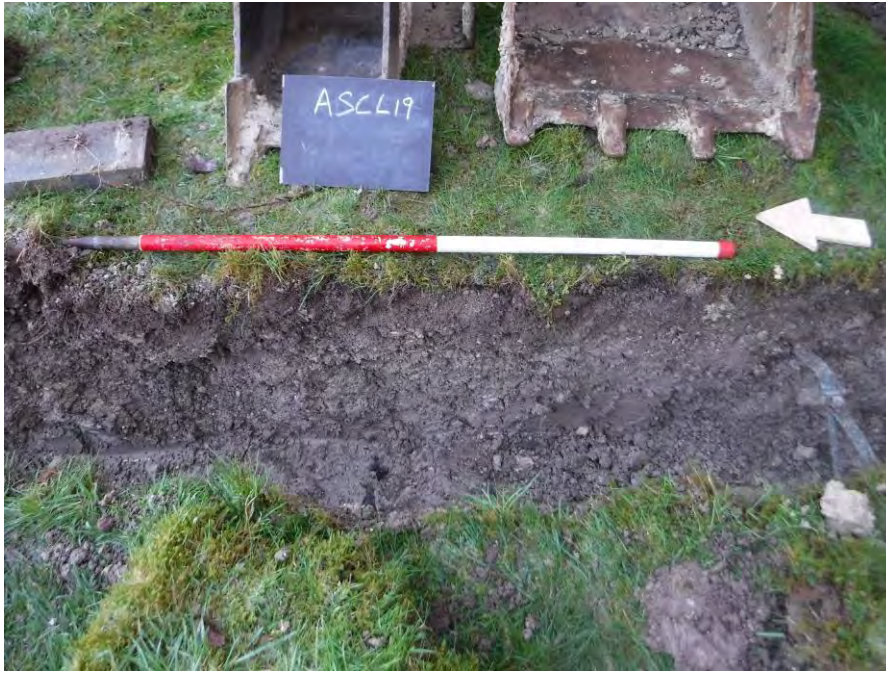
The lowest deposit encountered was a graveyard soil (02) of chalk clay; a reworked mixture of subsoil and degraded geology from constant excavation within the graveyard (Plate 1). This was present throughout the foul pipe trench, with a maximum thickness of 0.4m to the limit of excavation.

Plate 1: Section 1 looking east

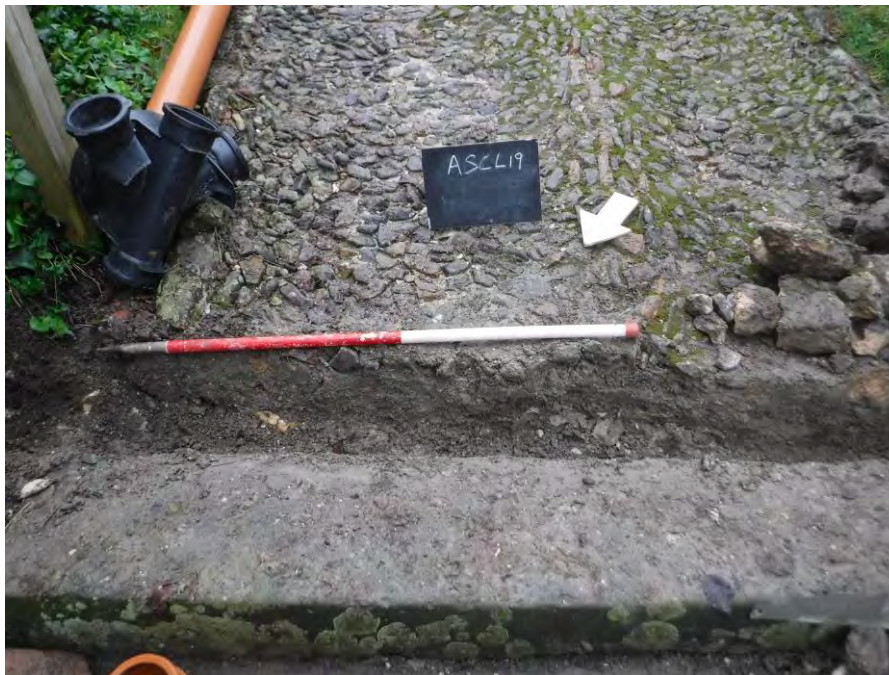
Two paths and a brick gutter were laid directly onto the graveyard soil (02). The path from the road to the main entrance of the church (05) consisted of flint and sarsen cobbles 0.16m in thickness. This path (05) was set also directly into the graveyard soil (02), which can be seen between the cobbles (Plate 2).

Plate 2: Path (05) looking southeast

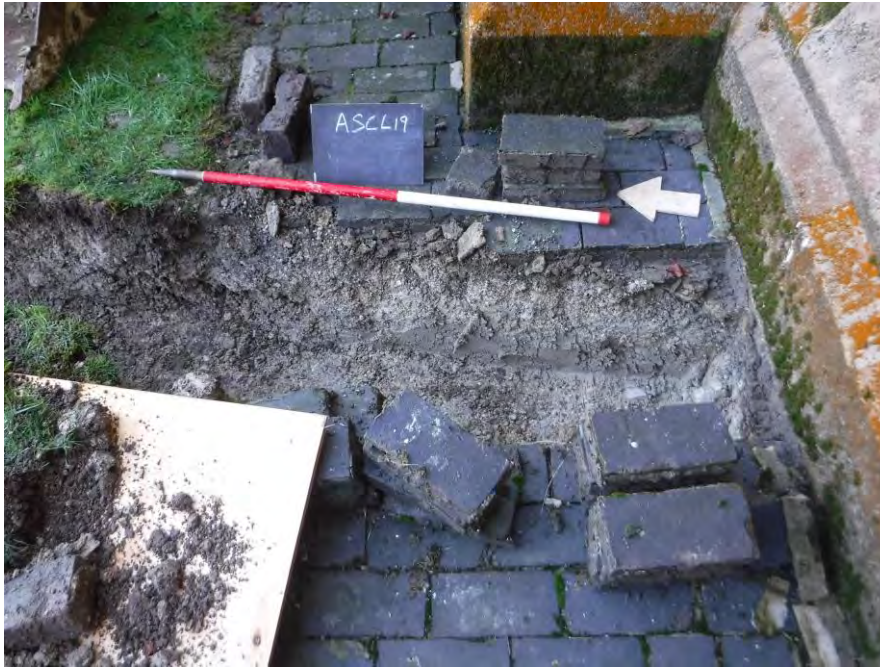
A brick gutter (03) ran round the edge of the church. This consisted of grey bricks, and was 50mm, or one brick thick (Plate 3).

Plate 3: Brick Gutter (03) looking east

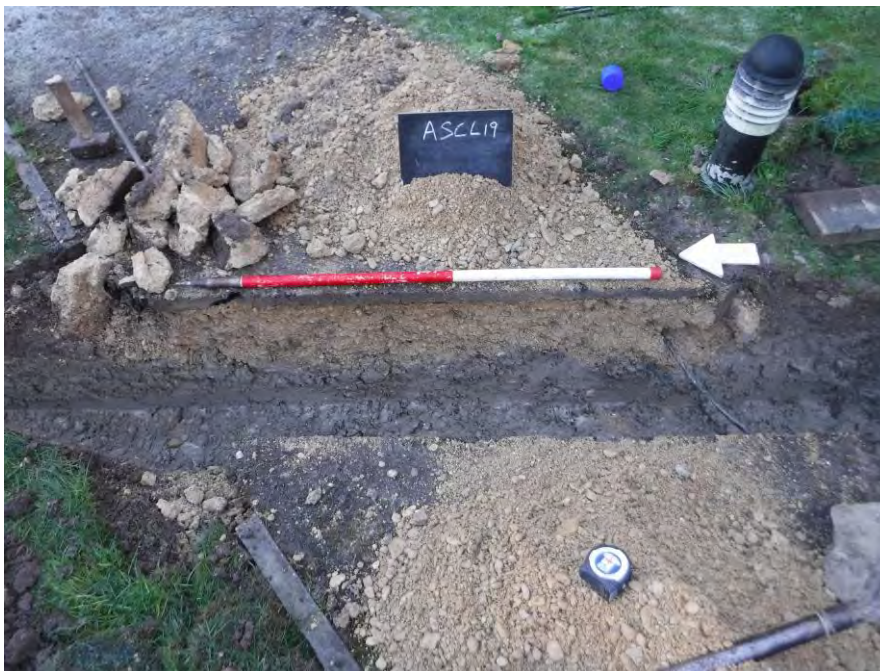
An asphalt path (04) branches off path (05) on a NE-SW orientation. This consisted of a 0.2m thick sandy gravel bedding, and a 40mm thick asphalt pathway, with concrete curb edging (Plate 4). The paths and gutter all cut the topsoil (01), which was a loose mid grey brown clay silt, 0.16m in thickness, with light rooting inclusions.

Plate 4: Path (04) looking east
