# All Saints Church, Ringsfield, Suffolk

*Archaeological monitoring*

CA Project: SU0107  
CA Report: SU0107\_1  
HER Ref: RGD 033

March 2020

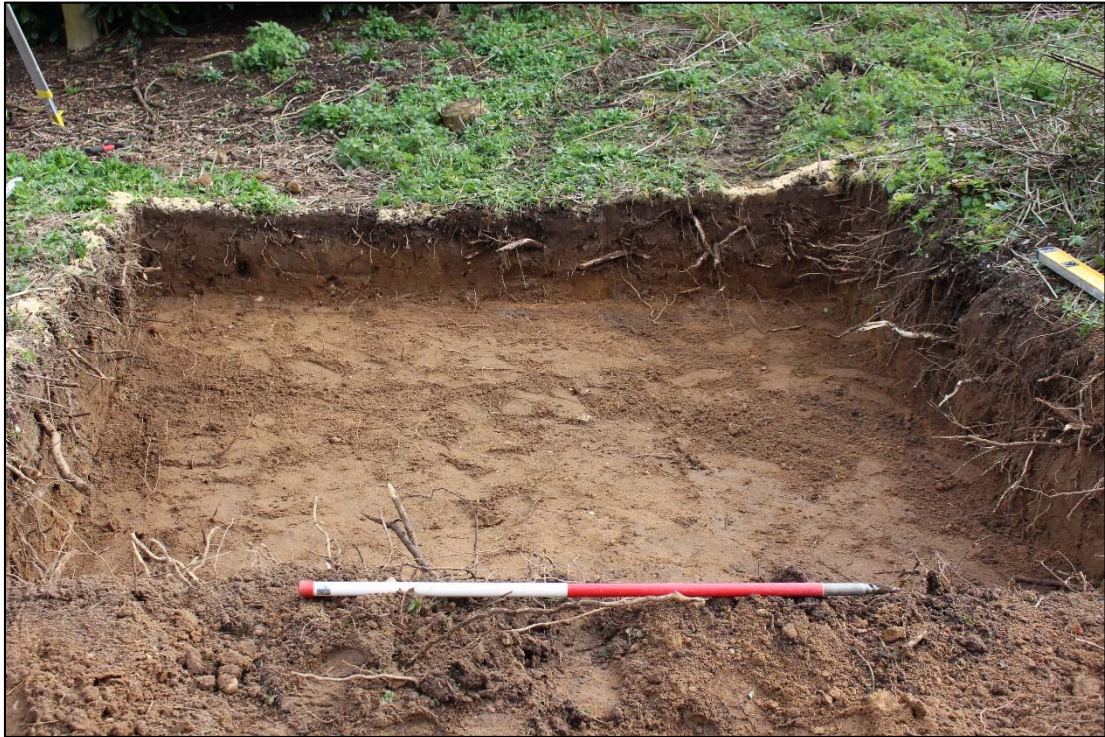
- 5.2 The footprint of the proposed building was machine stripped to a depth of between 0.4m and 0.65m (Plates 1 and 2). A thin layer of dark brown loamy sand topsoil c.0.1m

Plate 1. Excavated building footprint. Looking east, 1m scale

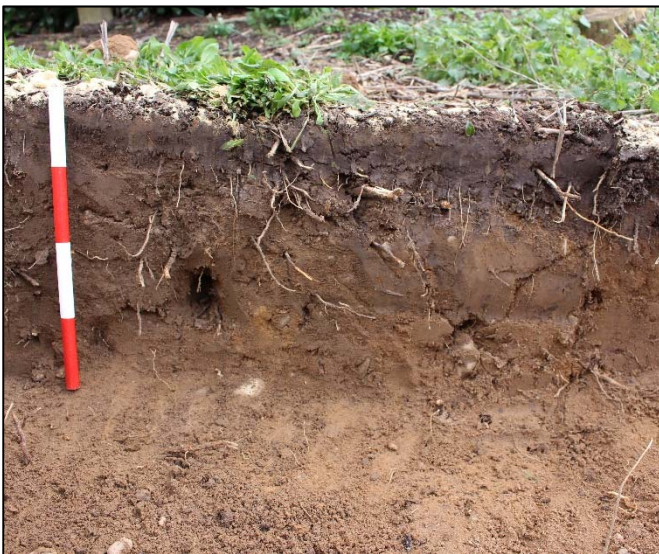
thick (0001), sealed a mid orangey brown friable clay silty sand subsoil (0002) to the full depth of the excavation. A service trench measuring 8m long, 0.3m wide and 0.5m deep was cut from the north east corner of the building footprint through the same soil profile (Plate 3). The excavated area was heavily root disturbed. No archaeological interventions were observed within the monitored groundworks, nor were any artefacts or disarticulated bones recovered from the upcast spoil.

Plate 2. Representative section of the building footprint. Looking north, 0.4m scale

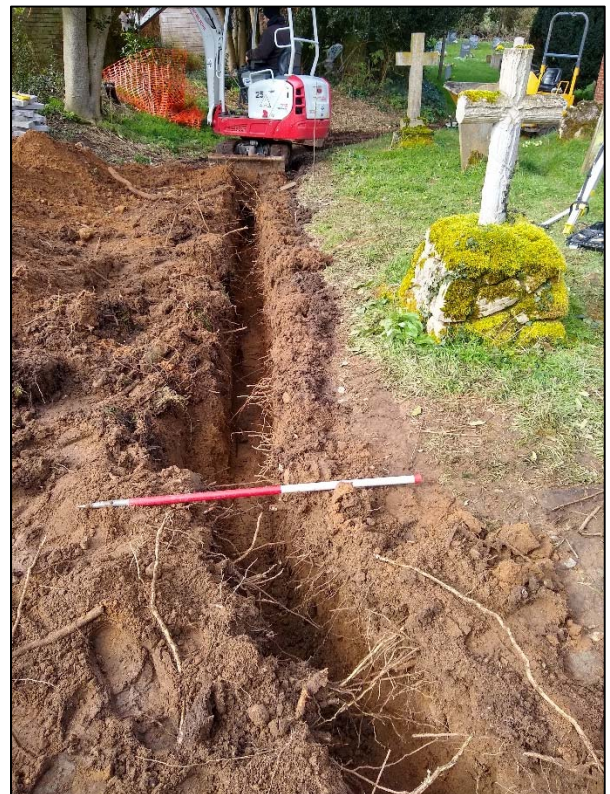
Plate 3. Service trench. Looking west, 1m scale

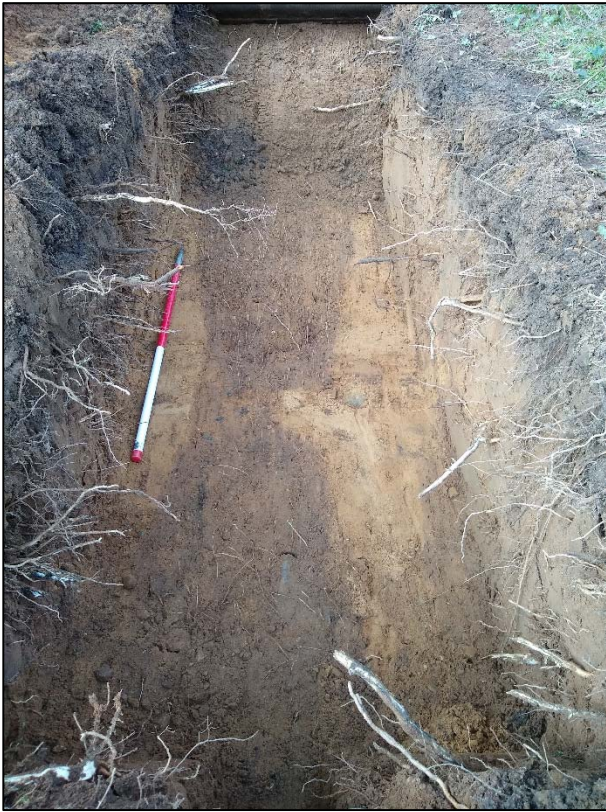
- 5.3 An area measuring 5m x 1m was excavated for a trench arch drain, to a depth of 0.8m (Plate 4). This cut through the same topsoil and subsoil layers observed in the building footprint and service trench. At a depth of c.0.65m, the natural subsoil was seen below subsoil layer 0002, within which grave cuts were visible. Subsequent excavation to the required formation level defined nine possible grave cuts, summarised in Appendix 1. Of these, 0003 and 0010 showed signs of coffin staining but the depth of burial was not reached in any of the exposed cuts. No dating evidence was observed or collected from any of the visible graves, however the coffin stains in 0003 and 0010 suggested the presence of the six-sided style of coffin, wider at the shoulder area and tapering towards both the head and foot ends. This suggests a post-medieval date for these burials.

A small assemblage of disarticulated bone, mostly skull fragments, was collected from the spoil approaching the base of the drain excavation. It is possible that this was derived from backfill of the grave cuts rather than from subsoil layer 0002 which was markedly sterile elsewhere.

Plate 4. Excavated trench arch drain, showing grave cuts in the base of the trench. Looking west, 1m scale

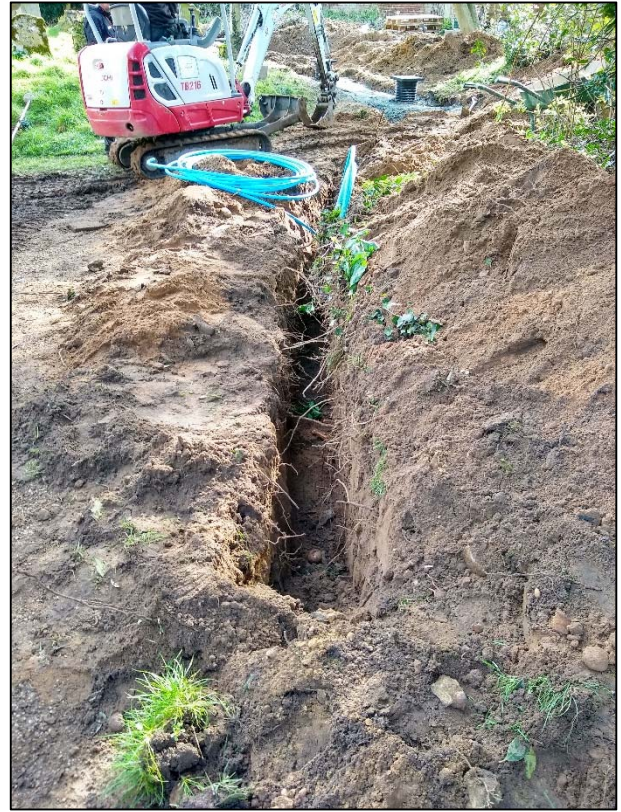
- 5.4 A 0.3m wide 0.7m deep trench was cut from the trench arch drain to an existing water supply on the west side of the church tower (Plates 5 and 6). On the south side of the path, this cut through the same heavily rooted soil profile as had been observed in the trench arch and it was clear that graves were present throughout the area, albeit impossible to define within such a restricted cut. An assemblage of bone collected from the spoil heap was reinterred in an area of natural subsoil exposed in the base of the trench. The majority of this was certainly disarticulated as the level of burials did not appear to have been reached, but minimal disturbance of shallower burials cannot be discounted.

On the north side of the path, the trench was cut through a dark brown sandy loam (0020) to a depth of 0.65m, below which paler yellowish brown silty sand could be seen in the base of the trench in places. It was not clear whether this was natural undisturbed subsoil or a reworked subsoil layer similar to 0002.

Plate 5. Water pipe trench, north side of the path. Looking east towards the trench arch drain

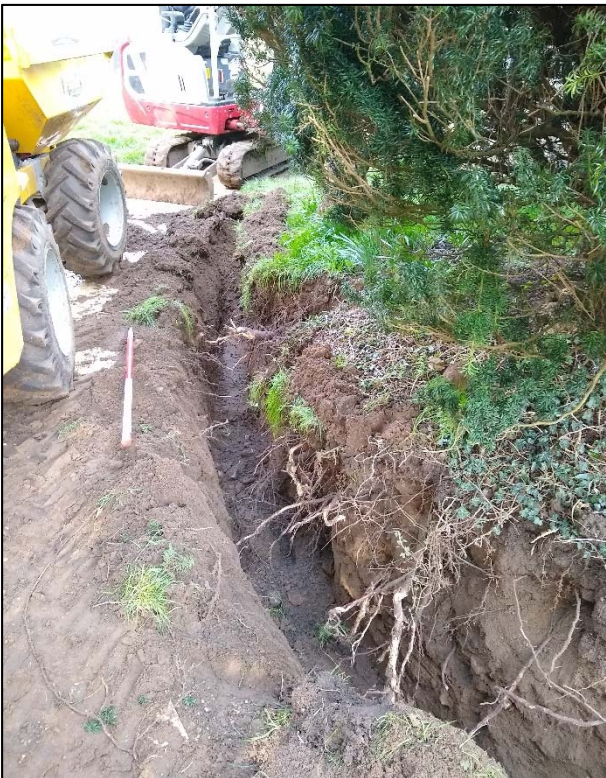
The top of a what was believed to be an *in situ* skull, 0021, was encountered at the base of the trench, indicating the likely presence of graves in this area, however, it was not possible to define an associated grave cut within the limited confines of the trench. The skull was undisturbed by the groundworks.

Plate 6. Water pipe trench, north side of the path. Looking north, 1m scale
