**Archaeological Watching Brief
on External Drainage Works at
All Saints Church, Hoby, Leicestershire**

Report Number: R-0109

Project Reference: ABH-2019-19

September 2020

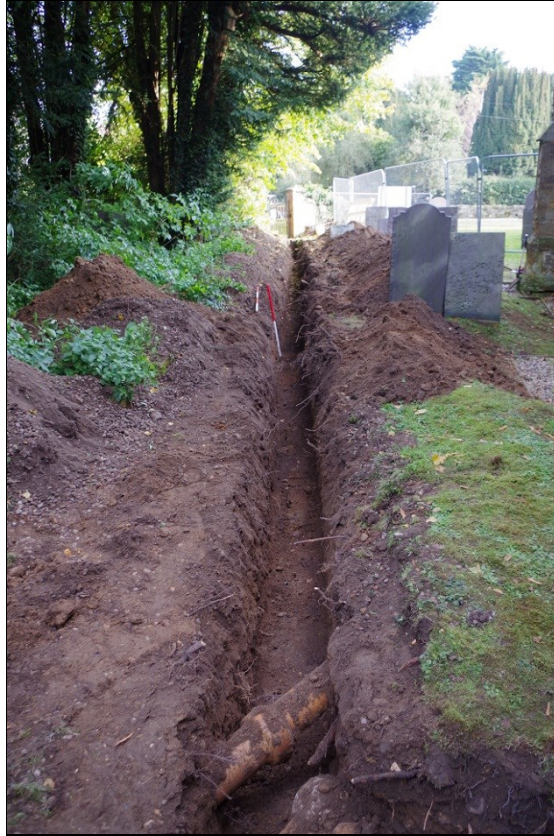
Photo 3. View of excavated service trench on line of path, looking ENE towards Main Street.

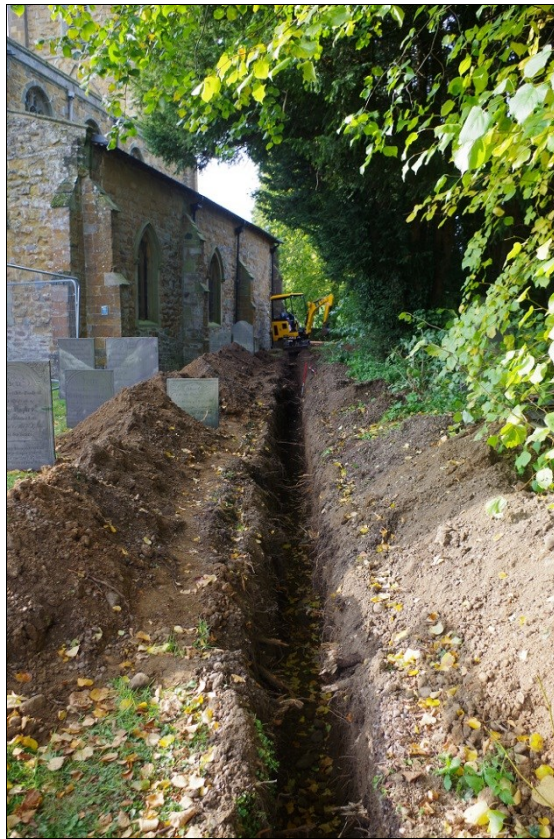
Photo 4. View of excavated service trench on line of path, looking WSW towards N door.

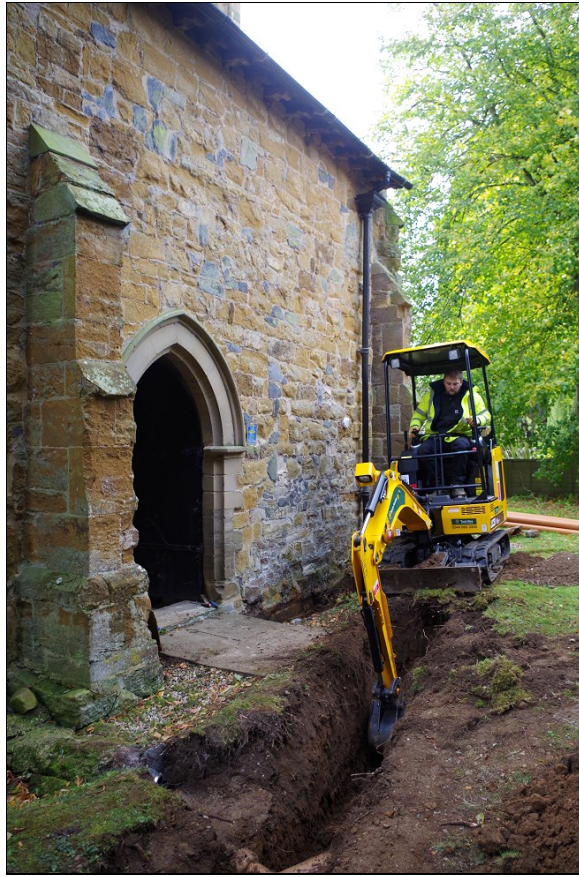
Photo 5. Excavation of service trench adjacent to north door of church, looking WSW.

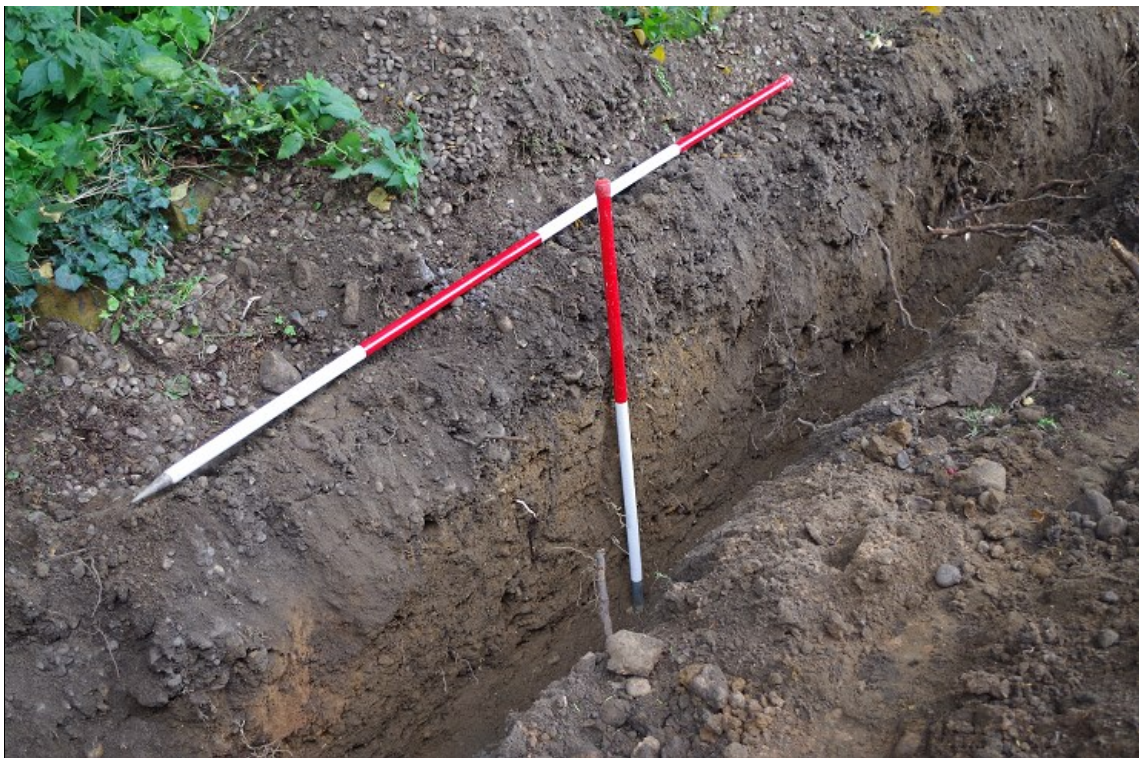
- 6.2 The deposit sequence exposed in section was consistent along the length of the trench, except where the ground was disturbed by tree roots or old drains. The surface of the footpath consisted of coarse gravel in a dark brown soil matrix (context 1) to a depth of 200mm, beneath which was a compact orange pea gravel (context 2), representing an earlier footpath surface, to a depth of 250mm. Below this was a fairly loose orange-brown coloured sandy silt clay (context 3), the lower horizon of which exceeded the depth of the trench.

Photo 6. Detail shot showing typical deposit sequence within service trench, looking N.

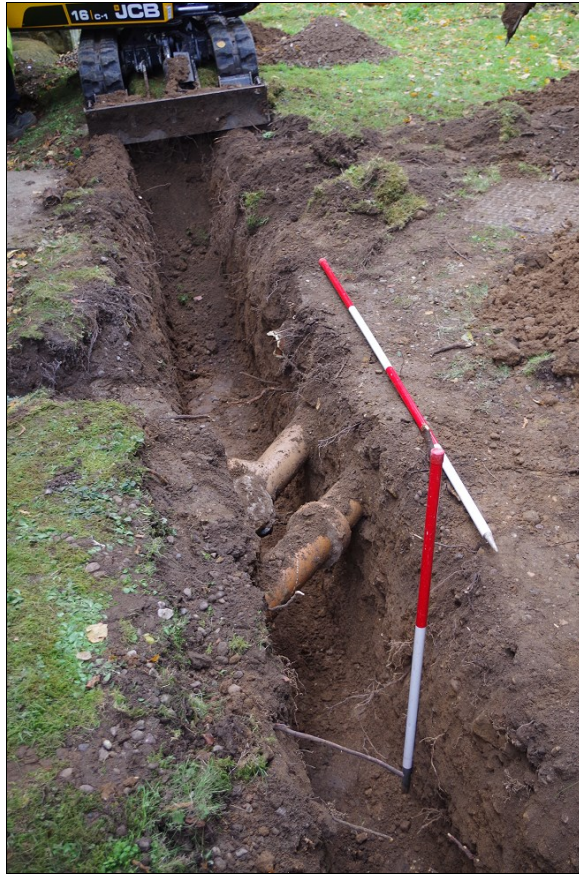
- 6.4 Several old drains were encountered, crossing the line of the service trench in the vicinity of the north doorway, the installation of which had resulted in much ground disturbance in this area.

Photo 7. Detail of old drains and inspection chamber outside north door, looking W.
