**Archaeological test-pitting at the Church of St Michael and All Angels,
Hallaton, Leicestershire (Crypt Reinstatement Project)**

Client: Hallaton Crypt Reinstatement Project

ULAS Report Number: 2020-135

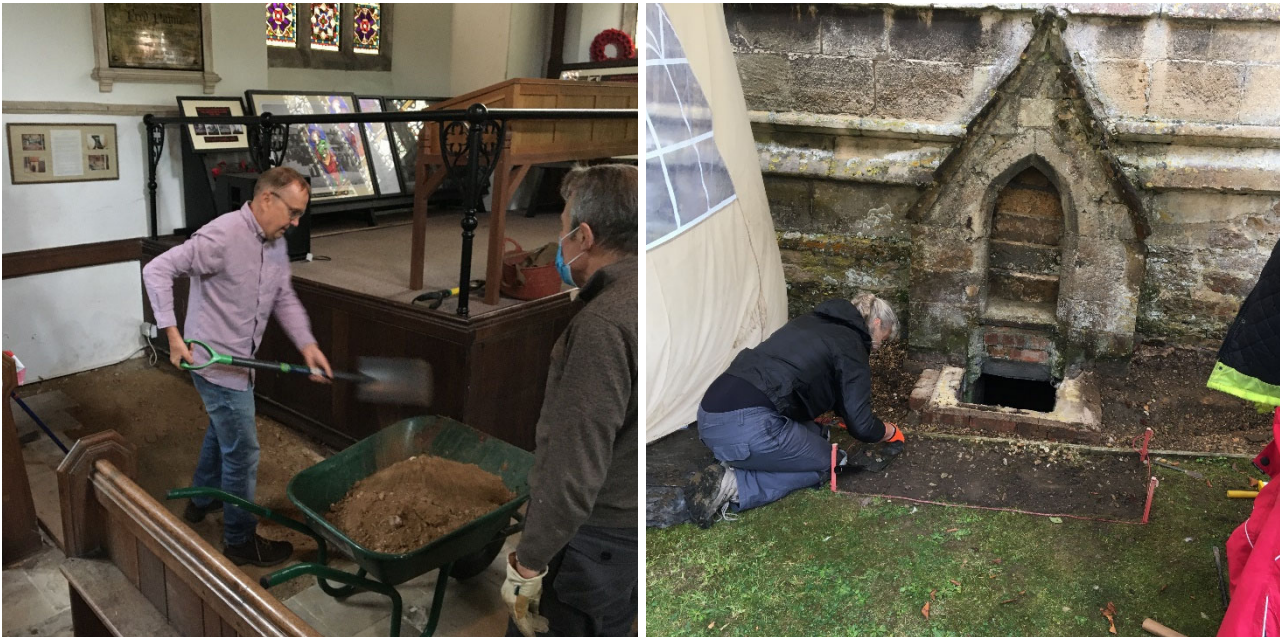
Figure 3: Volunteers from HFWG excavate Test-pit 1(left) and Test-pit 2 (right).

The test-pits were hand excavated (Figure 3) in a series of 0.1m layers to the natural substratum or a maximum depth of 1m, dependent on which was reached first. All excavation was undertaken with a view to avoid damage to archaeological deposits or features which appeared worthy of preservation *in-situ* or warranted more detailed investigation than for the purposes of the project. All spoil was screened for finds using sieves with a standard 10mm mesh, except for any heavy clay soil which was hand searched. Test-pit locations were tied into the Ordnance Survey National Grid using appropriate methods. Once finished, the test-pit was filled in and the turf/floor reinstated.

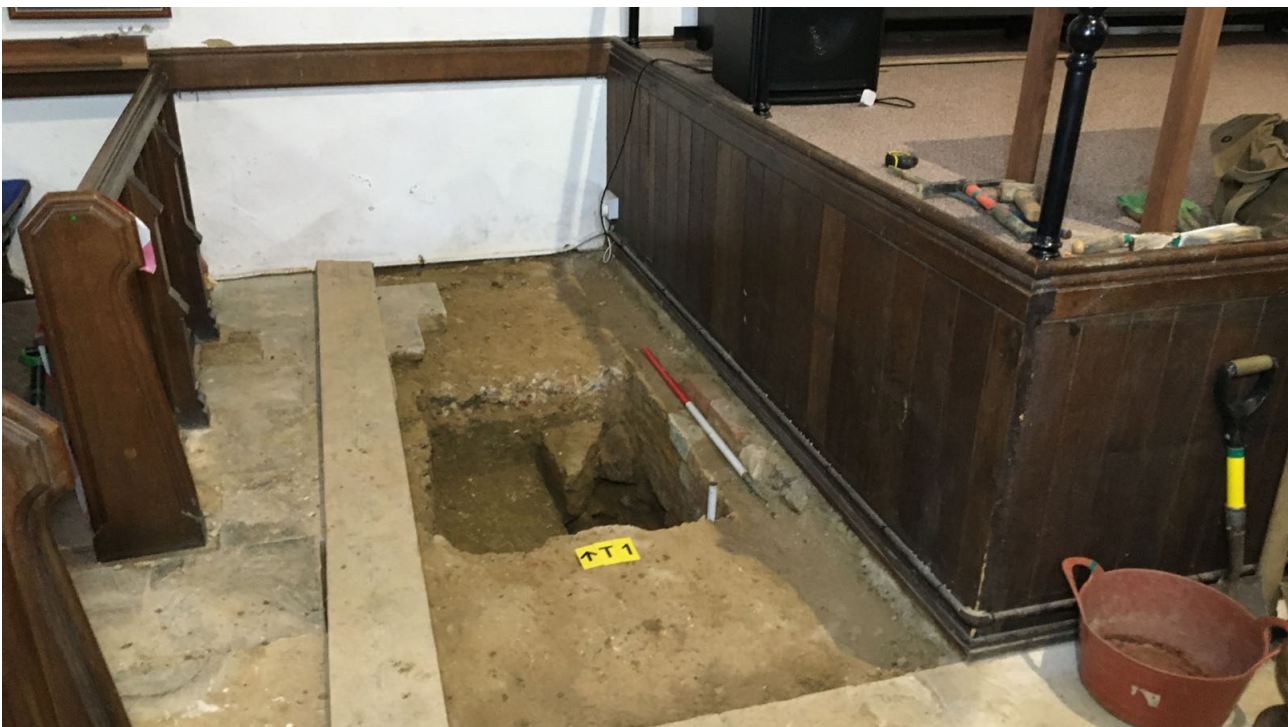
Figure 4: Test-pit 1 in the north aisle of the church, looking north. The raised area to the right is the roof of the crypt.

Test-pit 1 was situated in the north aisle of the church against the west wall of the crypt (Figure 4) where a new staircase is proposed leading down into the reinstated crypt. The area contained the Thomas Vowe (d.1691) ledger stone which was removed along with adjacent flagstones before work began. Beneath the flagstones was 20mm of dry lime mortar covering *c.*0.2m of concrete. This was consistent with church records from the late 19th-century restoration which indicated that the new floor was to be laid over 6" of cement (John Morison *pers. comm.*). This suggested that the Vowe memorial was not in its original position and no grave was uncovered beneath it.

Following the removal of the slab, a layer of concrete was uncovered. The concrete was removed from an area in the centre and a smaller test-pit excavated. Test-pit 1 measured *c.*1m by *c.*0.8m and was *c.*1m deep. Beneath the concrete on the west side of the test-pit was natural greyish-yellow silty-clay, probably the natural substratum. No earlier floors or deposits were observed. The clay was truncated to the east by the construction cut for the crypt which was *c.*0.36m wider than the present crypt wall (Figure 2). The present crypt wall formed the east edge of the test-pit. It appeared to have been mostly rebuilt in brick in the late 19th-century and was *c.*0.5m thick (Figure 5). Beneath the brick rebuild, at the north end of the test-pit and continuing north towards the aisle wall was the remains of a stone wall (Figure 6), presumed to be the original medieval crypt wall. The full width and depth of this earlier wall was not observed given the constraints of the test-pit but it was extrapolated to be *c.*0.86m wide with at least six courses of mud-bonded ironstone observed down to *c.*1m below the present floor level. No trace of this wall was observed from inside the crypt, although the lower courses of stonework in the rebuilt crypt wall could potentially have pre-dated its 'restoration'. The backfill of the construction cut for the rebuilt wall was a mixture of loose soil, rubble and clay which produced a small quantity of human charnel, modern pottery, glass and metalwork.

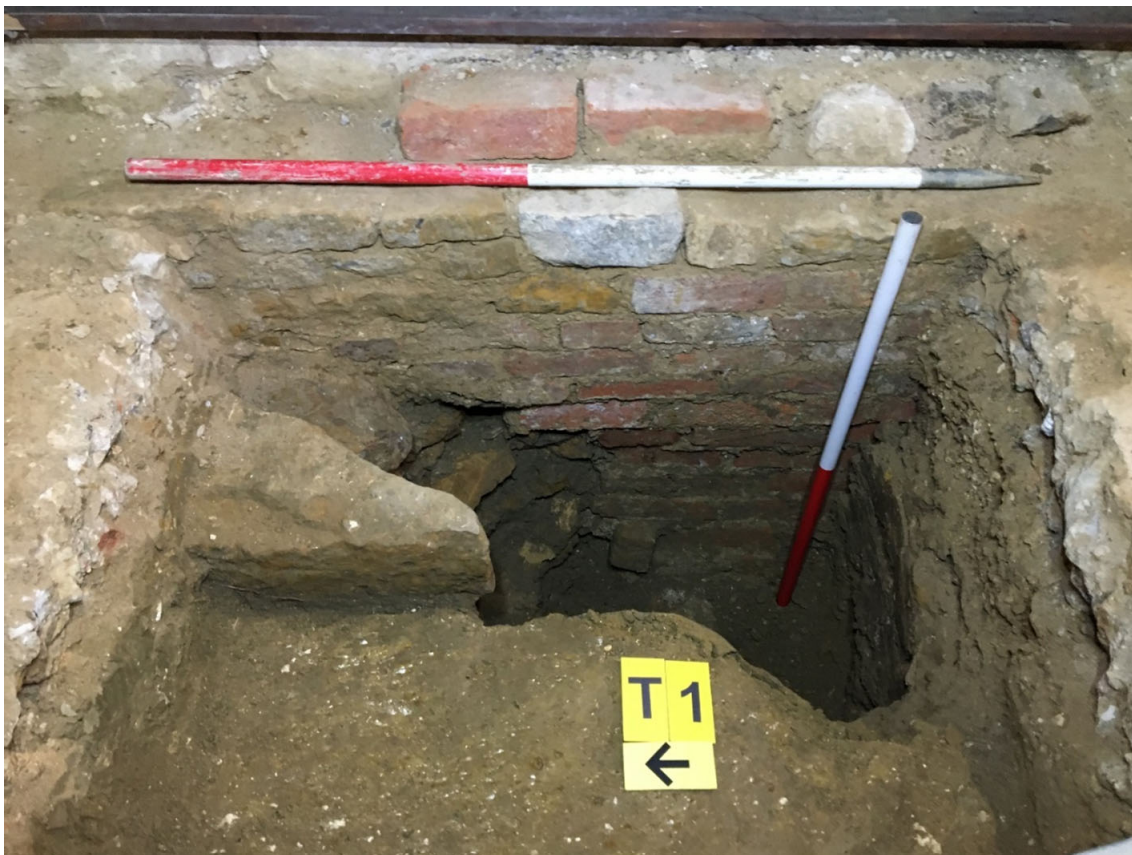
Figure 5: The rebuilt crypt wall built over the remains of an earlier stone wall, looking east.

The test-pitting at St Michael and All Angels Church, Hallaton found few archaeological features. Inside the church, late 19th-century restoration had removed earlier floor surfaces and deposits down to the natural substratum. No intrusive features (i.e. graves) were observed but the wall of the medieval crypt was identified. Some mud-bonded stonework still survived but the wall was extensively rebuilt in brick, probably during the 19th-century restoration when the crypt roof was reinforced to support an organ.

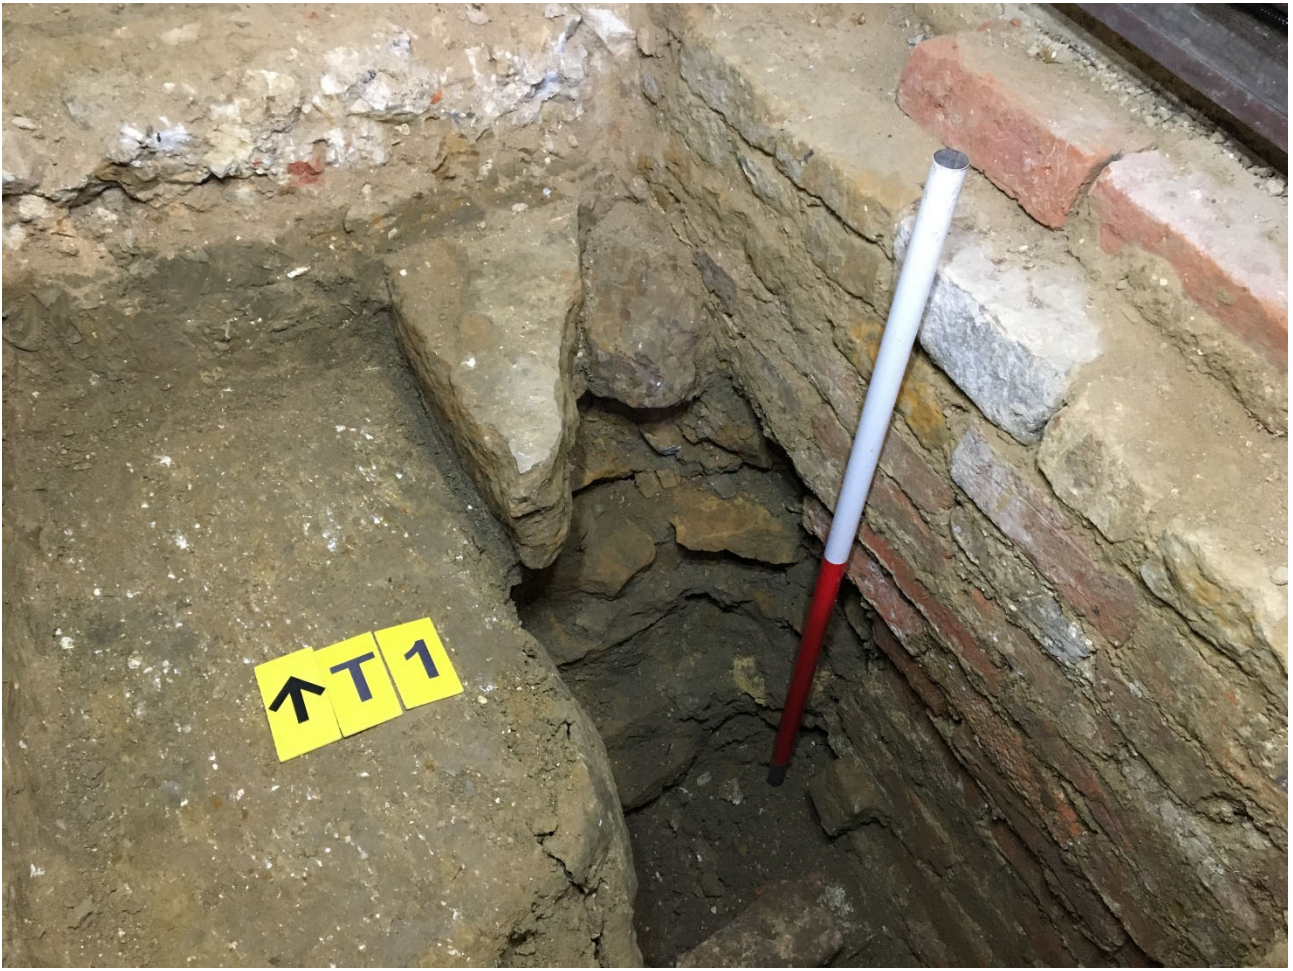
Figure 6: The mud-bonded stone wall beneath the rebuilt crypt wall, looking north-east.

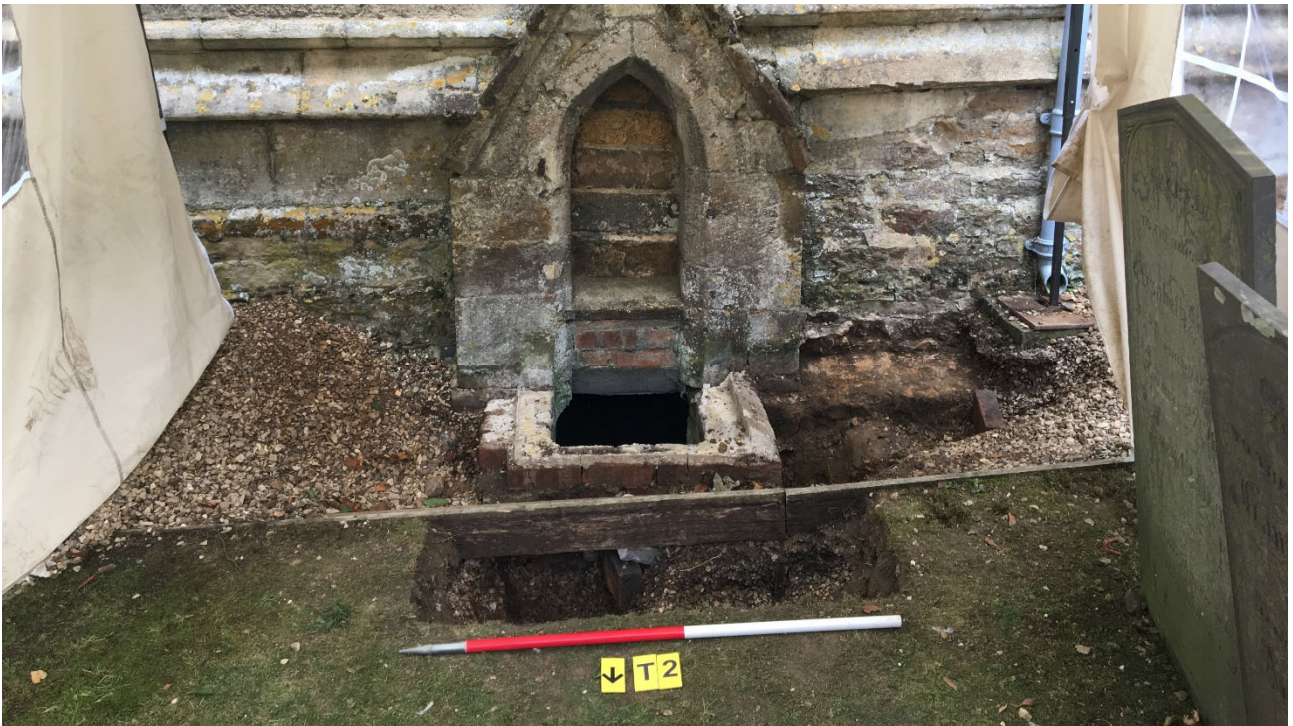
Figure 7: Test-pit 2 in front of the original entrance to the crypt, looking south.

Test-pit 2 was situated outside the church against the wall of the north aisle in front of a partially blocked archway which formed the original entrance to the crypt (Figure 2, Figure 7). This was reworked during the church's restoration in the late 19th-century, when a new entrance was inserted through the east wall of the crypt and the original entrance was converted into a coal chute for a boiler which was installed in the crypt. The original steps down into the crypt were allegedly replaced or covered over with a brick and cement chute. This was surrounded by a gravel path and bordered by grassed-over graves.

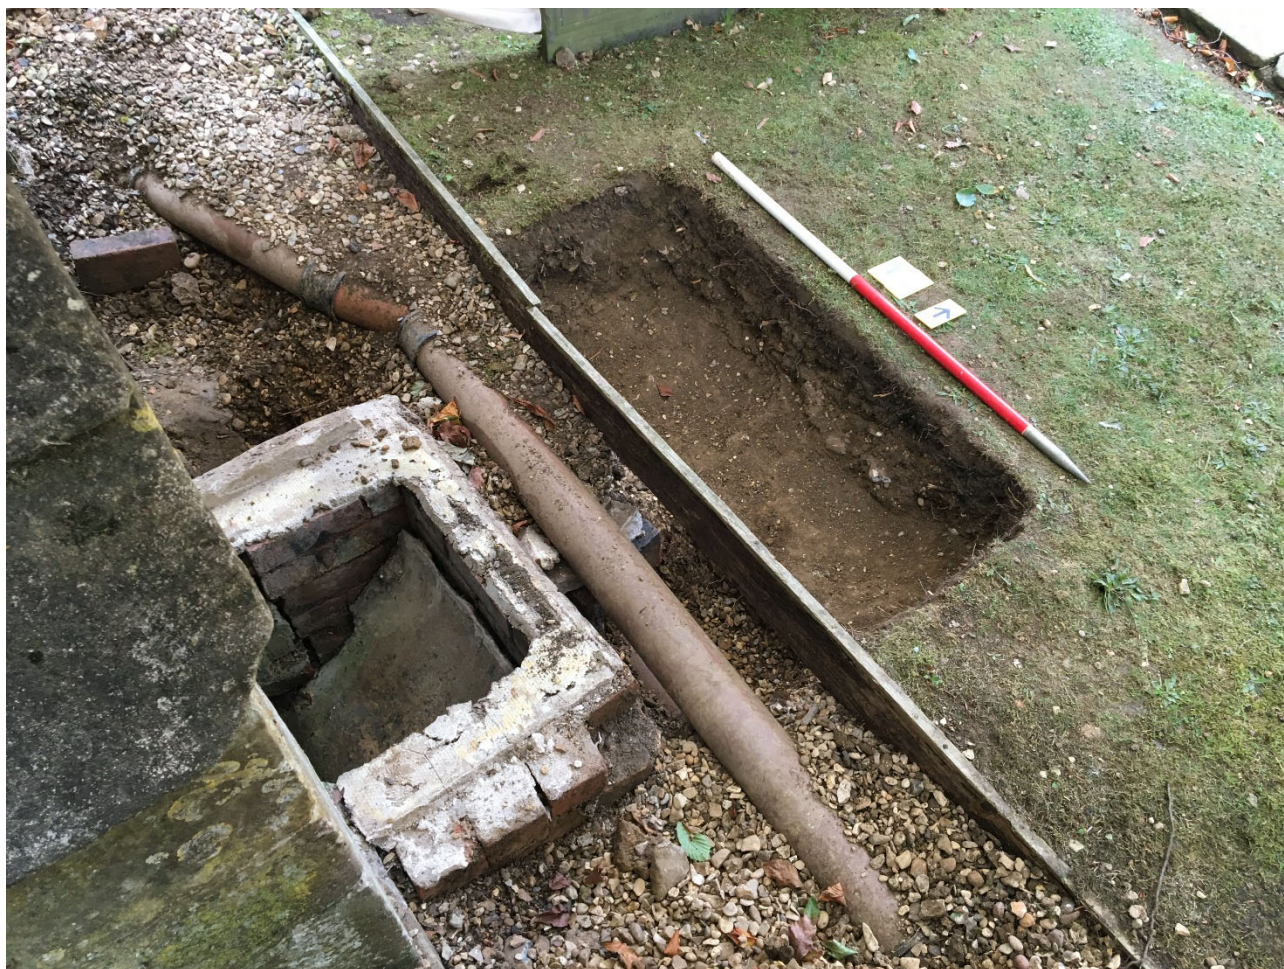
Figure 8: The coal chute and drain dug into the burial soil in front of the original crypt entrance, looking north-west.

The test-pit measured *c.* 1.5m by *c.* 1.2m and was between *c.* 0.3-0.5m deep. Removal of gravel from path, which projected *c.* 1m from the aisle wall, revealed two ceramic drainpipes running parallel with the wall (Figure 8). The pipes were *c.* 120mm diameter and were laid one over the other, at *c.* 50mm and *c.* 0.4m below the ground. The gravel filled the pipe-trench as well as the path and must have been intended to act as a soakaway. The brickwork of the coal chute extended down into the gravel at least five courses, with the lowest observed course projecting out slightly as a plinth. No evidence for the original steps into the crypt was observed and no further work was carried out in the gravel.

Outside the church, in front of the original entrance to the crypt, a modern coal chute and drains were dug into the burial soil of the graveyard. These concealed or had destroyed the steps leading down into the crypt.

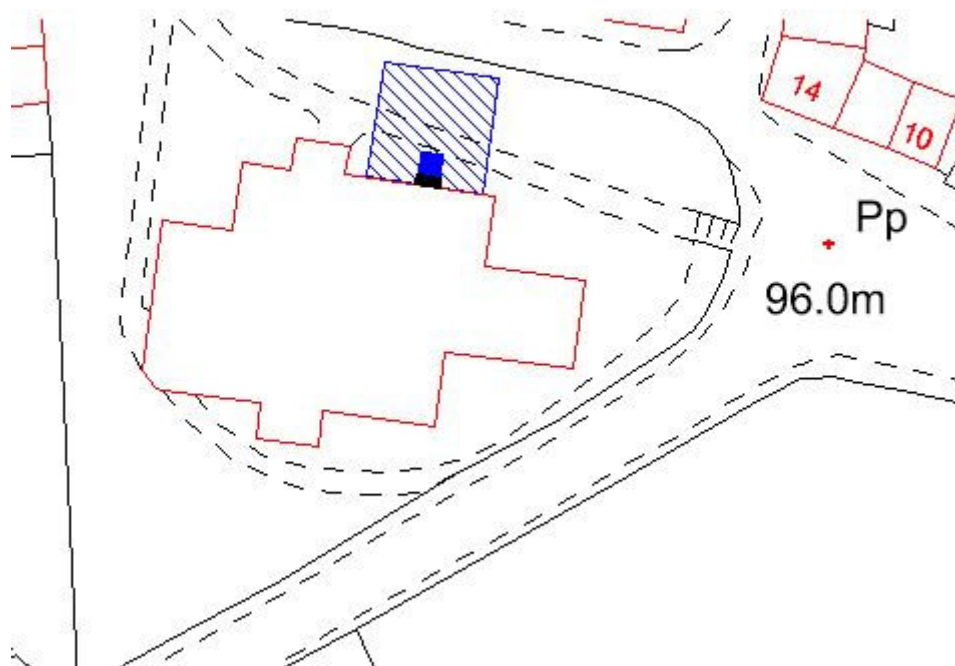
The area covered comprised a 10m grid on the north side of the church centred around test-pit 2 (Figure 9). The area contained a flagstone path and a number of gravestones as well as old tree stumps (Figure 10).

Figure 9: Location of Resistivity Survey (shaded blue) in relation to Test-pit 2 (blue square).

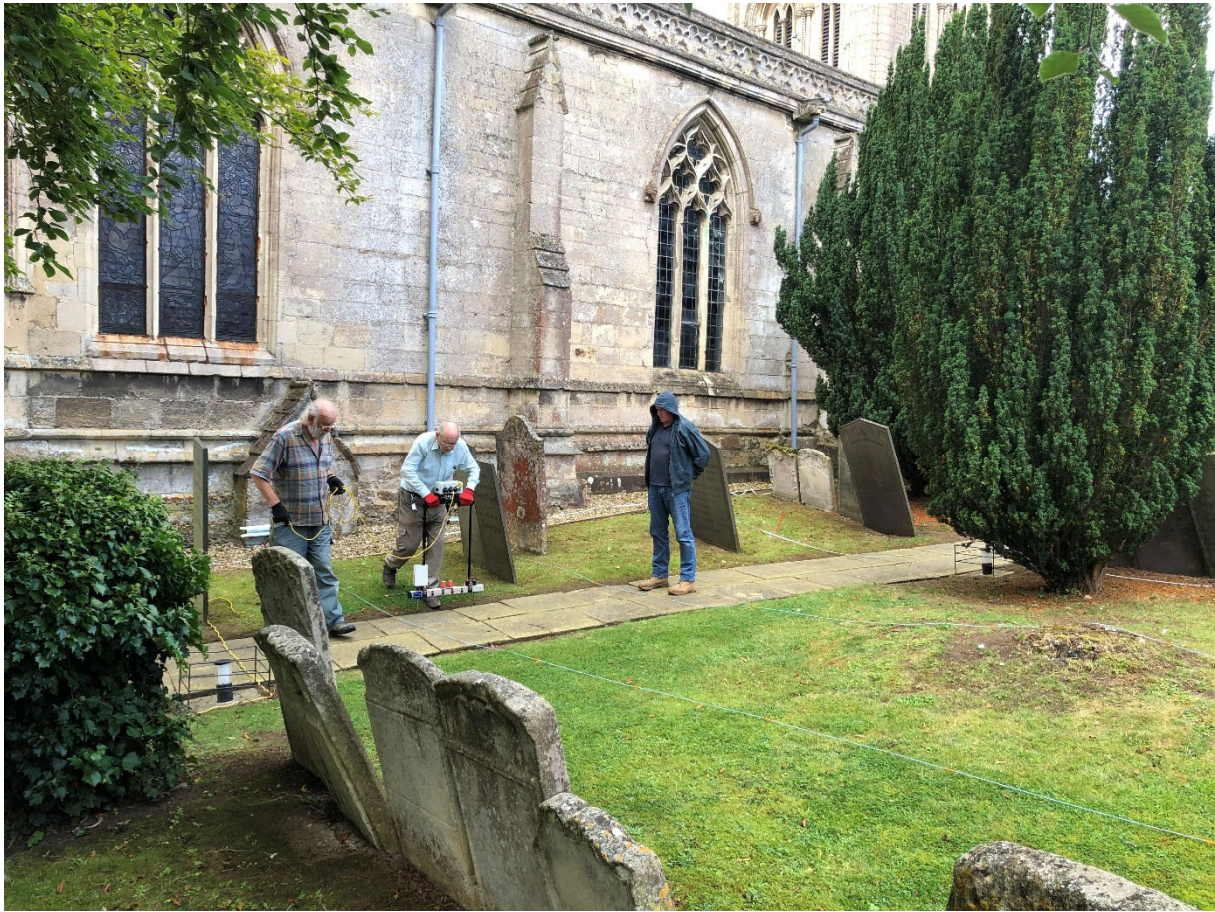
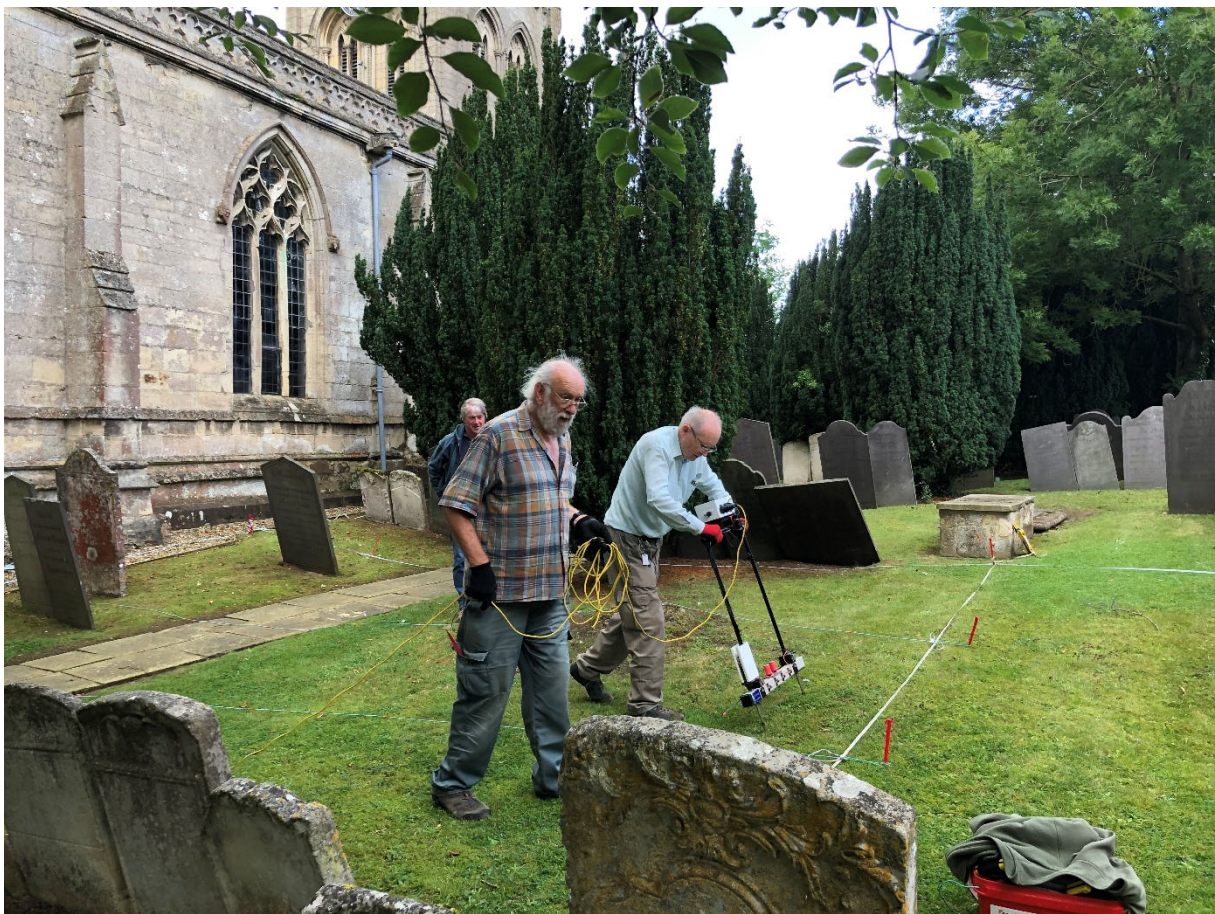
Figure 10: Resistivity survey being undertaken. The entrance to the crypt is visible in the top image.

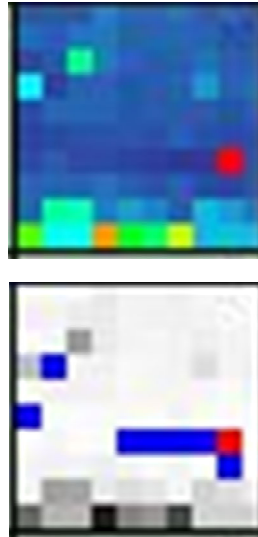
The results showed a ‘busier’ area along the church wall and the buttresses as well as a darker linear feature that corresponds with the pathway, but were otherwise negative for any anomalies and it seems likely that the path and graves in the area will have affected the result (Figure 11).

Figure 11: Results of the Resistivity Survey (church wall is along the bottom)
