## 2443 : ST. LEONARD THE LESS SAMLESBURY

WEST WINDOW REPAIR : ANCIENT GLASS INSERTS

**Proposal for conservation of ancient glass in w1**

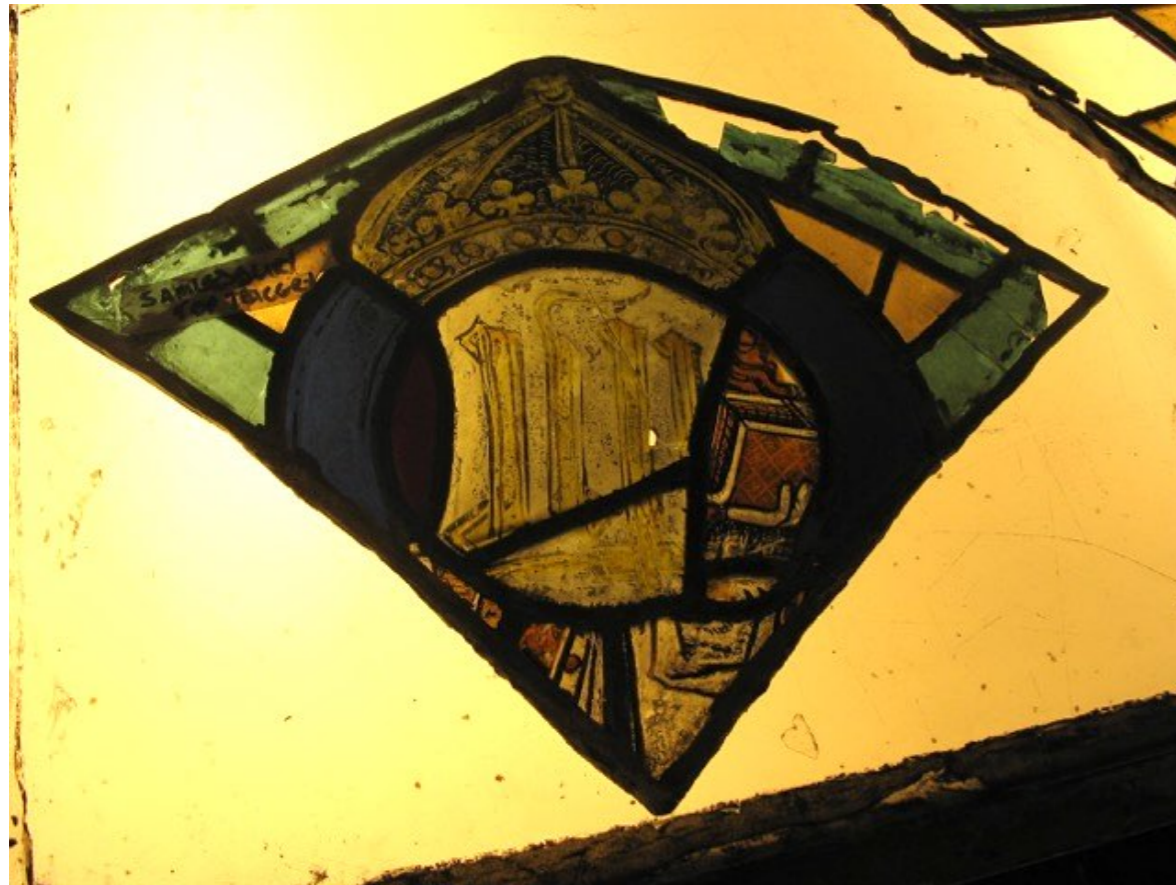
Window tracery B1

"MONOGRAM 'IHS' set on a ruby ground enclosed within a blue circular border unsigned with a crown. White, blue and ruby glass with black paint and yellow stain c1530-60. Monogram incomplete, with leaded and unleaded breaks; portions of border and ground replaced by stopgaps, including drapery and hand holding a book (late 15th/early 16th c) slight paint loss from monogram and crown. Leading decayed."

H 0.32m approx. W 0.26m approx.

for the three tracery panels, we have recommended kiln-distorted sheet glazing with a perimeter lead as the outer envelope<sup>2</sup>, releading and framing the historic glass

The fragmentary figure has been removed from its leads by PSG; at present the traceries remain in their c1860 leads, which are oxidised and at the point of structural collapse. Although an environmental protection system would prolong the effective life of the lead, given that it would no longer be exposed and have to fulfil the function of keeping out the weather, its role being limited to support of the glass, the condition of these panels is so poor that our recommendation is for complete releading.

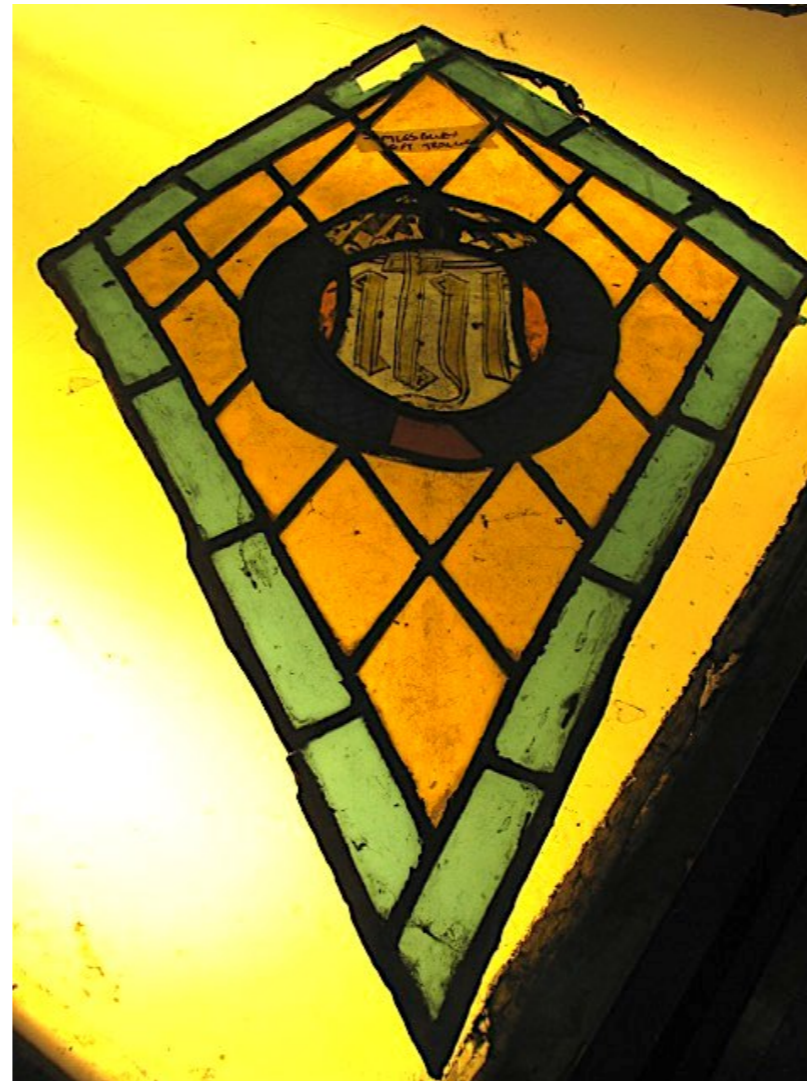
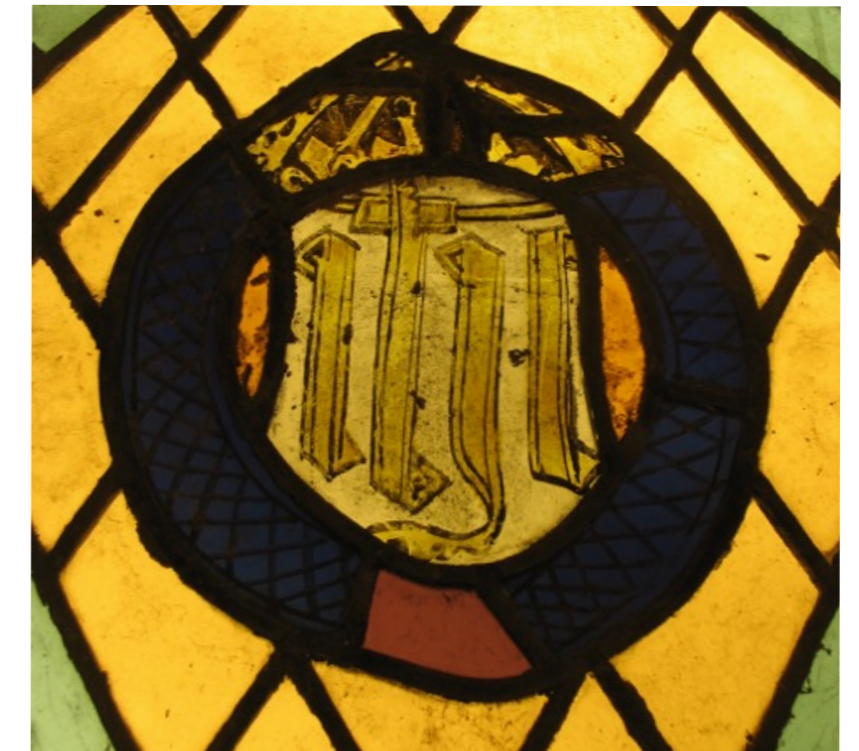
Window tracery A1

"MONOGRAM 'IHS' set on a yellow ground enclosed within a blue circular border unsigned with a crown. White, yellow and blue glass, with black paint and yellow stain. c1530-60 Crown cut down, with leaded breaks; stop gap in border."

d. 0.26m approx.

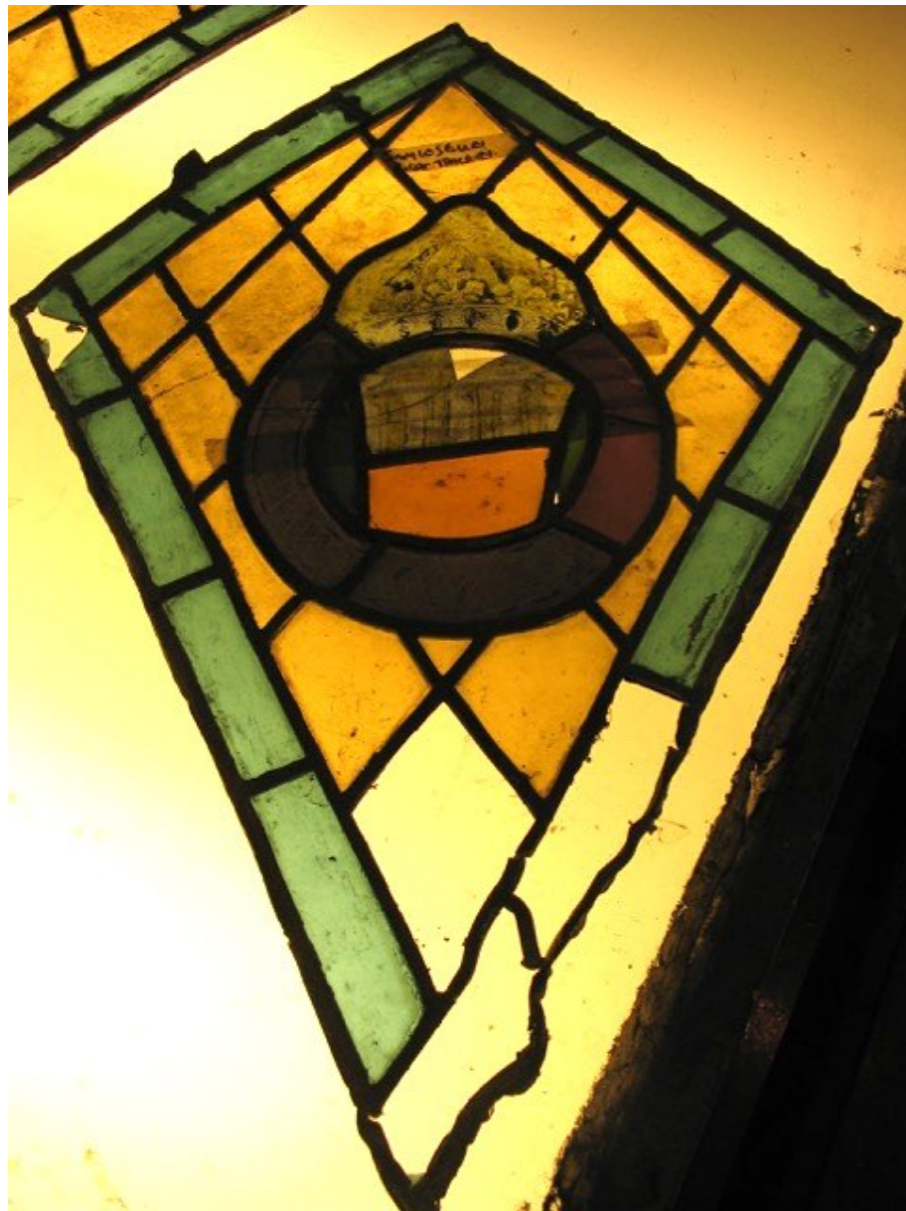
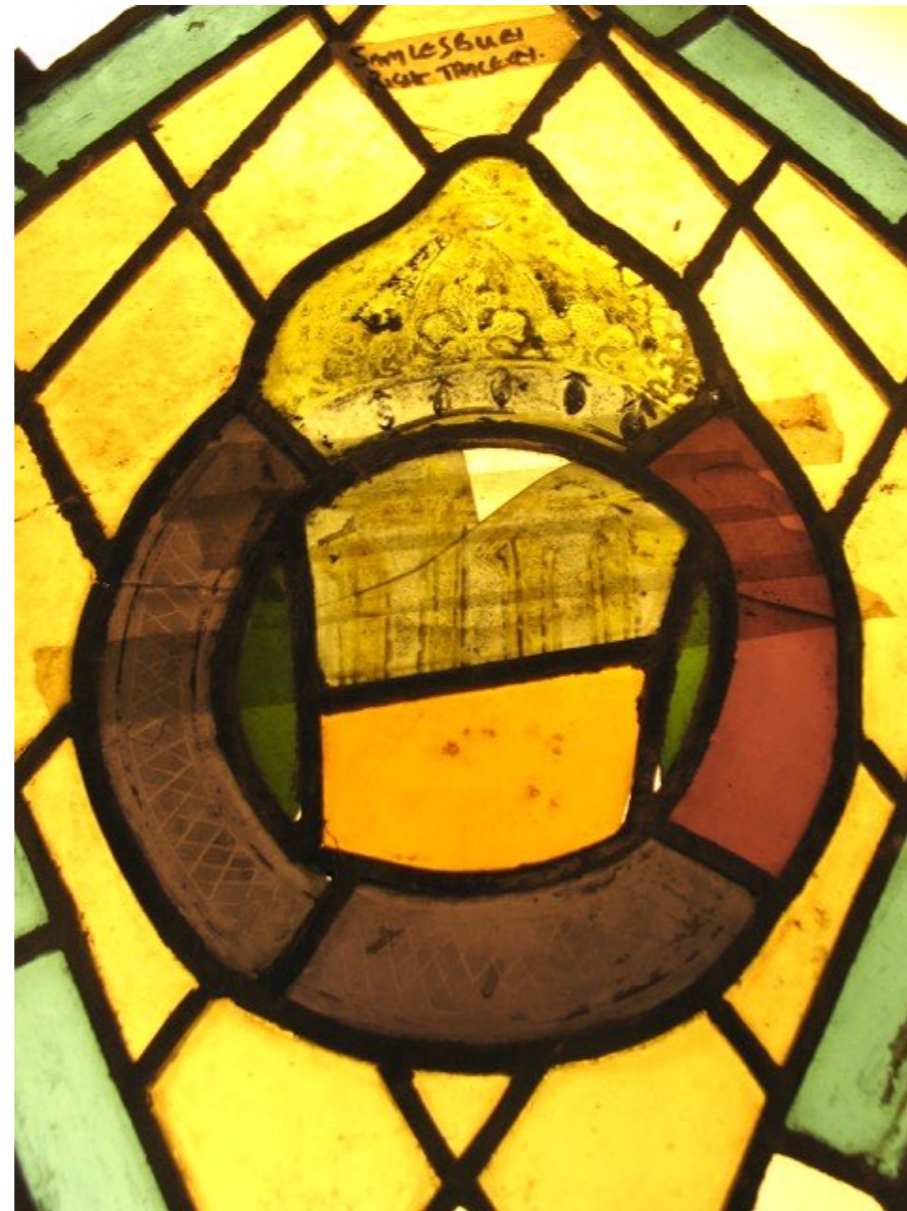
Window tracery A2

"MONOGRAM 'IHS' set on a green ground enclosed within a mauve circular border unsigned with a crown. White, green and mauve glass, with black paint and yellow stain. c 1530-60. Unleaded break across the monogram, the lower part of which is missing and patched; border partly restored; heavy paint loss."

H. 0.32m approx. W 0.26m approx.

A roughly triangular fragment of green glass - approximating to a square inch of material forming the top section of the sacred monogram in A2, showing on the 2002 image as fractured but secure within the leads has been lost. This loss is of recent date; PSG have an image of the window *in situ*, still complete, and one prior to removal showing its loss. We understand that a search for the missing piece on site proved unsuccessful.

Treatment of *lacuna*: our preference would be for a piece painted to blend with original, initialled and dated above lead flange

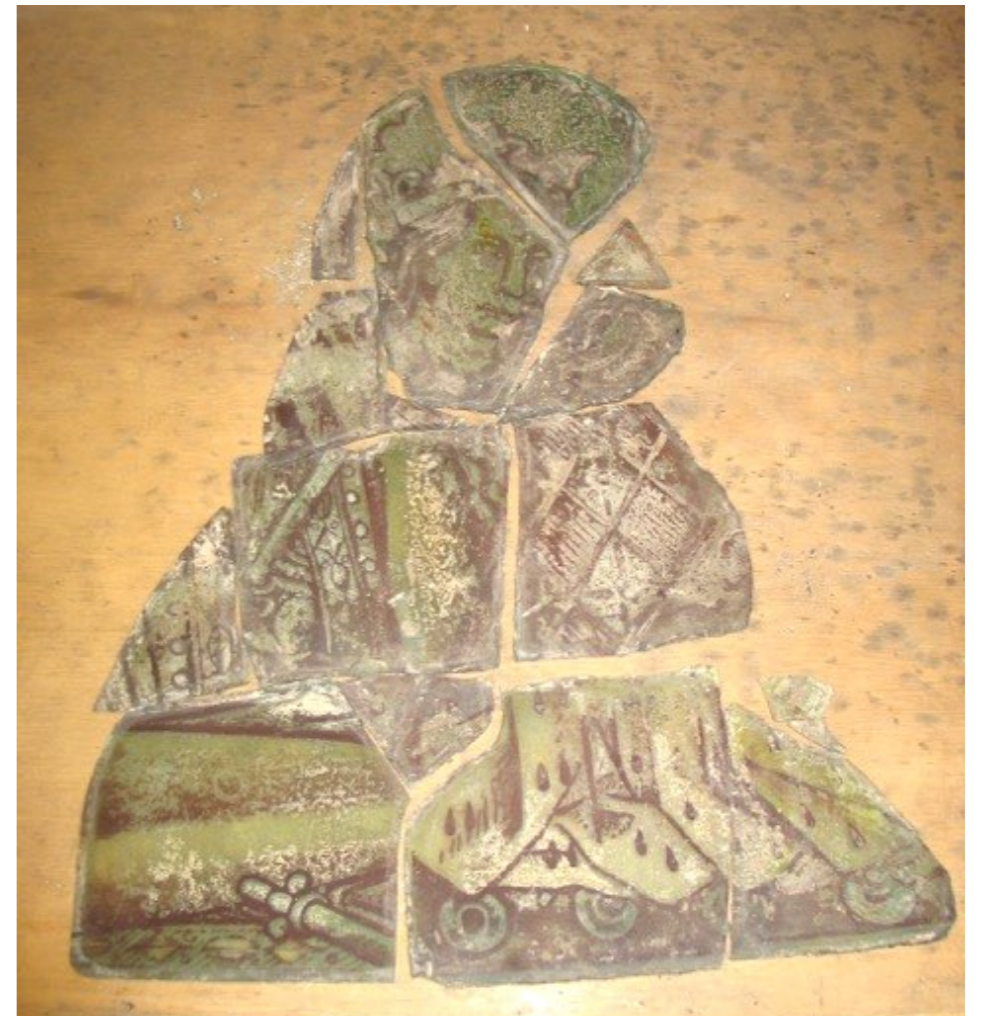
Window tracery 4b

"Fragments of a broken up figure of the Virgin holding a closed book and sceptre on a chequered base. The hand holding the book and other fragments are used to patch the topmost roundel. "

"Fragments of a figure of the Virgin, including a crowned head facing to sinister, a hand holding a sceptre, an ermine gown on a white floor diapered with annulets, drapery fragments, and chequered floor. Stain splashed on Virgin's face. White glass, with black paint and yellow stain. Late 15th/early 16th c. Leaded break across head, slight paint loss, pitting. Leading decayed, with panel buckling inwards. "

H 0.38m approx. W 0.38m approx.

for the main light figure we have recommended consideration be given to creation of an isothermal panel for the conserved glass within the main light, rather than a system for the entire light, as being a more cost effective option and for ease of maintenance. It would also permit removal of a single panel if required for exhibition purposes.<sup>1</sup>
