# CASTLERING ARCHAEOLOGY

**REPORT NO. 677**

# **VESTRY REFLOORNG AT**

# ST BARTHOLOMEW'S CHURCH

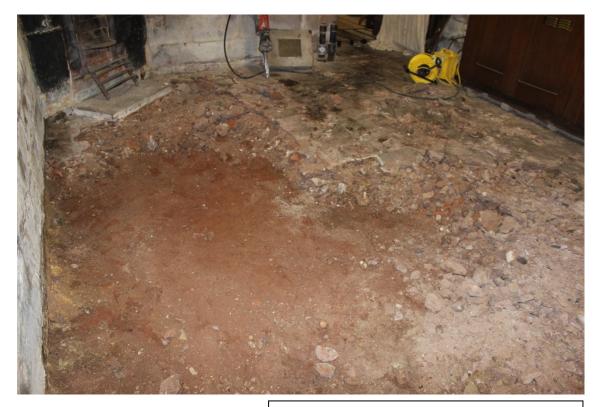
Plate 2: Breaking up the concrete floor

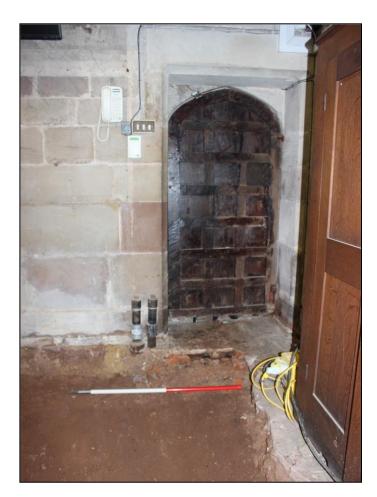
Plate 3:

Depth of excavation below door level

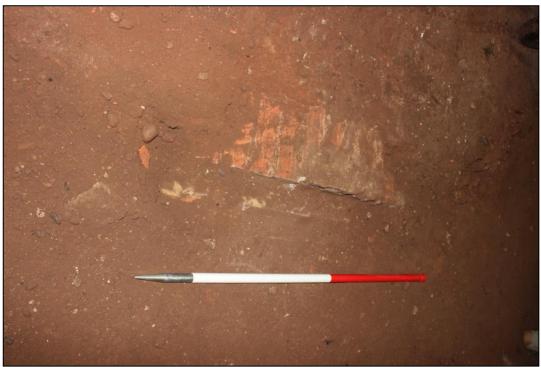
Plate 4:

4.2 Overall the removal of the floor exposed a soft red sand layer mixed with fragments of brick and speckled with mortar, confirming the belief that the composite screed floor lay above natural sands. Further excavation towards the centre of the room exposed the raised eastern arch of the tomb, constructed in a single course of 13 bricks. The arch measured 240mm wide (single brick width) and extended for 1.1m, which appears to be the width of the tomb. Beyond this length, the arch dipped and appeared to rest on the side walls.

Initial exposure of the arch

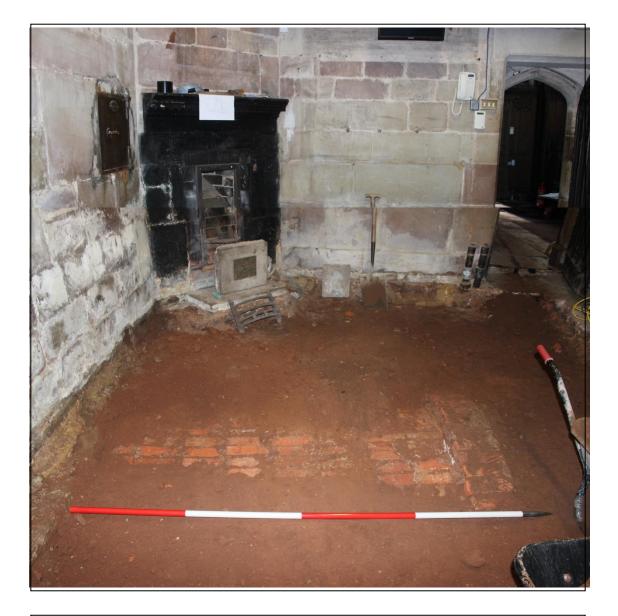
4.5 An area of the surface of the vault was hand cleaned to allow for some recording, although it was not within the remit of the project to make a full investigation of the tomb. The structure measured 2.2m on an east-west alignment. The tomb was constructed in hard-fired red bricks measuring a regular 240 x 70 x 60mm and laid with a medium hard lime mortar. Eight full bricks formed the length of the body of the tomb and the vaulted section extends for approximately 1.1m in width.

Plate 5: Tomb occupying central position with the Vestry, viewed from the north

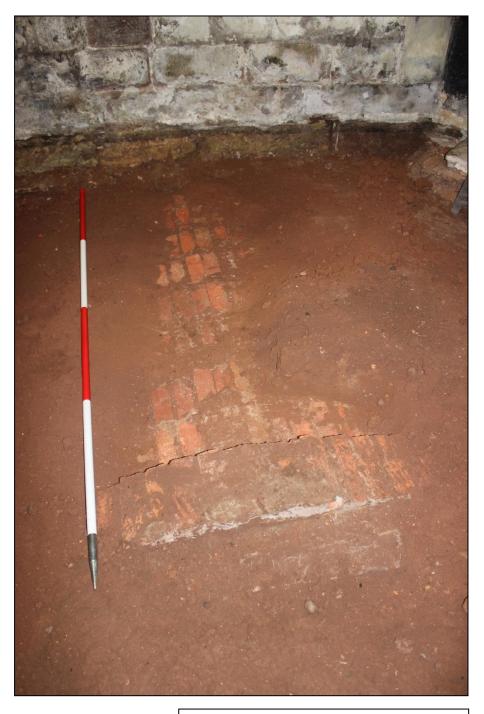
Plate 6: Tomb, viewed from the west
