# CASTLERING ARCHAEOLOGY

REPORT NO. 712

## RE-ORDERING WITHIN ST BARTHOLOMEW'S CHURCH

ARCHAEOLOGICAL MONITORING

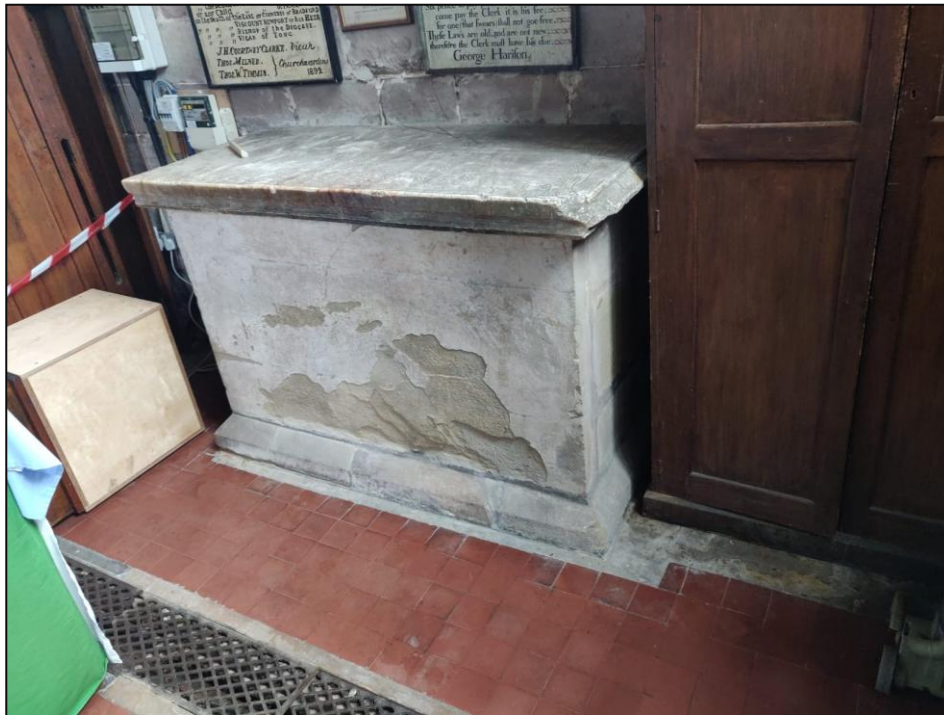
4.2 The tomb stood to a height of 0.95m above floor level, against the north wall of the church (Plate 1 *following*). It was already clear that the tomb was not sited in its original position and the materials beneath the incised slab were not original to its 16<sup>th</sup> century construction.

**Plate 1:**  
**Humphrey Vernon**  
**tomb, prior to**  
**works**

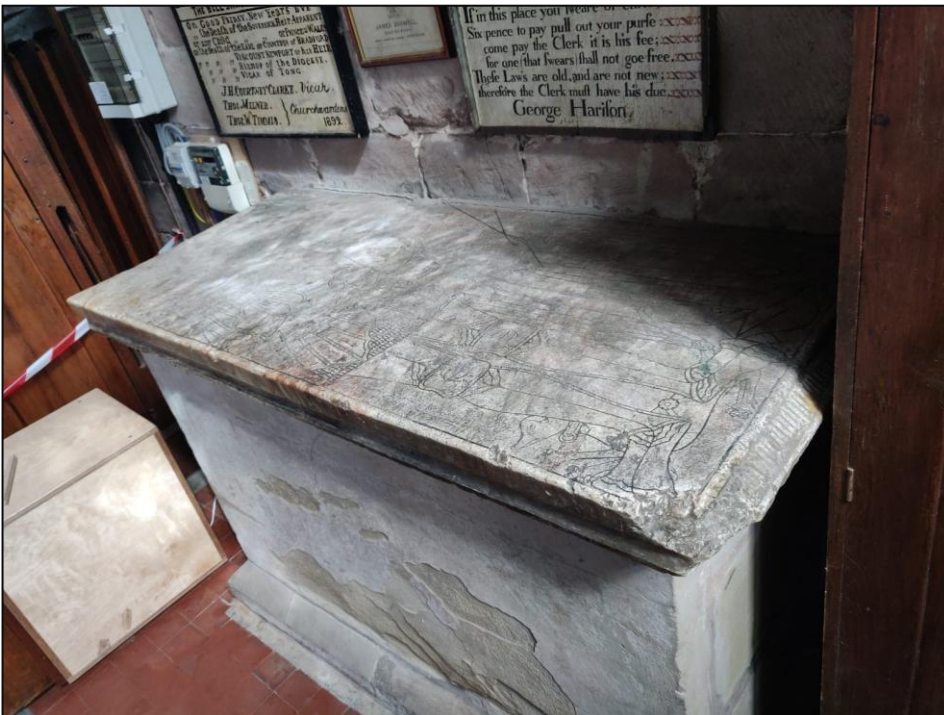
4.3 The alabaster slab measured 1.6m long by 0.7m wide. Although worn, the inscription could be identified as that of Humphrey Vernon and his wife Alice. Humphrey died on 28<sup>th</sup> August 1531 and his wife shortly after (Plate 3). The incised slab has a profiled edge detail on the south and west sides, with an inscription engraved along the edge of the east end (as noted in situ). This suggests that the tomb was originally set away from the wall and concurs with other opinions that the slab was designed to be on a tomb chest. If so, there is no record of where the original chest tomb was sited or when it was dismantled.

**Plate 2:**  
**Incised alabaster**  
**memorial slab**  
**depicting, in black**  
**lines, Humphrey**  
**Vernon, dressed in**  
**Tudor armour, and**  
**his wife, Alice.**

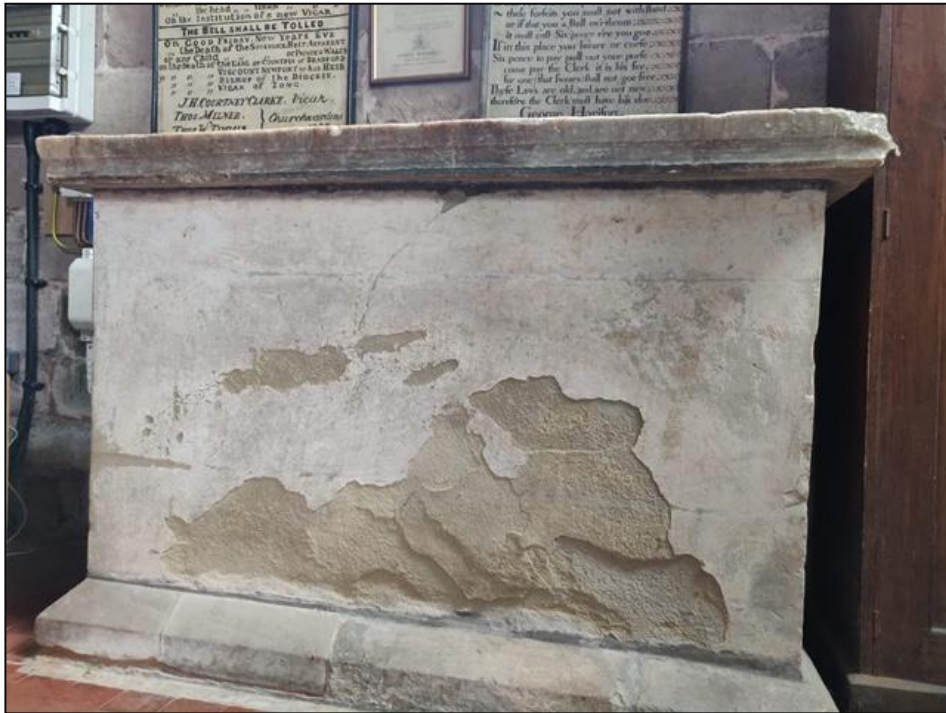
4.4 The tomb was methodically dismantled revealing a mix of building materials, which one can only assume were sourced on site in the past. The large limestone slab that fronted the tomb was un-inscribed and roughly hewn on the inside. The side walls were formed by sizeable blocks of stone, also rough on the inside, and gaps in the stonework were infilled with brick. It was clear that none of this material was cut especially to build the chest tomb.

**Plate 3:**  
**Front slab**

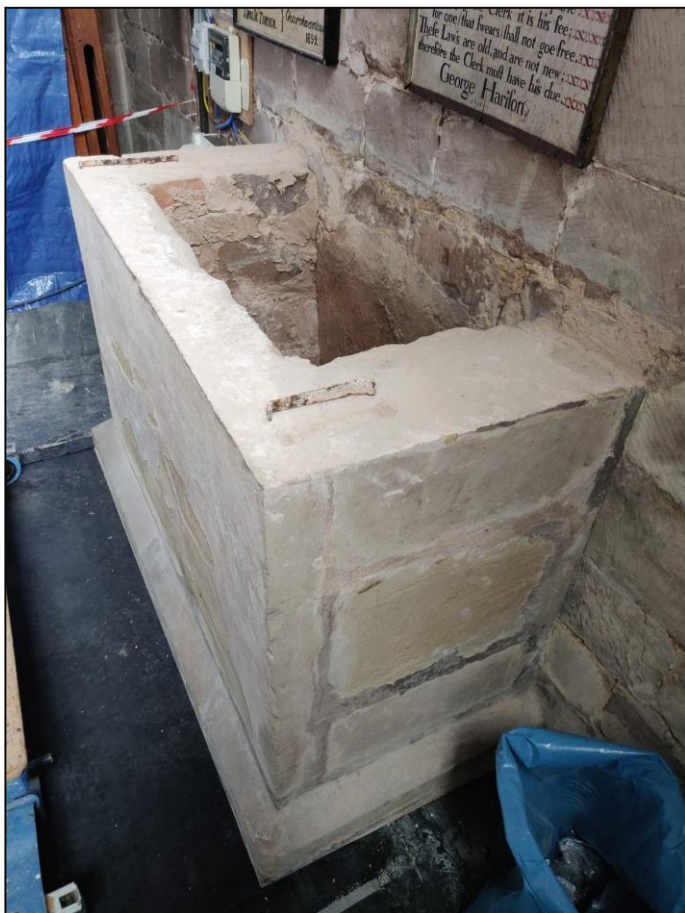
**Plate 4:**  
**Following removal of the top slab**

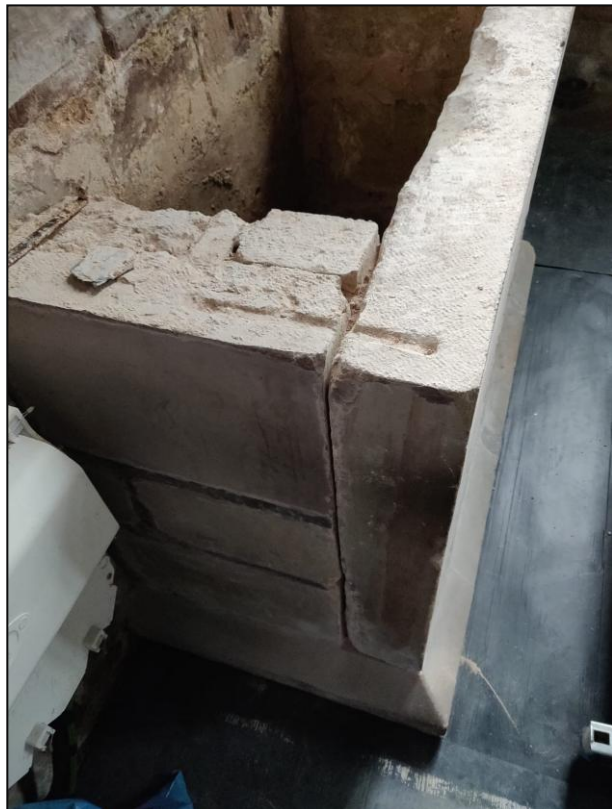
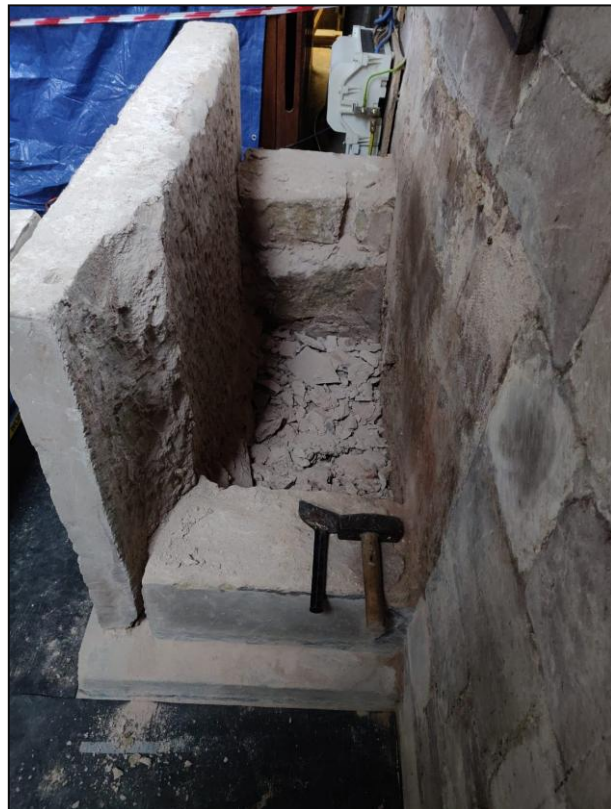
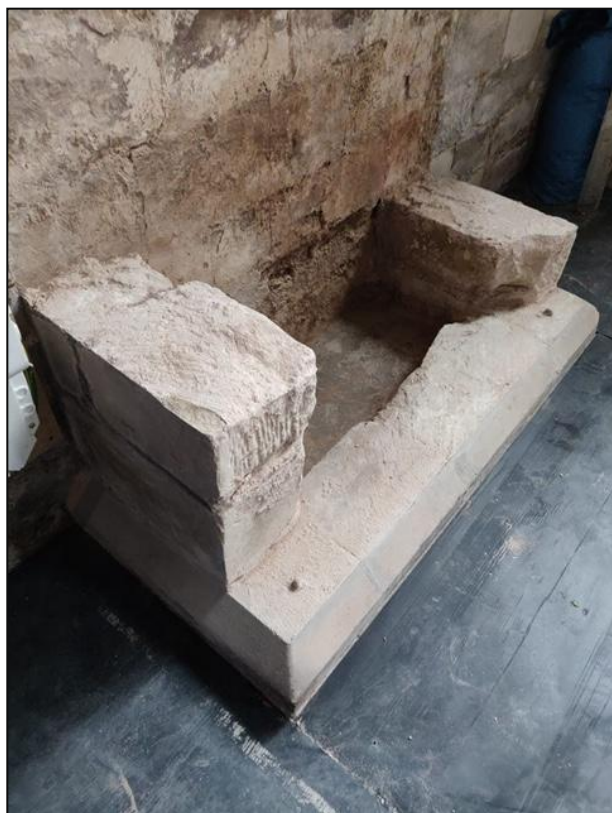
**Plates 5-7:**  
**Gradual process of dismantling**

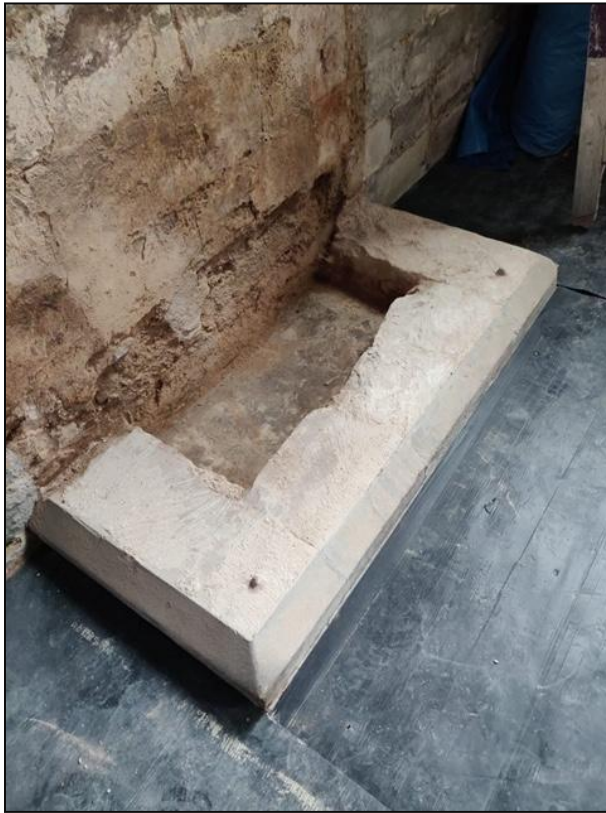
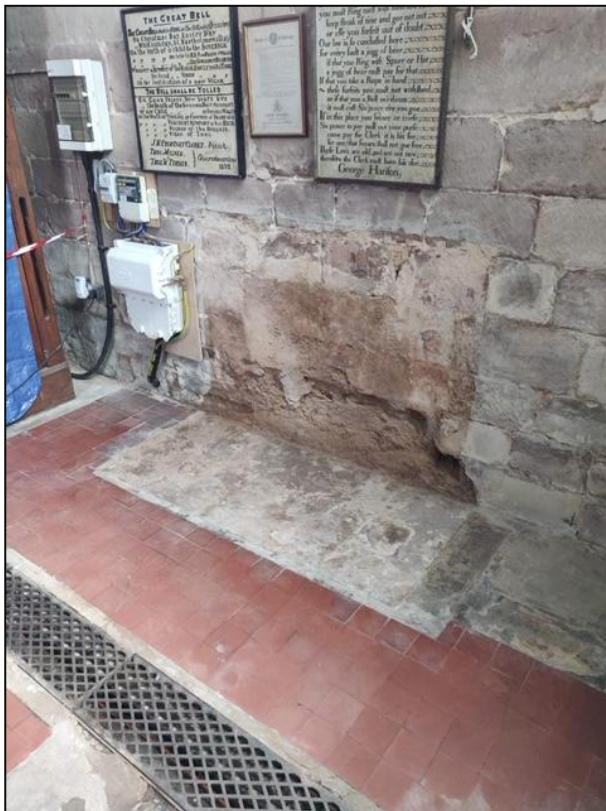
4.5 The dismantling work affirmed the accepted theory that the memorial slab was re-sited as a piecemeal chest tomb against the wall during late 19<sup>th</sup> century restoration work. At this date it is believed that it was repaired and re-erected in its current position parallel with and adjacent to the other tombs of the Vernon family. The tomb sat on a screed floor, surrounded by the red tiled floor of the north aisle.

**Plates 8-11: Kerbed base and screed floor**

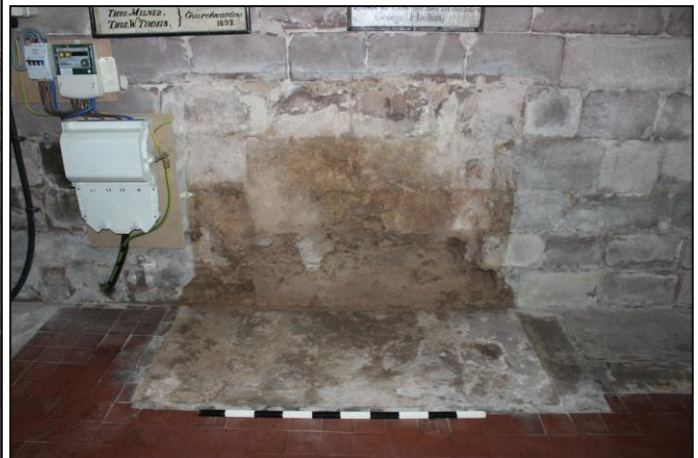
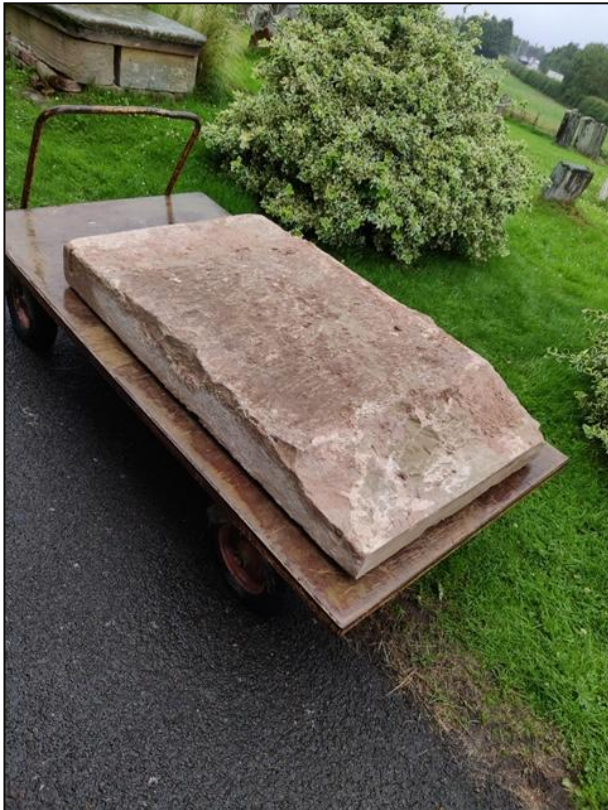
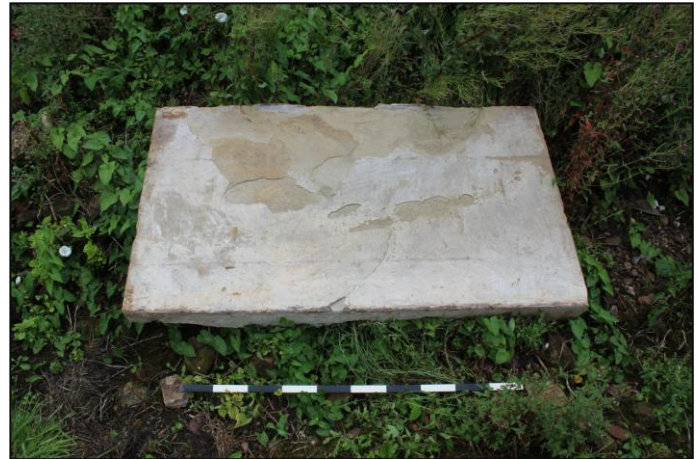
**Plates 12-13:**

**The un-inscribed front slab**

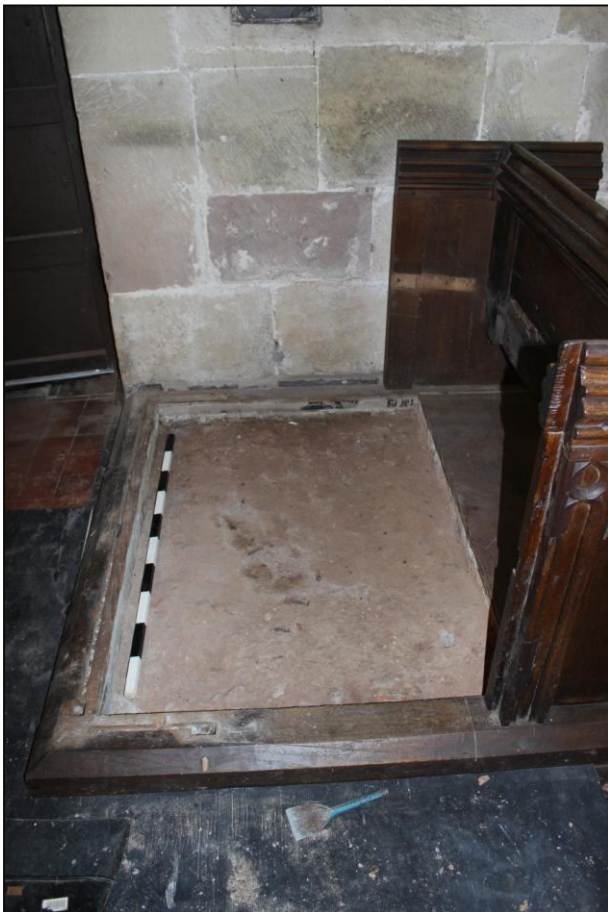
**Plates 14:**

4.6 Other re-ordering work included the removal of two pews to either side of the south door. These also revealed a screed base, surrounded by the red tiled floor.

**Screed floor below pews**
