Archaeological Attendance During Trial Pit Investigation at
the Church of St Mary Magdalene, Peckleton, Leicestershire

Report Number: R-0120

Project Reference: ABH-2020-08

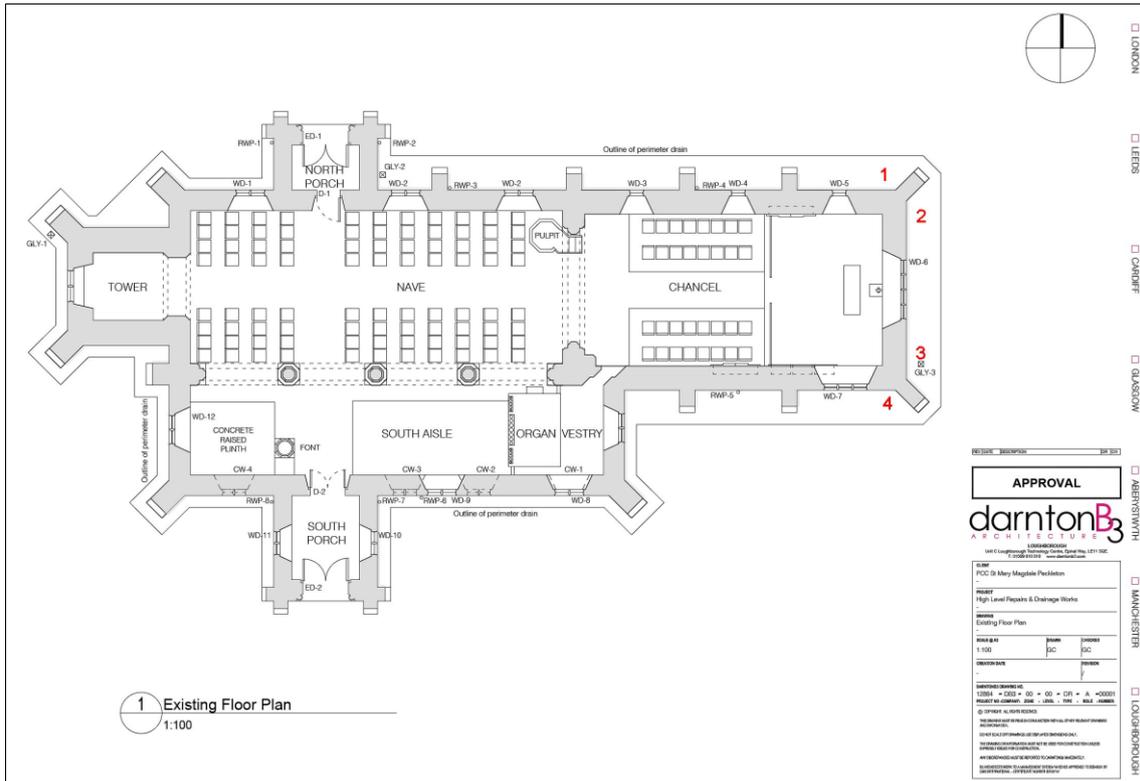
Figure 4. Plan of St Mary Magdalene showing Trial Pit locations in red. After Darnton B3.

6.1 The archaeological watching brief monitored the excavation of four test pits located on either side of the buttresses at the north-east and south-east corners of the church, which served to establish the nature and depth of the north, east and west wall foundations of the chancel.

6.4 The trial pit locations are shown in Figure 4 and the plans and sections are illustrated in Figures 5-8.

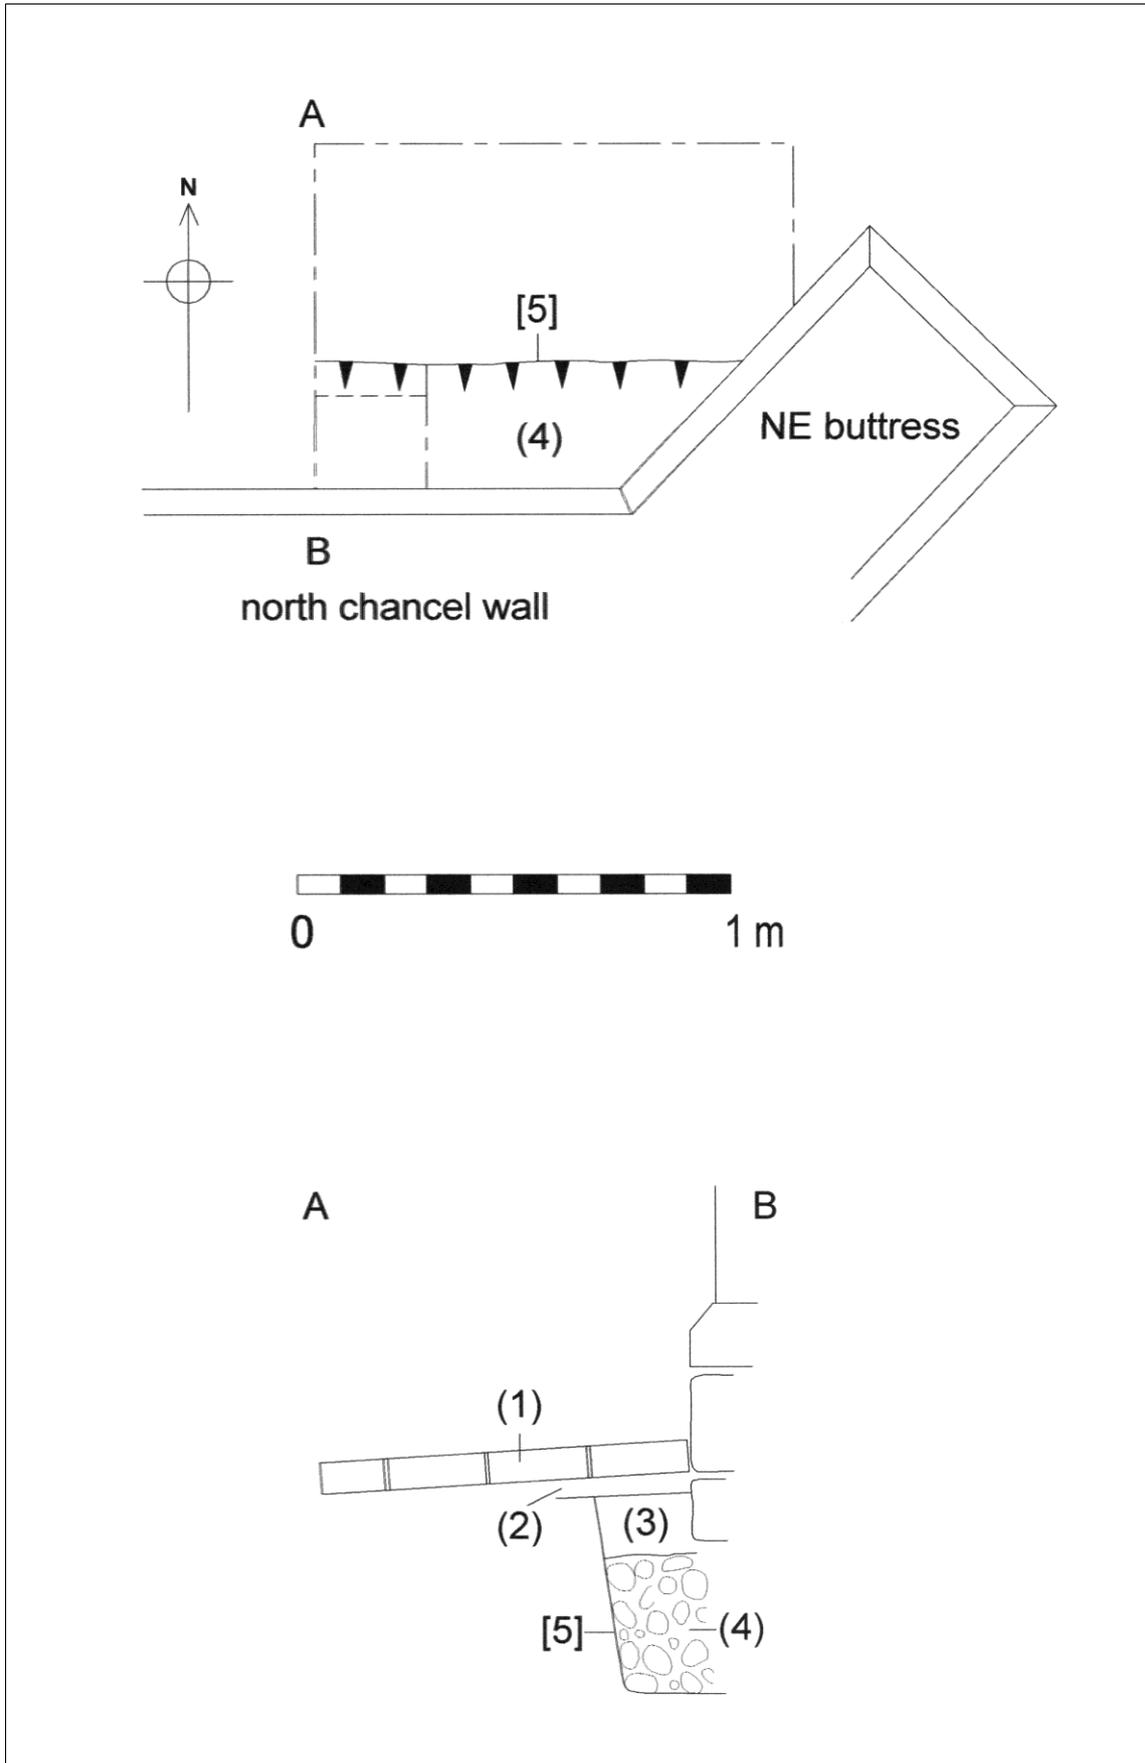
Figure 5. Plan and Section of Trial Pit 1.

7.2 Trial Pit 1 was located against the external face of the north wall of the chancel, adjacent to the buttress at the north-east corner. The maximum dimensions of this trial pit were: 1.10m E-W x 0.80m N-S x 0.60m deep.

7.3 The blue brick surface (1) was laid on a bedding layer of sand (2), to a depth of 0.12m. Below this a linear cut [5] was exposed in plan, 0.29m north of the north chancel wall and parallel with it. The cut had a near-vertical northern edge and a flat base that was 0.6m below the level of the blue-brick surface. The cut contained two fills, the upper of which (3) was a red-orange coloured sandy clay containing a few pebbles. The lower fill (4) was a compact deposit composed of water-worn pebbles in a red-brown sandy clay matrix.

7.4 Cut [5] was evidently a construction trench for the north chancel wall foundation, with the granite rubble wall built off the compacted pebble lower fill (4). The base of the granite rubble wall was 0.24m below the blue brick surface and 0.55m below the top of the chamfered limestone plinth course on this elevation.

7.5 No finds were recovered from Trial Pit 1 and no human remains were encountered.

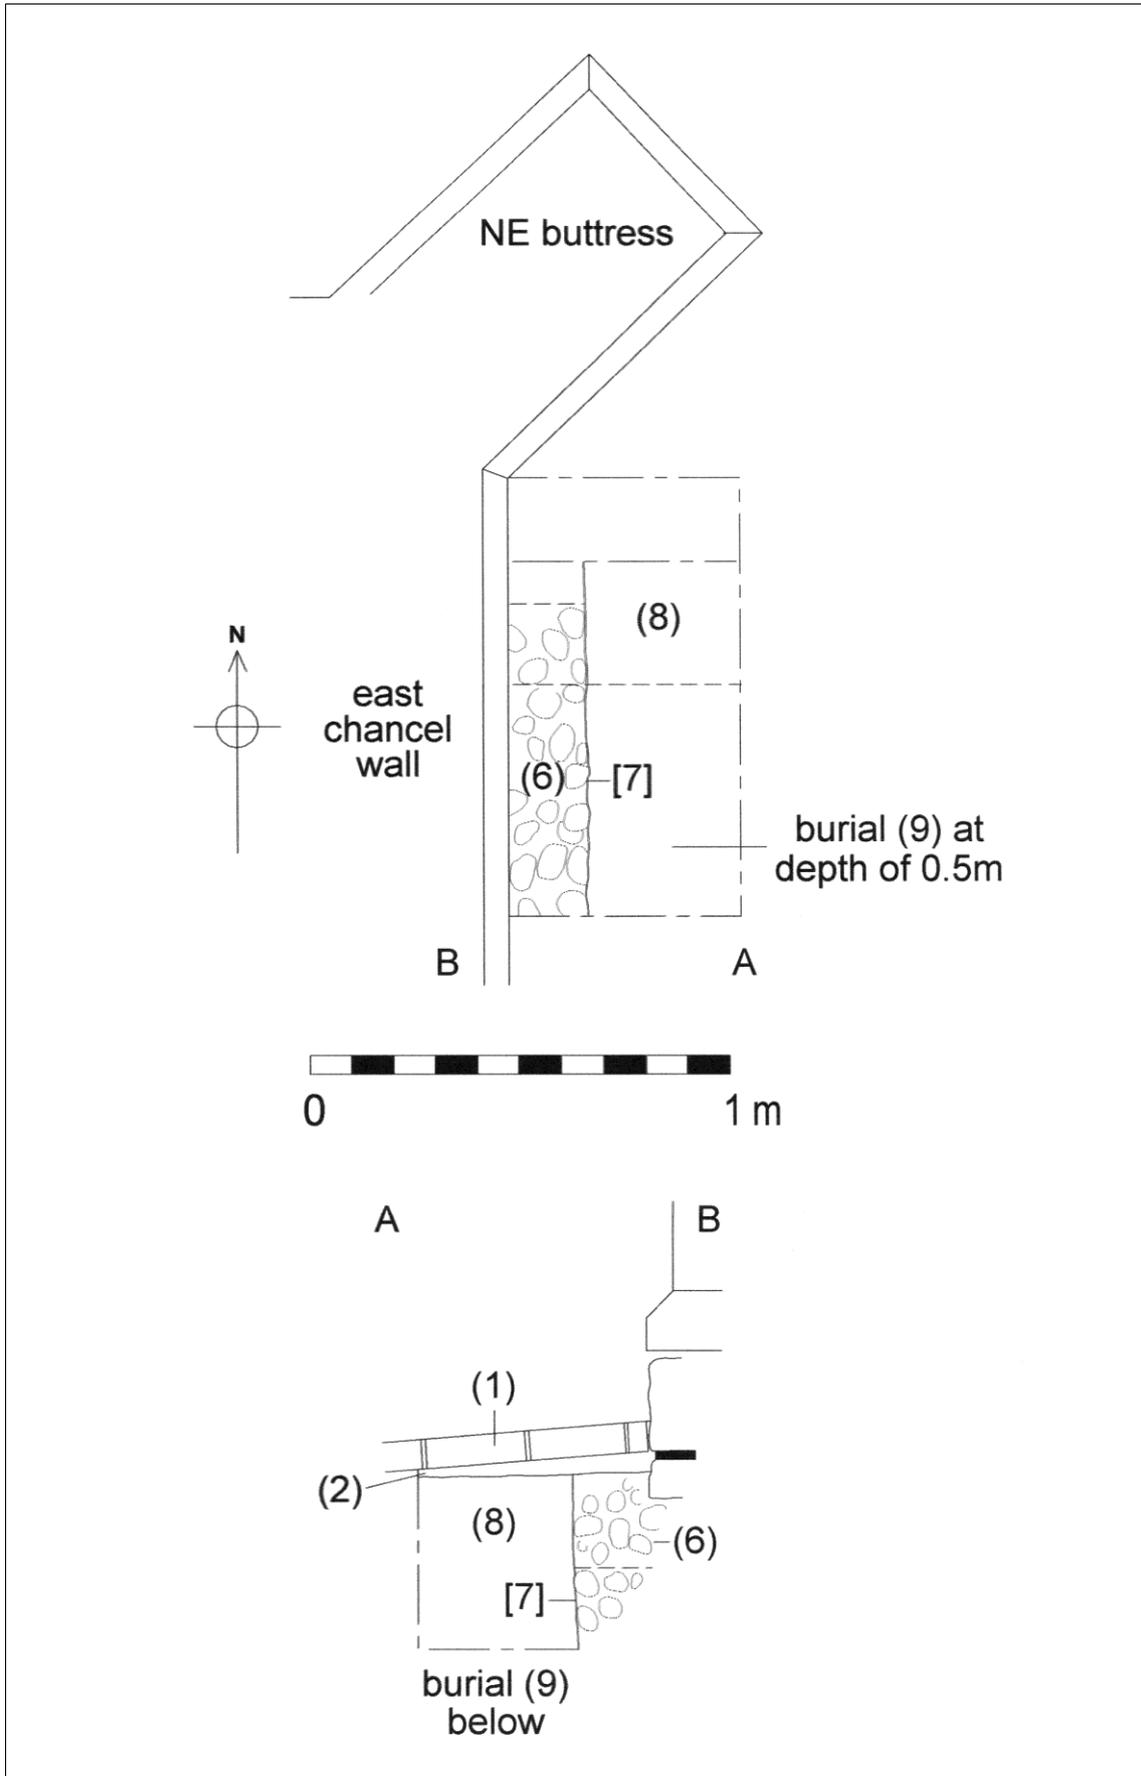
Figure 6. Plan and Section of Trial Pit 2.

7.6 Trial Pit 2 was located against the external face of the east wall of the chancel, adjacent to the buttress at the north-east corner. The maximum dimensions of this trial pit were: 1.05m N-S x 0.50m E-W x 0.55m deep.

7.7 Below the brick surface (1) and its sand bedding layer (2), a linear cut [7] was exposed in plan, at a depth of 0.12m below the blue brick surface. The eastern edge of this was 0.19m east of the outer face of the chancel wall and parallel with it. Cut [7] had a vertical eastern edge, the base was not exposed; it contained a single fill (6) composed of water-worn pebbles in a compact red-brown sandy clay matrix.

7.8 Cut [7] was a construction trench for the east chancel wall foundation, with the granite rubble wall built off the compacted pebble fill (6). The base of the granite rubble wall was at 0.19m below the blue brick surface and 0.50m below the top of the chamfered

limestone plinth course on this elevation. Between the lowest two courses of the wall was a bed of black bitumen that served as a damp proof course.

- 7.9 The construction trench [7] was cut through a red-brown sandy clay layer with common inclusions of small pebbles (8). Within this deposit, at a depth of 0.50m below the surface, articulated human remains (9), representing an inhumation burial, were encountered. Excavation was terminated at this depth and the burial was not exposed or investigated further. No finds were recovered from Trial Pit 2.

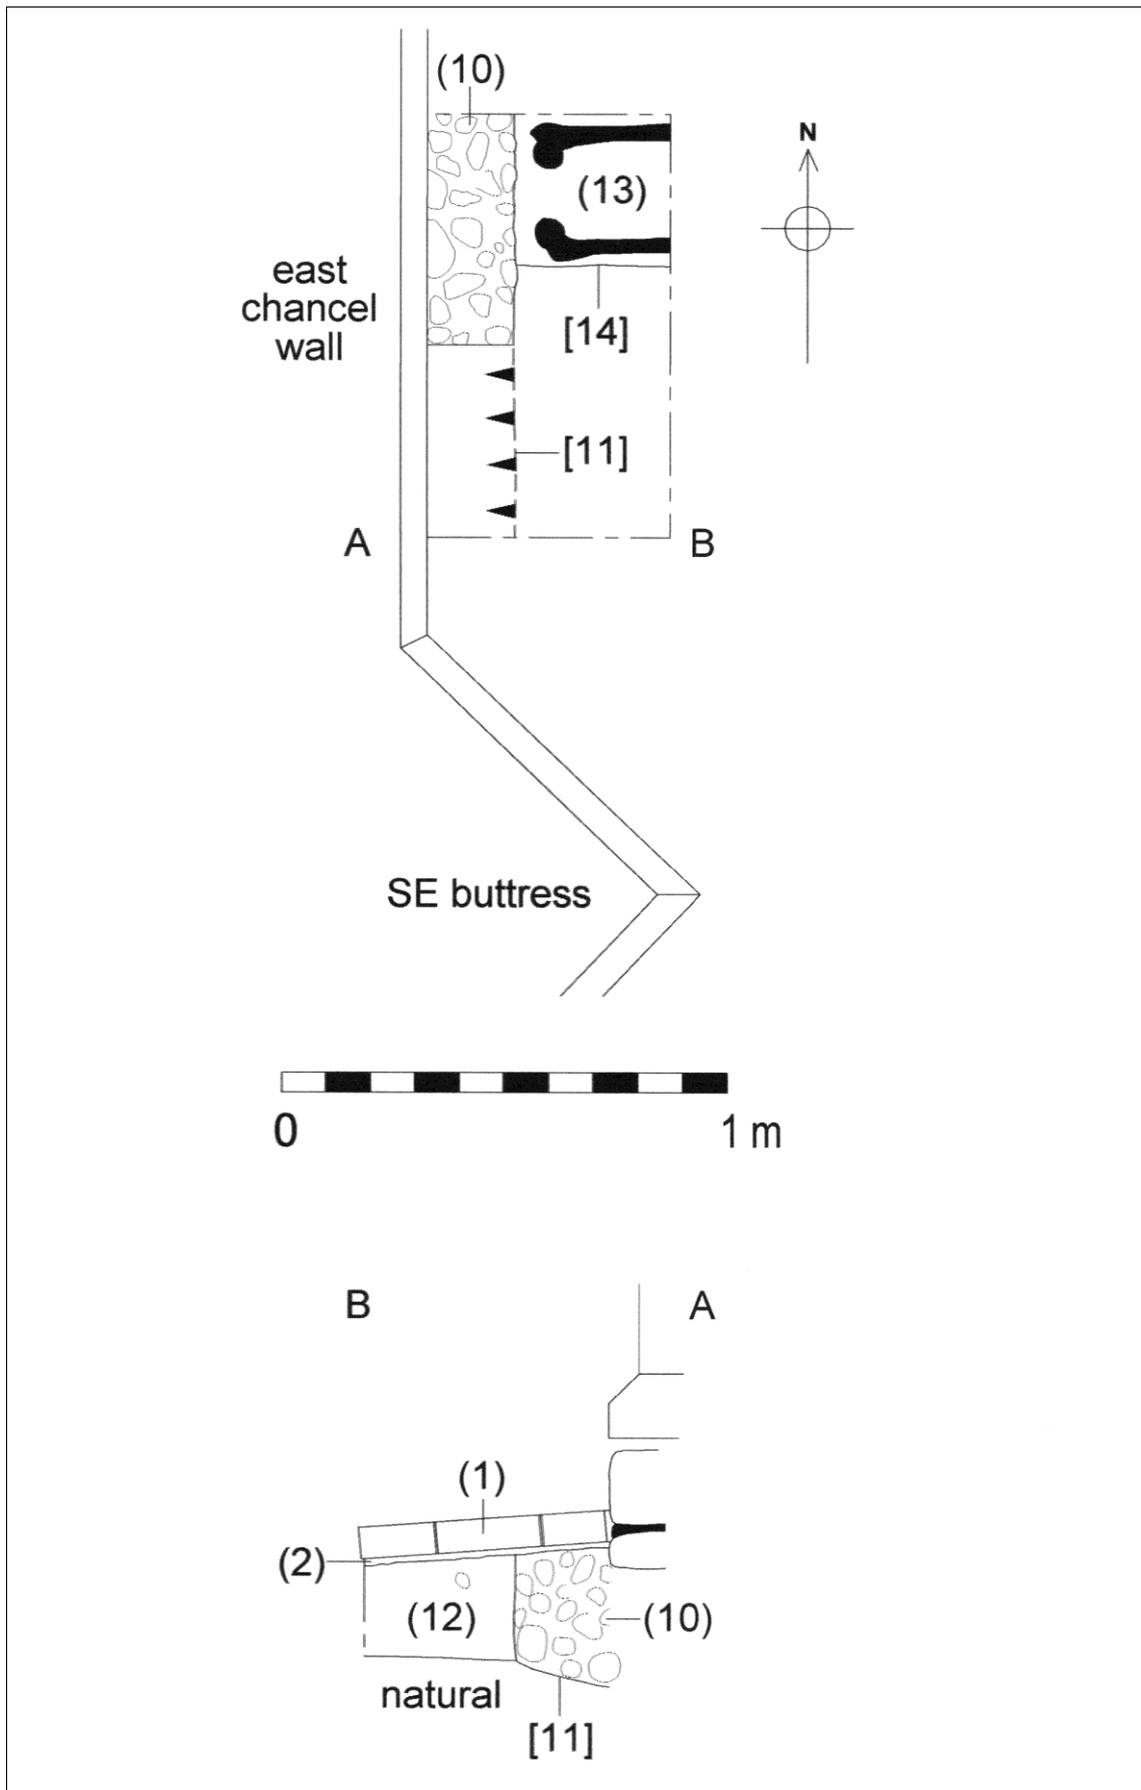
Figure 7. Plan and Section of Trial Pit 3.

- 7.10 Trial Pit 3 was located against the external face of the east wall of the chancel, adjacent to the buttress at the south-east corner. The maximum dimensions of this trial pit were: 0.95m N-S x 0.55m E-W x 0.40m deep.

- 7.11 Beneath the blue brick surface (1) and its sand bedding layer (2), a linear cut [11] was exposed in plan at a depth of 0.09m. The eastern edge of this was 0.20m east of the external face of the chancel wall and parallel with it. The eastern edge of cut [11] was vertical and the visible portion of its base sloped gradually to the west; its maximum depth was 0.40m below the blue brick surface. The construction cut [11] contained a single fill (10) composed of water-worn pebbles in a compact mid-brown coloured sandy clay matrix.

- 7.12 The base of the east chancel wall was 0.13m below the blue brick surface and 0.44m below the top of the chamfered limestone plinth course on this elevation. The wall was founded on the compact pebble fill (10) of the construction trench [11]. Between the lowest two courses of the wall was a bed of black bitumen that served as a damp proof course.

- 7.13 The construction trench [11] was cut through a compact red-brown sandy clay layer with occasional inclusions of large pebbles (12). Below (12), at a depth of 0.30m, was the geological natural ground, which consisted of firm red-brown coloured clay. Cut into the geological natural ground at the north end of the trial pit was a grave [14], within which a pair of adult femurs were partially exposed (13). The western half of this grave was truncated when the construction cut [11] for the foundation of the east wall of the chancel was excavated, indicating that the burial predates the chancel. The human remains were left *in situ* and no other finds were recovered from this trial pit.

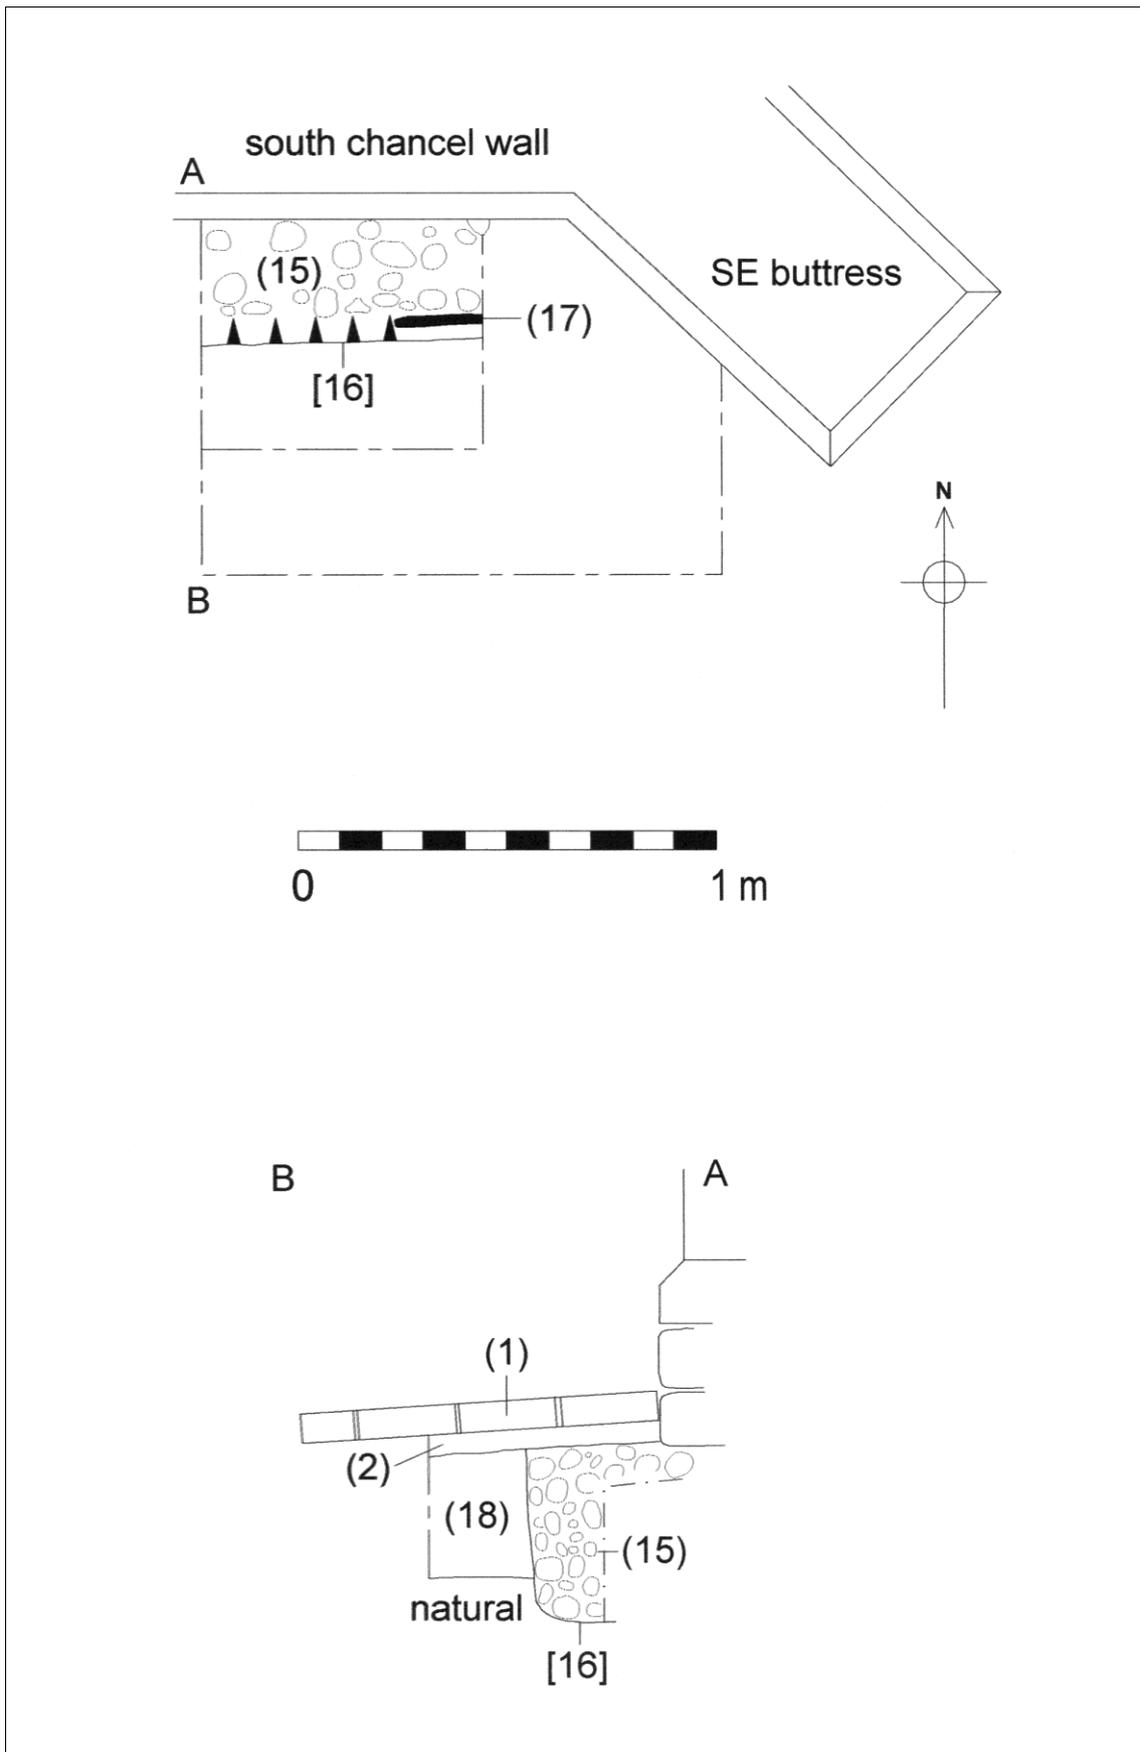
Figure 8. Plan and Section of Trial Pit 4.

- 7.14 Trial Pit 4 was located against the external face of the south wall of the chancel, adjacent to the buttress at the south-east corner. The maximum dimensions of this trial pit were: 1.24m E-W x 0.85m N-S x 0.56m deep.

- 7.15 Beneath the blue brick surface (1) and its sand bedding layer (2), a linear cut [16] was exposed in plan at a depth of 0.17m. This was aligned east-west, parallel with the chancel wall and 0.30m south of its external face. The southern edge of the construction cut was near vertical and its flat base was 0.56m below the level of the blue brick surface. Cut [16] contained a single fill (15), composed of water-worn pebbles in a compact red-brown sandy clay matrix. A human long-bone and other fragments of chancel (17) were found within fill (15), laid against the southern edge of cut [16]; these were left *in situ* and reburied when the trial pit was backfilled.

- 7.16 The base of the south chancel wall was 0.14m below the blue brick surface and 0.44m below the top of the chamfered limestone plinth course on this elevation. The wall was founded on the compacted pebble fill (15) of the construction trench [16].

- 7.17 The construction trench [16] was cut through a red-brown coloured sandy clay layer (18), below which the geological natural clay occurred at a depth of 0.45m.

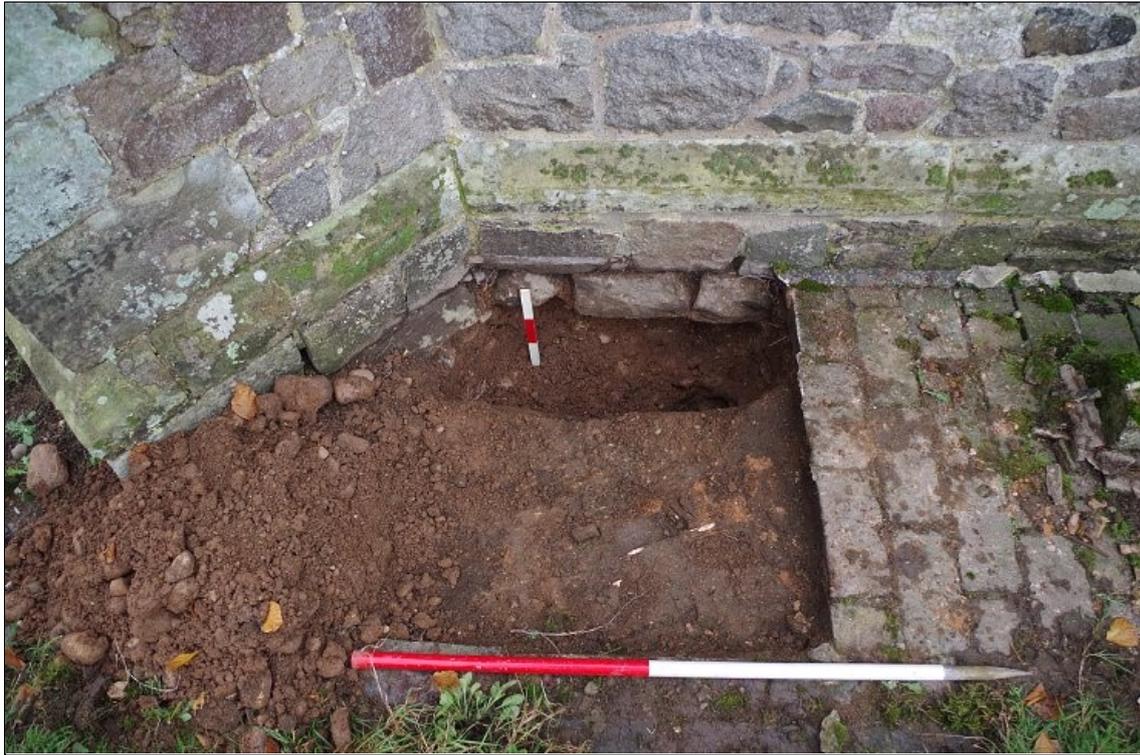
Photo 3. General view of Trial Pit 1, looking S. The compacted pebble fill (4) has been excavated, exposing the foundation trench cut [5].

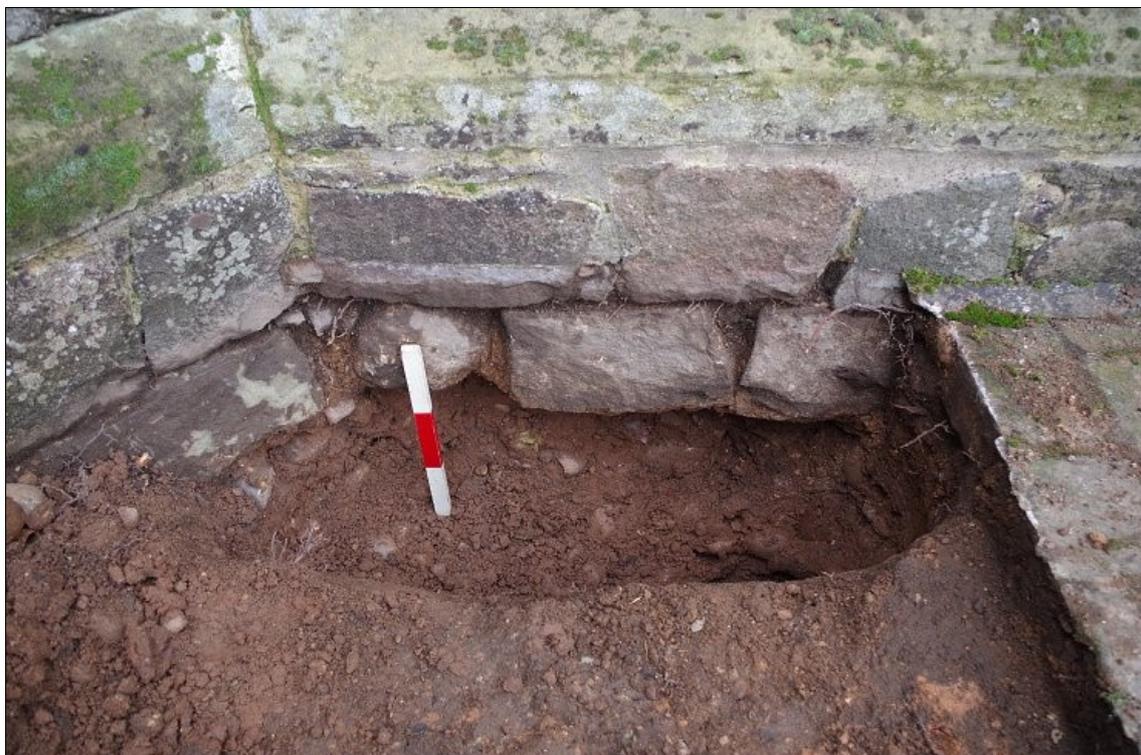
Photo 4. Trial Pit 1, showing lower course of north chancel wall above fill (4) of foundation trench [5], looking S.

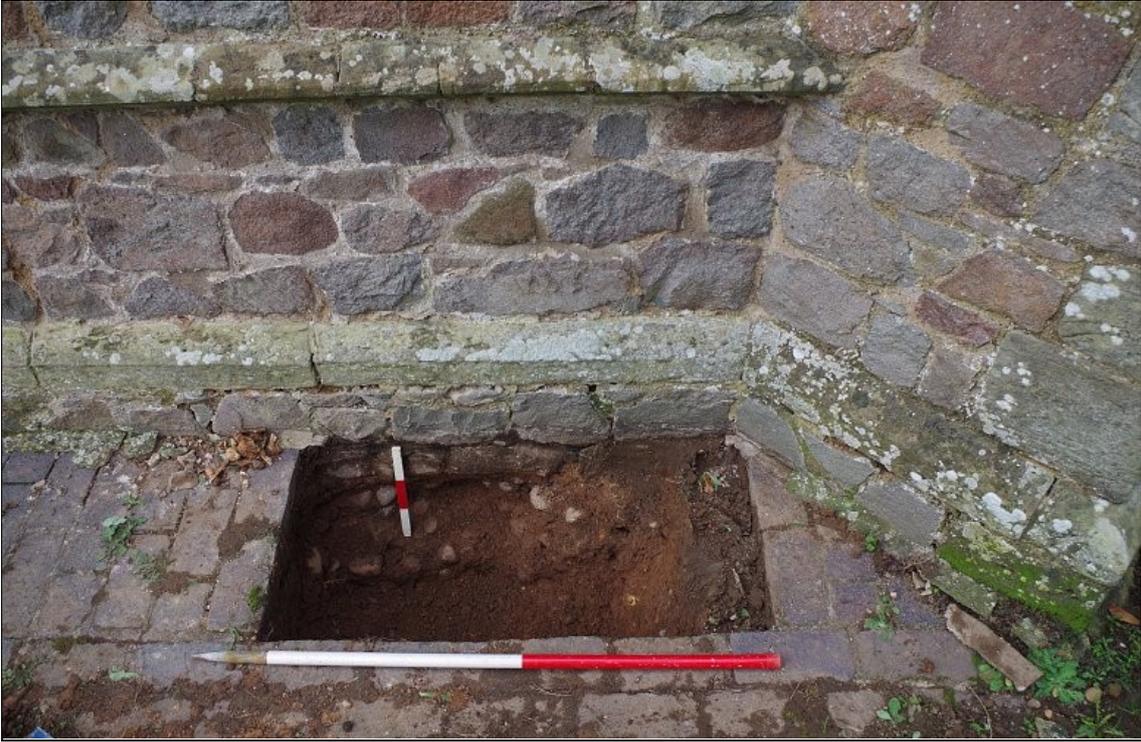
Photo 5. General view of Trial Pit 2, looking W.

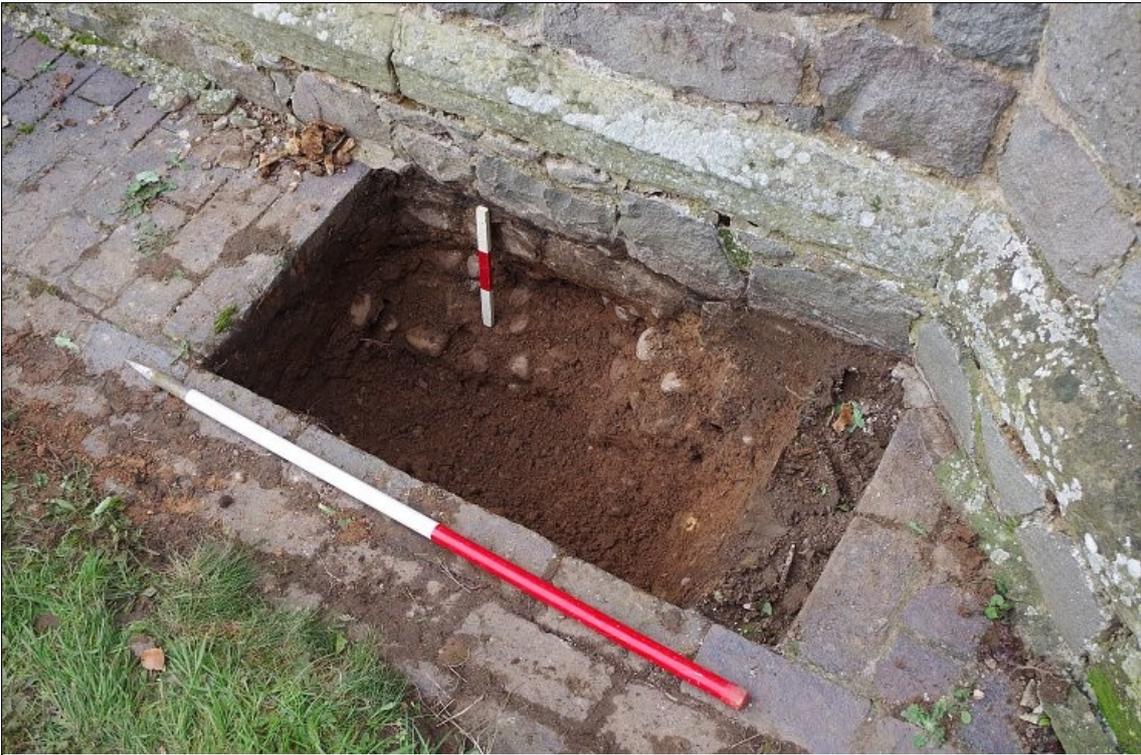
Photo 6. Trial Pit 2, looking SW with vertical photo scale resting on compacted pebble fill (6) of foundation trench [7]. Burial (9) is not exposed in this shot.

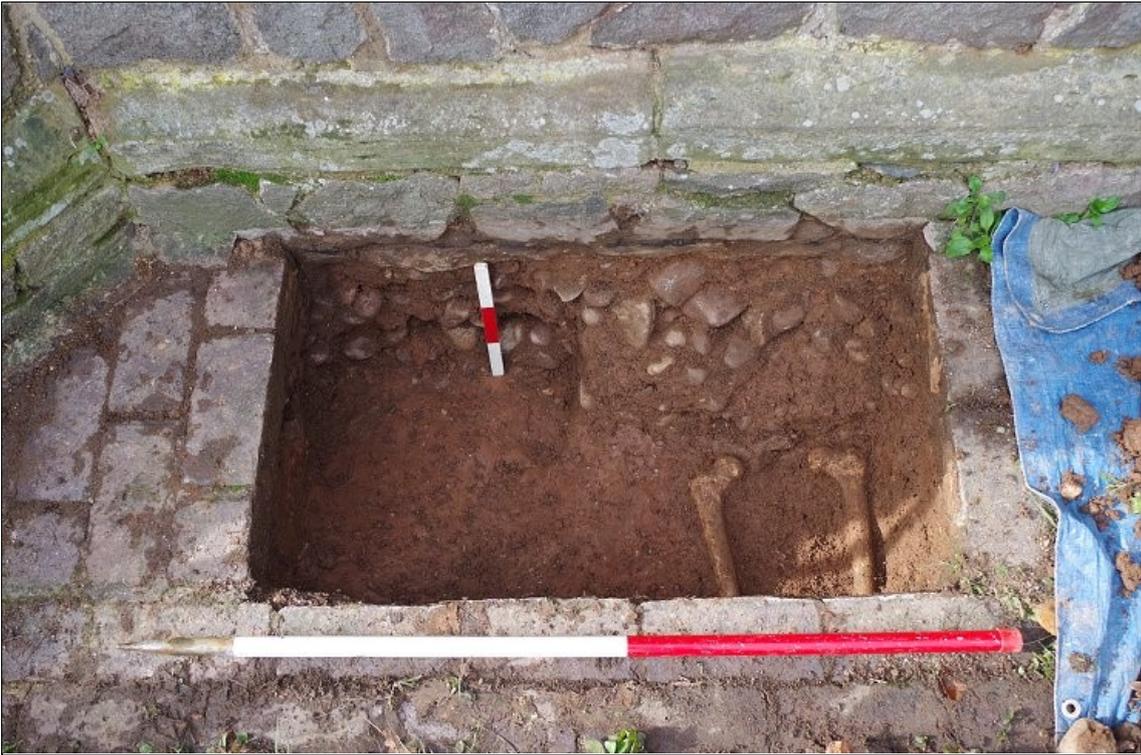
Photo 7. General view of Trial Pit 3, looking W.

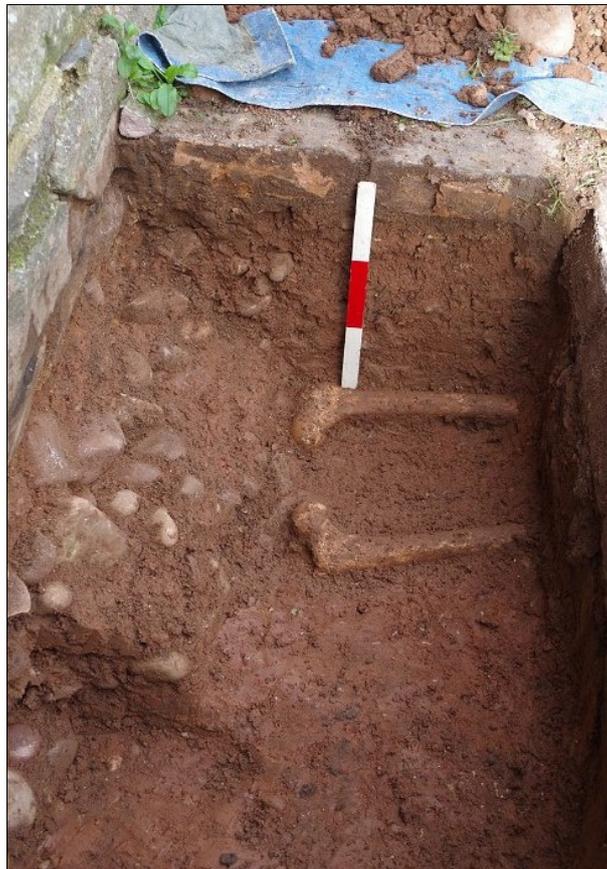
- 8.6 Excavation of the foundation trench for the east chancel wall truncated the western half of a grave [14] that was partially exposed in Trial Pit 3. The inclusion of charnel (17) within the fill of the construction cut [16] for the south chancel wall foundation, exposed in Trial Pit 4, indicates that other burials were also affected by the excavation of the foundation trenches. These burials must predate the foundation trenches but their age is uncertain. The relatively shallow depth of the burials exposed in Trial Pit 2 (c. 0.5m below present ground level) and Trial Pit 3 (c. 0.3m below present ground level) tends to suggest that these are earlier rather than later in date and they could be medieval.
- 8.7 The burials encountered in Trial Pits 2 & 3 serve to confirm that there are a number of unmarked graves immediately outside the east end of the chancel.

Photo 8. Trial Pit 3, looking N showing compacted pebble fill (10) of foundation trench [11] and truncated burial (13) in grave [14].

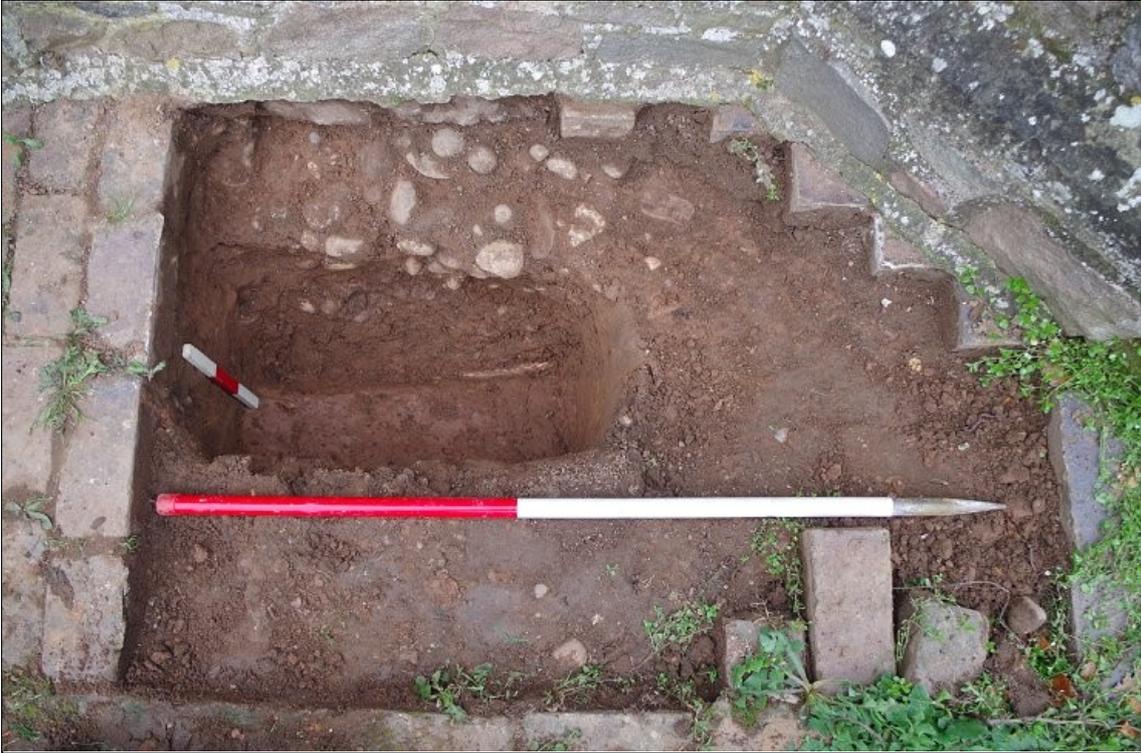
Photo 9. General view of Trial Pit 4, looking N.

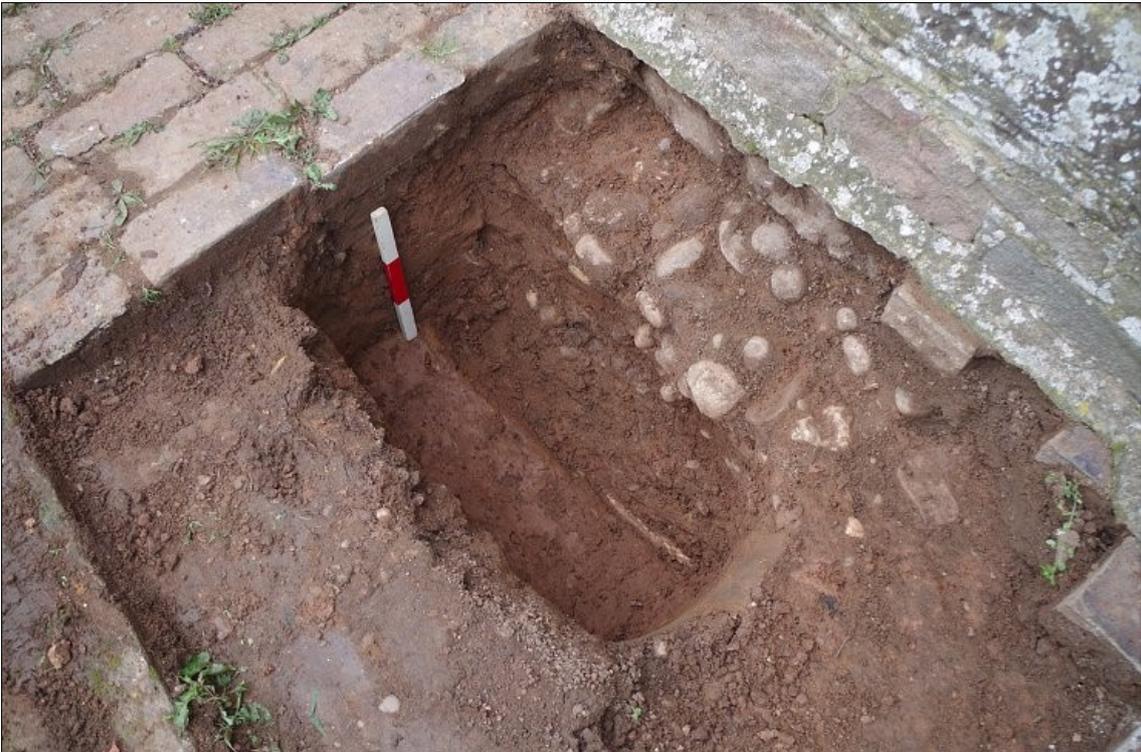
Photo 10. Trial Pit 4, looking NW with scale bar resting on natural clay and foundation trench cut [16] to right of this. A human long bone (17) is within of the partially excavated fill (15).
