The Church of St Thomas of Canterbury

Compton Valence

Report describing the conservation and cleaning of the painted text above the donations box

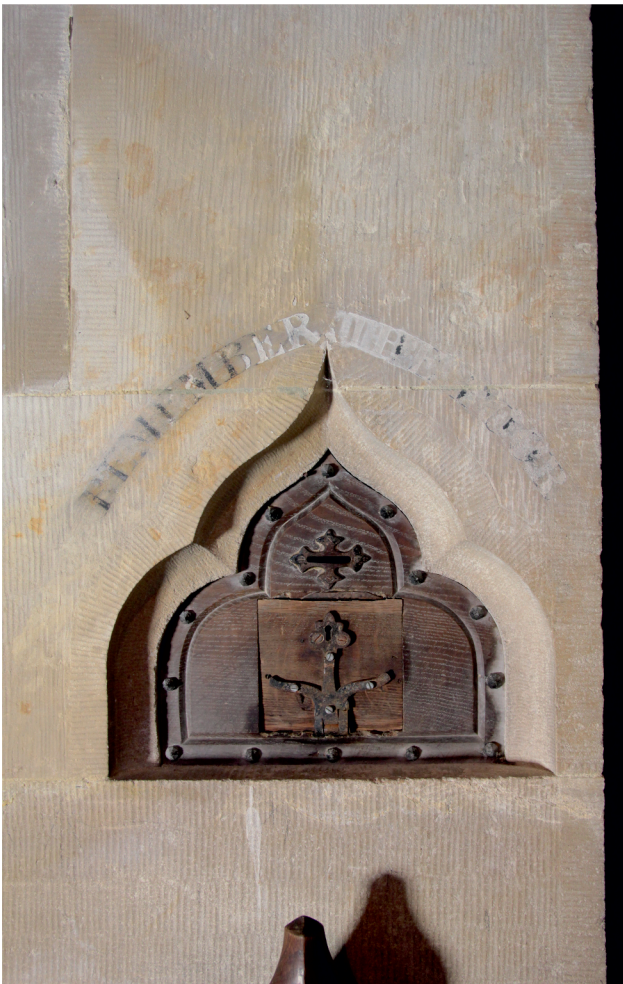
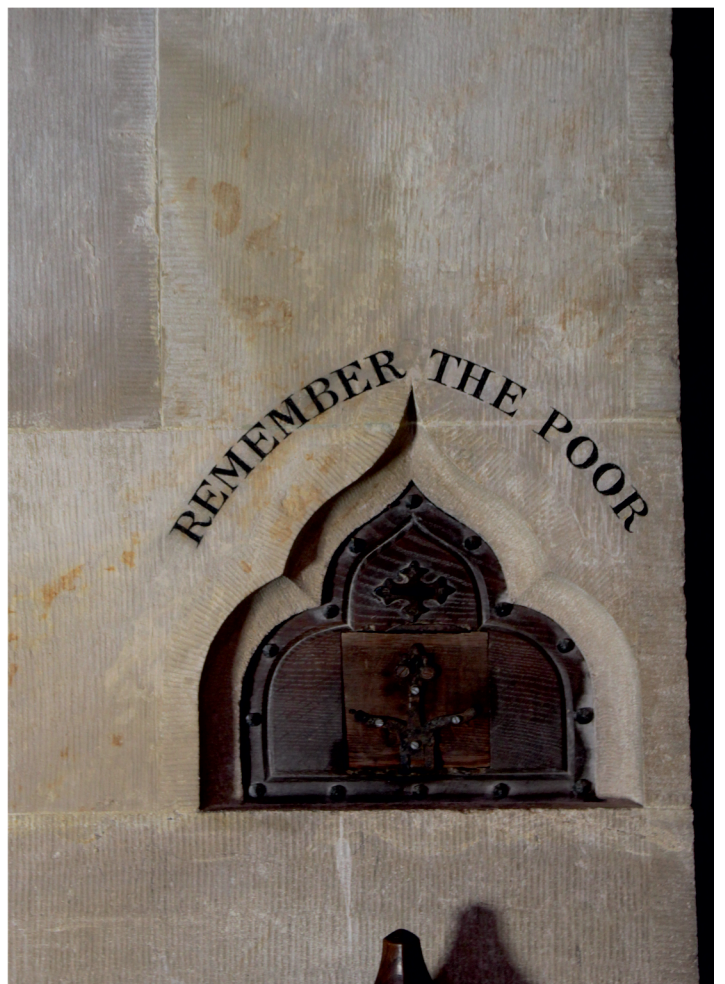
3 and 4 below - left before conservation, right after conservation.

Loosely adhering dirt and dust was removed from the painted text and surrounding ashlar using a soft artists' brush. Further deposits of dirt and dust was removed using a Wishab™ self-abrading sponge. More stubborn surface dirt was removed using a small damp sponge dipped in clean water, avoiding the painted lettering. Dirt around the lettering was removed with a cotton wool bud on a swabstick so as to avoid the lettering.

The lettering crosses a joint between two stones. This joint was repointed with a fine lime mortar (3 parts sand / 1 part lime putty).

In preparation for retouching, existing lettering was consolidated with a 2.5% solution of Paraloid B72 in xylene. Missing parts of the text were then retouched with artists' watercolour paint. If needed, at a later date, it will be possible to remove the retouching without disturbing original paint.

Using watercolour paint, minor blemishes in the surrounding ashlar were toned out. This was done to enhance the overall appearance of the painted text.
