AN ARCHAEOLOGICAL WATCHING BRIEF
AT THE PARISH CHURCH OF ST. JOHN THE BAPTIST, CHURCH LANE,
MILDENHALL, WILTSHIRE.

**National Grid Reference: SU 2097 8948
Planning Reference: 19/05352/FUL
Wiltshire Museum, Devizes Accession Number: DZSWS -
35-2021**

June 2021

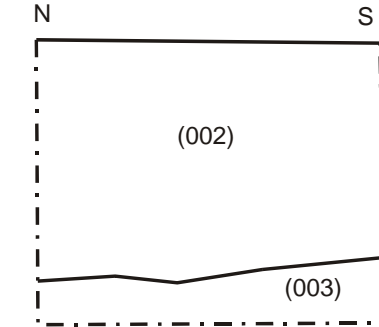
Representative Section 17, West Facing Section, scale 1:20

7.4.2 A short length of trench was excavated from the rear of the site of the disabled toilet block northwards and terminated at the septic tank excavation. This trench measured 3.10m in length, 0.35m in width and was excavated to a depth of 0.55m below ground levels [Plates 100 and 101]. The septic tank excavation itself was of 3.40m in length by 2.0m in width and was monitored to a depth of 1.10m below ground levels, when the monitoring was terminated [Plates 102-105 and 107-112]. These excavations extended through the topsoil horizon (002) and into the underlying natural horizon of river gravels (003), which extended to the base of these excavations. This deposit sequence was recorded within **Representative Section 17 [Plate 106]**.

- 002** As above. Recorded within **Representative Section 17**. Depth - 0.75m.
- 003** As above. Recorded within **Representative Section 17**. Depth - >0.20m.

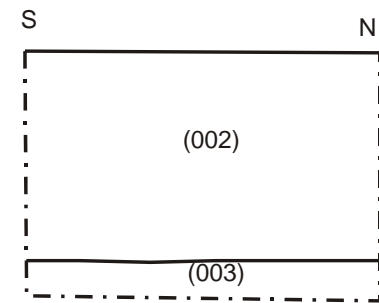
Representative Section 7, East Facing Section, scale 1:20

- 7.1.5 To the north of the churchyard pathway and beyond it, a further and final section of cable trench was excavated to connect to the site of the new disabled toilet block. These mechanical excavations initially comprised a small area of limited ground reduction that measured 5.80m in length, of 1.40m in width and went to depths of 0.20m-0.30m below ground levels [**Plates 43-45**]. From this limited area of ground reduction, the final section of the new electric cable trench was excavated to the same uniform width of 0.30m and to depths of 0.60m below ground levels [**Plate 46**]. These further excavations were confined to a topsoil horizon (**002**), (which was

recorded beyond the former churchyard boundary) and was recorded within **Representative Section 7 [Plate 47]**. No archaeological activity as identified here and there were no finds.

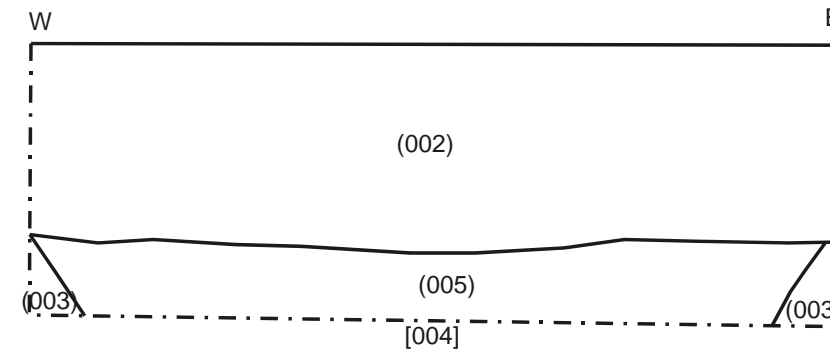
Section 15 of the Pit Cut [004] with Fill (005), South Facing Section, scale 1:20

7.3.3 The cut of an undated small pit [004] was identified towards the eastern end of this trench. This feature was sealed by the topsoil horizon (002) and was cut into the natural horizon of river gravels (003). The profile of this pit was recorded within **Section 15**. The fill (005) did not yield any finds [Plate 91] .

- 002** As above. Above (**003**) and (**005**). This fill yielded finds of two sherds of late pots-medieval to modern pottery. Recorded within **Representative Sections 8-16**. Depth - 0.57m.
- 003** Natural horizon of river terrace gravels. Soft, light orange brown silt matrix with small-medieval angular stones and flint fragments 60%-80%. Below (**002**). Recorded within **Representative Sections 8-16**. Depth - >0.56m.
- 004** Cut of a small and undated pit. Cut into (**003**). Profile recorded within **Section 15**. Length - 2.26m, width - >0.30m, depth - >0.21m.
- 005** Fill of the undated pit cut [**004**]. Soft, mid orange brown silt with moderate small angular stones and flint fragments. Below (**002**). This fill did not yield any finds. Recorded within **Section 15**. Depth - >0.21m.
