## St Petrock's, Timberscombe, Somerset

### Tower Commemorative Plaque

### Conservation Report

### October 2021

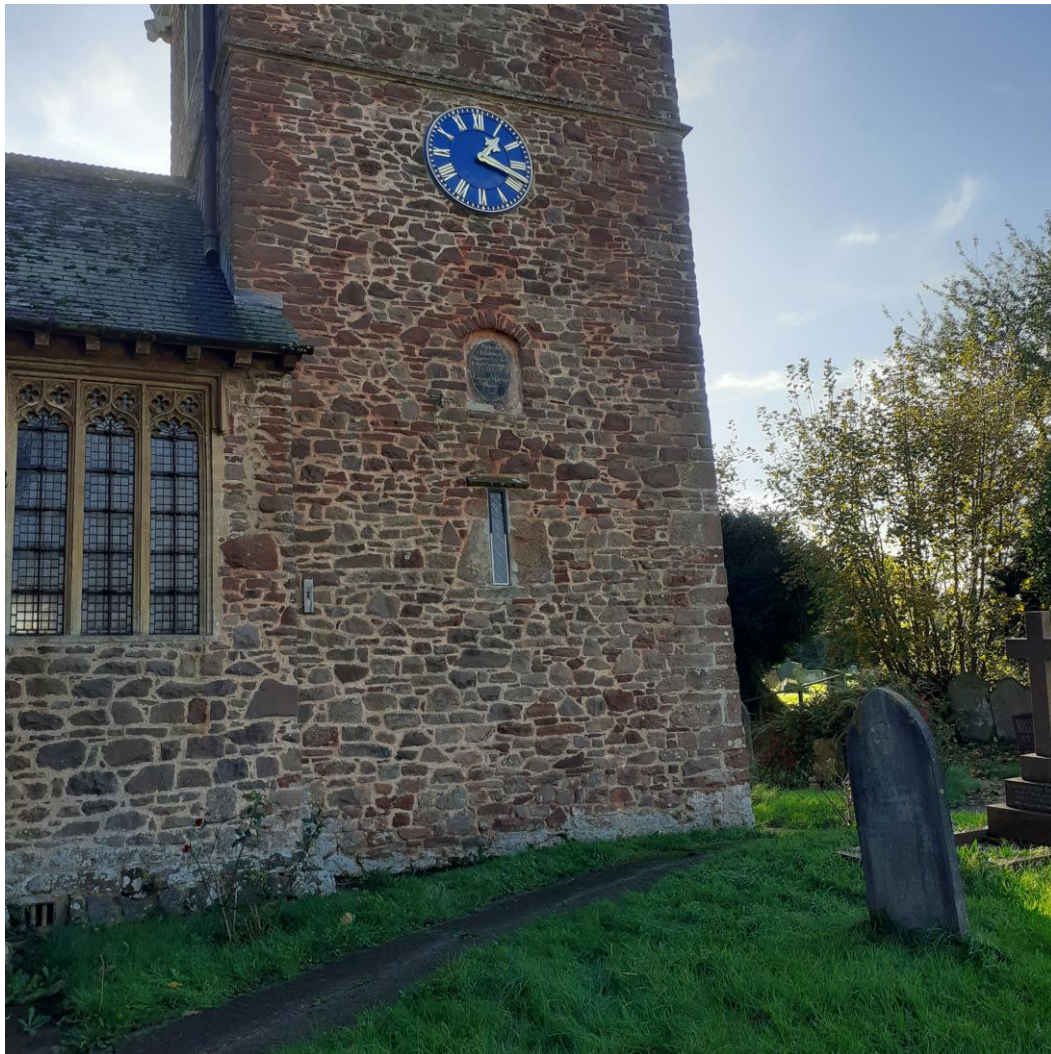
The inscription plaque is fixed on the external north face of the tower, below the clock face, bears the date 1701 and is apparently carved of a local material, a sandy limestone to judge from the areas of visible surface. The lettered inscription is V cut and the entire surface of the plaque has been painted black at one time. However, it seems likely that the letters were originally picked out in white, and fragments of white do remain in corners of the lettering.

Photo 1 the plaque's position on the north face of the tower

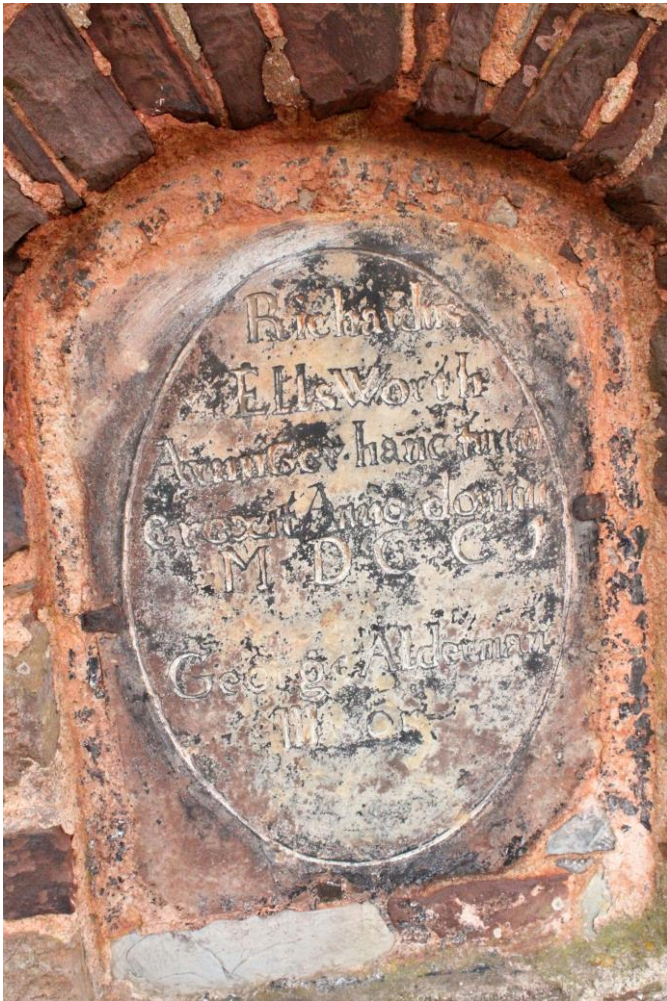
The plaque was in reasonable condition; there were some small areas of stone surface breaking down and the last word of the inscription, *Mason*, had begun to lose its definition. In addition, the letters had become difficult to read because of the loss of much of the black surface paint layer and a confusion of different colours throughout. There were two large ferrous cramps to either side of the plaque; these were corroded and had done some slight damage to the surrounding stone.

Photos 2 and 3 The plaque before (left) and after work

Areas of stone surface breakdown were locally consolidated, as appropriate with Primal B 60a 20%, or with lime slurry. Areas of loss and damage were filled with colour matched lime mortars based on a hot mixed quicklime mortar with a small addition of Argical pozzolan to ensure the set. These mortars were covered with cotton wool for a couple of days to prevent quick drying. The lettering of the lowest word, “Mason” was partially remade with lime mortar to allow it to be legible once more.

The black painted surface was reintegrated with Keim mineral silicate paint with lamp black pigment; this in itself rendered much of the inscription legible again, but in some areas, the letters were very faint and so a further Keim-based paint was applied where necessary into the lettering to reinstate the white letters. The end result was a plaque that still appears weathered and aged, but allows the inscription that is its primary purpose to be read once more.

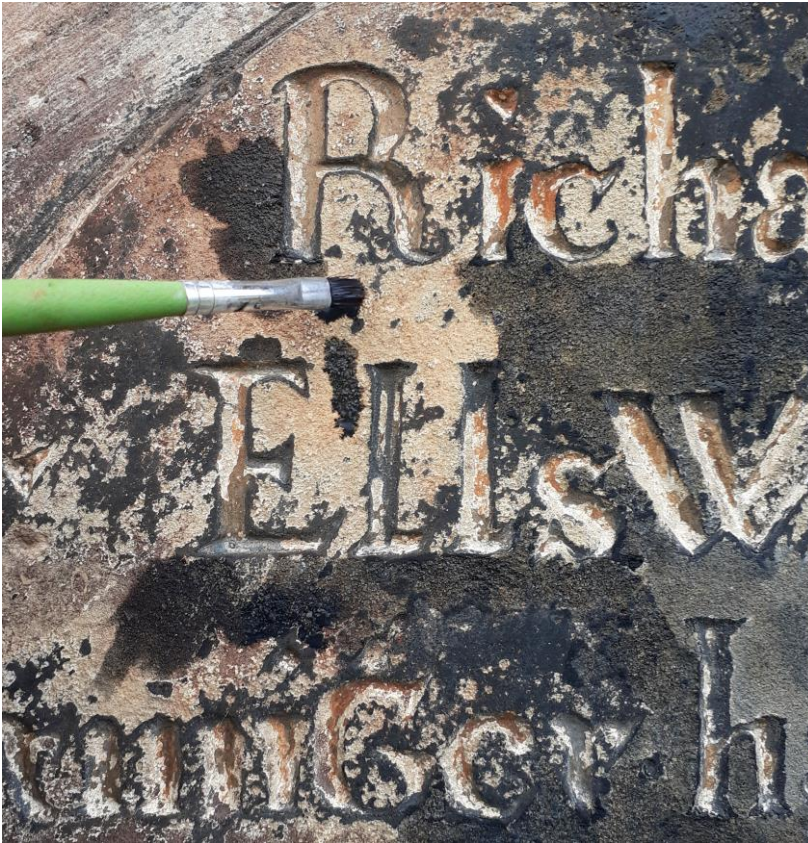
Photo 4 left: application of Keim paint

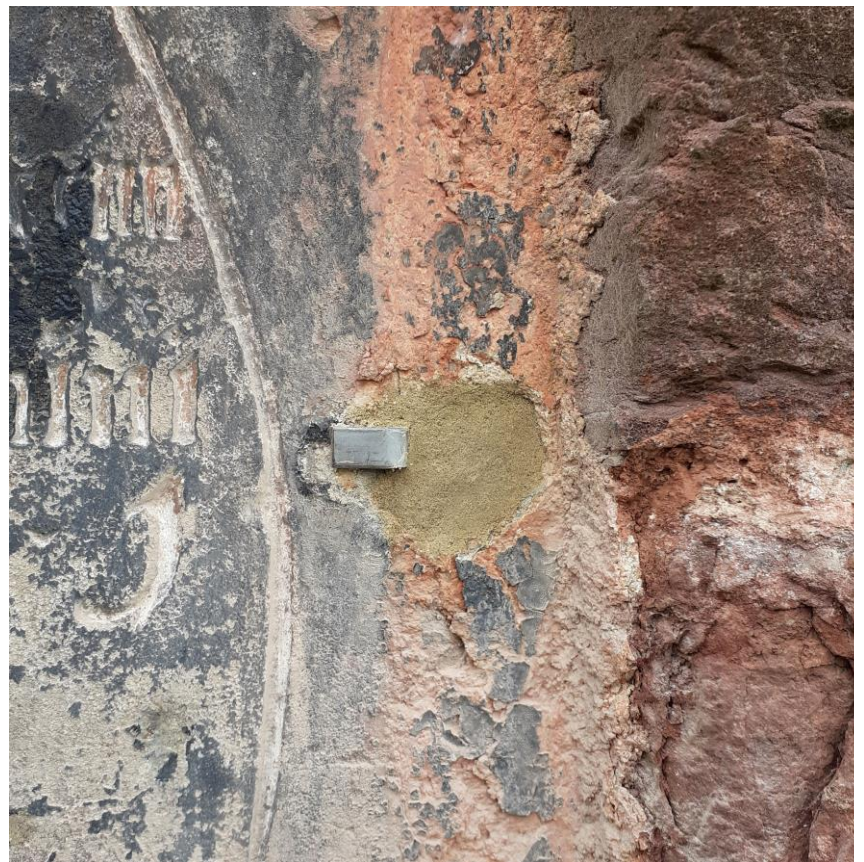
Photo 5 below: new stainless steel fixing inserted and pointed

The two ferrous cramps were carefully removed with fine drills and hand tools. Though it is debatable whether these fixings were in fact doing much fixing work, it was agreed that replacement fixings of stainless steel would be inserted. These were set in resin and pointed into position with lime mortar. The visible faces of the cramps were then painted black to make them unobtrusive.
