Energy Audit and Survey Report

St Mary's Church, Shenley

Author	Reviewer	Date	Version
Paul Hamley	Marisa Maitland	29 th March 2021	1.2

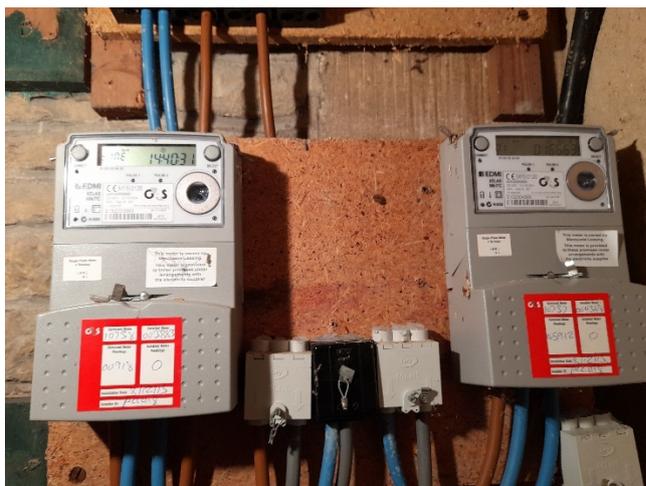
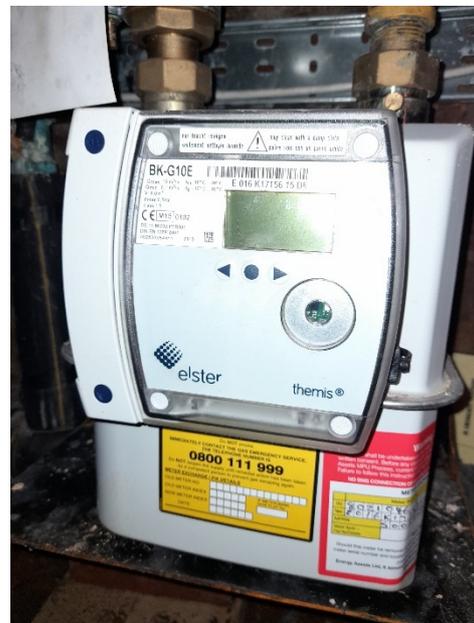
Utility	Meter Serial	Type	Pulsed output	Location
Electricity – meter 1 (Left)	E15Z003883	EDMI Atlas Mk7c	Yes	Lean to shed, NE corner next to vestry
Electricity – meter 2 (Right)	E15Z004568	EDMI Atlas Mk7c	Yes	As above
Gas	E016 K17156 15 D6	Elster themis BK-G10E	Yes	Subterranean boiler room, NE of vestry

Provision of two electricity meters is from the period when there was separate day and night billing.

It is recommended that the church consider asking their suppliers to install smart meters so that the usage can be monitored more closely, and the patterns of usage reviewed against the times the building is used.

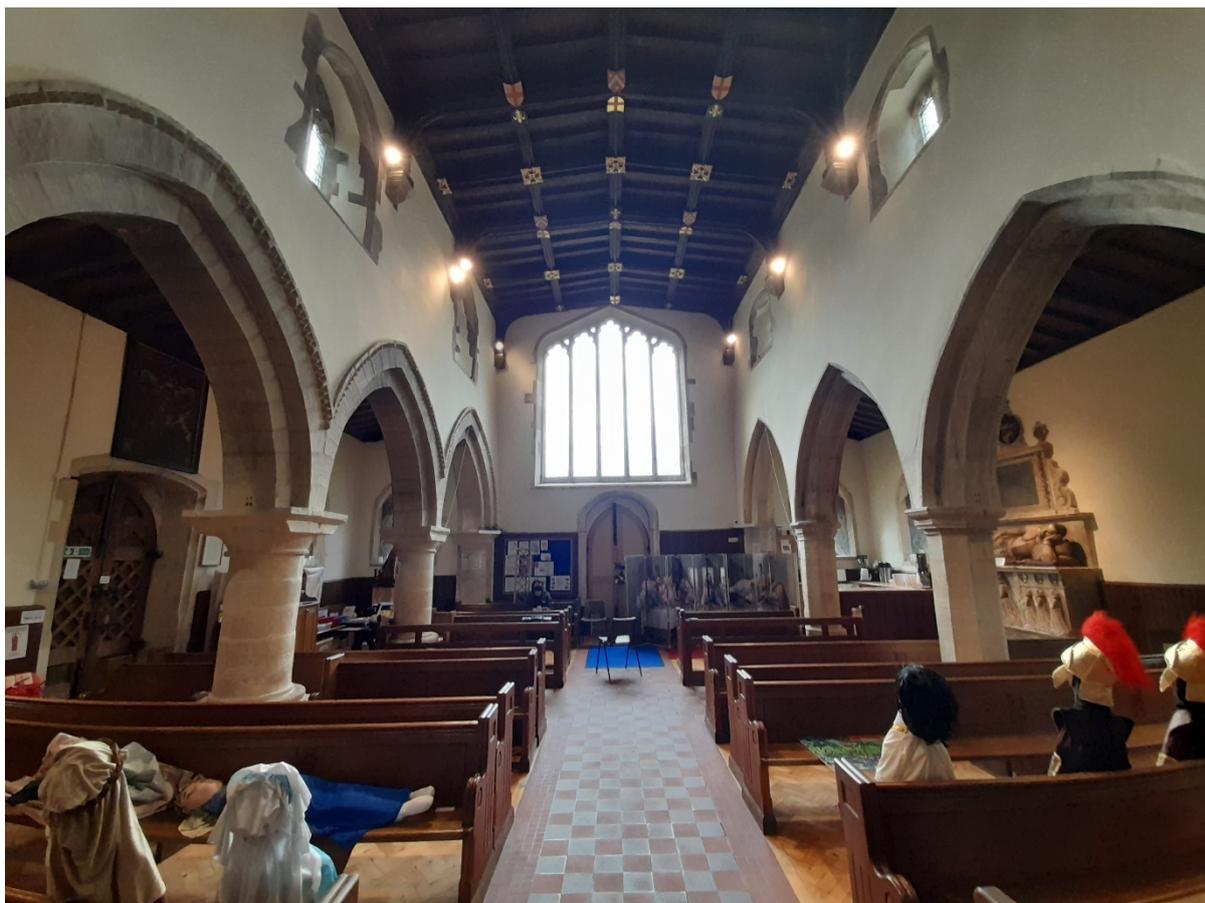
The church currently uses gas fired central heating to heat the church. This is reported to work well and provides adequate thermal comfort into the church. The boiler is a Viessmann EcoTec, light commercial model, thought to be of 50kW capacity.

It serves a network of large pressed steel radiators in the nave and aisles (4 x 3m length, 5 x 1.8m length) plus a smaller pressed steel radiator with narrow bore pipework in the vestry.

The boiler was installed in 2012 and appears to be in good order. At 9 years old, it should be assumed to be in mid life, so a boiler replacement plan should be developed.

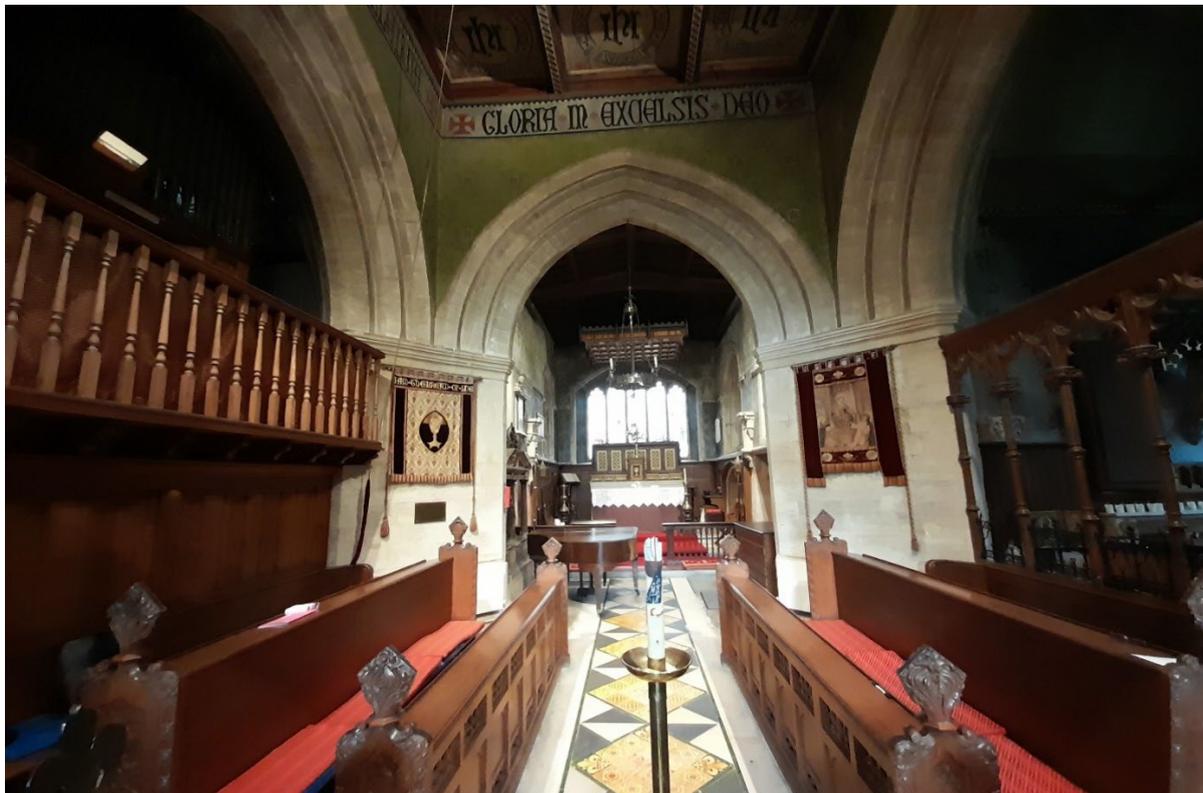
The choir stalls (above), situated under the crossing tower might be heated by under pew heaters, if this were found to be necessary to top up the space heating. This may not be necessary, as the north transept ceiling over the organ has been insulated (image below), and there is a relatively low ceiling above (with the ringing chamber above this).

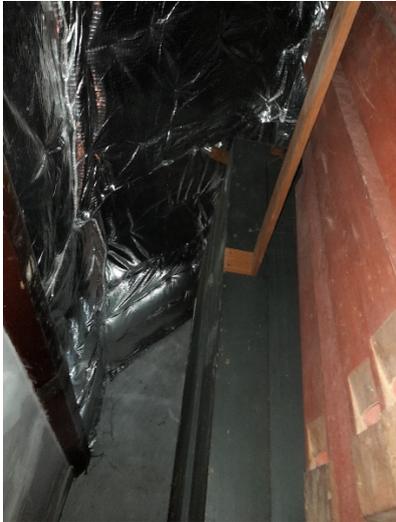
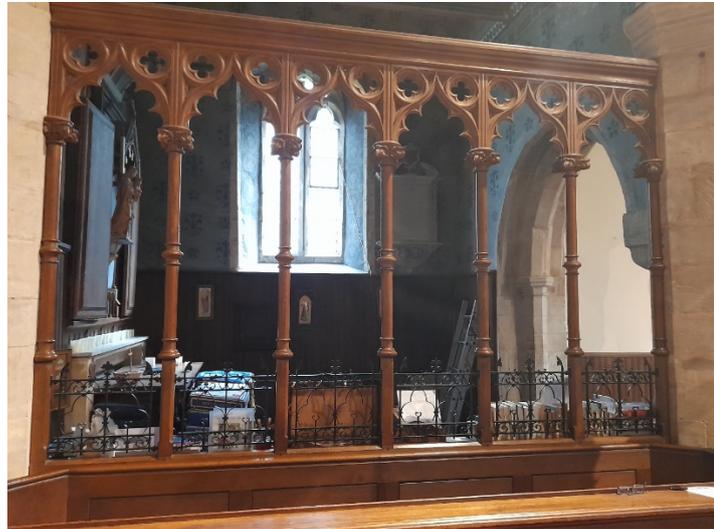
The Lady Chapel (above, right) may be considered to be thermally isolated by a glass screen in the future. If this occurs, direct electric heating could be provided by radiant infra red heating panels (non glowing), as these would offer rapid heating, so the chapel could be used for small meetings held at short notice without having to heat the whole of the building.

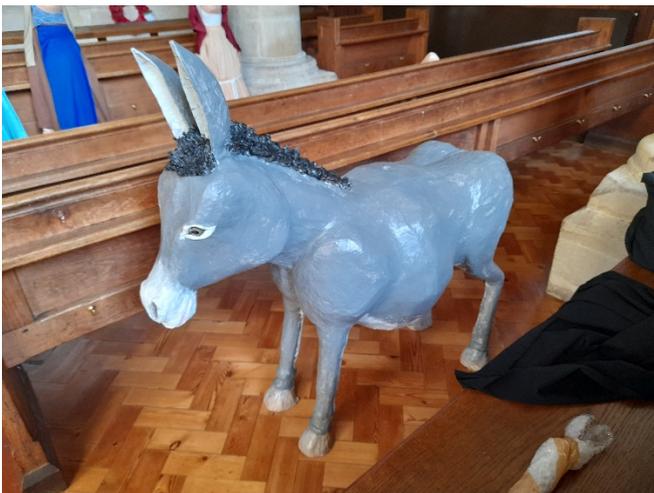
Continuous background heating has been tried out at St Mary's Church. It was discovered to be more expensive than heating on demand, and problems with the floor occurred with parquet blocks lifting. This is not recommended for a building with low hours of use.

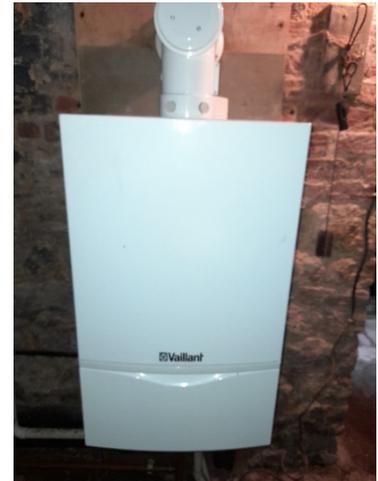
The boiler does not appear to be fitted with a magnetic particle filter. This apparatus catches any rust or metal particles and prevents them being deposited on the boiler heat exchanger. One should be installed if it is planned to continue using the water heating systems long term.

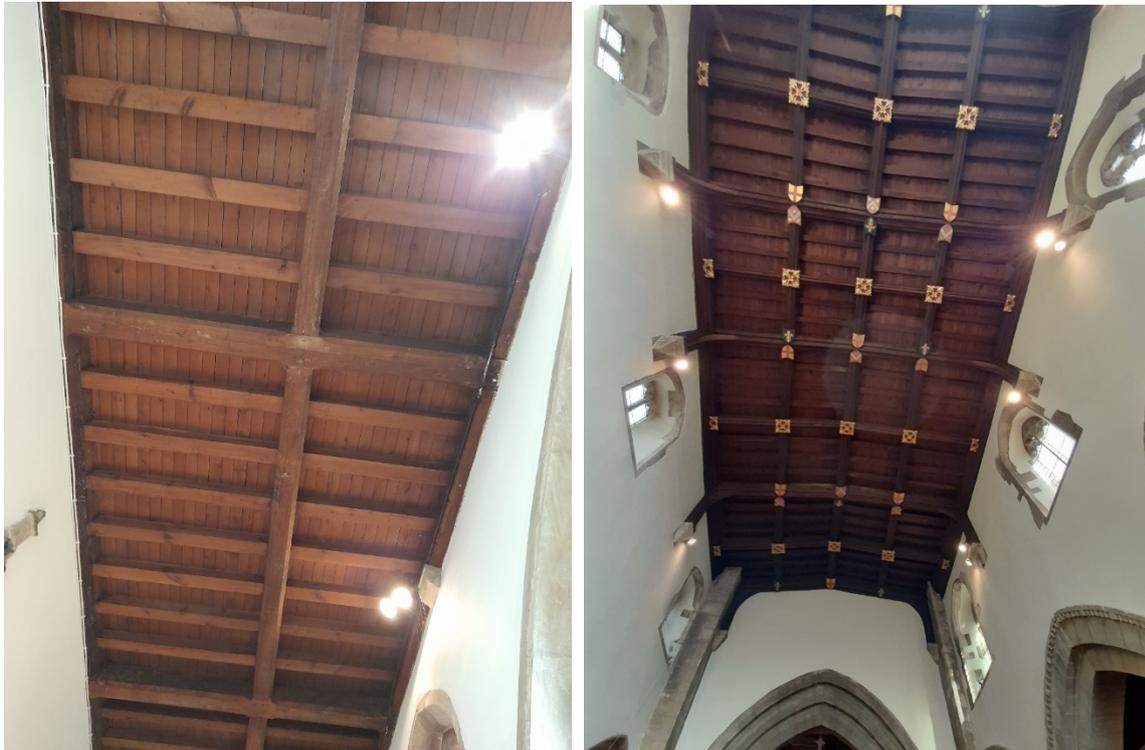
Neither aisle or nave roof are suitable for installation of rectangular panels for aesthetic reasons. The aisle beams are too close together.

Far infra red rectangular panels (non glowing) would allow the Lady Chapel to be independently heated should it be glassed in and used as a small meeting room. e.g. for midweek prayers or communion.

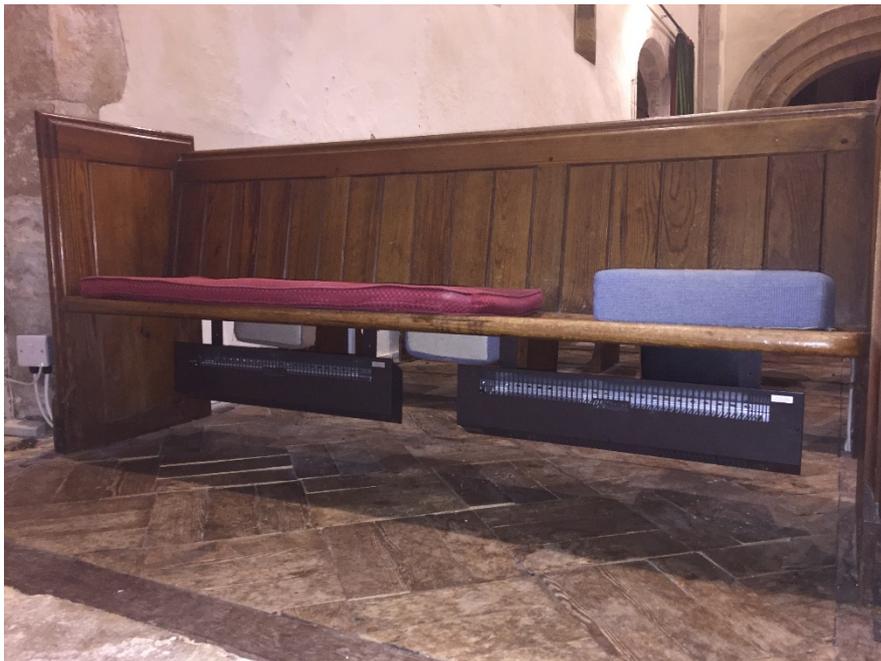
The under pew (see photo below) and panel heaters have been recently installed at St Andrews Church, Chedworth, Gloucestershire, GL54 4AJ. The church is open in daylight hours so can be viewed at any time.

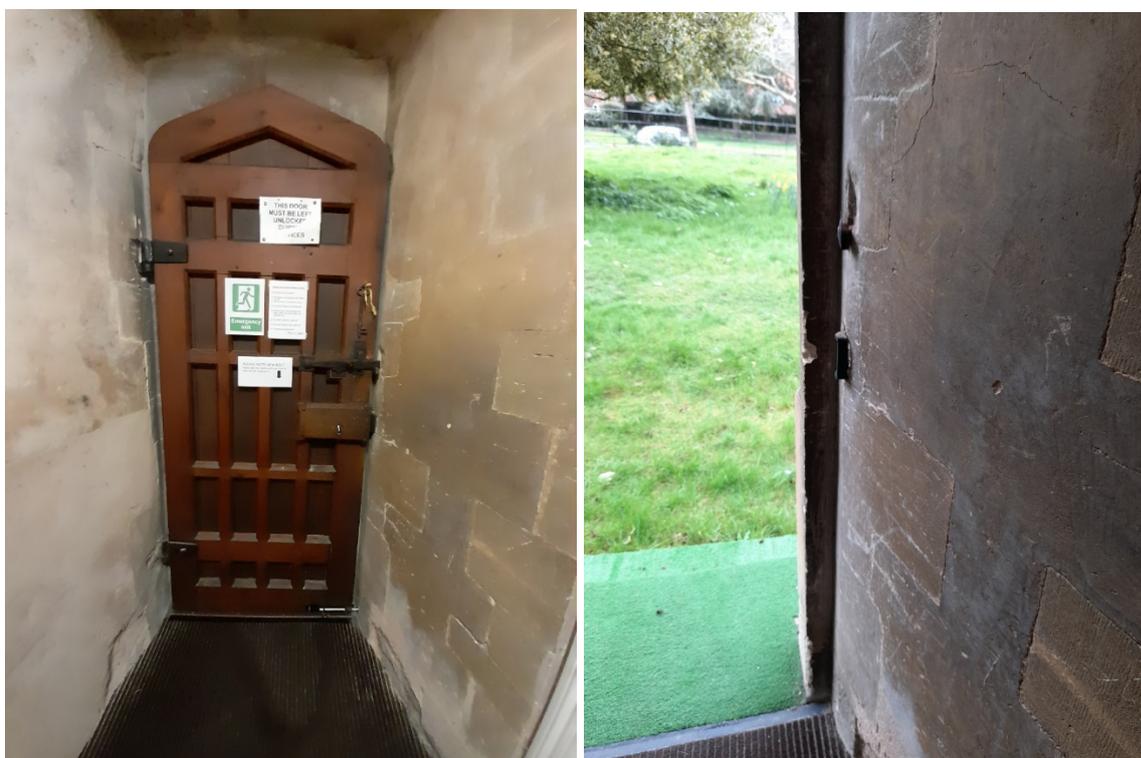
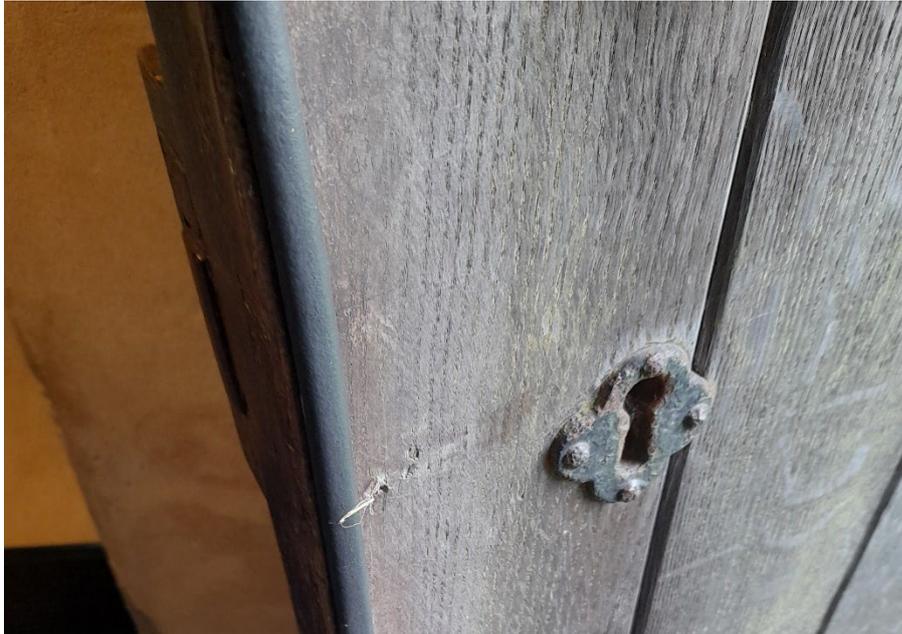
Some of the doors at St Mary's have been fitted with a rubber seal where the door closes against stonework. This does not cover the bottom of the door. There may be an opportunity to fit a weather seal here, inside the green carpet.

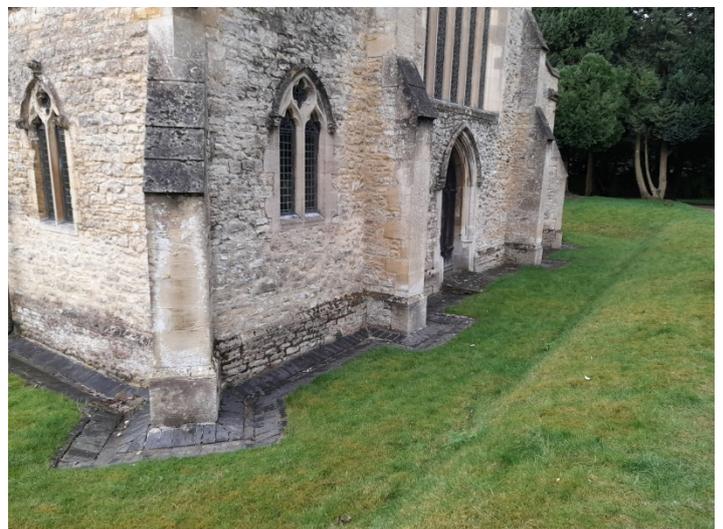
The image above shows that the ground around the church is built up in each direction (apart from at the east end, which slopes away), effectively creating a moat for groundwater to drain into. This may be associated with historic burials raising the ground level; bones in unmarked graves having been found near to the church when digging a trench. The topography may be contributing to the water ingress into the boiler room and former coal / oil store area.

Maintaining a suitable outlet for water which collects in the stone guttering at the base of the walls (drainage ditches and soakaways) should be discussed with your Inspecting Architect.

Any water retention close to the building will lead to rising damp within the walls and consequent fabric damage and higher heating costs.

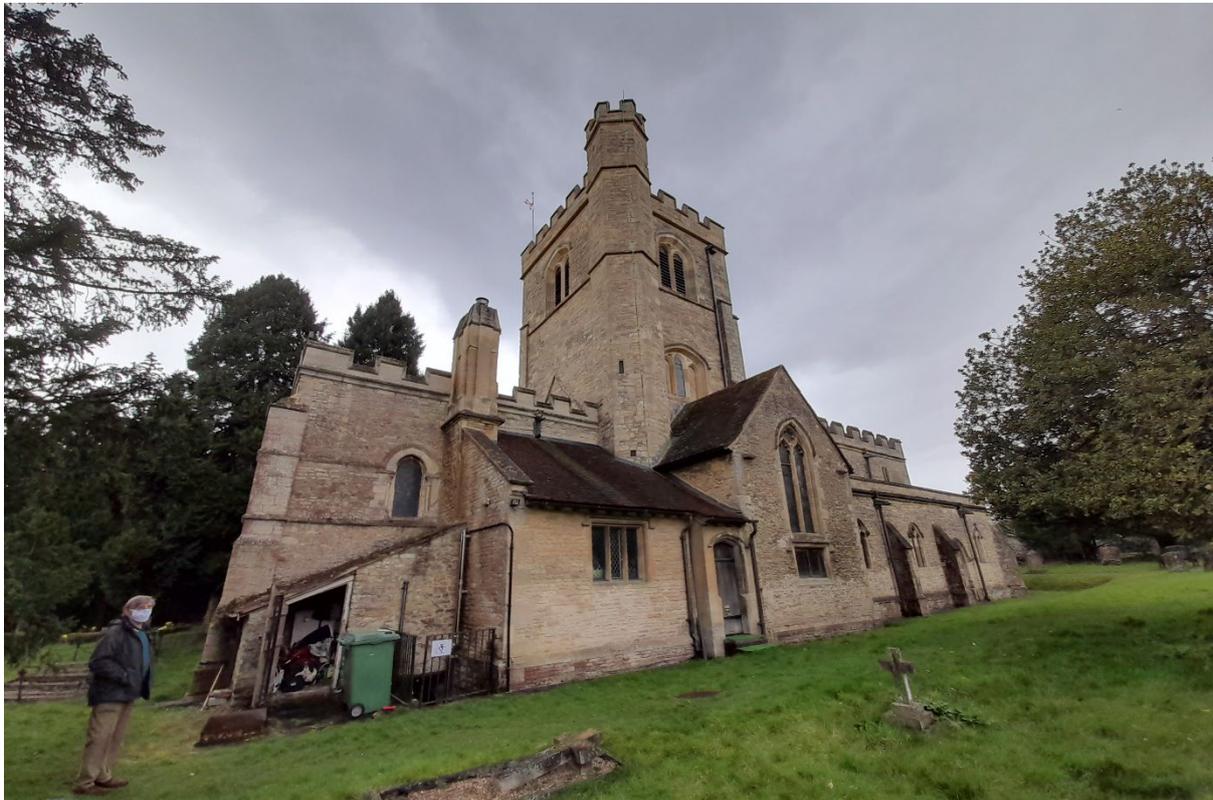
The boiler room is located under the Victorian era vestry, dating from 1888. The coal store and “reservoir” are under the lean to structure which houses the organ blower, and the bin.

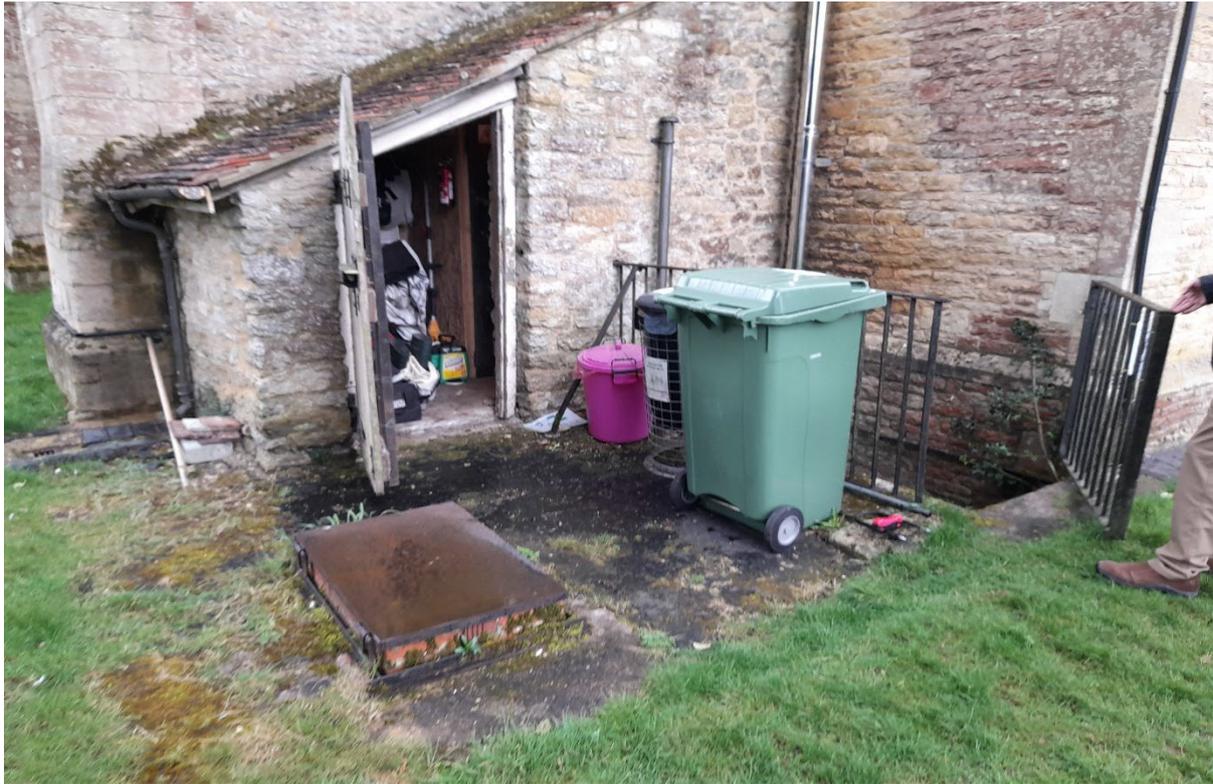
Water ingress to the coal store may be occurring through the concrete slab, or around the oil filling hatch, or the nearby drain (below).

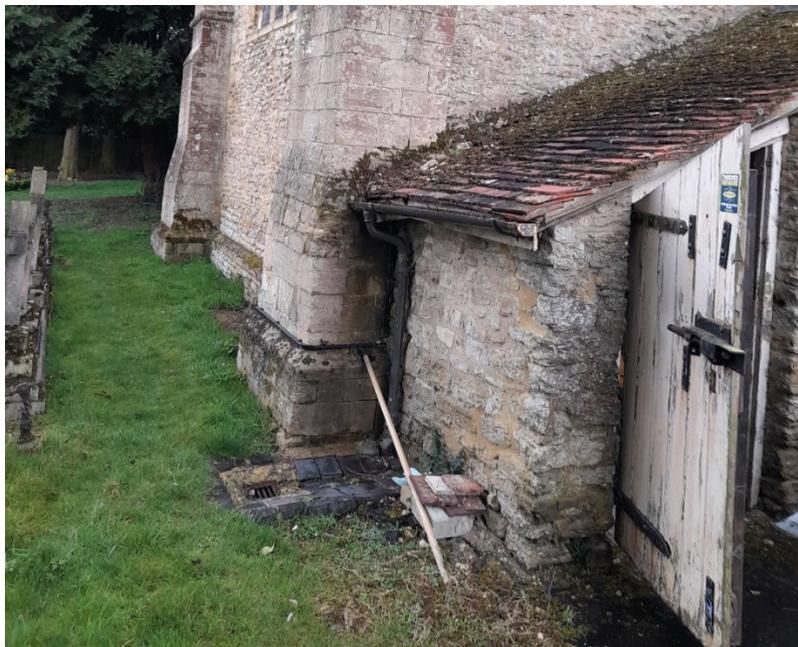
The former coal store acts as an unintentional reservoir. It is the location of the redundant, but not necessarily empty, oil tank (rusted, to the left) has collected around 40cm depth of water. This may be due to the nearby drain (above) leaking, or the gully and soakaway system which unintentionally allows a route for water to pool in this void, or it may be due to the concrete slab above the space allowing water through directly.

It is recommended that the oil tank and any contents are removed before it rusts through and results in an oil spill into the ground. The bottom of this store is higher than the floor level of the adjacent boiler room; some pipework and the expansion tank is located close to the floor. If the single course of bricks currently retaining the water is punctured, damage to plant will ensue.

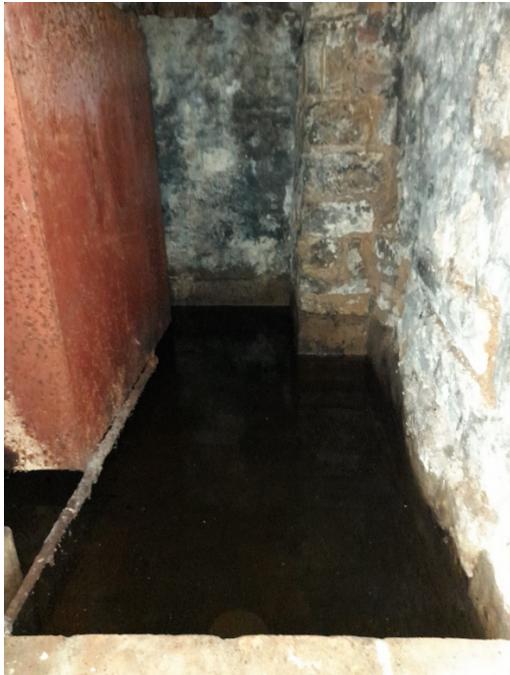
An unintentional reservoir of ground water is maintained by the low brick wall to the fore.

If this water does not seep away, further ingress will overtop the wall and run into the boiler room.

If it does seep out, it is going into the foundations.

It is recommended that the Inspecting Architect is asked to investigate the foundations of the vestry which form the boiler room walls, particularly the wall on the north side pictured below, where there is water ingress through the gas pipe conduit.

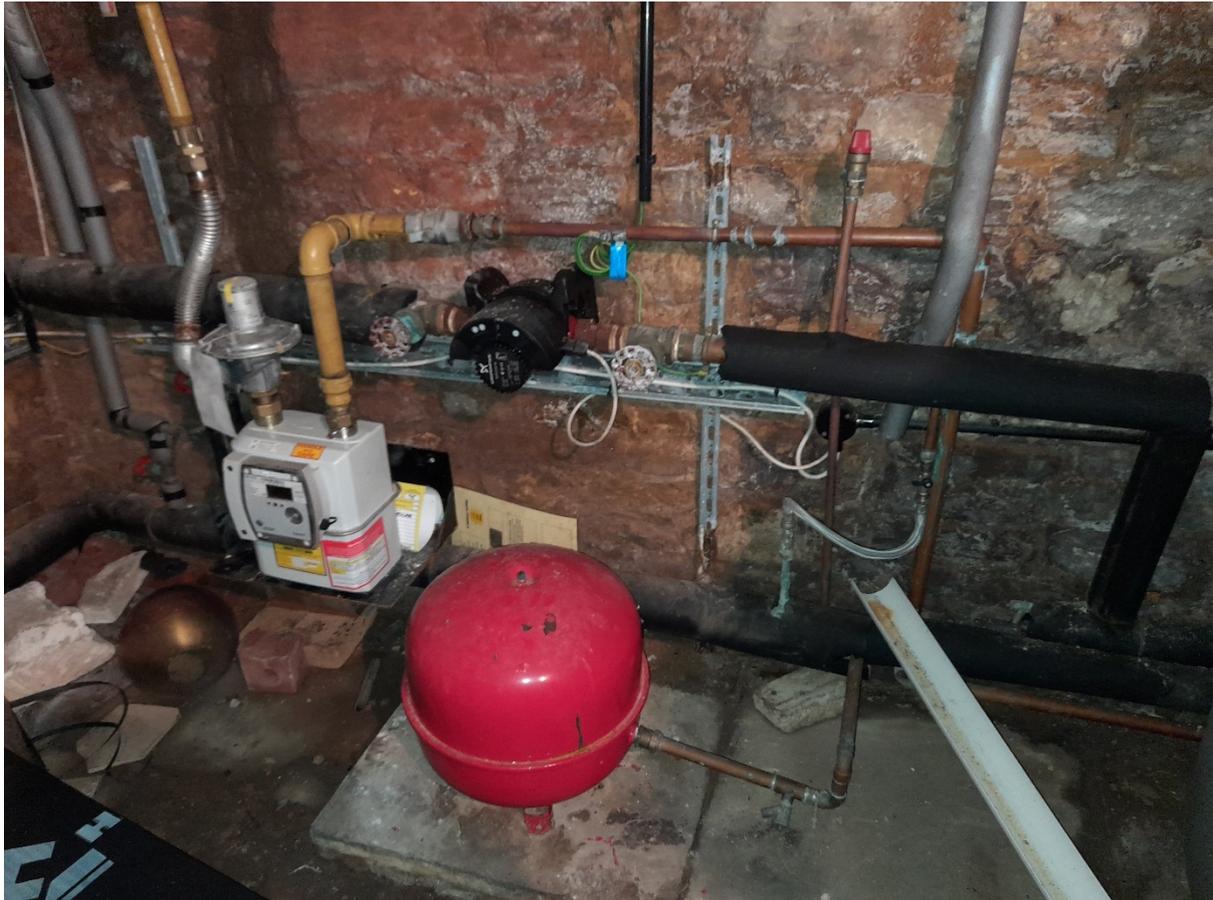
The isolation valves each side of the circulation pump have been severely corroded and cannot be turned. The red expansion tank is corroding and most of its paintwork is loose. The stopcock supplying water to the site (out of picture, above right) is corroded shut. The white guttering channels water from a leak to the drain below the condensing boiler to the right.

The valves may be “rescued” by an application of WD40 and oil, allowed to soak in. Do not attempt to hit valves with a hammer to free them.

It is recommended to consult a plumber to regain a working stopcock as a priority.

It is recommended to insert some sort of plastic sheeting between the wall and valves, recirculating pump and gas meter to protect them from water.

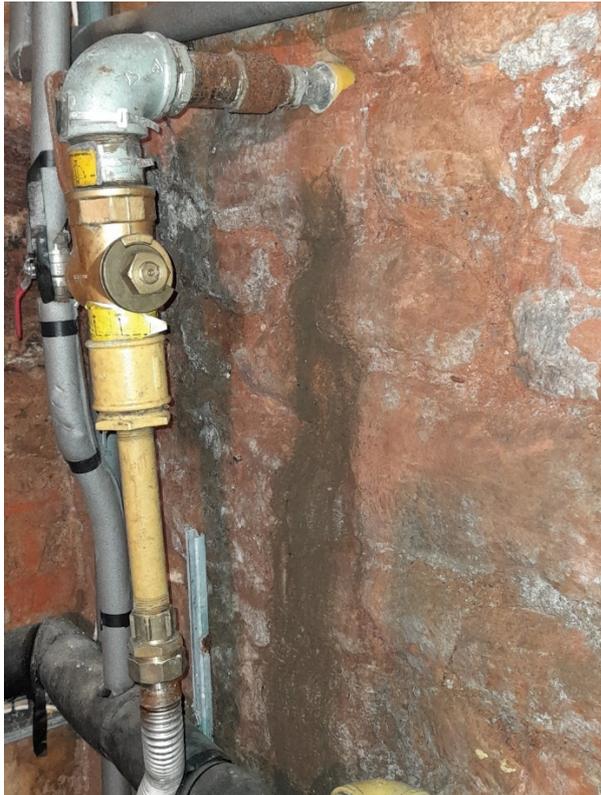
Water has been coming through the wall where the gas pipe enters. The wall was described as “crumbly”.

Remediation works to this area may be required. If the church chooses to proceed with a heat pump installation, this area under the vestry and the coal store under the lean to shed would be needed for plant installation: a combined solution which ensures (i) water ingress is halted (ii) any issues with the vestry foundations are solved (iii) a dry plant space is created is likely to be needed.

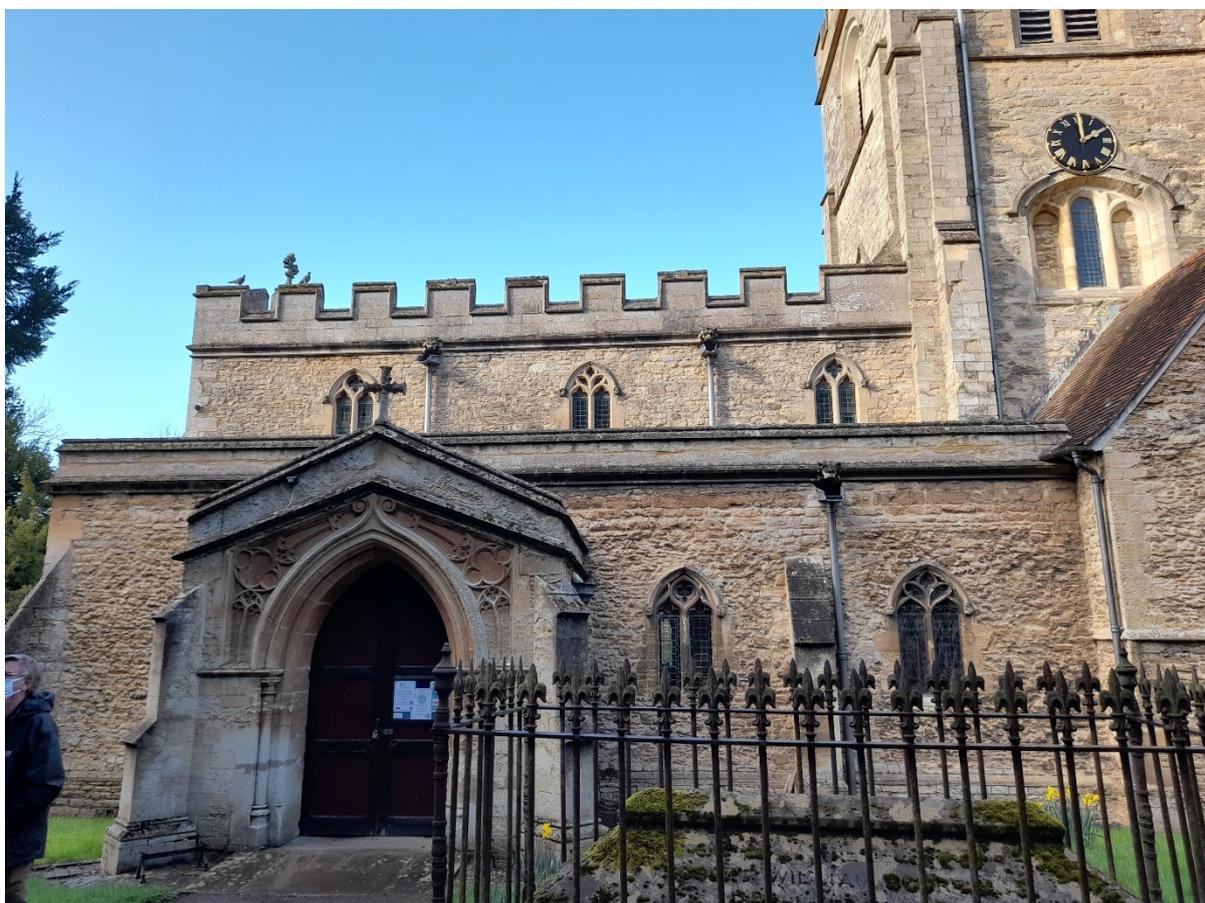
The nave and south aisle roofs are low pitched and offer sites for installation of solar photovoltaic panels which would not be visible behind the parapets.
