Results of an Archaeological
Watching Brief during works at
St Helens Church,
Eddington Road, Nettlestone,
Isle of Wight, PO34 5EF
(IWHER Event: EIW 1163)

4th March 2021

Dr. Ruth Waller,
Past Wight Heritage
Consultancy,
Sandringham House,
19 Newport Road,
Cowes, PO317PA
www.pastwight.co.uk
Report Ref:
PW/2021/85

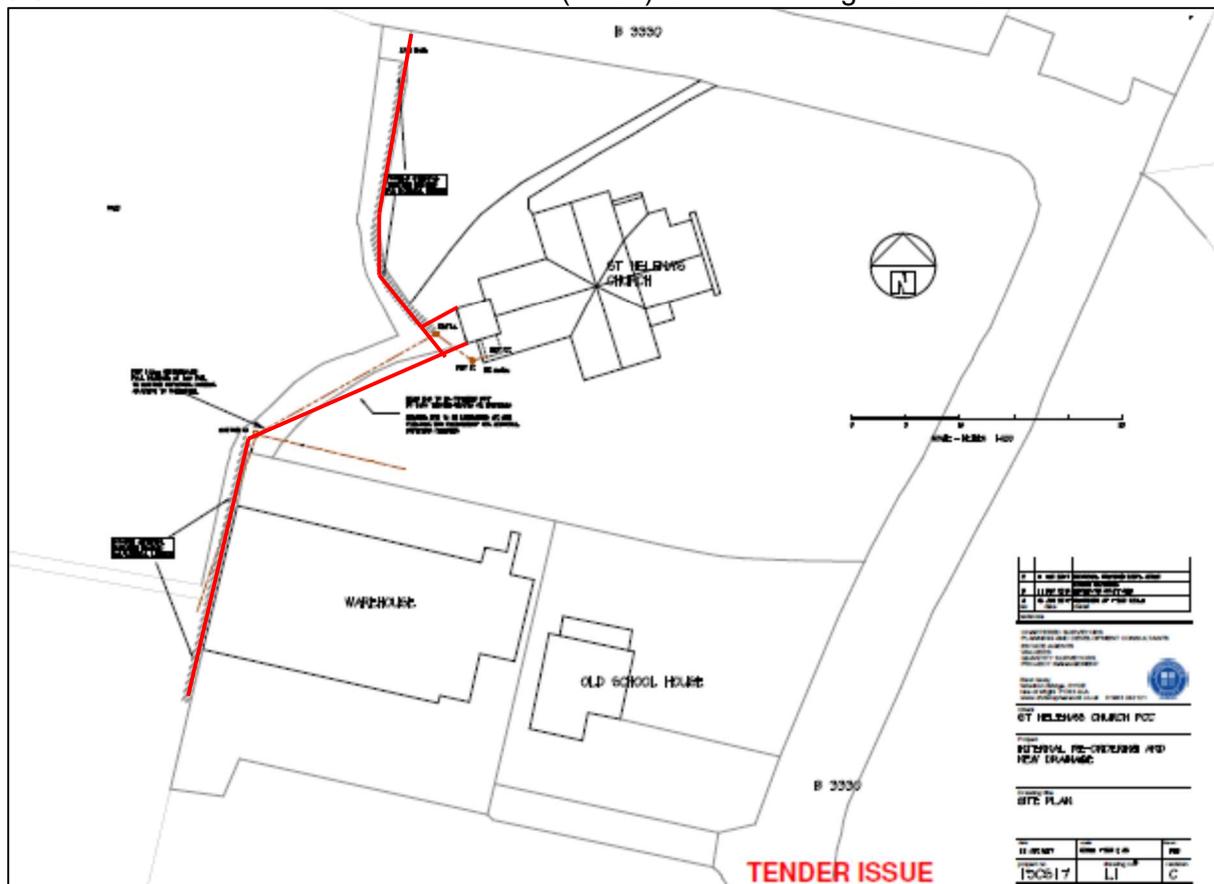
Figure 2: Route of electricity cable and sewer trenches through the churchyard

- 3.4 The archaeological intervention was given the event number IWHHER EIW 1163 by the Isle of Wight County Historic Environment Record (HER).
- 3.5 The route for the external trenches (in red) is shown in Figure 2 below:

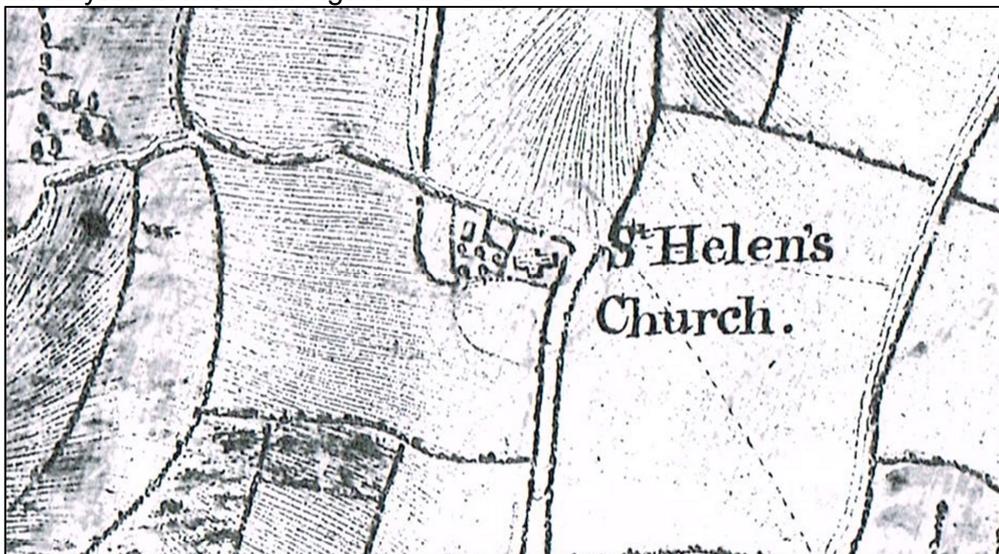
Figure 3: Section of the 1810 Mudge map showing the churchyard

- 5.8 The 1810 mapping shows the churchyard before any of the extensions evidenced by the documents held at the IW County Records Office.
- 5.9 The 1839 St Helen's Tithe map and Schedule (IWCRO JER/T/259 and JER/T/261), shown in Figure 4 overleaf, also shows the churchyard at a similar size to that recorded on the 1810 Mudge map.
- 5.10 On the Tithe Schedule, the Church is shown as and parcel number 462 which is listed as owned by the Church Warden and occupied by the Reverend Dr Young.

- 5.7 The earliest mapping available which shows the church and churchyard in detail is one of the original survey sheets for the Ordnance Survey of England dating around 1793 (which covered the Island as a key military coastal defence area). The surveys are called the "Mudge" maps after Lieutenant Colonel Mudge who supervised the work and include details which were not drawn onto the revised First Edition Ordnance Survey map of 1860's. The section of the Mudge map published in 1810 showing the churchyard is shown in Figure 3 below:

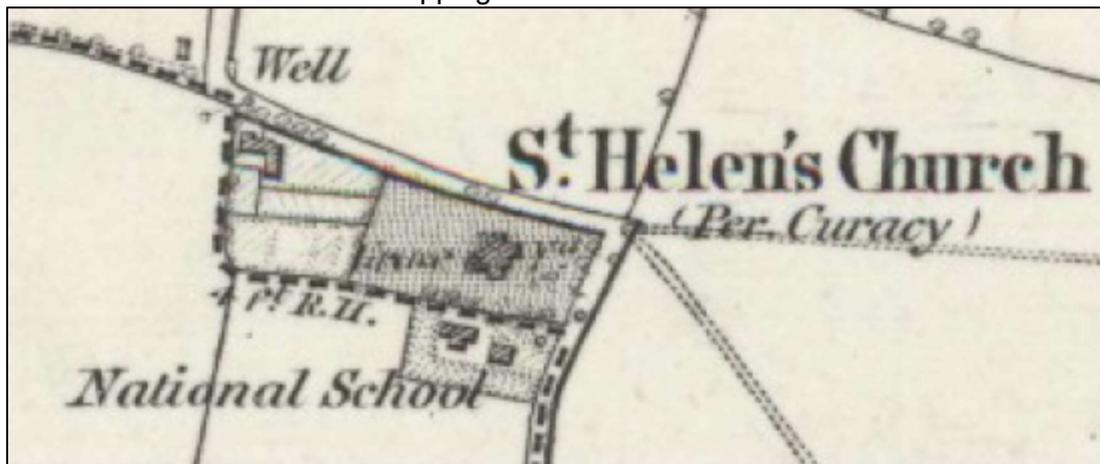
- 5.11 The First edition Ordnance Survey map of 1861, in Figure 5 below, shows that the churchyard appears to have been extended to the west into the land parcel shown as number 461 on the Tithe mapping.

Figure 5: Section of the 1861 OS map showing the churchyard

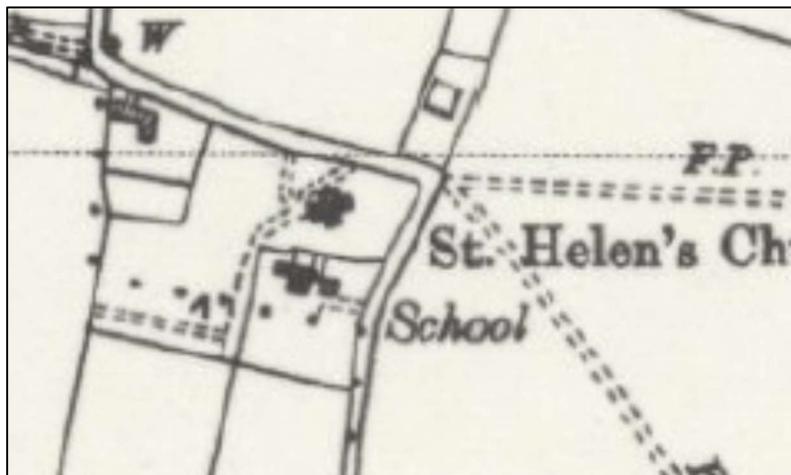
Figure 8: Section of 1942 OS map showing churchyard

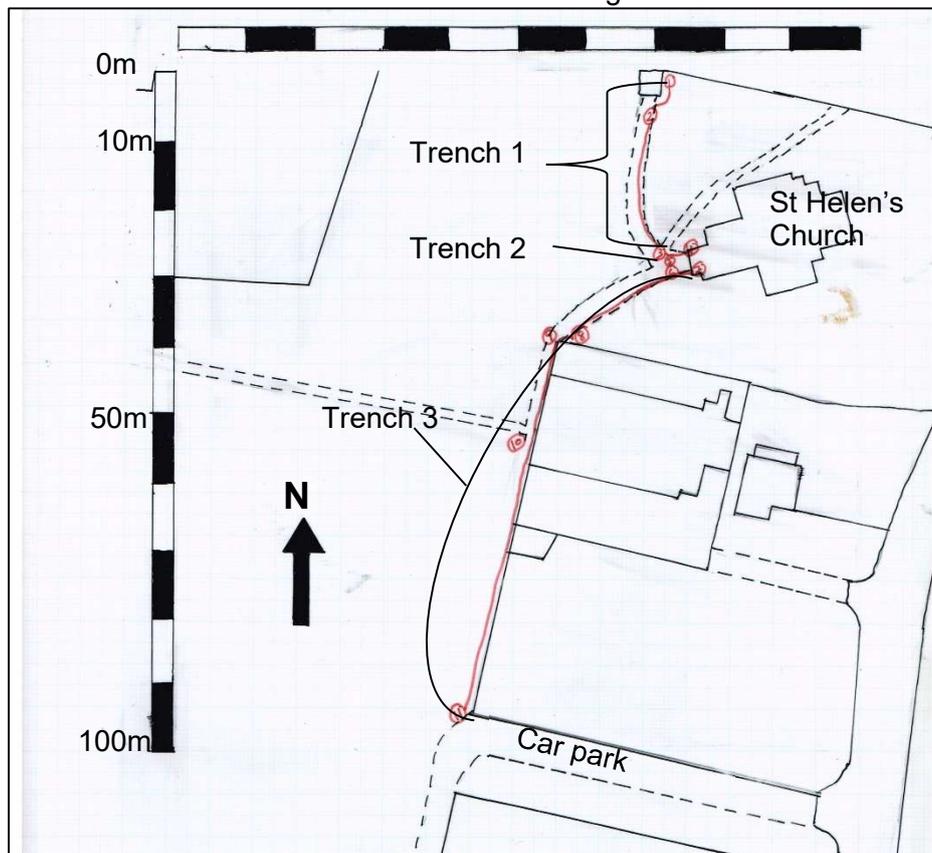
Figure 10: Location map of trenching

- 7.7 Both the electricity cable and water pipe were being placed into the same trench, which was excavated to a width of 0.40m and to a depth of 0.50m. Starting at the eastern edge of the lych gate from a point at 1 on Figure 10 (SZ 62573/899998), the trench was excavated for a distance of 2.60m southwards through the grassed area to point 2 on Figure 10, on the eastern edge of the gravelled path at SZ 62570/89994 and then excavated southwards through the eastern edge of the gravelled path itself following the curve of the path to the east for a distance of 18m. At position 3 on

Figure 10 (SZ 62571/89975), the trench was then excavated in an easterly direction to connect with an existing drain (4 on Figure 10) immediately to the north of the church porch at SZ 62576/89974. This first trench was recorded as Trench 1.

7.8 Trench 2 was excavated from a starting point SZ 62573/89973 (5 on Figure 10) at southern edge of Trench 1 as it curved eastwards to meet the drain to the north of the porch front corner. Trench 2 was excavated for a distance of 3.4m southwards through the gravelled path area directly in front of the church porch to SZ 62572/89972 (point 6 on Figure 10), where it met Trench 3 coming westwards from the drainage pipe installed to the south of porch.

7.9 Trench 3 was excavated from a newly installed drain pipe on the wall to the south of the porch (position 7 on Figure 10) at SZ 62578/89971 and then excavated westwards along the eastern edge of the gravelled path itself following the curve of the path to the south-west for a distance of 22.97m. The trench was then excavated in a southerly direction to connect with an existing drain inspection chamber immediately to the north of the corner of the external wall of the neighbouring warehouse property at SZ 62560/89962 (Point 8 on Figure 10). A southern extension of Trench 3 was then continued from the drain inspection chamber to the north-western corner of the warehouse wall (SZ 62556/89961) at position 9 on Figure 10 and from there was excavated for a length of 22.56m along the eastern boundary of the existing pathway to a metal gate at position 10 on Figure 10 (SZ 62552/89946). From here Trench 3 continued southwards for 46.05m to position 11 on Figure 10, a point at the gate of the carparking area where a light was due to be installed (SZ 62542/89902).

7.10 The three trenches are shown as excavated in Figure 10 below:

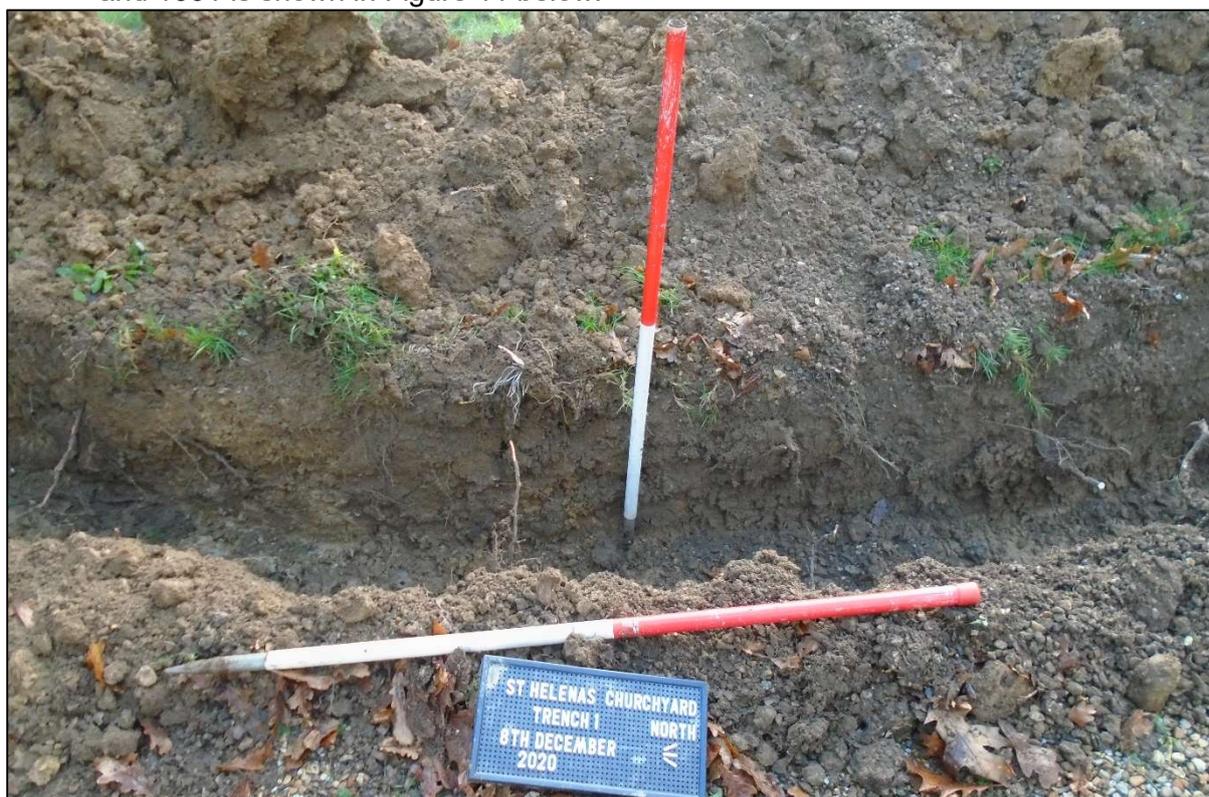
Figure 11: East Section of Trench 1 at 2.60m south of start.

8.1.1 The turf and topsoil layer (Context 1000) and a layer of subsoil (Context 1001) directly below it lay within the first 2.60m of Trench 1. Context 1000 was a dark brown (Munsell 7.5YR 3/2) sticky silty turf and topsoil layer with many roots and small pebbles. The top of Context 1000 was measured at 45.28m AOD at SZ 62573/89998 and at 45.17m AOD at a distance of 2.60m southwards along the trench. The base of context 1000 was measured at 0.21m depth at SZ 625730/89998, at 0.24m from the top of the trench at 1 metre along its length and at 0.21m at 2 metres along the trench length.

8.1.2 Context 1001 was a very stiff silty clay which lay directly beneath Context 1000 within the first 2.60m of Trench 1. Consisting of yellowish brown (Munsell 10YR 5/4) silty clay with many fragments of flint and stone (<2cm²). The top of Context 1001 was measured at 45.04 AOD and it was 0.24m deep at the start of Trench 1 to the east of the lychgate, 0.26m deep at 1m and 0.29m deep at 2m. A series of photographs of the eastern side of this trench was taken for the site archives and one of these showing Contexts 1000 and 1001 is shown in Figure 11 below:

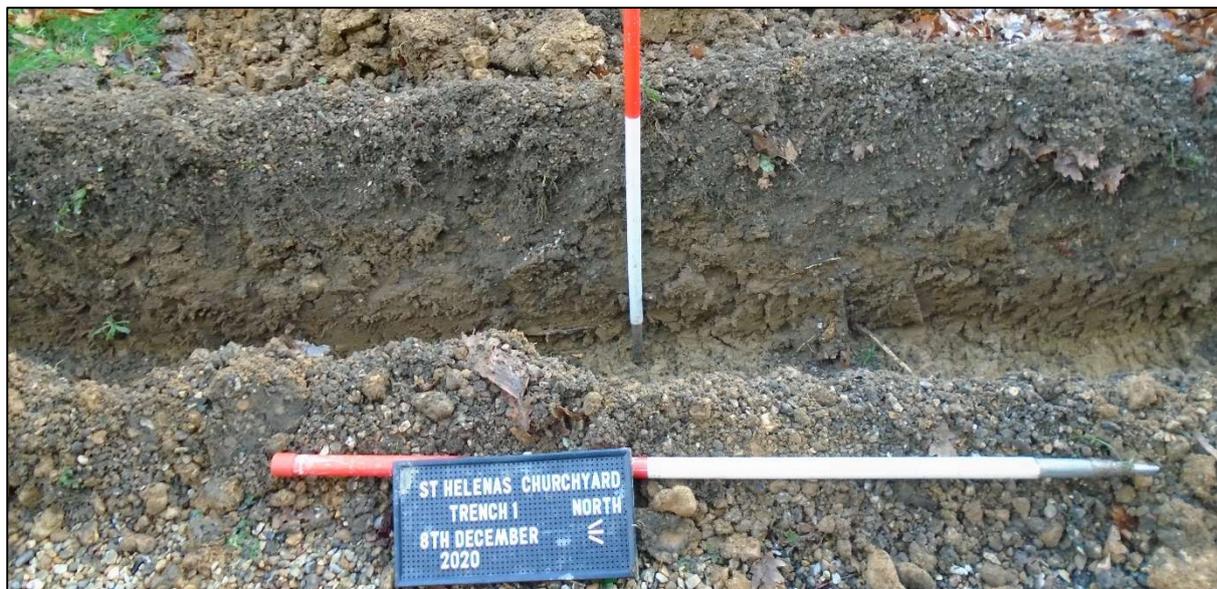
Figure 13: part of Eastern section of Trench 1

8.1.5 Context 1002 overlay Context 1001 along the entire length of Trench 1 until it reached SZ 62571/89975 (point 3 on Figure 10). At this point, Trench 1 continued eastwards to connect with the existing drain at SZ 62576/89974 (point 6 on Figure 10). A series of record photographs of the eastern section of the entire length of this trench were taken for the site archive and one of these showing Contexts 1002 and 1001 is shown in Figure 13 below. No change in stratigraphy or presence of any features or structures were observed in this part of trench 1 which is shown on Figure 14 overleaf.

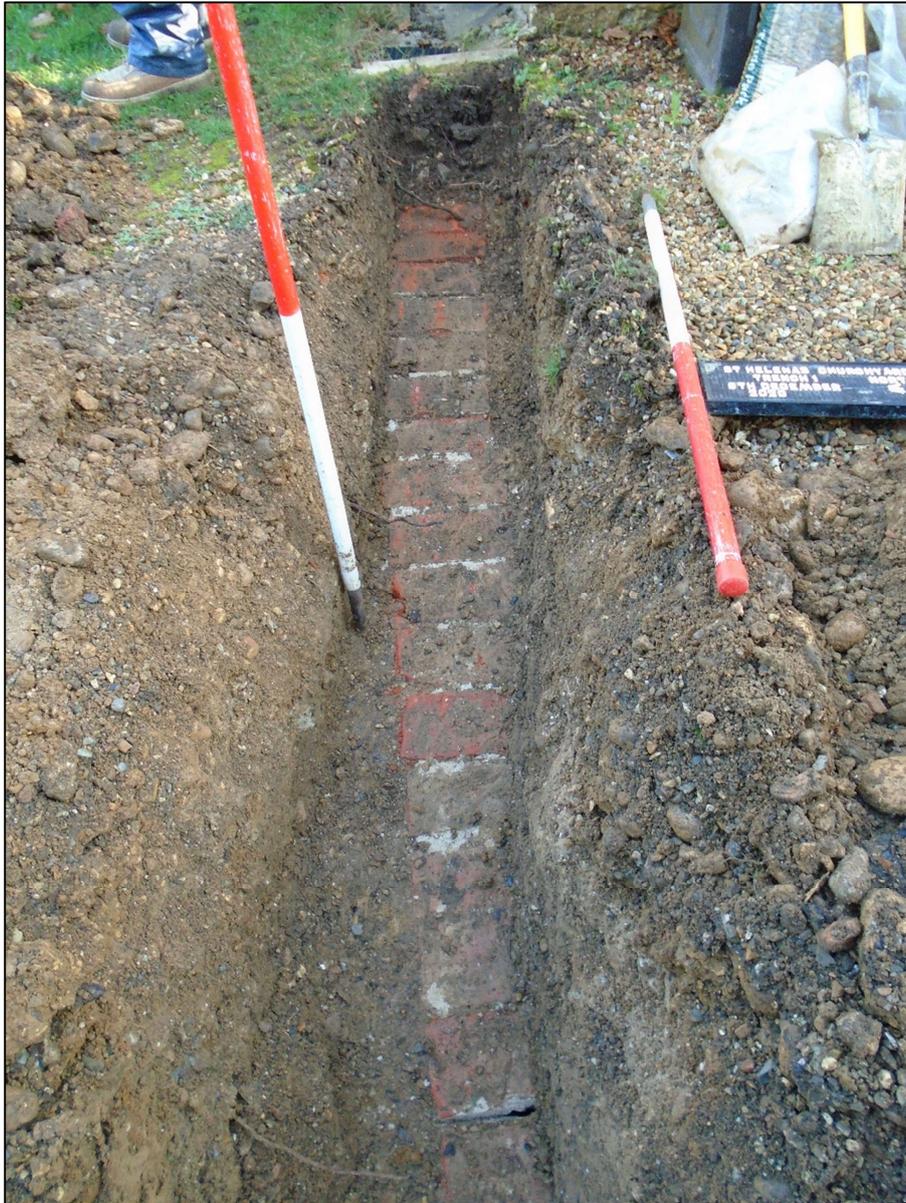
Figure 15: Structure in southern end of Trench 1

- 8.1.6 Within the final 4m length of Trench 1 some structural remains of probable Victorian or later drainage channels were recorded.
- 8.1.7 Within this southern end of Trench 1, a series of 17 mortared red bricks had been laid out from east to west within Context 1001 as shown in Figure 15 overleaf.

- 8.1.8 The east to west aligned line of bricks was mortared together and curved round slightly to the south in the western end of Trench 1. This brick feature was not drawn to scale plan but was recorded by photographs which form part of the site archive.

- 8.1.9 The feature consisted of 17 red bricks which butted up to the concrete drain seen in Figure 15 above at its eastern end. The width of all of the bricks was 0.12m and the lengths of those which were fully exposed in the trench were between 0.25 and 0.27m. The depths of the bricks were not measured as they were left insitu within the trench and the pipe was laid on top.

- 8.1.10 The bricks were mortared together with a white mortar between 1.5cm and 3cm thick between the bricks. The top of the most northerly brick was measured at 44.67m AOD and the top of the most southerly brick was measured at 44.59m AOD.

- 8.1.11 No dating evidence for the construction of the structure was found within the trench, however the measurements of the bricks themselves suggest that they may have been

laid before the British Standard metric size was introduced in the 1970's (Woodforde, 1976).

- 8.1.12 Because of the route taken by the brick structure and its abutment with the drain lying to the north of the church porch, it is suggested that these bricks form the top of a drainage channel and that they probably sit on top of a drain pipe leading water from the drain away from the foundations of the church.

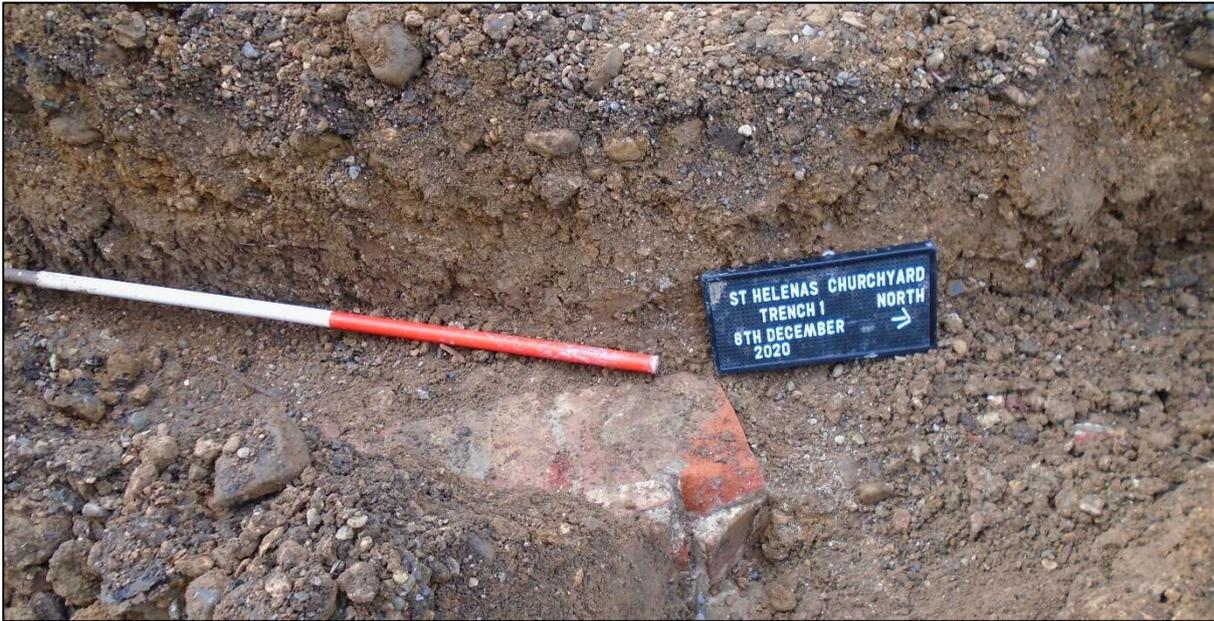
Figure 16: North section and brick structure in northern end of Trench 2

- 8.2.3 Four mortared red bricks were visible in the bottom of Trench 2 at its northern end lying on an alignment which joined with the existing concrete drain on the southern side of the church porch at SZ 62578/89971, which can be seen in Figure 17 overleaf. These were not drawn to scale and are shown with the north section of Trench 2 in Figure 16 overleaf.

- 8.2.4 The four mortared bricks were aligned from north-west to south-east and were each 0.25m to 0.27m long and 0.12m wide. They appeared to be of the same fabric and size as those within the brick structure recorded in the southern end of Trench 1, with the same mortar fabric and width of mortar between them as the bricks in Trench 1. The top of the easternmost brick was measured at 44.79m AOD and the top of the westernmost brick was measured at 44.77m AOD. When the base of the trench was hand cleaned, a gap of 0.12m was measured in plan between the most westerly brick of the structure in Trench 1 and the northern most brick of this Trench 2 structure. These four bricks lay above but with no physical relationship to the structure in Trench 1.

- 8.2.5 Because of the similarities between the sizes, the fabric of the bricks and mortar and the alignment of both with the two concrete drains on either side of the church porch, it is suggested that both have similar dates and functions taking surface and rainwater away from the church foundations.

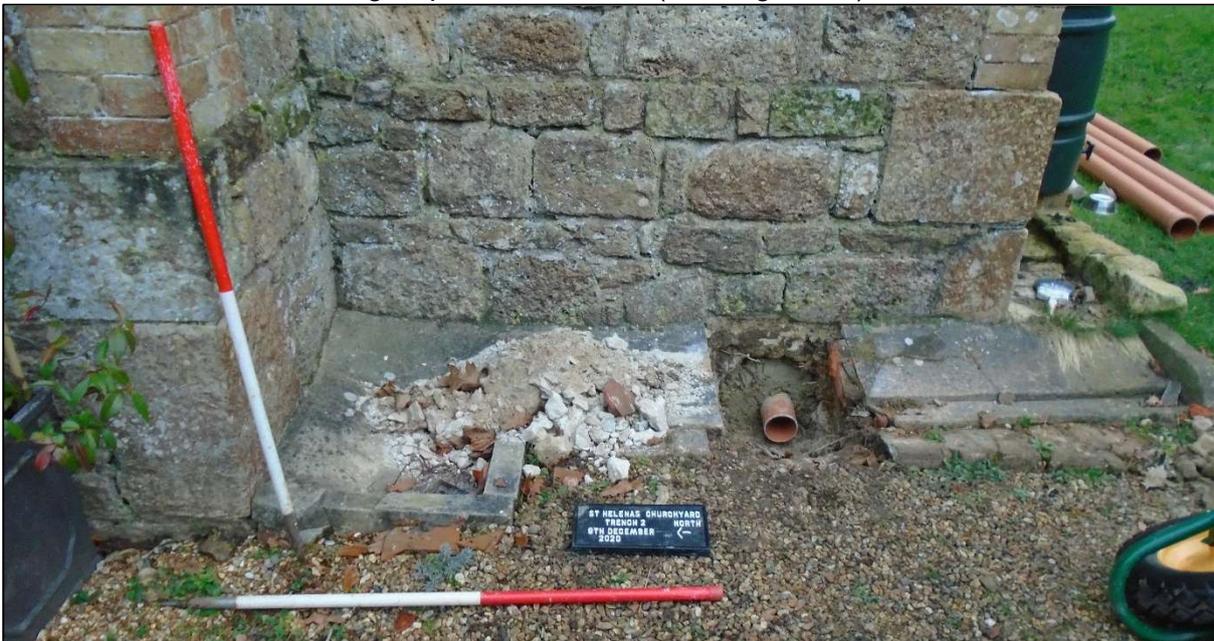
Figure 17: New drainage pipe and start of Trench 3 before excavation

8.3.1 Trench 3 started at SZ 62578/89971 to join onto a new drainage pipe built into the wall of the church (shown in Figure 17 below) and was 0.40m wide, 0.50m deep and followed the southern edge of the gravel footpath from the church for a length of 22.97m to the existing inspection chamber (8 on Figure 10) at SZ 62560/89962.

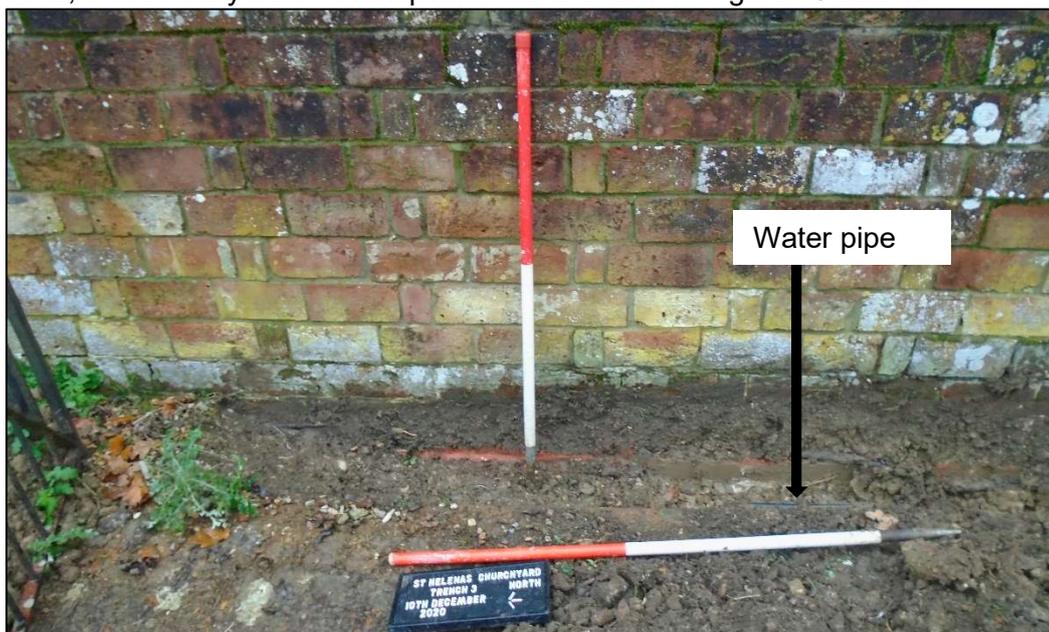
Figure 18: Trench 3 from gate with existing water pipe

- 8.3.6 At gate, the black pipe carrying water to the tap by the entrance to the carpark was visible at a depth of 0.26m within the trench and the electricity cable was laid on top of this, immediately below the topsoil. This is shown in Figure 18 below.

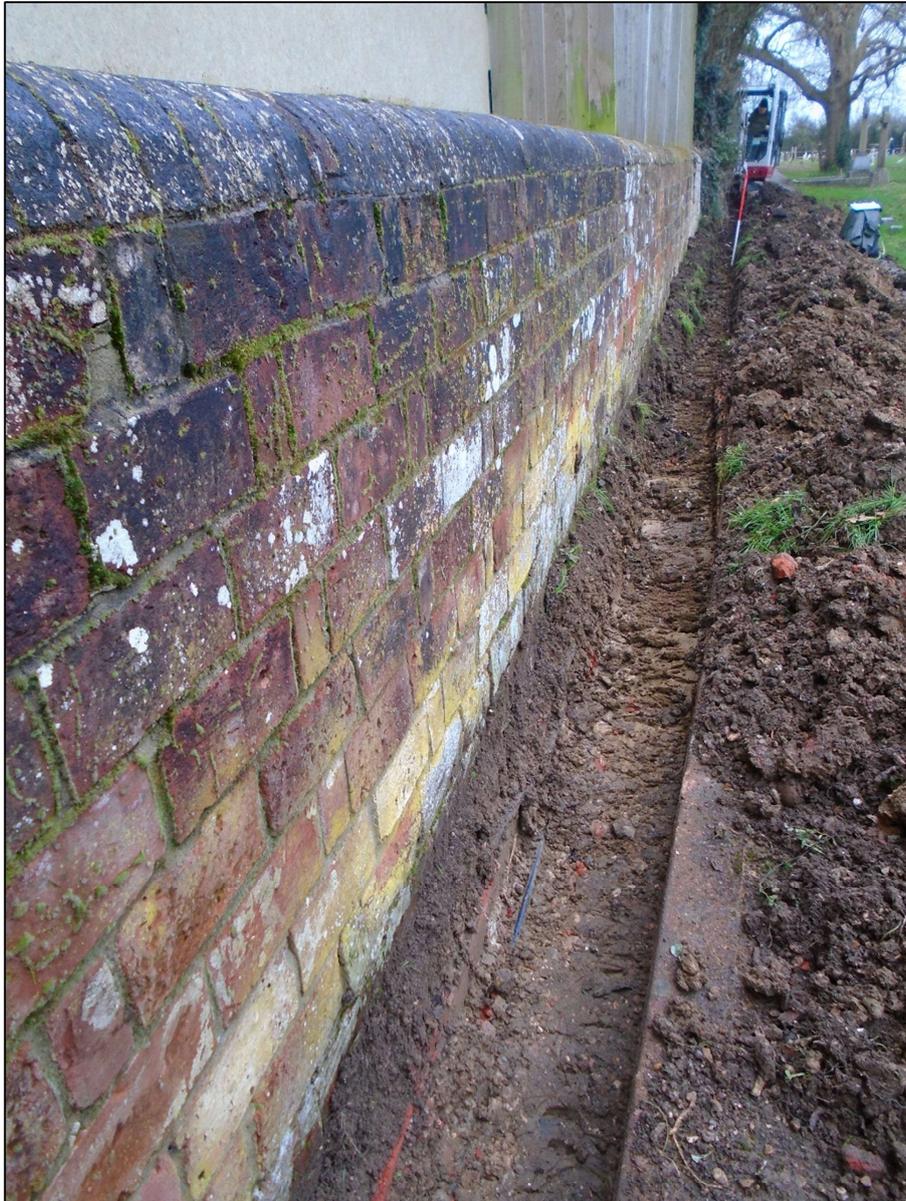
Figure 19: Trench 3 from the gate southwards

8.3.7 No archaeological remains were present in Trench 3 and a series of photographs of the east section was taken along its length for the site archive. Part of Trench 3 is shown in Figure 19 below.
