CPAT Report No. 1839

St. Christopher's Church, Pott Shrigley

Archaeological Watching Brief

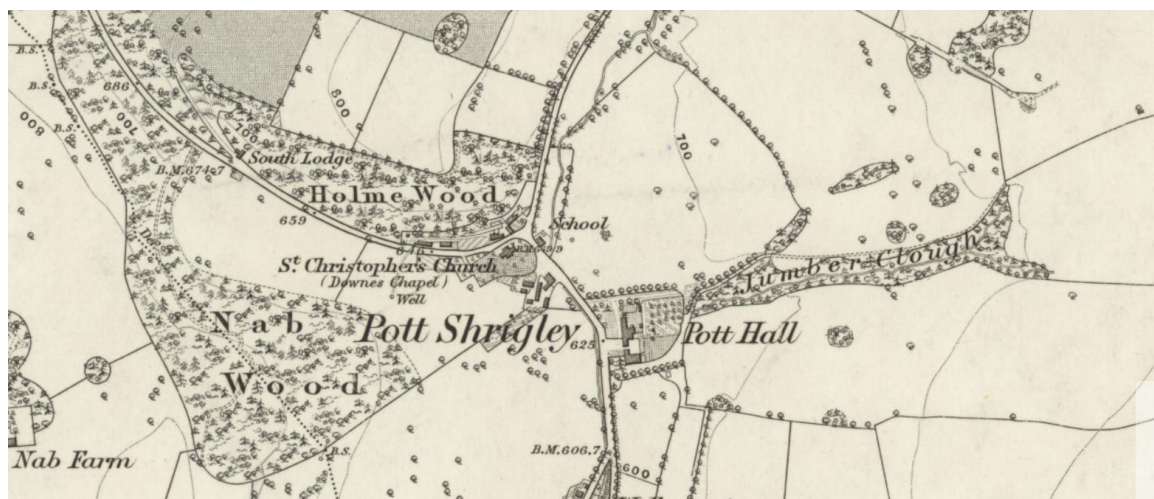
Figure 3 1871 OS Map showing the church grounds with path directed towards the eastern part of the wall, although no ingress point is detailed.

- 2.6. The early maps of this area (Figures 3 & 4) record the church yard as being smaller and rhomboid (Figure 4), with the current area of excavation being within a former property and not belonging to the original churchyard. By the 1871 publication of the Ordnance Survey map (Figure 3), it is noted that the buildings are absent and the land parcels onto which they were built have been incorporated into the churchyard.

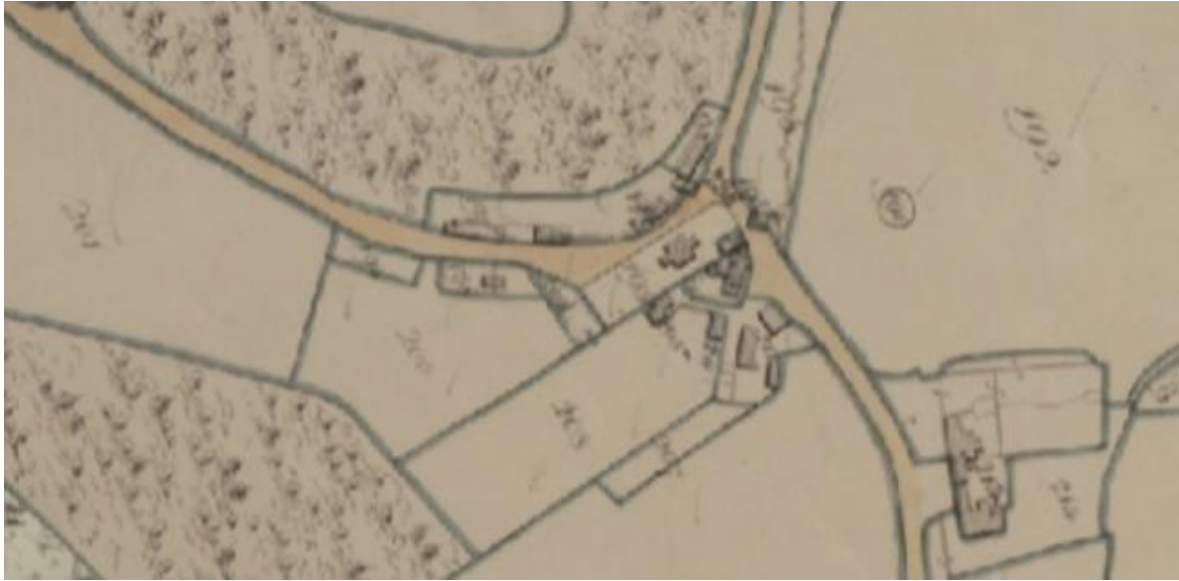
Figure 4 1848 Tithe map detailing the church grounds as a rhomboid shape adjacent to cottages, which are now demolished and their land form part of the churchyard.

- 4.2. The remains of the wall, upon comparison with the 1848 tithe map during the post-excavation process, may in fact belong to the earlier phase of usage of the area in association with the now demolished building(s), possibly representing a boundary wall between the building and public land. No structural remains of the building(s) were discovered, nor was there domestic waste or rubble that could be associated with domestic use. As the redeposited material was removed and the former wall was recorded, it was evident that the base clay deposit underneath was a natural geological material that was sterile, having no archaeological features apparent within it.

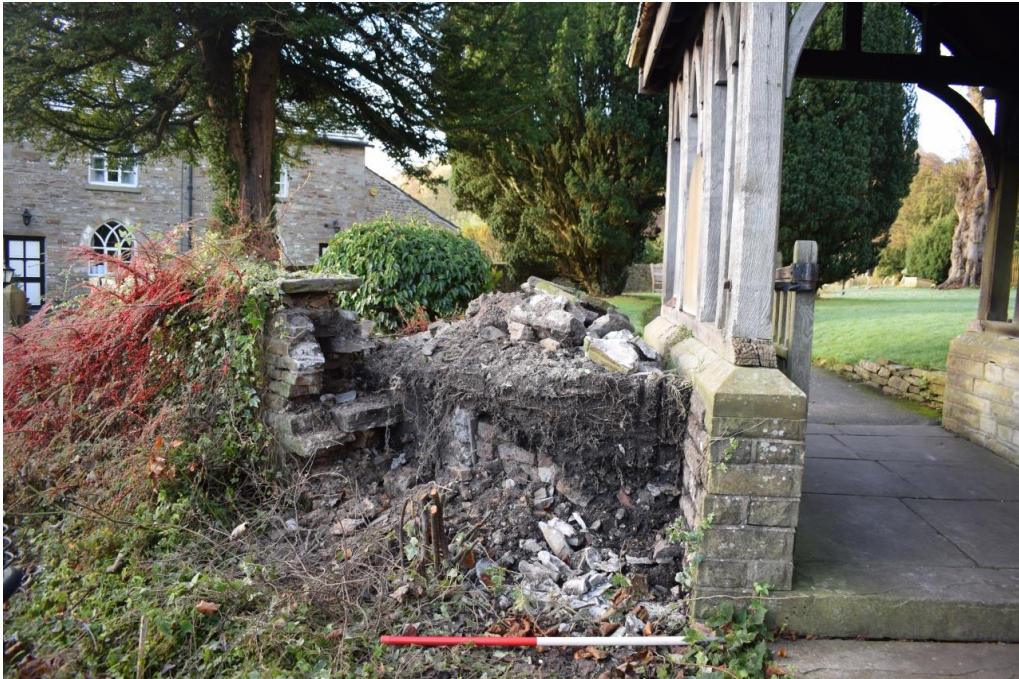
Figure 5 Wall removed at site of easy access ramp installation. Viewed from east. CPAT photo 4962-0001

- 3.2. Before excavation began, the existing wall was removed at the area in which the easy-access ramp was to be installed (see Figure 5). The wall's removal exposed redeposited material, including in situ mortared brick and cement with modern waste inclusions. This was probably a structural device to secure the wall. The mortared brick and cement can be seen in Figure 6. The excavation area was directly alongside the south wall of the lychgate (Figure 7). The topsoil was approximately 0.1 to 0.2m deep, and was a dark greyish black loamy silt.

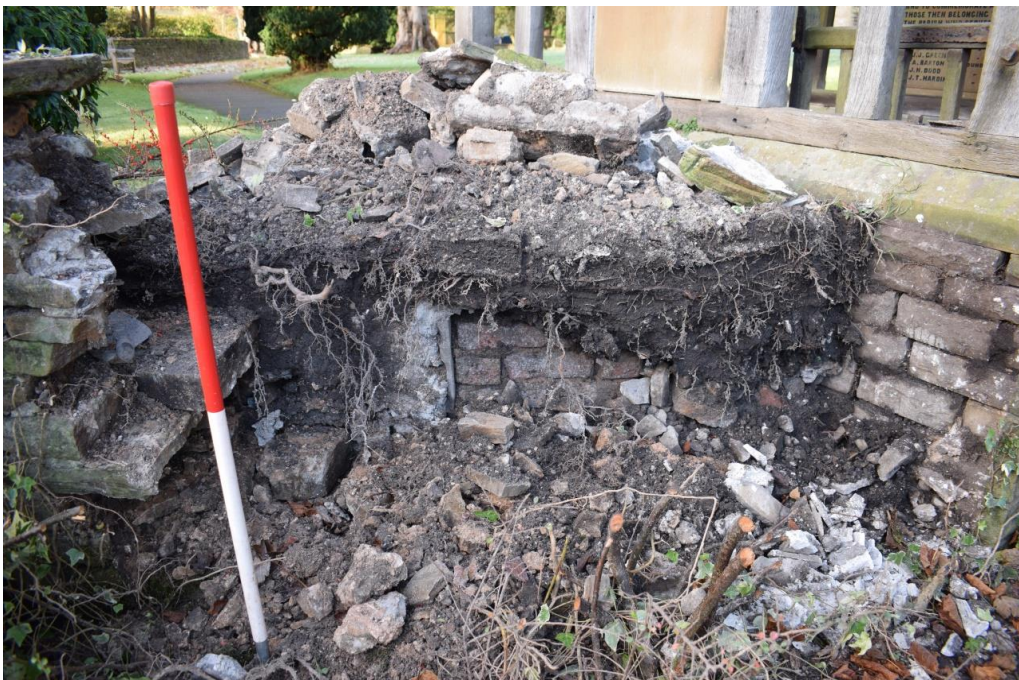
Figure 6 Wall removed at site of easy access ramp installation, detailed view of redeposited soil in situ. Viewed from south east. CPAT photo 4962-0005

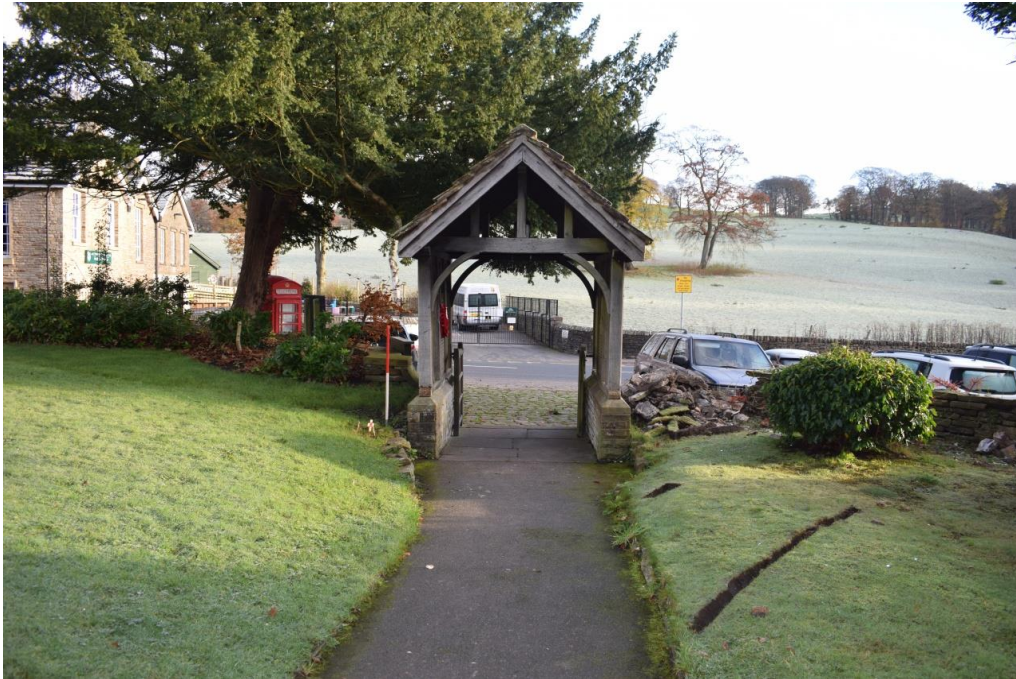
Figure 7 Excavation area shown in relation to the lychgate. Viewed from west. CPAT photo 4962-0009

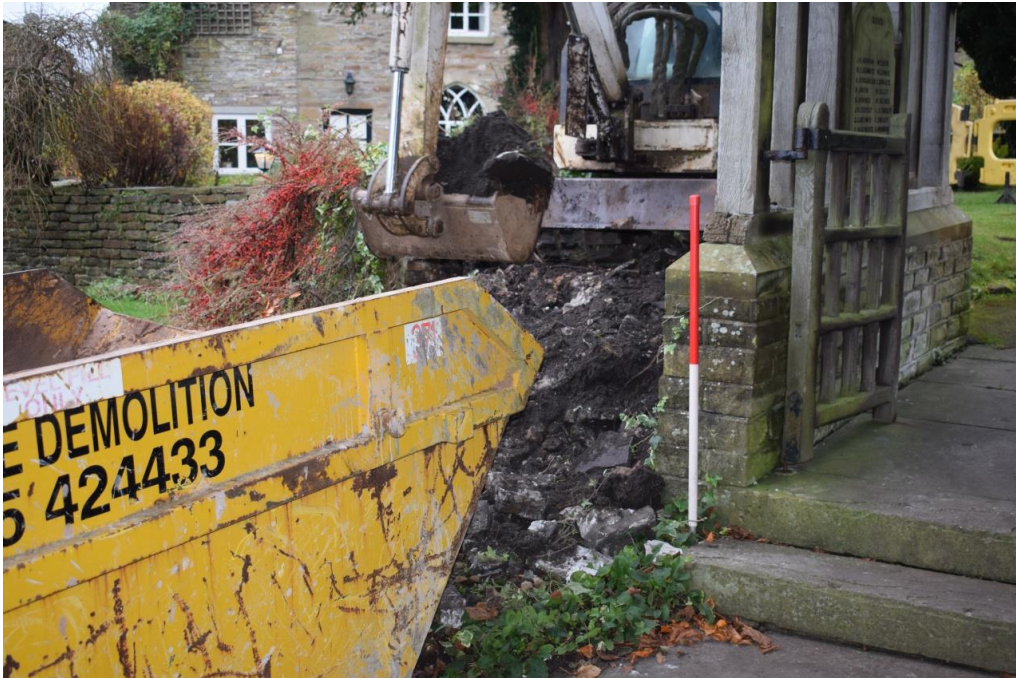
Figure 8 Excavation undertaken by 0.6 tonne mechanical excavator. Viewed from north east. CPAT photo 4962-0012

- 3.4. Excavation was undertaken by a 0.6 tonne mechanical excavator, except in circumstances that required careful removal of soil, which was undertaken by hand. Due to the position and spatial limitations of working within the churchyard, the movement of the machine was limited to tracking over the excavated area at regular intervals to dispose of spoil (see Figure 8).

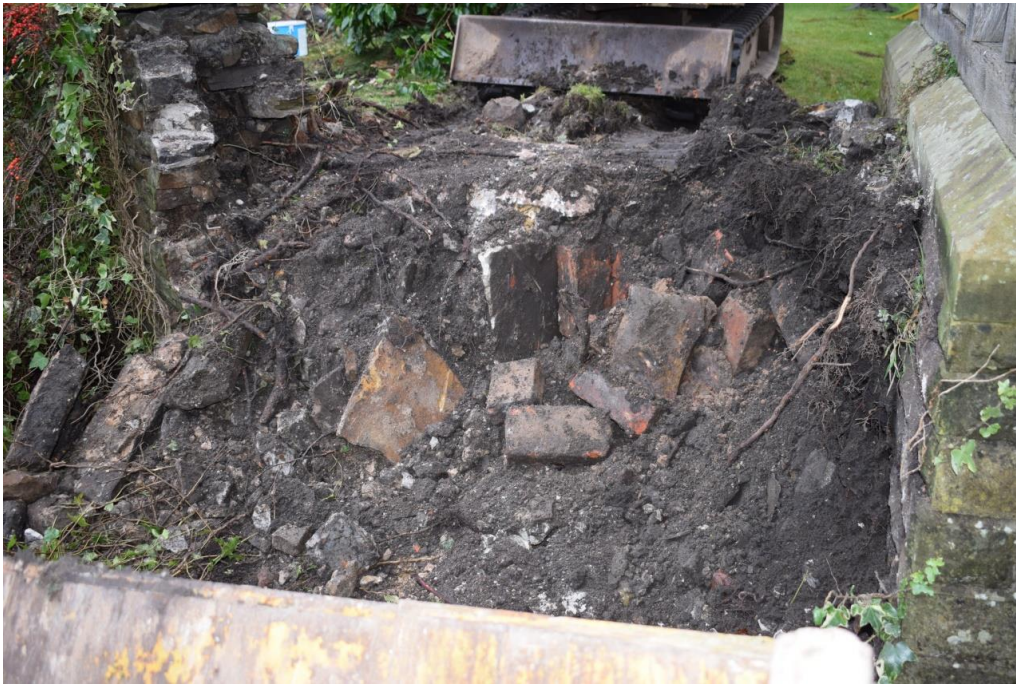
- 3.5. The soil near to the wall was a dark grey loamy silt redeposited soil, with fragmentary concrete, mortar and ceramic building material inclusions, as well as complete in situ bricks and

concreted stones (Figure 9). The stones were typical local limestone and resembled the fabric of nearby dry walls, implying that they may have been repurposed.

Figure 9 Ceramic building material and stone redeposit, as well as in situ material performing a structural purpose behind the removed wall. Viewed from north east. CPAT photo 4962-0015

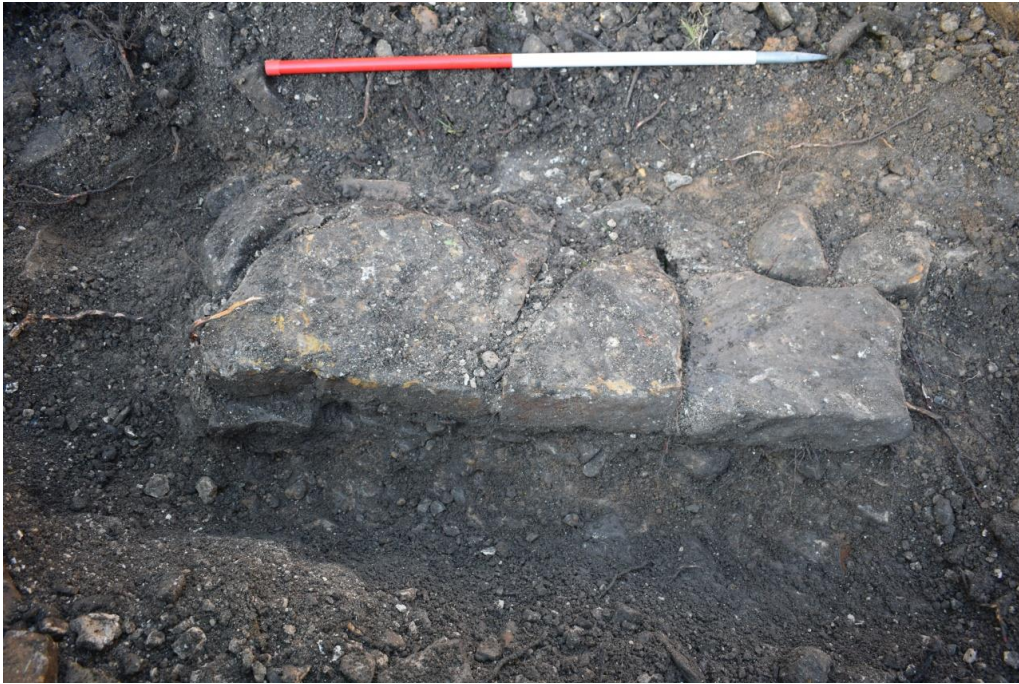
- 3.6. Immediately beneath the redeposited soil, there were the remains of a former drystone wall ranging approximately 1.05 to 1.2m inwards from the current wall (Figure 10). The wall did not survive beyond the recorded extent, and was positioned directly onto the dark yellow firmly compacted natural clay base soil. The limestone fabric resembled that which was used in the current mortared wall, as well as the material within the redeposited deposit, as stated above. The remains were only a single course, reaching a maximum height of 0.3m, and had small hearting stones positioned under the large foundation stones at the outer (south-eastern) face of the wall.

Figure 10 Remains of former wall found beneath redeposited material. Viewed from south east. CPAT photo 4962-0024

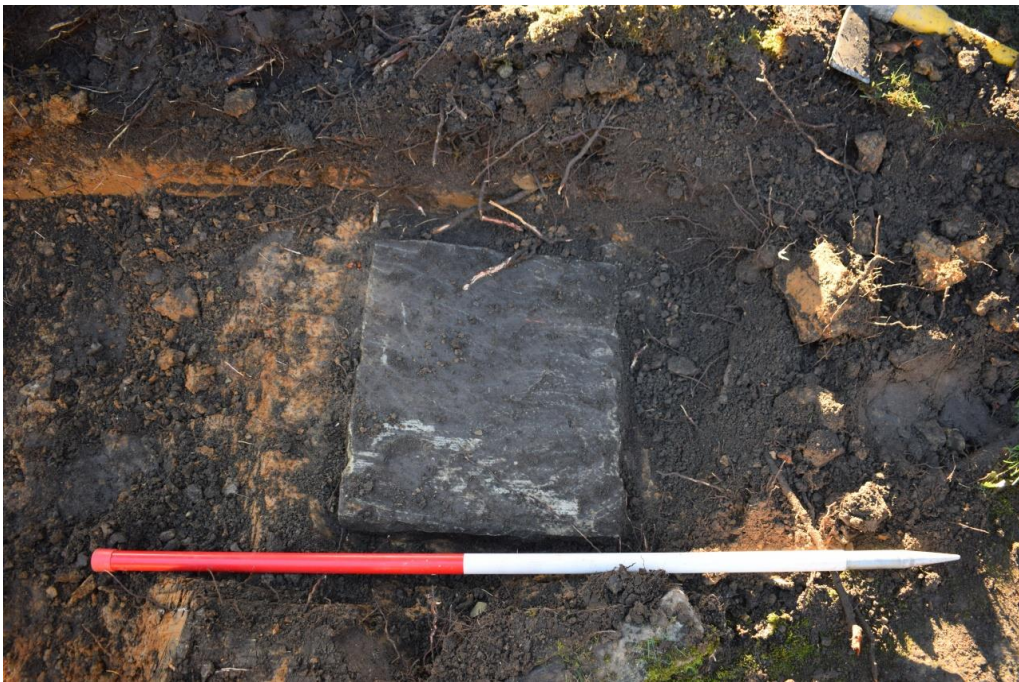
- 3.7. At the western end of the excavation to the immediate south of the current asphalt path, there was a single limestone slab directly under the topsoil, and positioned on the base soil with no cut or connecting feature apparent (Figures 11 & 3). Cleaning the area back manually provided no other discrete features. The slab was 0.3m x 0.43m and had no discerning features. It may have been the remnant of an earlier discarded pathway.

Figure 11 Single slab directly under topsoil. Viewed from north. CPAT photo 4962-0025

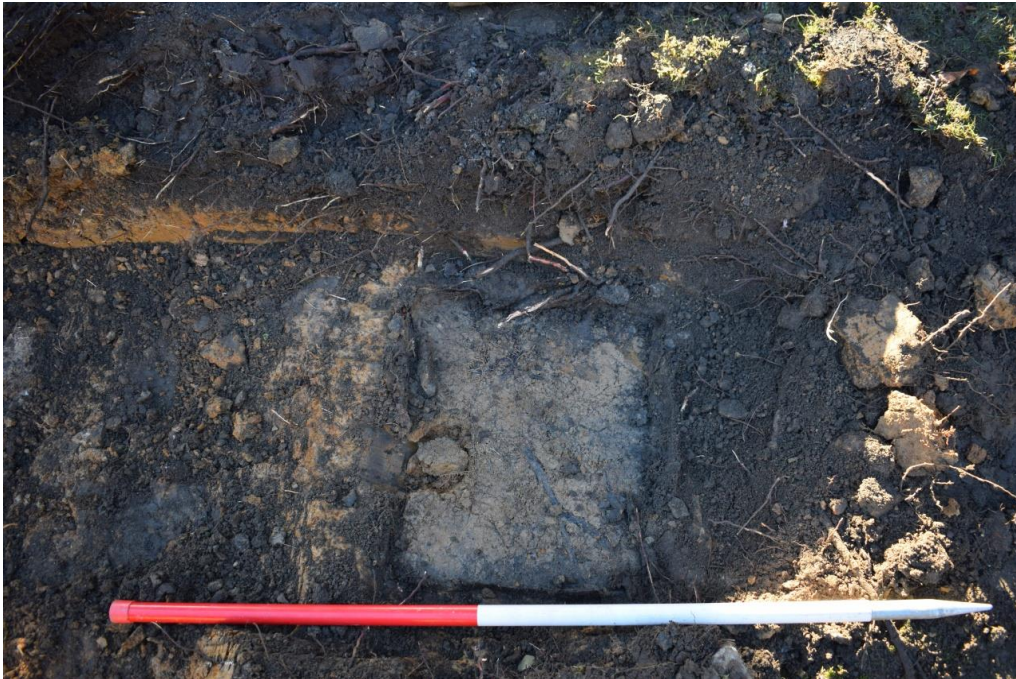
Figure 3 Clay base soil directly beneath slab. Viewed from north. CPAT photo 4962-0026

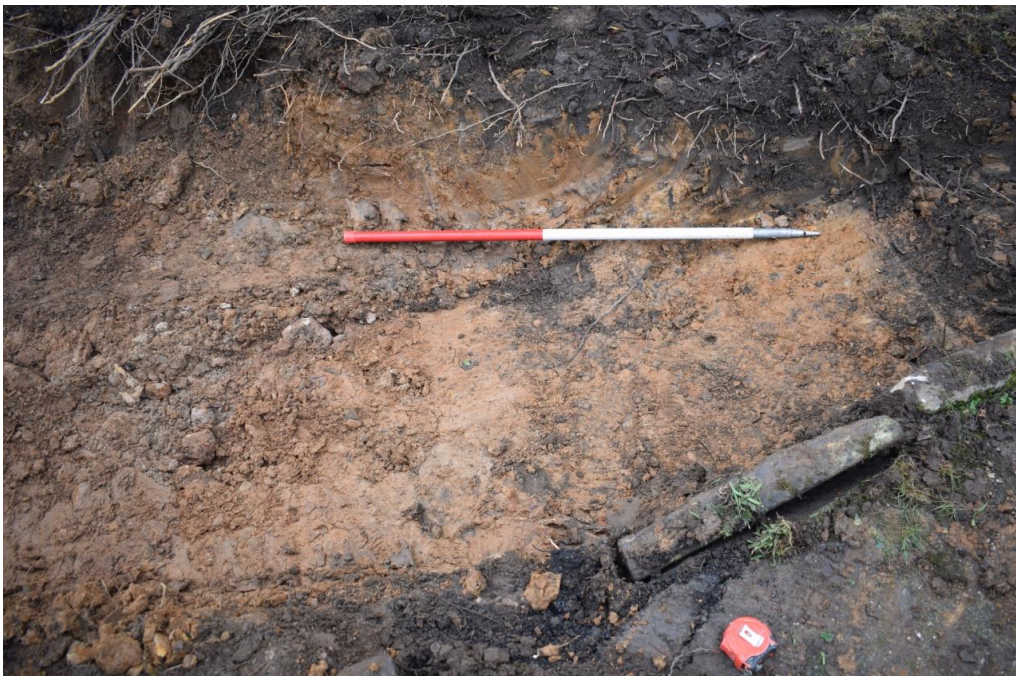
- 3.8. The natural clay base soil was reached in a significant portion of the excavation area, with no features discovered to the interior of the wall remnants (described in section 3.6). Lenses of greyish yellow natural compacted sandy clay with higher density of gravel inclusions were present in patches through the soil (see Figure 4). Testing these deposits by hand-digging proved them to be of natural geological origin.

Figure 4 Clay base soil with gravel inclusions. Viewed from north. CPAT photo 4962-0033

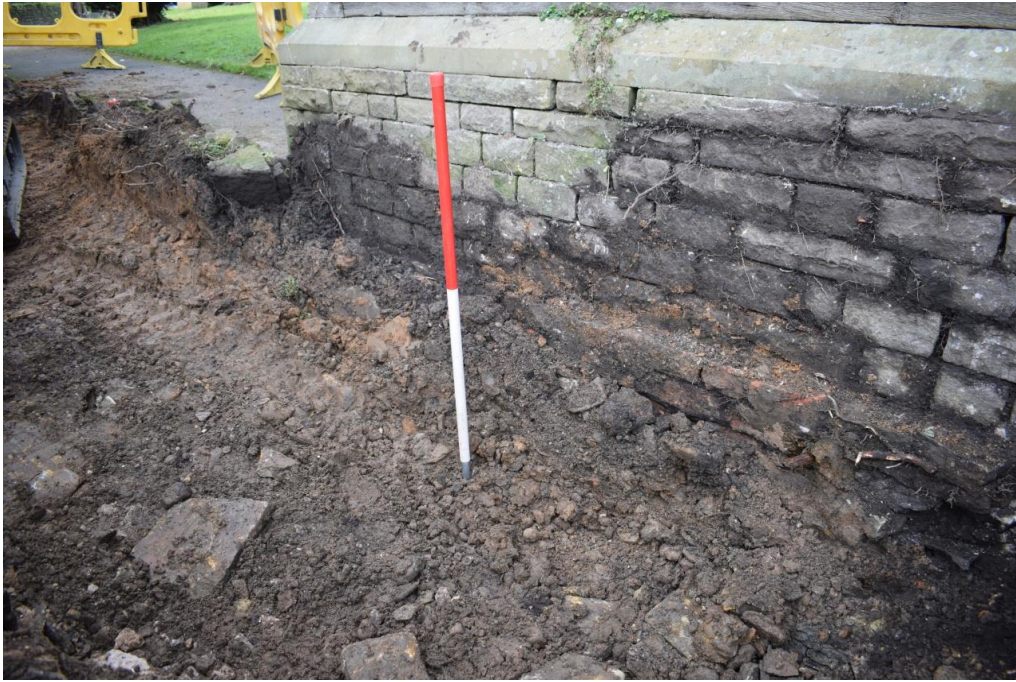
- 3.9. The excavation reached a maximum depth of 0.9m from the existing ground surface. The redeposited material continued in the outer area up to 0.7m from the boundary, but after this it was not excavated to a depth (to accommodate the laying of aggregate for the access ramp foundations) sufficient to reach natural (Figures 5 & 15).

Figure 5 Depth reached in reference to the lychgate. Viewed from south east. CPAT photo 4962-0033

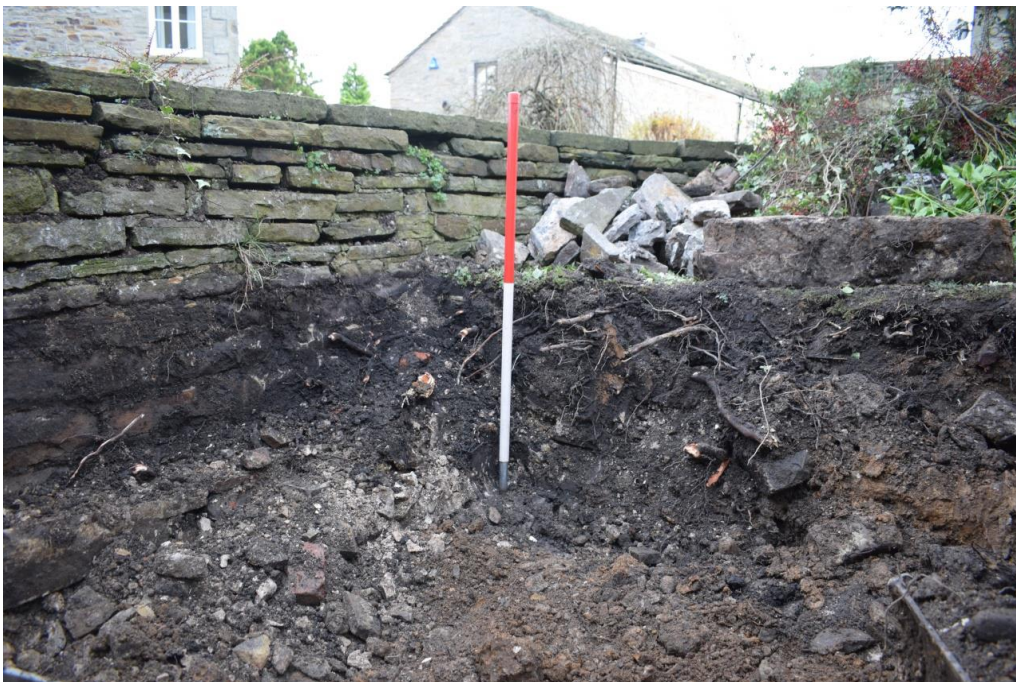
Figure 6 Depth reached in reference to the existing wall. Viewed from south east. CPAT photo 4962-0038

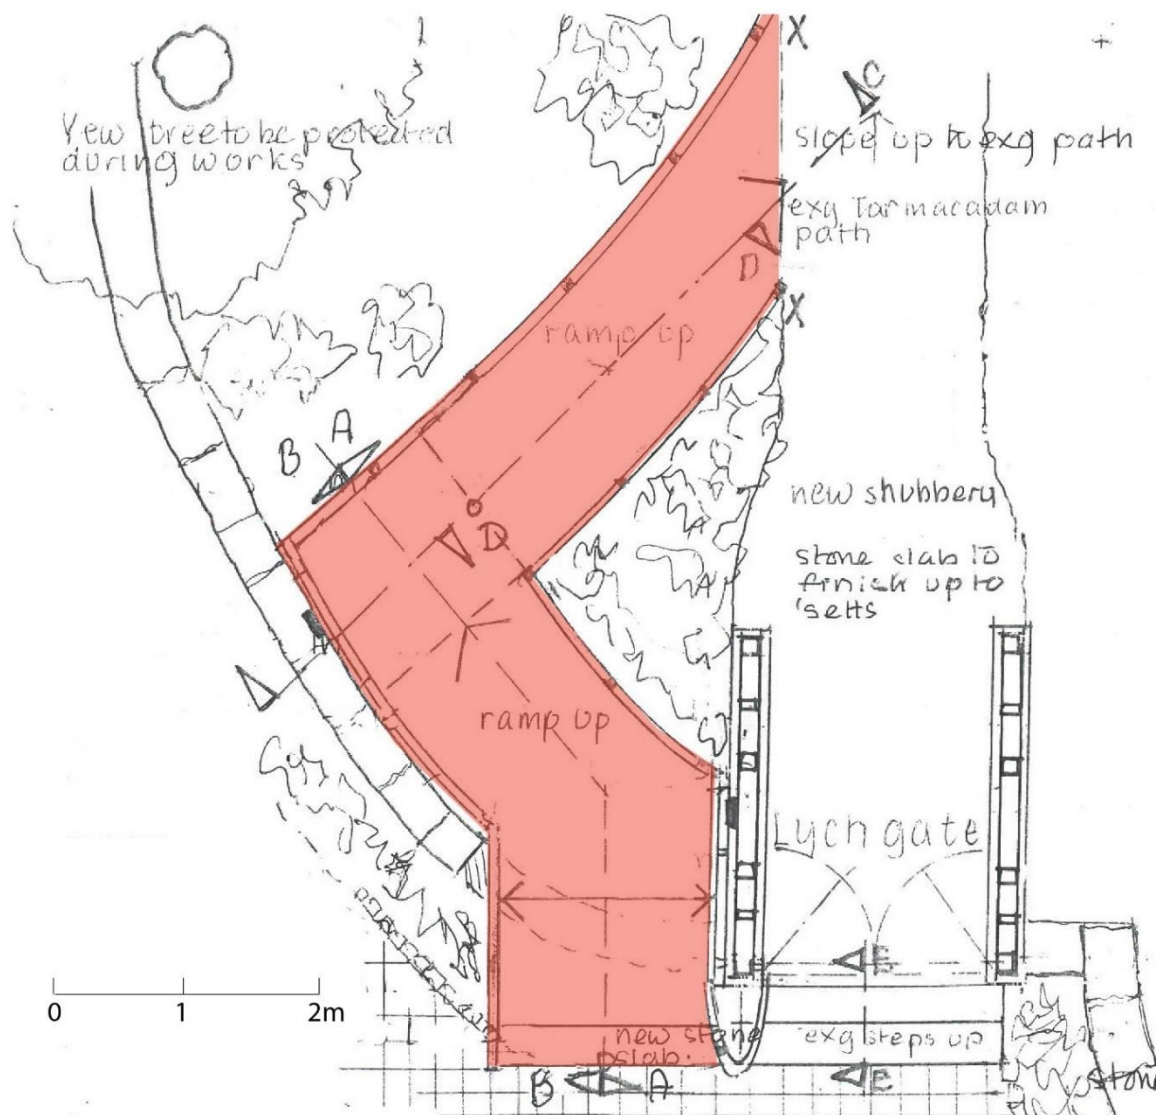
Fig. 3 Plan of the groundworks

-
- 3.2. Groundworks will comprise ground reduction and levelling to allow for the installation of a ramp adjacent to the existing lychgate at the south-east extent of the churchyard (Fig. 3). The general reduction will vary in depth between 0.25m at the north-west extent of the ramp and 0.5m at the south-east extent. Additionally pockets 0.5m in depth will be excavated for stanchions.
