**ST LAWRENCE CHURCH,
LONDON ROAD,
MORDEN,
LONDON BOROUGH OF MERTON,
SM4 5QT**

PETROLOGY REPORT

PCA REPORT NO: R13707

Petrological Identification of the stone types used in the East Window and Quoins and comment on the brickwork

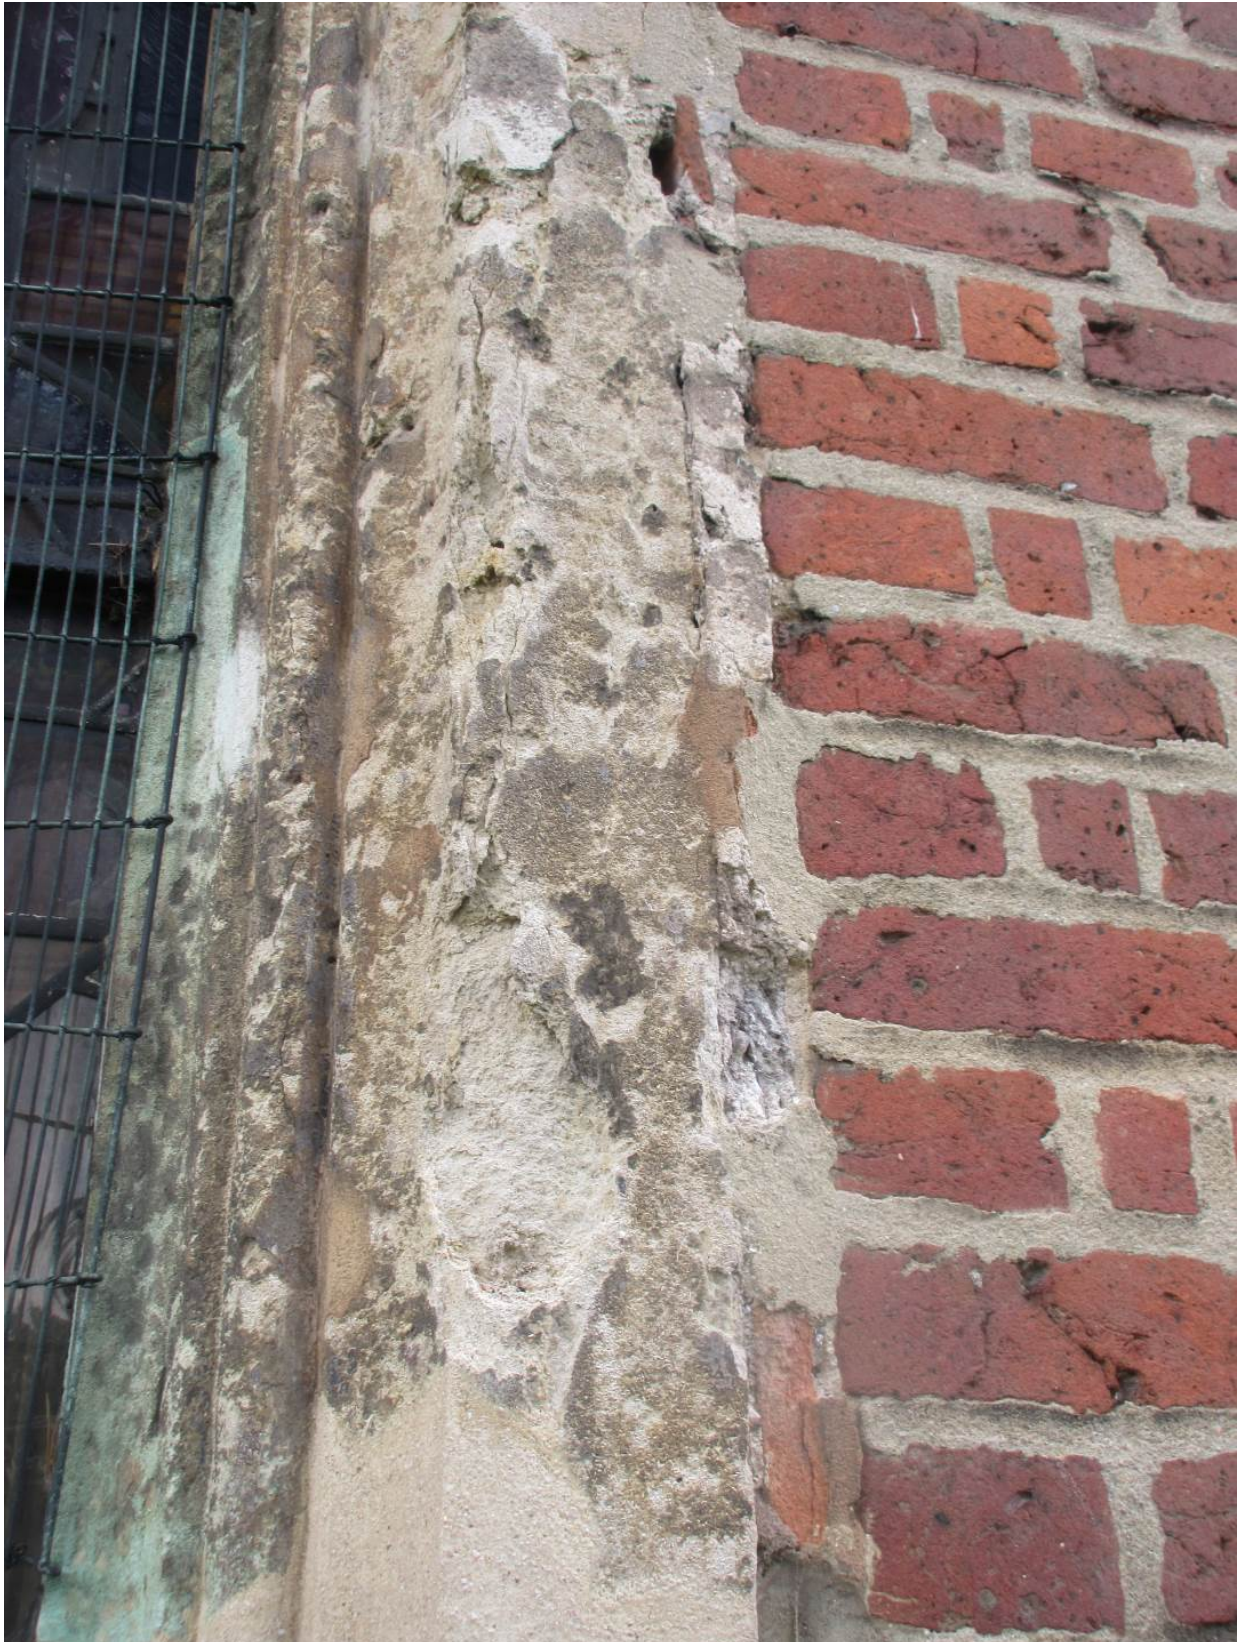
Plate 2 Blistering of Headington stone in the jamb of the east window

Vertical elements of the 17th century east window had suffered extensive weathering and flaking particularly in areas strengthened by a very hard impermeable hydraulic pale cream-brown gritty mortar (19-20th century), causing these vertical mullions and window jambs to spall, warp and break-up in places (**Plate 2**). Spalling began in the lowermost vertical sections of the window tracery and jambs at the juncture with large horizontal stone elements. These basal elements, forming the external stone sill of the window, were later post-medieval replacements made from a slightly different darker pale cream brown rock. The application of the hard impermeable mortar with same hue as the stone sill at this juncture and above was meant to show a seamless boundary between the sill and vertical elements giving the impression that the stone was all made from the same rock type.

Its open porosity (BRE E5236; 34.7%) which makes it conducive to fine, accurate carving also makes it highly vulnerable to polluted atmospheres, creating widespread characteristic blistering (Arkell 1947 Sass & Viles 2010), accentuated by the render covering of the impermeable hydraulic seal of the 19th to 20th century Roman cement.

The fabric of the Headington stone used in the 17th century vertical jambs and mullions of the east window as well as the quoins of St Lawrence Church, Morden is decaying rapidly. It requires replacement stone urgently.

The obvious choice would be to use Clipsham stone from the Middle Jurassic (Bajocian) already successfully employed as a replacement stone in the windowsill of the east window. Of a similar if not identical hue to the Headington stone, Clipsham stone has the added benefits of having a lower overall porosity (15%) rather than (35%) of Headington stone and greater strength, making it resistant to long-term chemical and physical decay. It is also recommended that the impermeable hydraulic cement render is not replaced with a comparable material but a more breathable lime sandy mortar cement.

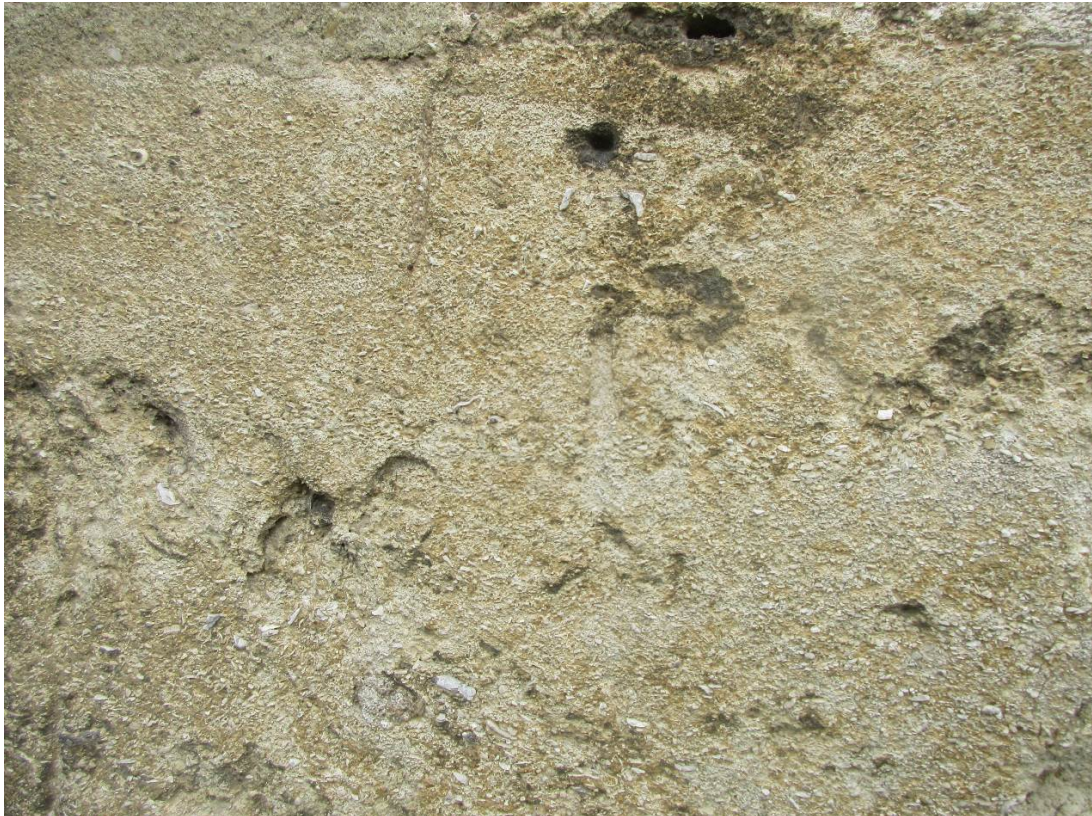
Plate 3a Close up of Headington stone in the jamb of the east window

Nearly all of the vertical mullions (typically 95cm long) and jambs of the primary 17th century external east window of St Lawrence's Church had an identical petrological match with samples of Headington stone from the Upper Jurassic (Oxfordian), Oxfordshire. This banded pale cream to yellow-cream open textured shelly (echinoid and coral) grainstone (Dunham 1962) (**Plate 3a**) lies on the easternmost edge of the Jurassic limestone outcrop in Oxfordshire immediately to the east of Oxford in the villages of Headington and Wheatley, easily accessible to London via the River Thames (outcrops lie just 6km away). It is in fact the closest limestone freestone resource to London (80km).

Detailed hand specimen comparative analysis shows it to have thin, gently curved, but not laminated, shelly fragments which stand out above the surrounding pellet grained sometimes light cream sparry matrix, which weathers very pale brown. In thin section, these are probably *Ctenostereum* brachiopod (Hayward 2009). Stems of crinoids (possibly *Plegiocidaris florigemma*) (**Plate 3b**) and a near complete echinoid (possibly *Nucleolites cluncularis*) (**Plate 3c**) were observed in comparable materials identified from quoins from the north-east corner of the church (see below). Both are common fossil types from the Upper Jurassic (Oxfordian) of Oxfordshire. Unlike the replacement limestone types, which did not contain ooids.

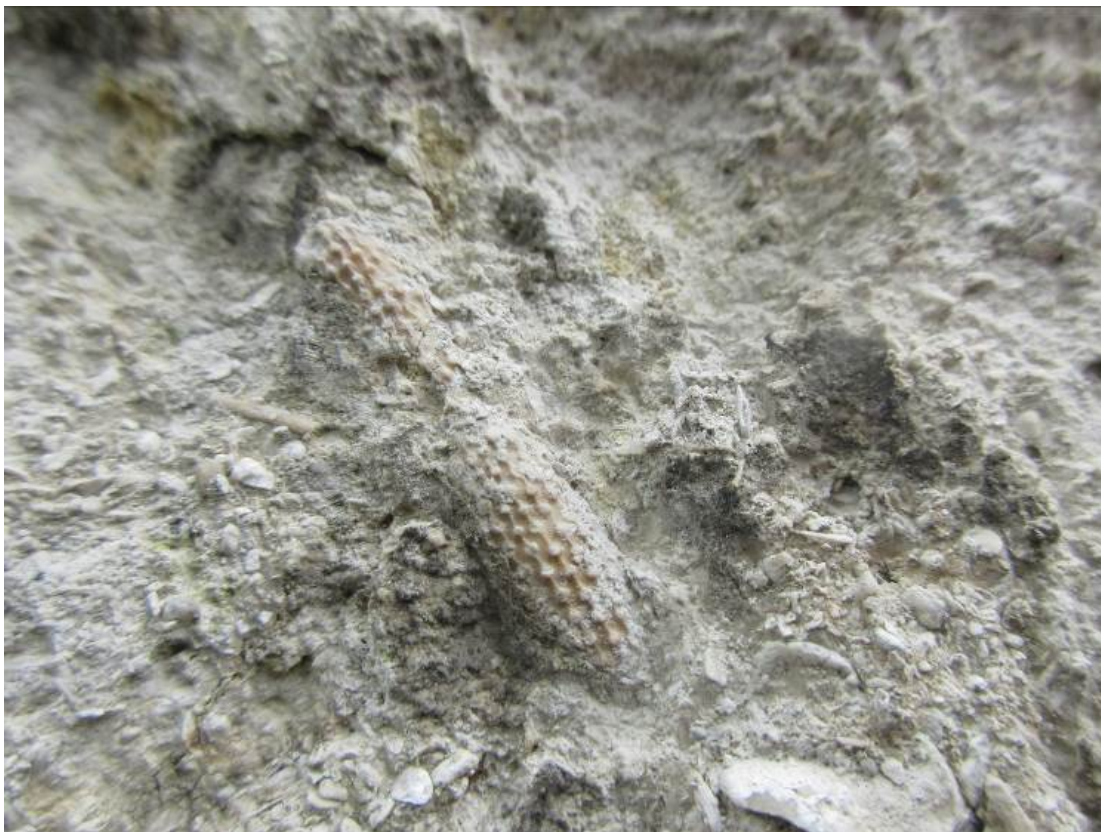
Plate 3b Close up of Crinoid *Plegiocidaris florigemma* in north-east quoin of St Lawrence Church, typical of Headington stone (Upper Jurassic) Oxfordshire

Set into the south-east and north-east corners of the east elevation of St Lawrence Church, Morden are 500mm long x 315mm wide x 185mm high blocks of stone having an identical petrological match to Headington stone or Wheatley stone used in the vertical mullions of the 17th century east window. They have suffered the same type of spalling and weathering, especially at the quoin edges and contain examples of crinoid stems (possibly *Plegiocidaris florigemma*; **Plate 3b**) and a near complete echinoid (possibly *Nucleolites cluncularis*; **Plate 3c**), both typical of the Oxfordian (Upper Jurassic).

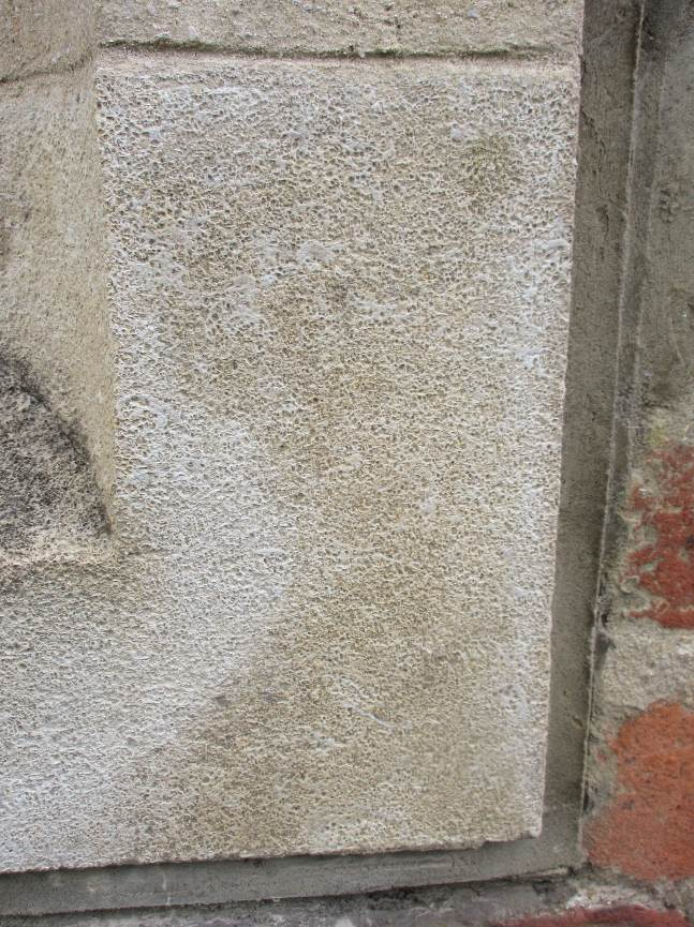
Plate 4a Stone window sill in Clipsham stone

Individual long (1m 6cm) moulded elements forming the replacement window-sill of the east window had a good petrological match with samples of Clipsham stone from the Middle Jurassic (Bajocian) of South Lincolnshire. In hand specimen this limestone is homogeneous hard interlocking shelly oolitic grainstone (Dunham 1962), consisting of a mosaic of large (1mm) round pitted carbonate grains called ooids and a whiter shell component, containing often-complete bivalves and brachiopods. (**Plates 4a and 4b**). It has a deeper creamy-brown hue than the Headington stone and its fresh hard

surface is an indication of its greater resistance to weathering borne out by its much lower porosity (14-15%) (Leary 1989, 24) than Headington stone and its durability, recorded as one of the toughest limestone types (Class A) in the British Isles and the hardest of the Lincolnshire Limestones (Leary 1989, 22).

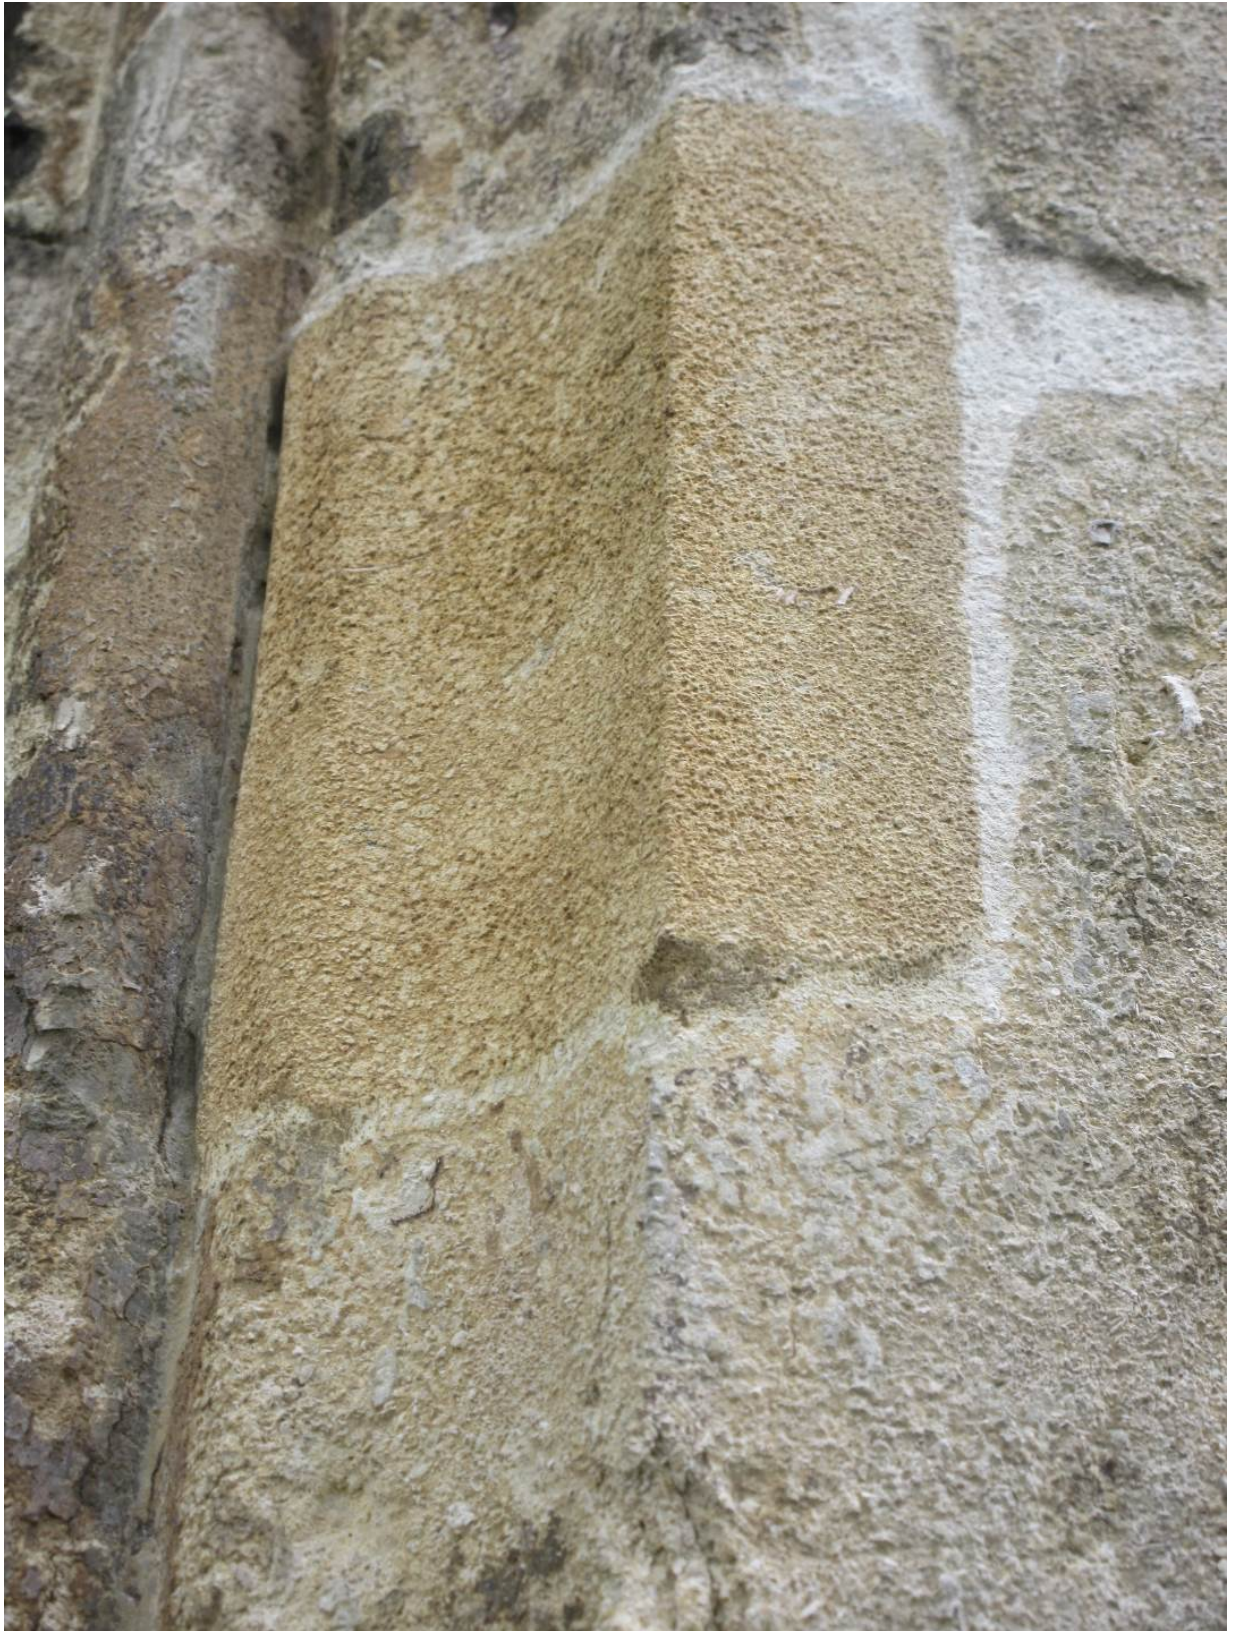
Plate 5 Taynton stone inset

Five small (15cm high) insets (**Plate 5**), set one metre up in the vertical mullions and jambs between the Headington stones in the east window have a good petrological match with samples of Taynton stone from Middle Jurassic (Bathonian) of West Oxfordshire. This much deeper coloured pale orange brown coarse banded shelly oolitic grainstone (Dunham 1962), contrasts markedly with the much paler cream Headington stone, forming a two-tone window surround. Outcrops lie close to the River Windrush and would have been easily accessible by boat to London via the River Thames (Sumbler *et. al.*, 2000).

It is not clear whether their fresher sharp edges are down to their lower porosity (19%) and durability Class C (Leary 1989, 73) and/or the possibility that they could be later replacement stones.
