WATCHING BRIEF ON EXTERNAL  
GROUNDWORKS TO NORTH OF  
ALL SAINT'S CHURCH, DEANSWAY,  
WORCESTER

WCM 101826

# Watching brief on external groundworks to north of All Saint's Church, Deansway, Worcester WCM 101826

28<sup>th</sup> July 2010  
Mike Napthan MIFA

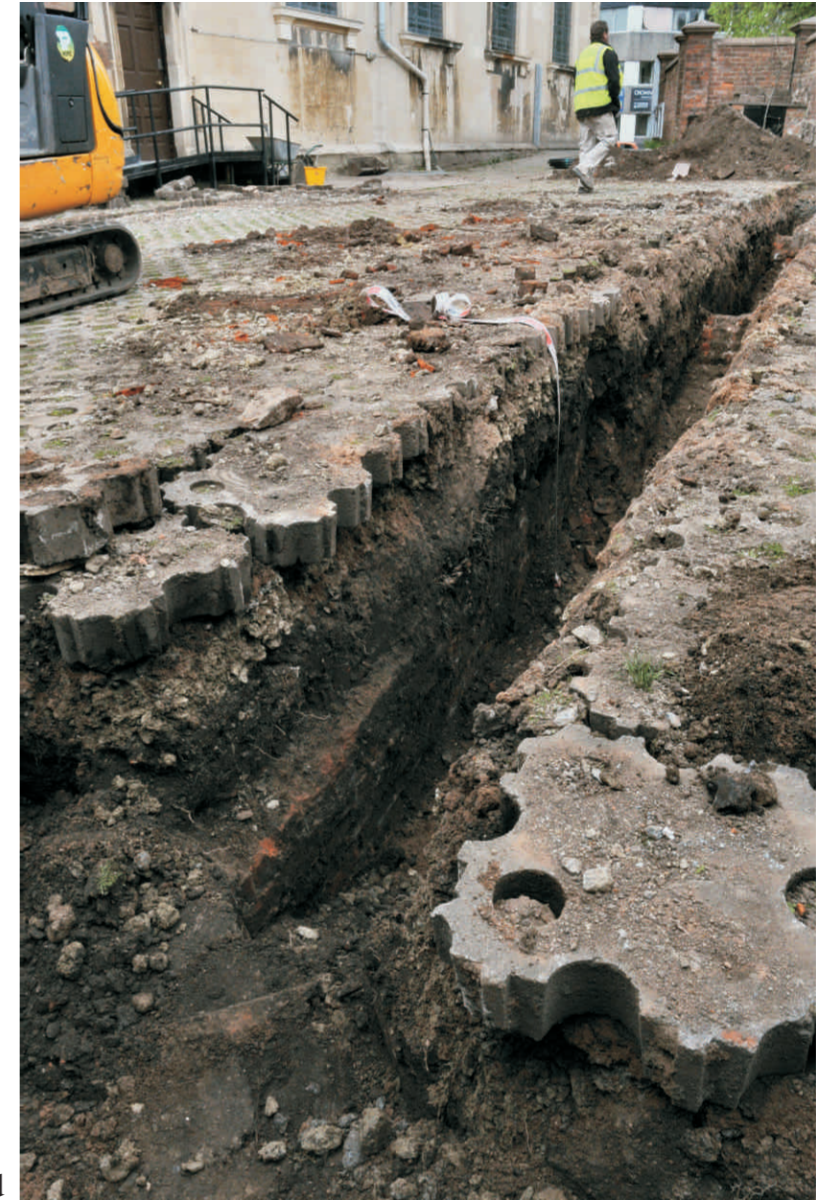
Sandstone scar of former vestry/school room on southern elevation of aisle

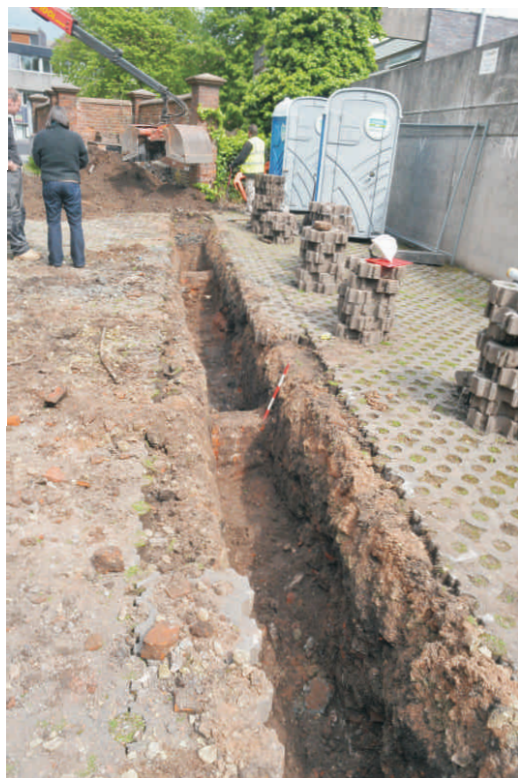
Brick footing of 1849 school room in foreground

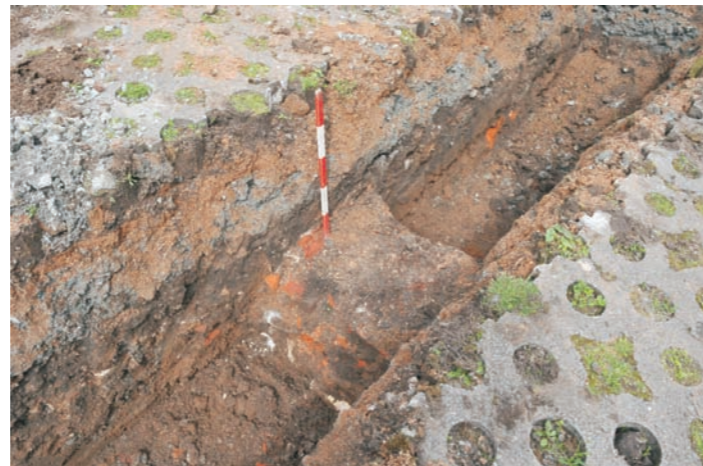
Brick and stone foundation of "Vestry"

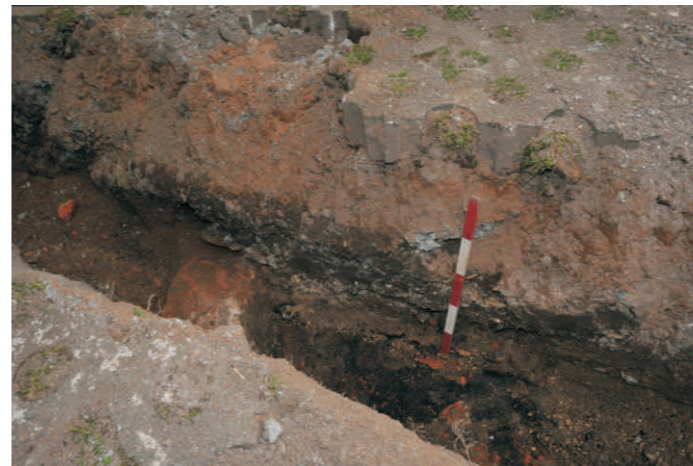
Brick flooring at base of trench near tower

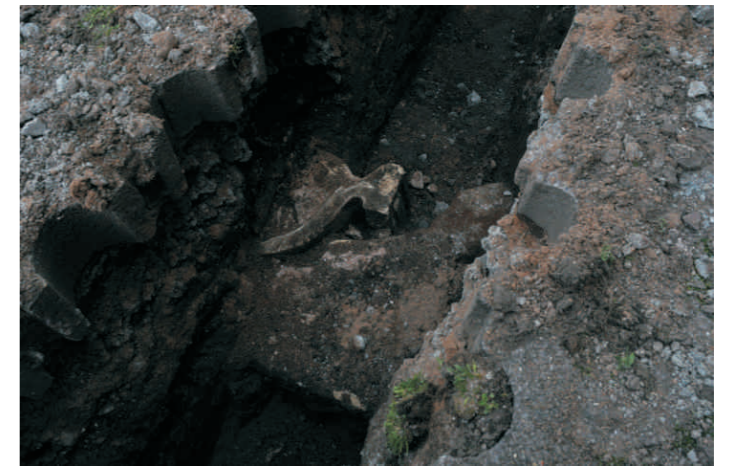
Corbel re-used in foundation

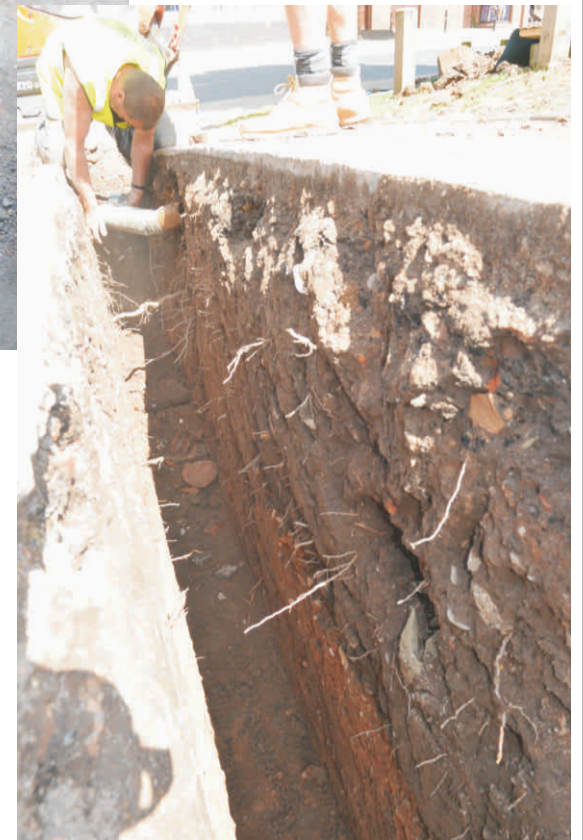
View facing north-east showing redeposited sand and gravelly deposits

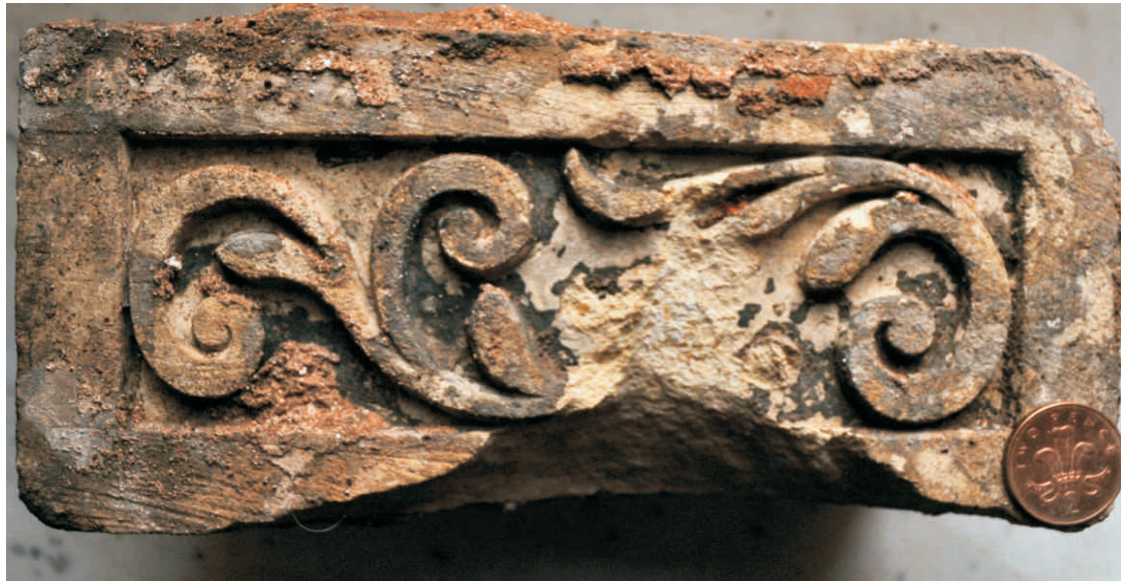
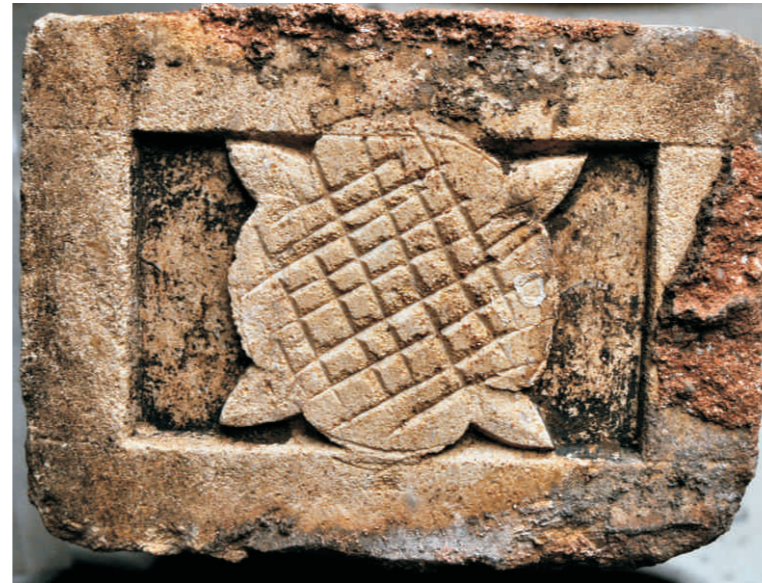
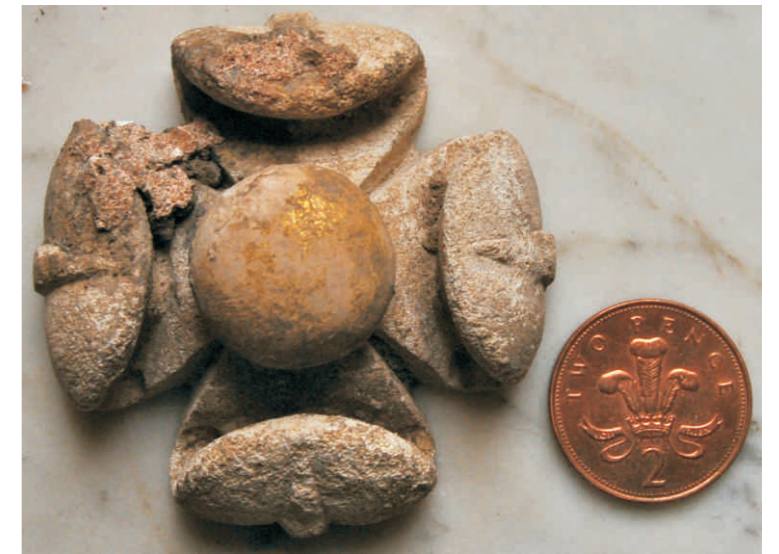
- 8.2 Eight distinct fragments of stonework were recorded. Fragments A and B, although recovered separately from the spoil proved to be joining parts of a single monument. "A" was a rectangular block of fine grained limestone (not local). It was finely finished and carefully carved with scrolled foliage on the two long sides. Only one short end was carved, this with a central roundel surrounded by four petals. The central roundel was keyed with cross-hatching. This patch of cross-hatching matched precisely cross hatching and compo bedding on the back of Fragment B. Fragment B was a neatly carved florette with a gilded central boss and four part folded petals (Fig 7). Fragment C, possibly from the same monument consisted of a substantial fragment of a large corbel, the face being decorated with an acanthus leaf. The sides of the corbel were decorated with a simple incised line reflecting the bulge of the corbel. The back part of the corbel appears to have engaged into a vertical surface (Fig 7).

Detached florette "B" - note gilding. Dimensions 63x63x27mm)

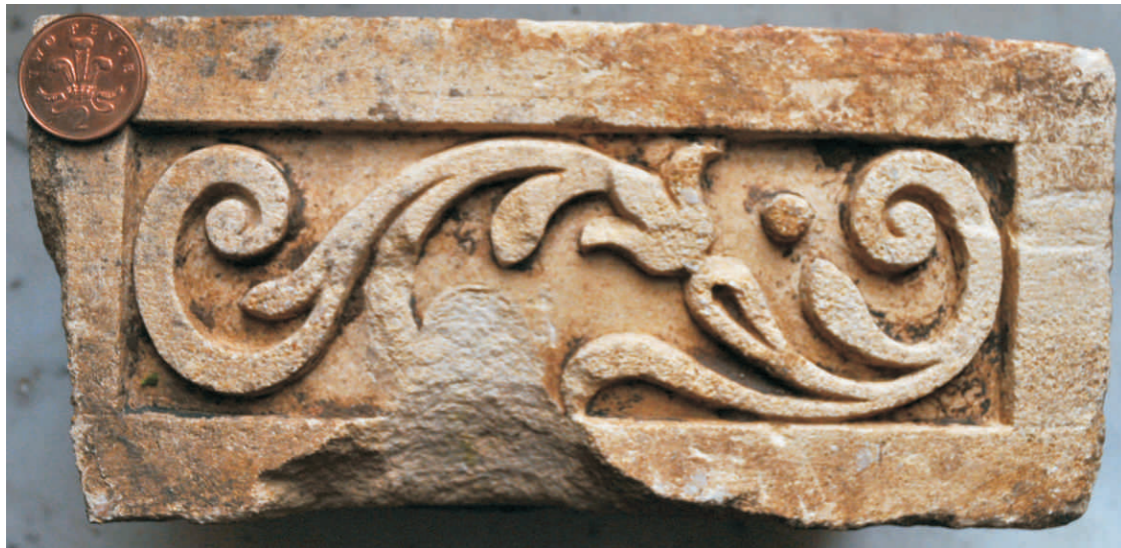
Above and left - Block A - rectangular plinth (dimensions 445x145x102mm)  
decorated on three sides - note keying for detached florette

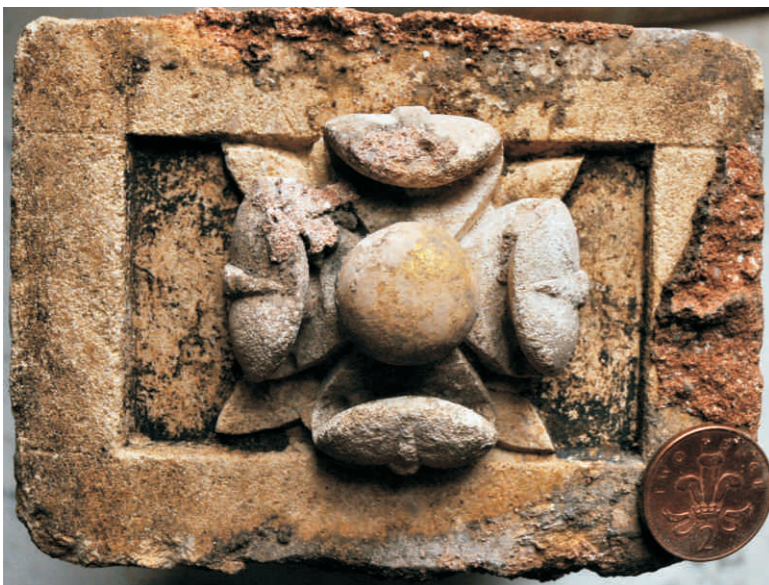
Blocks A and B reunited

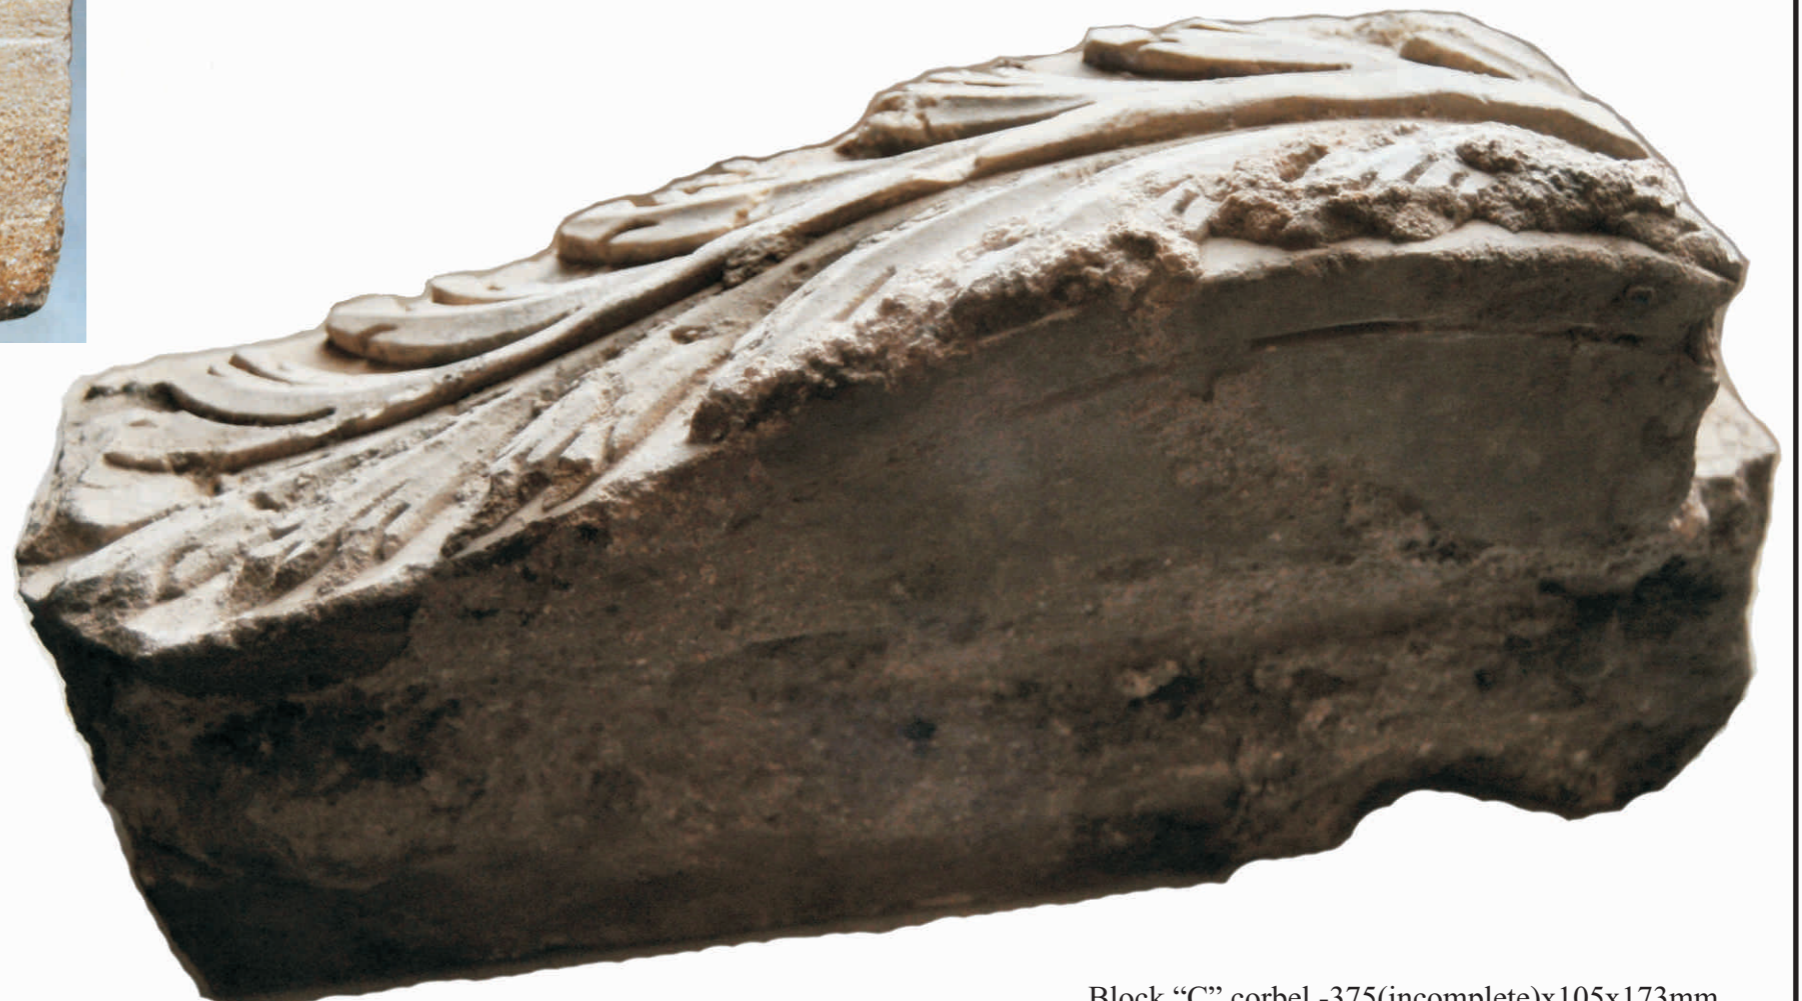
Block "C" corbel -375(incomplete)x105x173mm

Figure 7: Stone architectural fragments A-C - all fine grained limestone, and probably from the same monument - all have later mortar adhering.

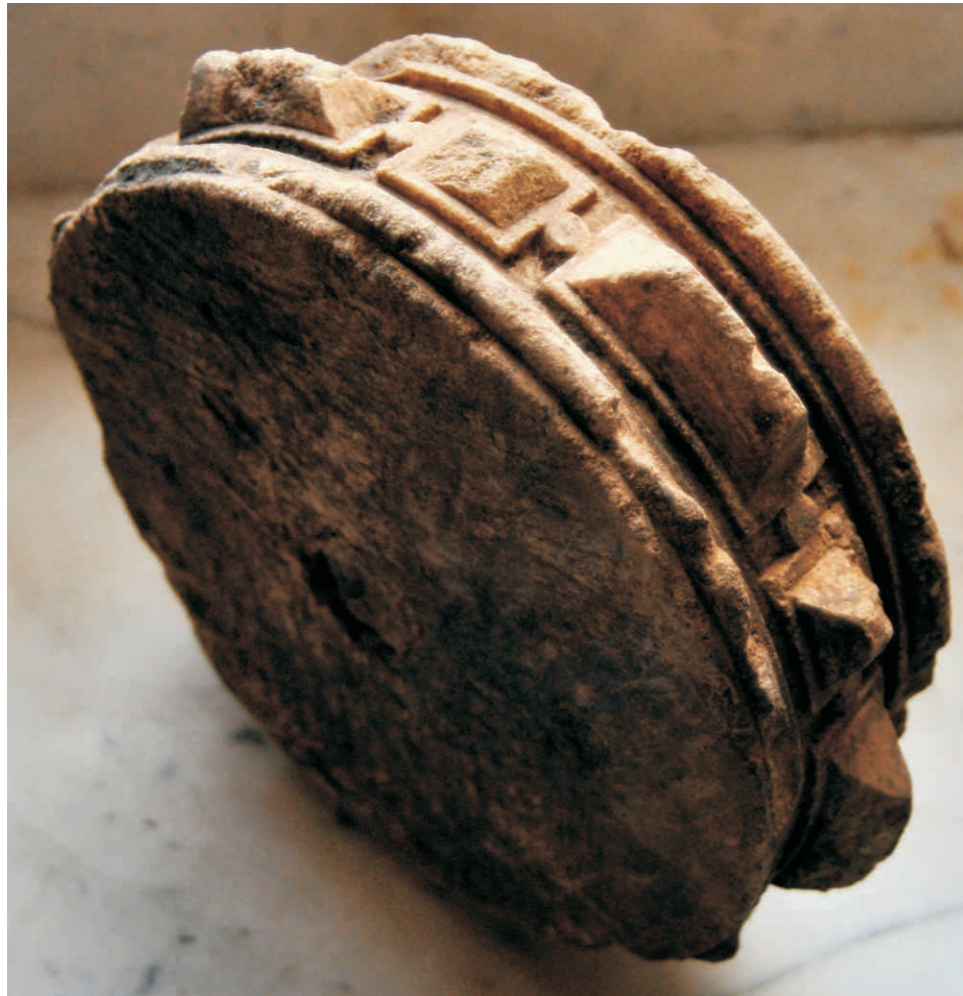
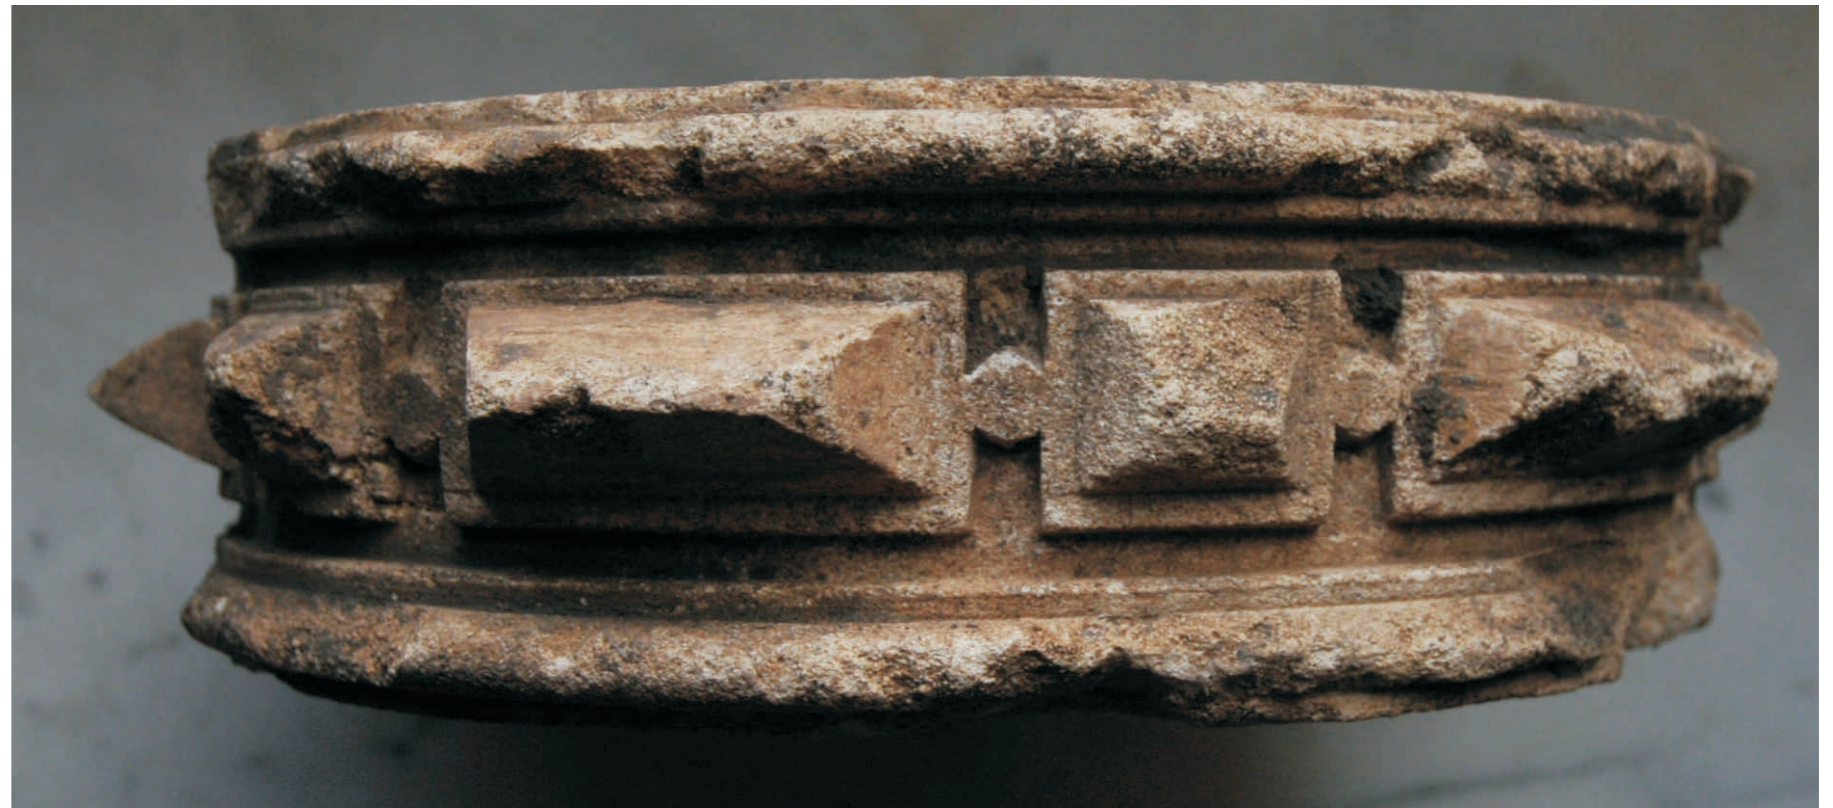
- 8.3 Block "D" was a thin circular column drum with carved projecting lozenges, alternately long and short separated by flat pellets. The quality of carving was high, and there were faint traces of gilding on the lozenges. The material was a fine grained limestone very similar to fragments "A" to "C" (Fig 7). Block "E" consisted of a flat slab of similar stone, with a finely moulded edge. This block appears to have been the capping of a pilaster or a small plinth.

Block "D" - ornate column drum in fine grained limestone, traces of gilding to projecting bosses. Central piercing. Dimensions 197x 58mm.

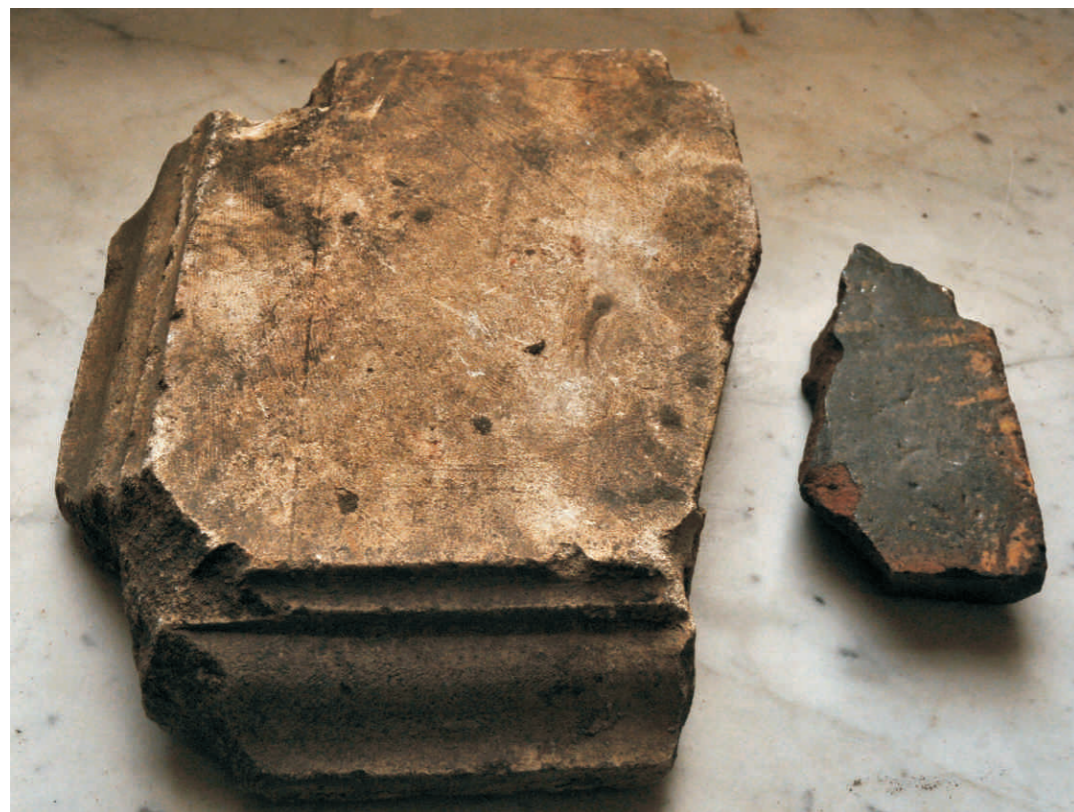
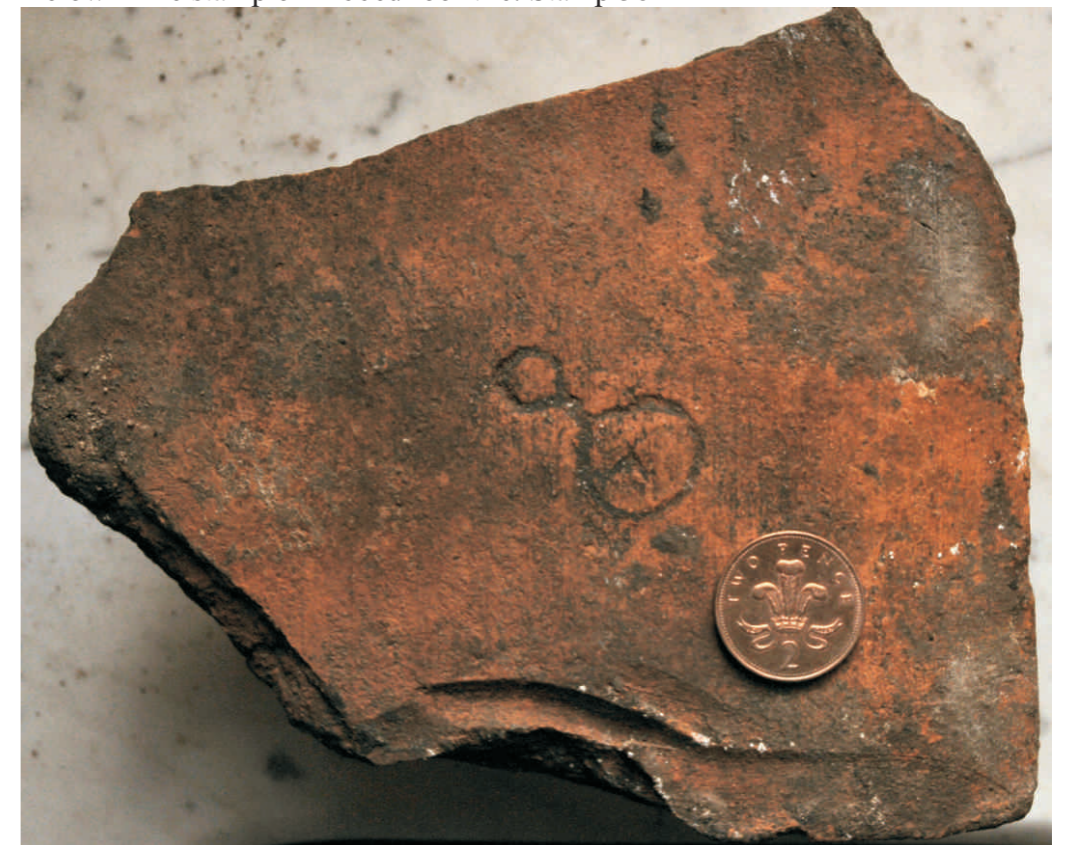
Figure 8: Stone architectural fragments D and E, probably from a similar source to blocks A-C. Significant fragments of ceramic tile, including rare tile stamp similar to Stamp 7, Figure 207 Dalwood et al. 2004.

consisted of a flat nibbed roof tile with a tile stamp rarely recorded in Worcester (Fig 8) and a fragment of green glazed encaustic floortile from a multi-tile pattern (Fig 8). The stamped tile had a stamp similar Stamp 7, Figure 207, Dalwood 2004, consisting of two linked circles. Whilst other tile stamp patterns are found generally in the City (eg the cross in circle stamp and its variations) this particular stamp is known only from the Deansway area. The floor tile fragment was too worn to be recognizable, though the presence of partial arcs strongly suggests a multi-tile pattern.

Far left  
Block "E" fragment of monument  
pilaster capping - fine grained limestone  
240 deepx52mm thick. 205mm wide (incomplete)

Fragment of medieval green glazed decorated  
floor tile - too worn to be precisely identified.

Below - Tile stamp on nibbed roof tile. Stamp 38x22mm

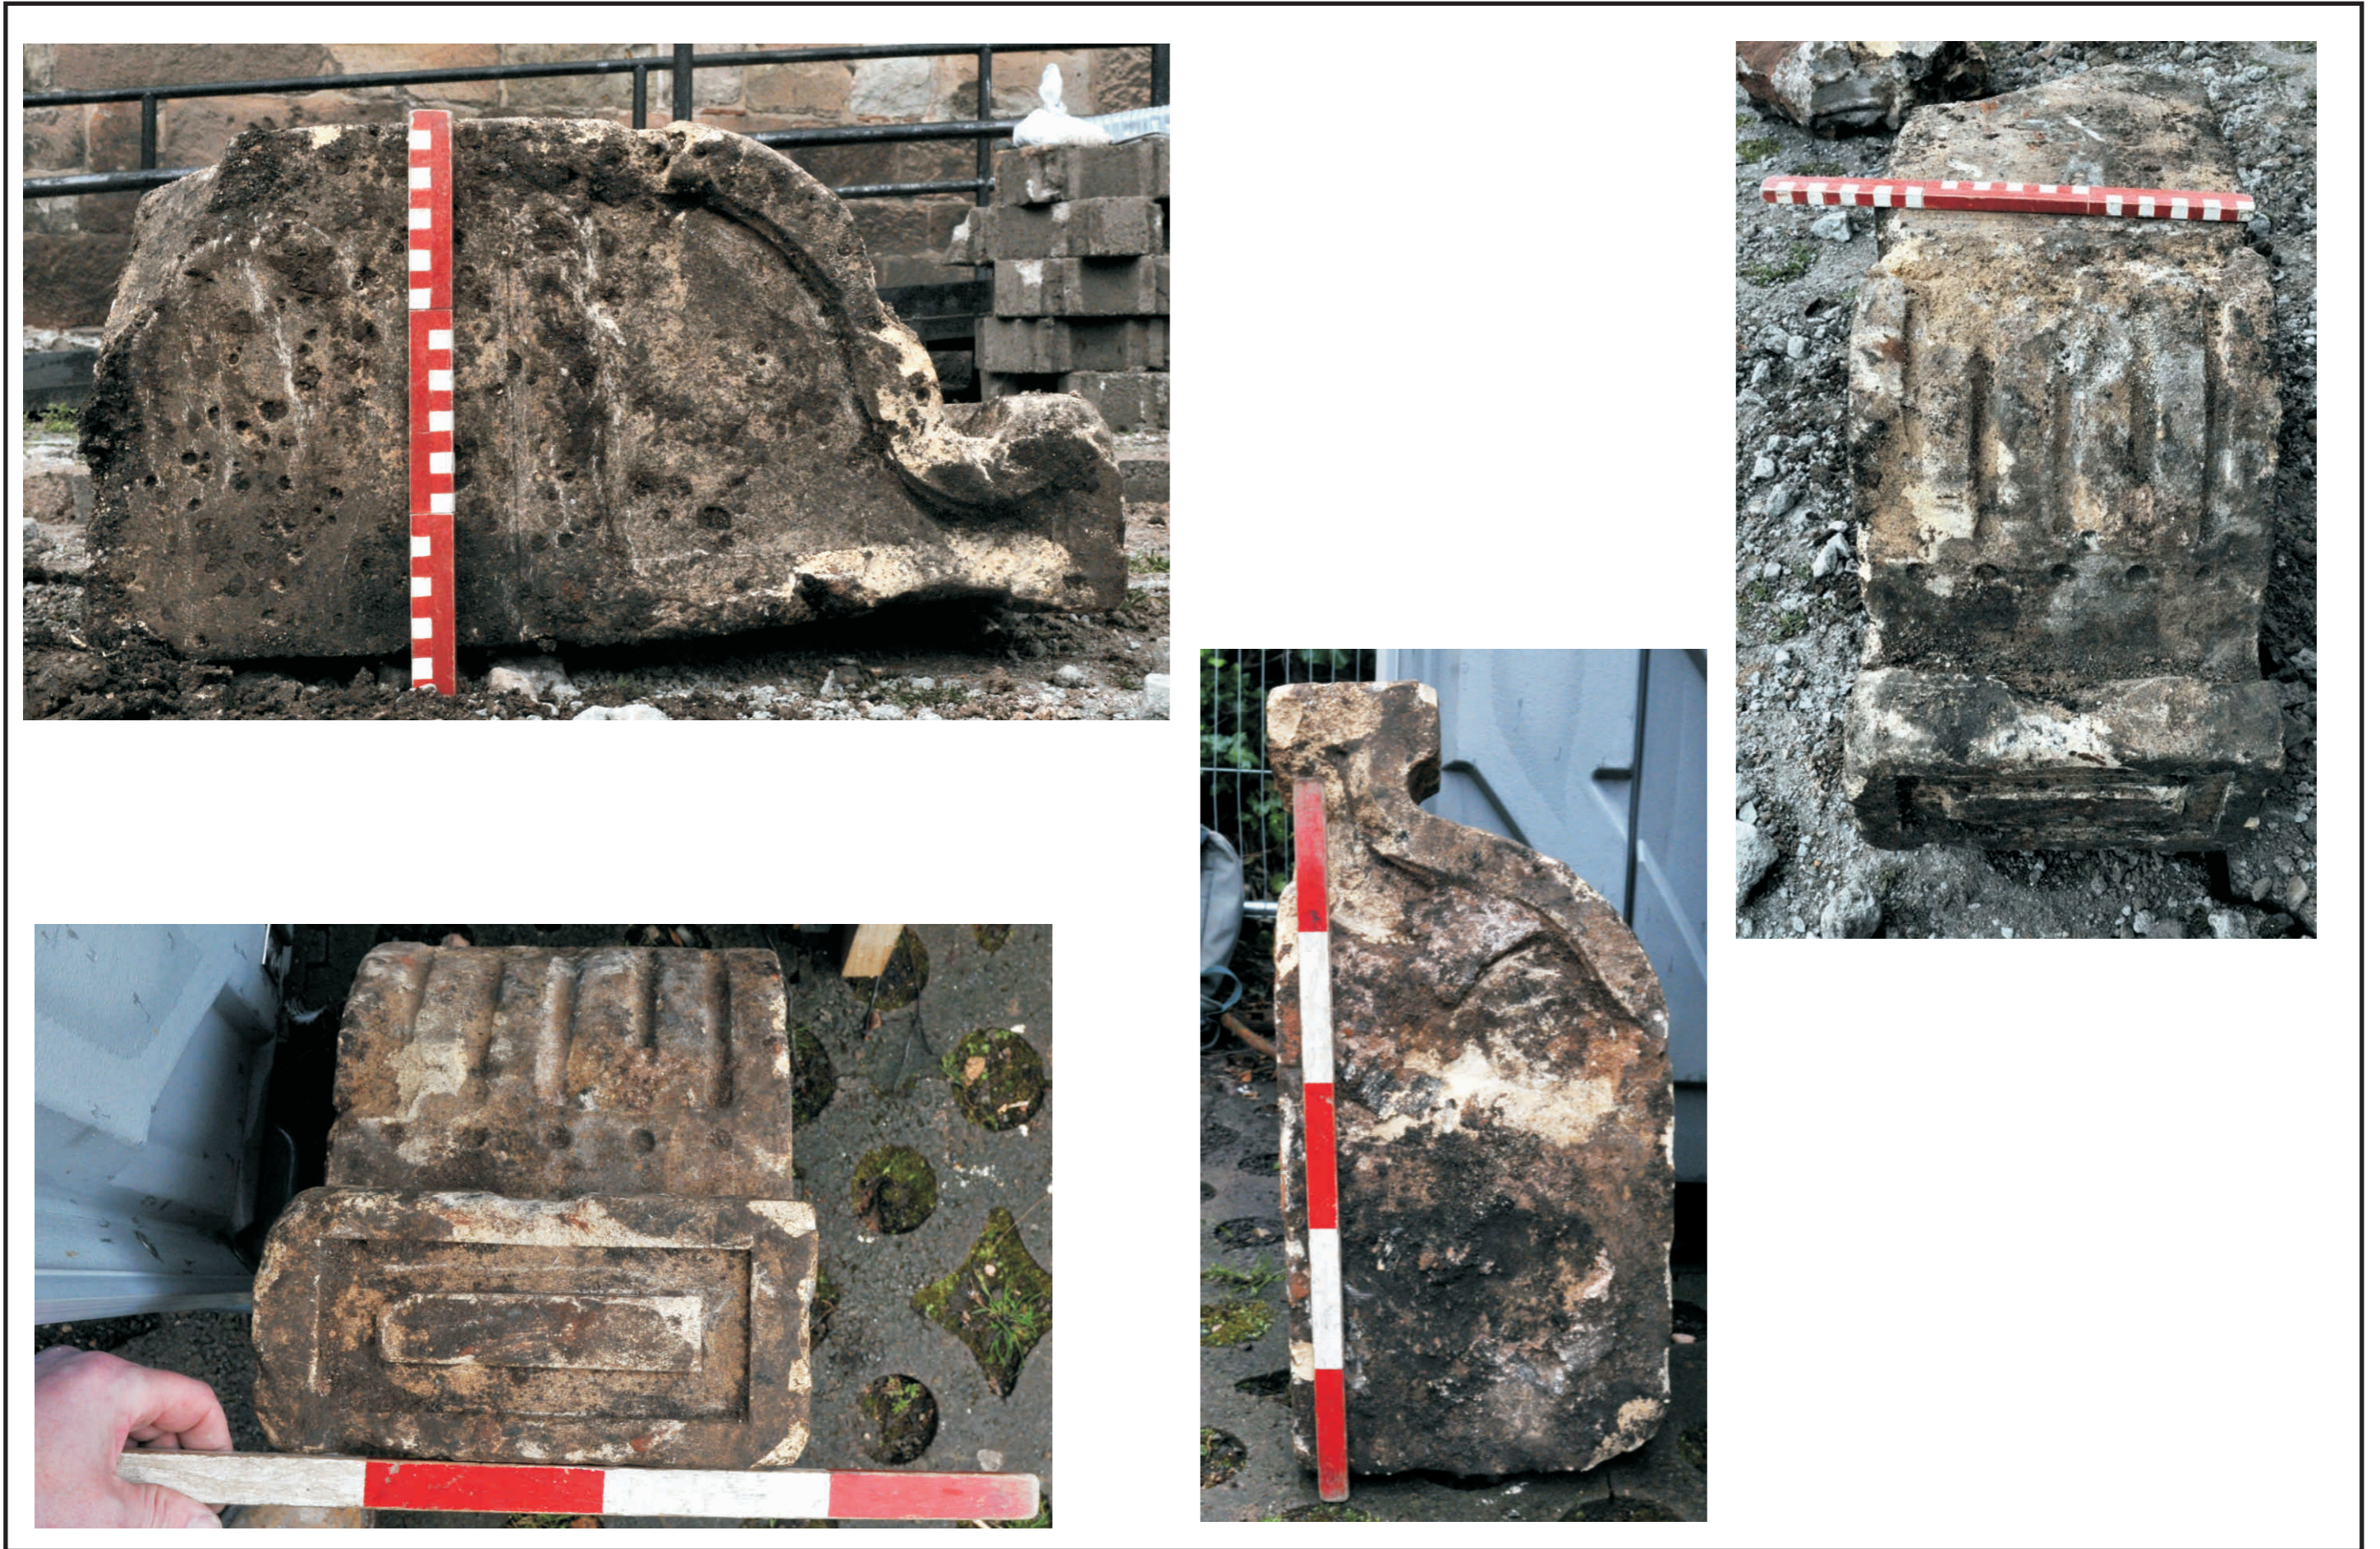
- 8.4 Block "E" (Fig 9) consisted of a massive stone corbel recovered from the foundation of the probable vestry building. The material was a moderately fine limestone. The form of the corbel was unusual, with a distinct outward turn to the toe. The body of the corbel was incised with five flutes terminating above similarly positioned dimples. The toe was decorated by a simple rectangular pane in a recessed rectangular field.

Figure 9: Substantial limestone corbel recovered from foundations of former vestry. Not retained (reburied on site) Approx dimensions 280x230x560mm.
