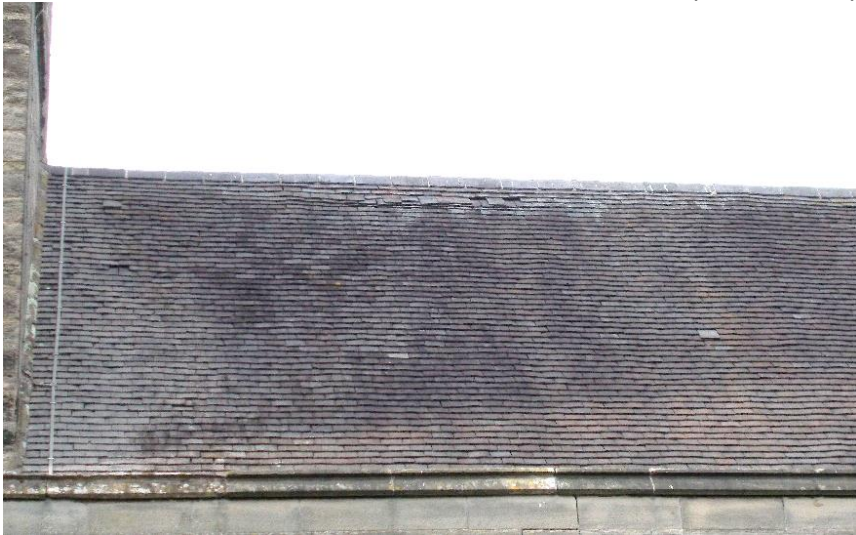
South Nave Roof – patches of slipping tiles:

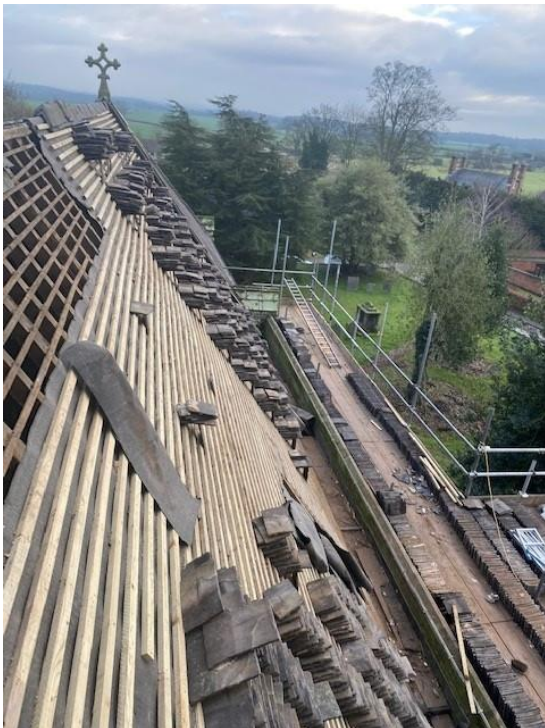
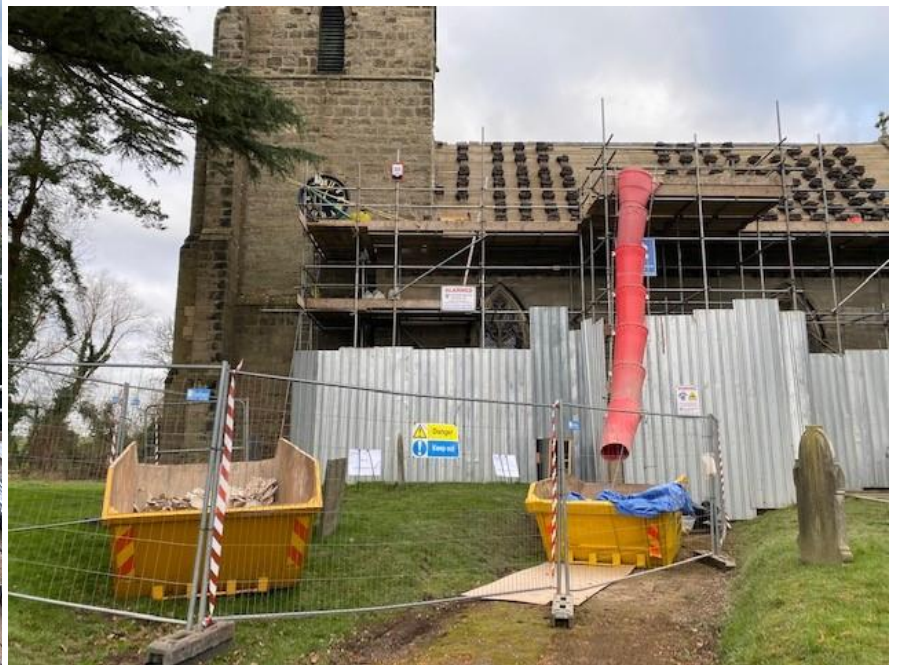
Roof work in progress:

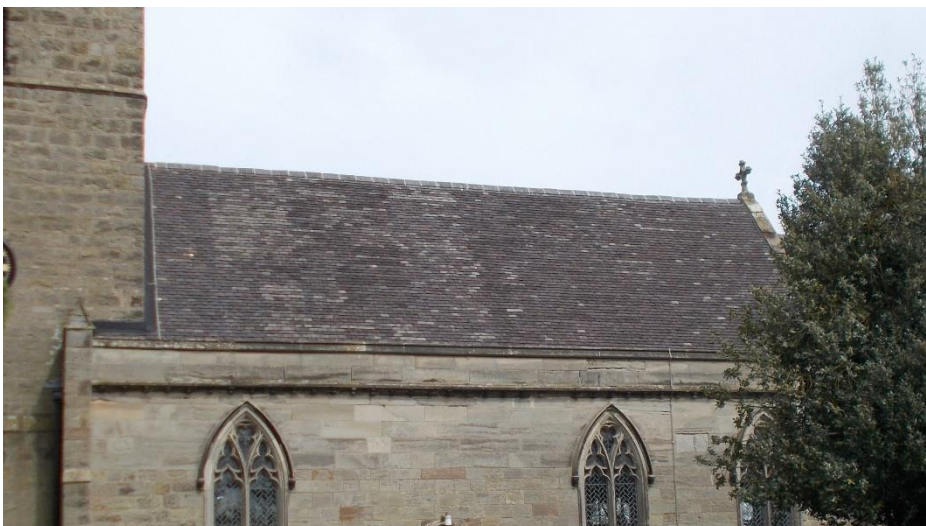
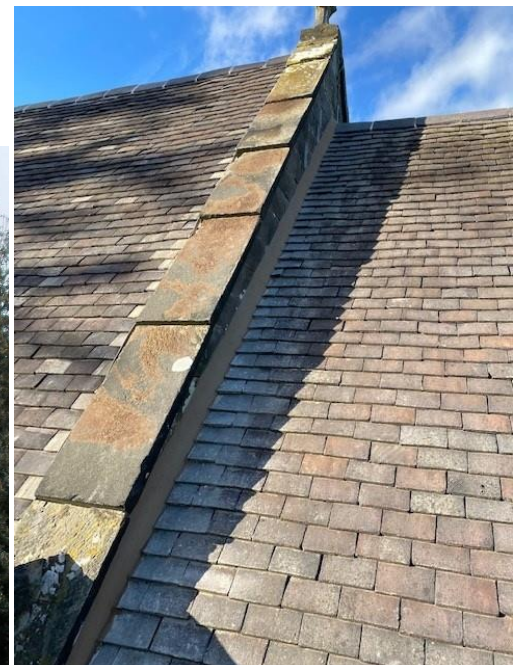
Roof done:

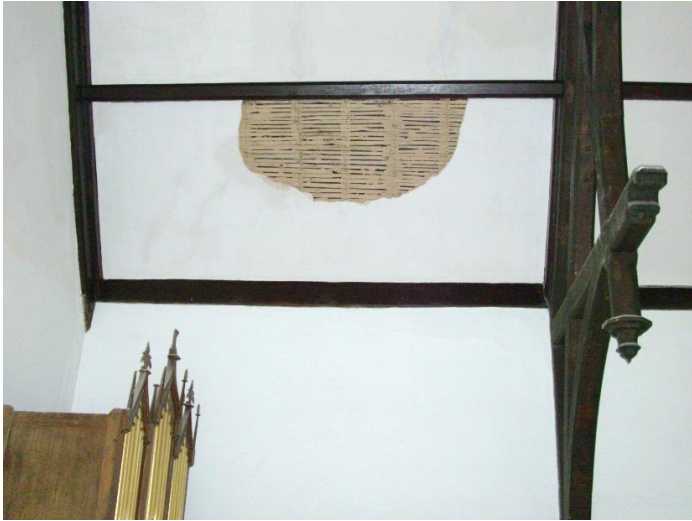
Nave Ceiling –plaster fall:

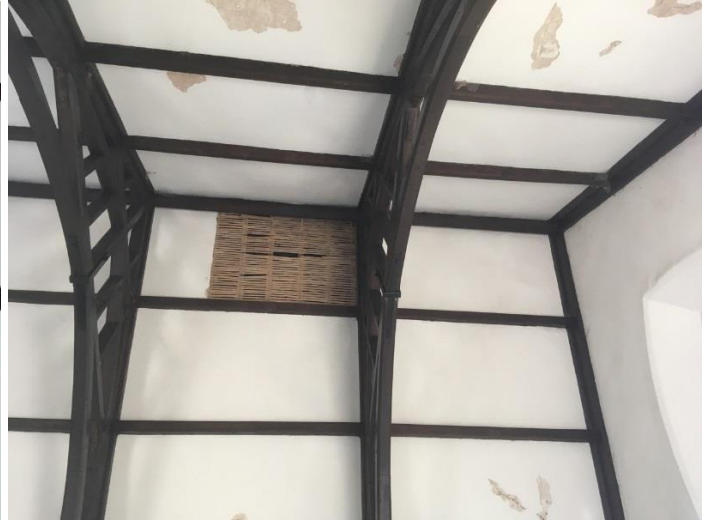
Chancel ceiling - plaster fall, after testing:

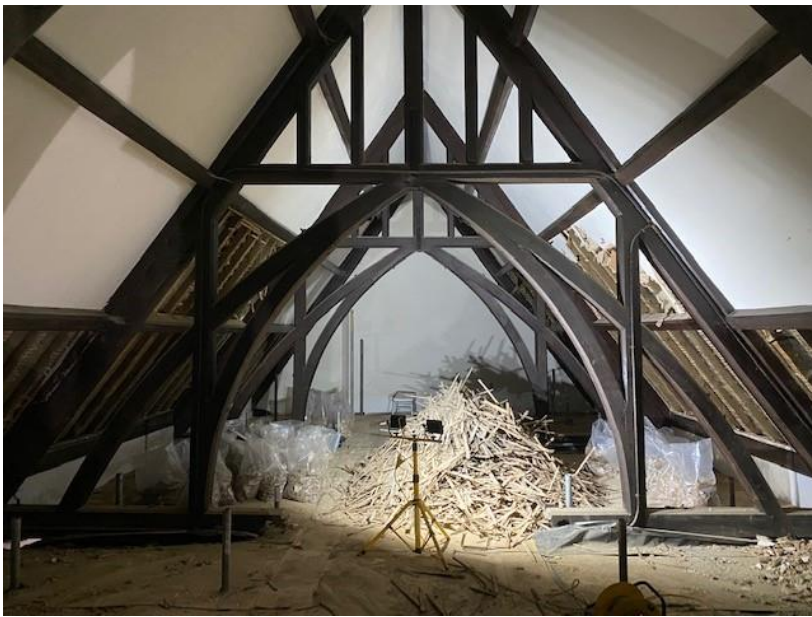
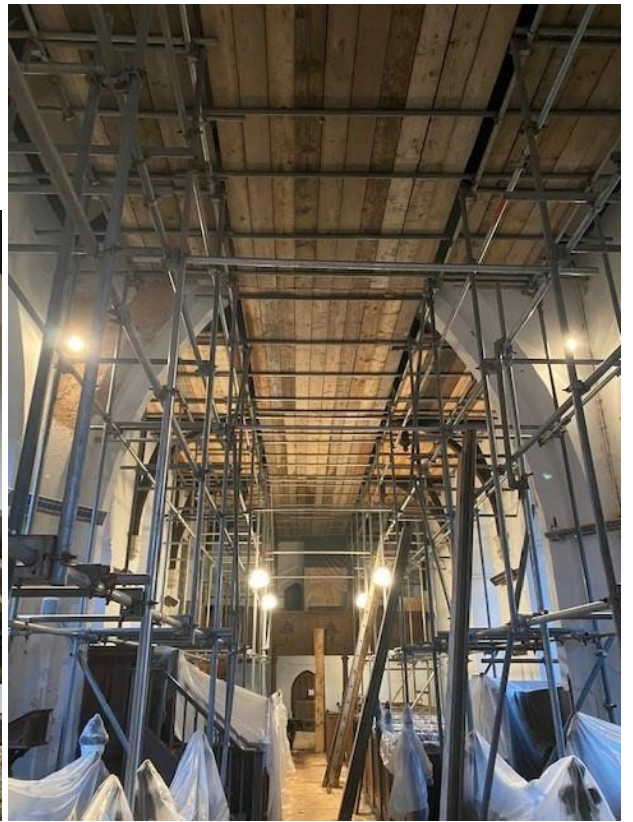
Ceilings work in progress

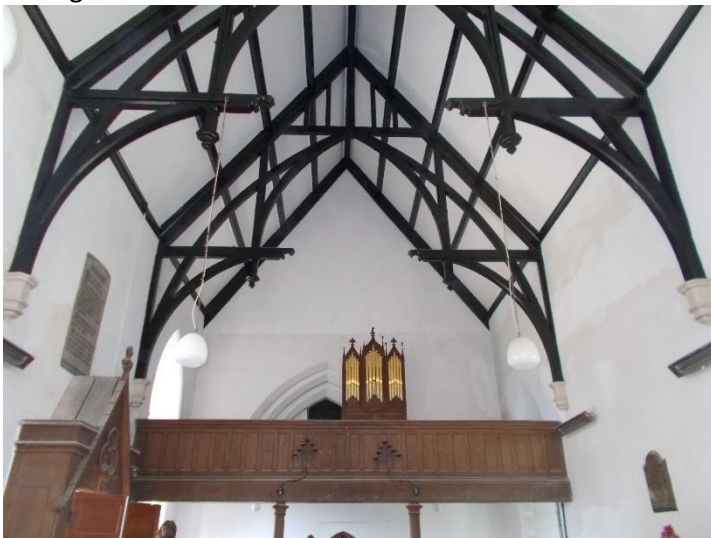
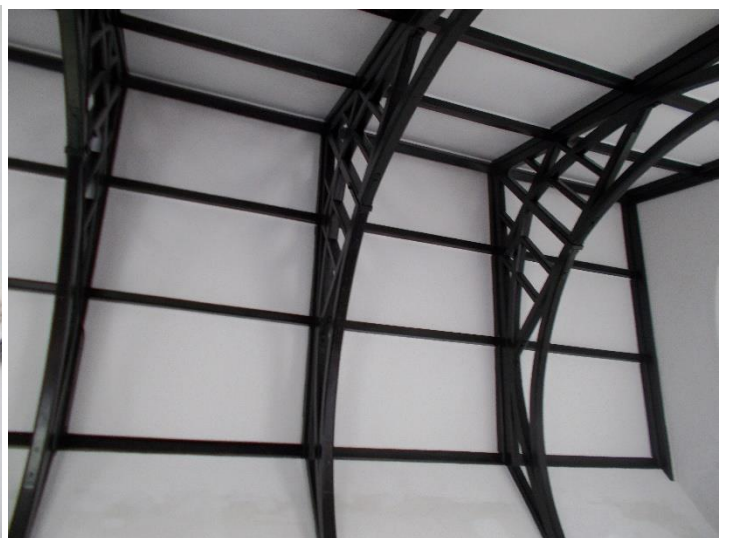
Ceilings done:

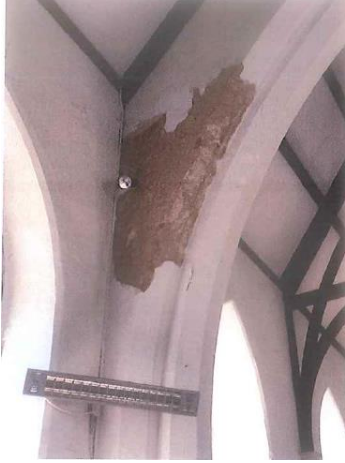
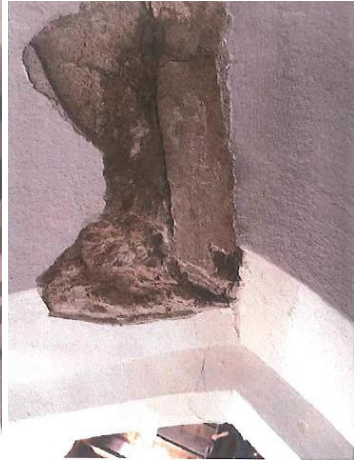
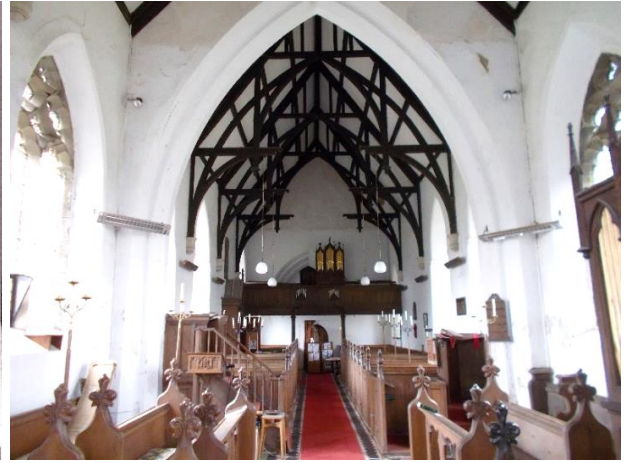
Wall plaster - various patches of failing plaster:

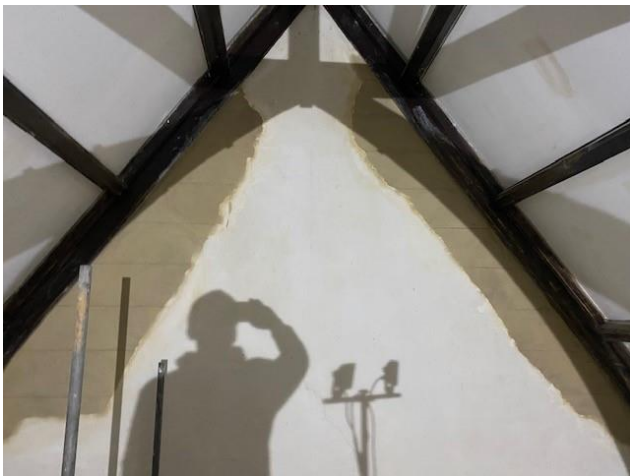
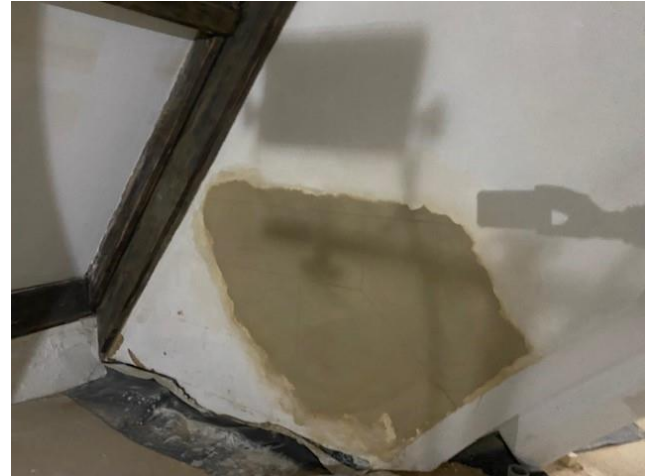
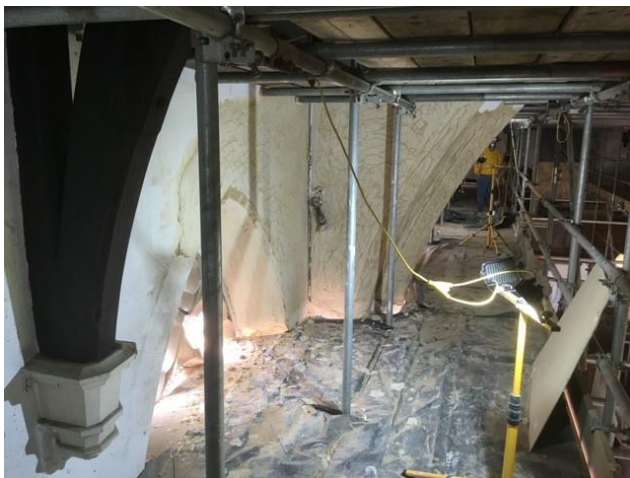
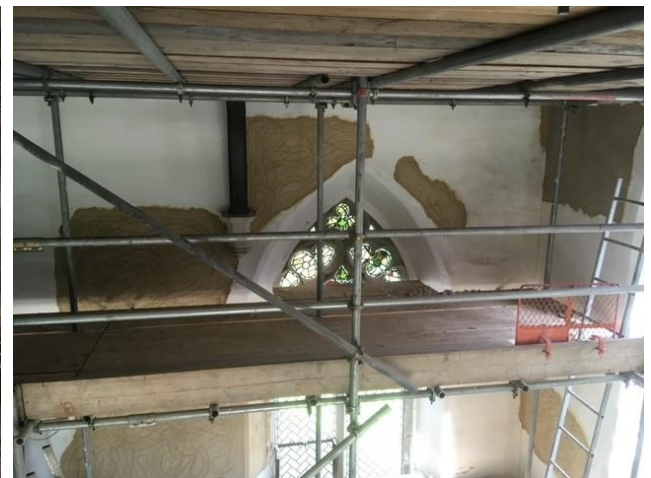
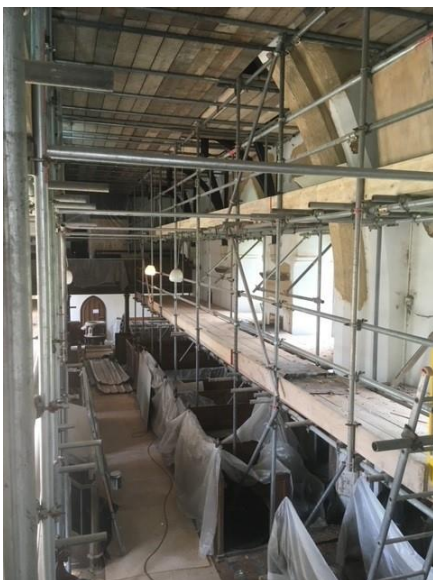
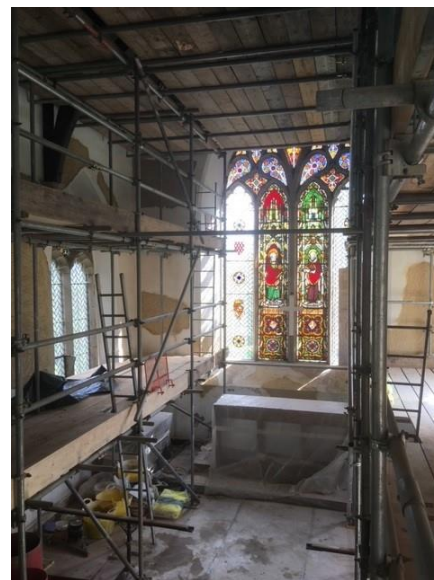
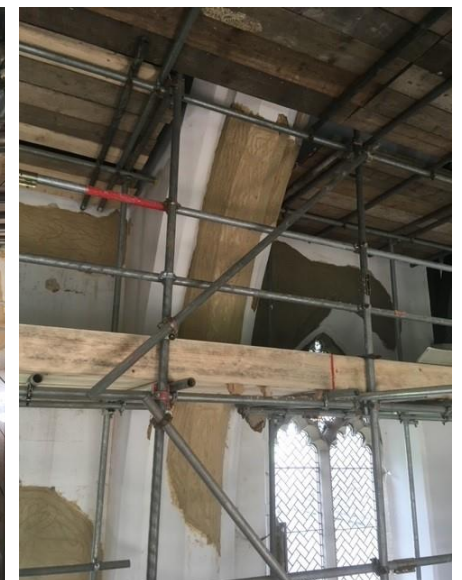
Plaster work in progress:

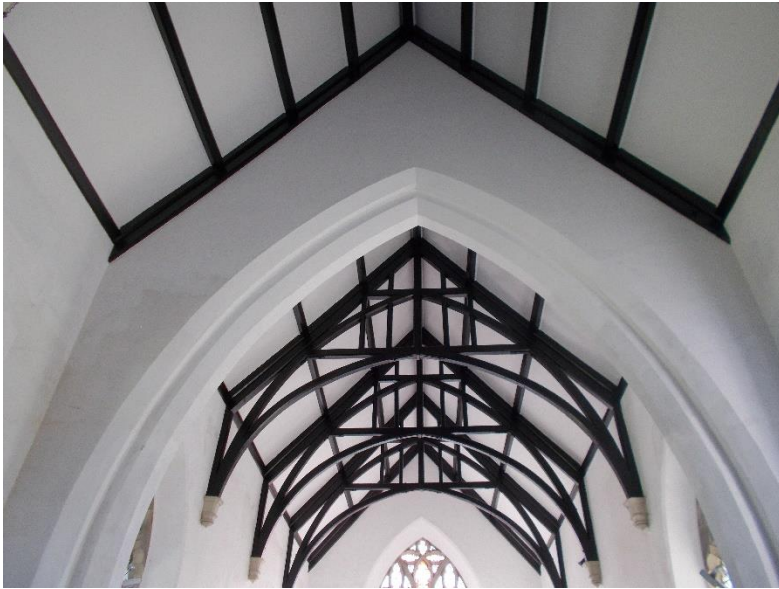
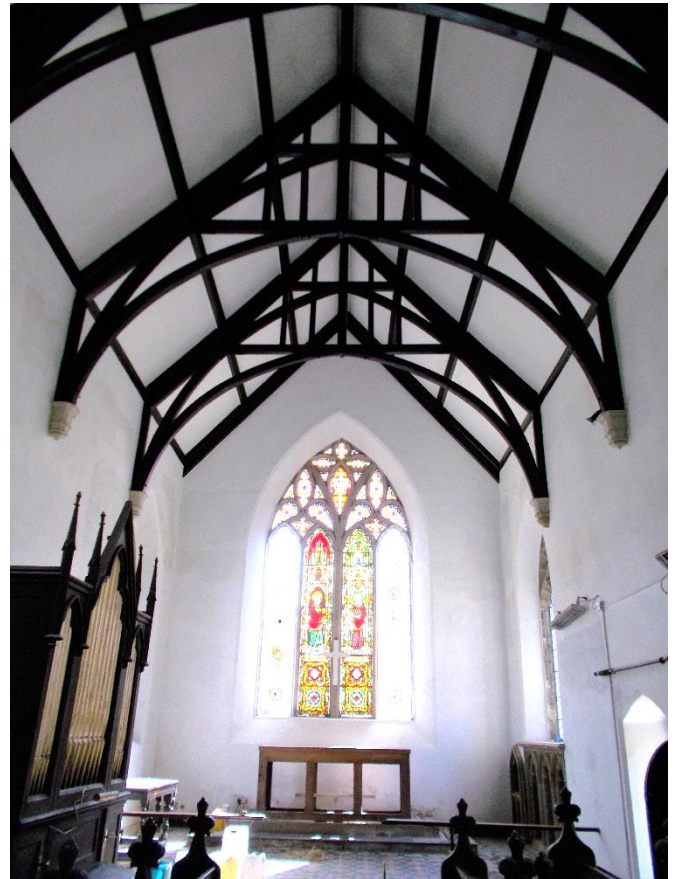
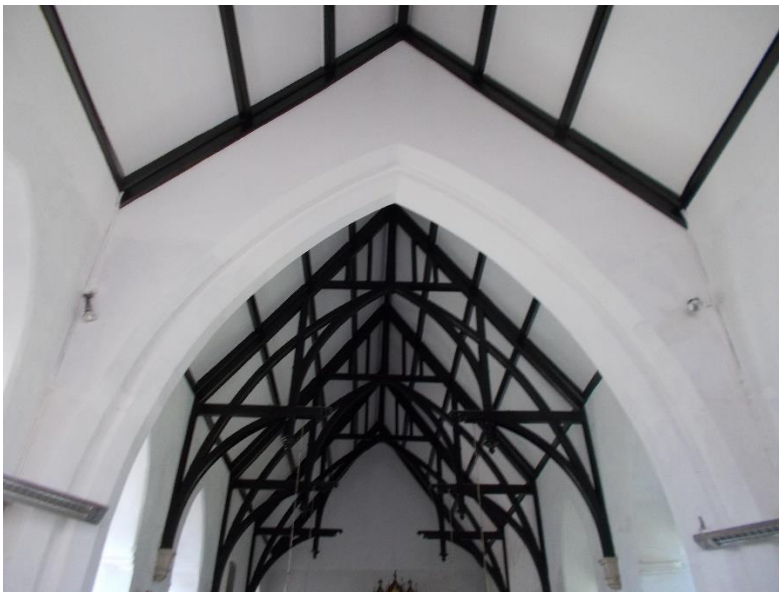
Walls done:

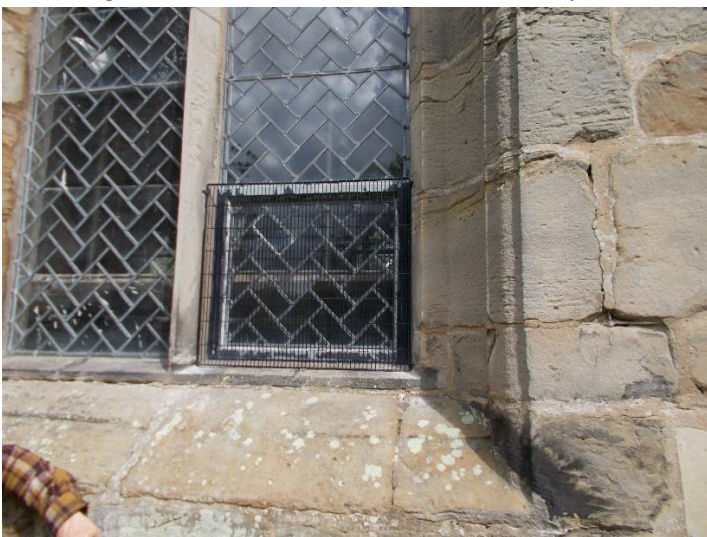
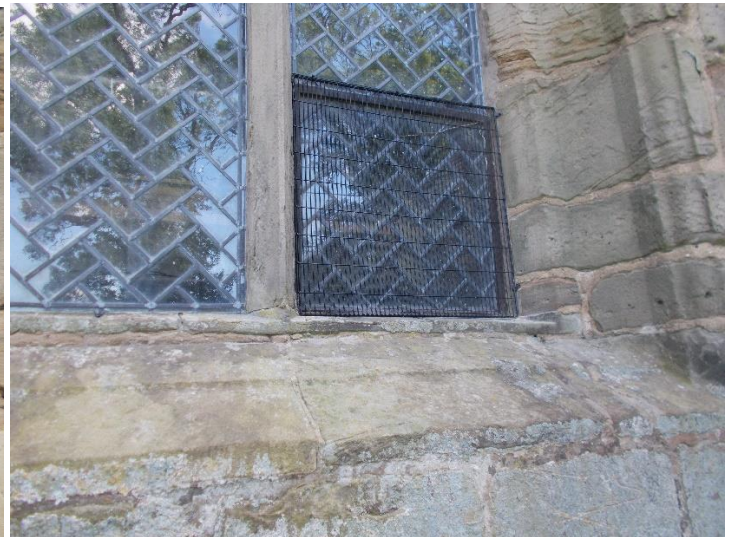
Window grills – for ventilation without bird entry:
